Profile/Photo Observation Report

Date:	04/09/2018	Weather:		Coding:	PACP 6.0
Pipe Length (ft):		Owner:	City of Hobart	Pre Clean:	Not Known
P.O.#:	219	Surveyor:	B. Helbling	PSR:	P-708-023-035
Customer:	City of Hobart	Clean Date:		Shape:	C

Street:	West 14th Street	Flow Control:	Not Controlled
City:	Hobart, IN	Year Renewed:	
Location:	Light Highway	Tape/Media #:	DEP219
Purpose:	Routine Assessment	Dia/Height:	12"
Use:	Sanitary	Material:	PVC
Drain Area:		Lining:	
Category:	NA		
Comment:	YES501824 Submittal 2		
Location Details:		Direction of Survey:	Upstream
US MH:	M-608-035	DS MH:	M-708-023
		Total Length Surveyed (ft):	74.3

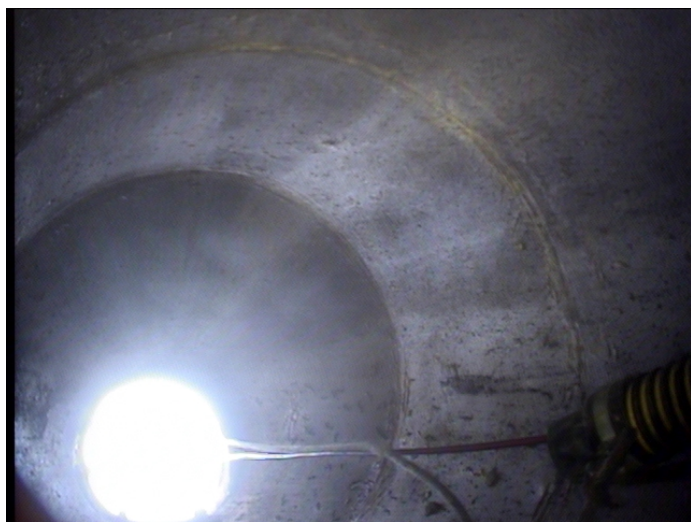
Code: **AMH**
Description: **Manhole**

Distance (ft): **.0**
Structural Grade: **0**
O&M Grade: **0**
Clock Start/From:
Clock To:
1st Value:
2nd Value:
Value Percent:
Continuous Index:
Within 8" of Joint: **NO**
Remarks: **M-608-035**

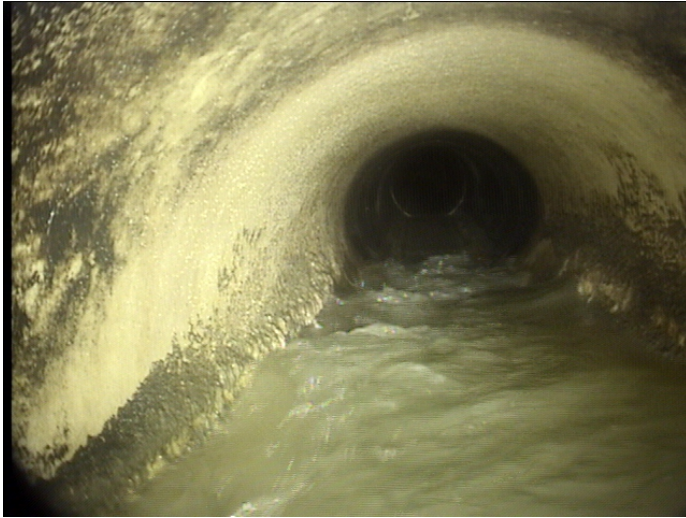
Code:	MWL
Description:	Water Level
Distance (ft):	.0
Structural Grade:	0
O&M Grade:	0
Clock Start/From:	
Clock To:	
1st Value:	
2nd Value:	
Value Percent:	10.000
Continuous Index:	
Within 8" of Joint:	NO
Remarks:

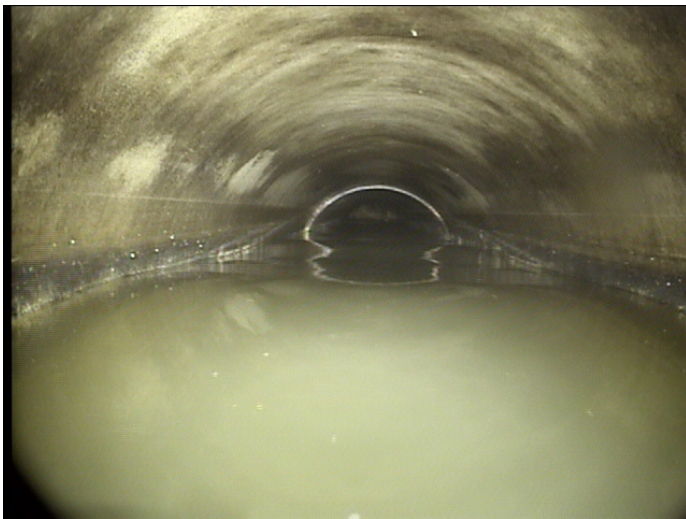
Code:	MWL
Description:	Water Level
Distance (ft):	67.3
Structural Grade:	0
O&M Grade:	0
Clock Start/From:	
Clock To:	
1st Value:	
2nd Value:	
Value Percent:	50.000
Continuous Index:	
Within 8" of Joint:	NO
Remarks:

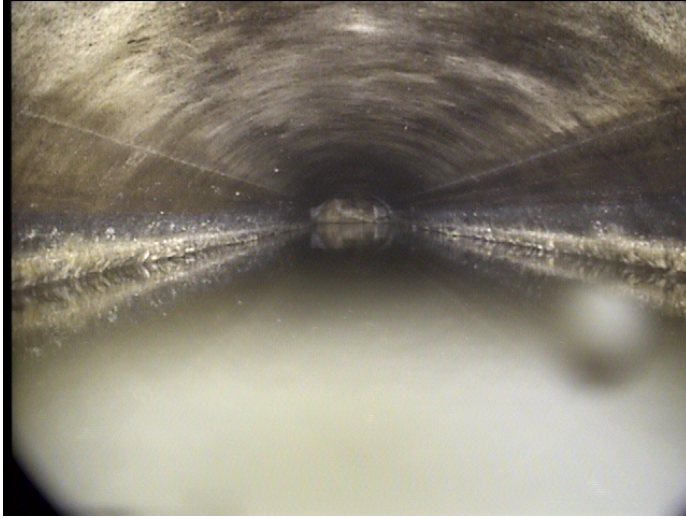
Code:	MSA
Description:	Abandoned Survey
Distance (ft):	74.3
Structural Grade:	0
O&M Grade:	0
Clock Start/From:	
Clock To:	
1st Value:	
2nd Value:	
Value Percent:	
Continuous Index:	
Within 8" of Joint:	NO
Remarks:	Cannot pass debris under flow
