Profile/Photo Observation Report

| Street: | FOXCROFT STREET | Flow Control: | Not Controlled |
| City: | Hobart, IN | Year Renewed: | |
| US MH: | M-608-038 | DS MH: | M-608-039 |

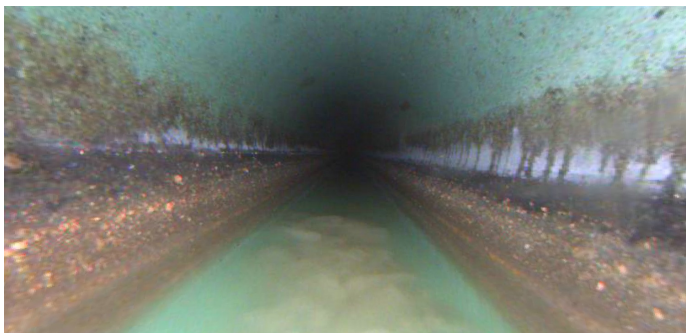
Code: **AMH**
Description: **Manhole**

Distance (ft): **.0**
Structural Grade: **0**
O&M Grade: **0**
Clock Start/From:
Clock To:
1st Value:
2nd Value:
Value Percent:
Continuous Index:
Within 8" of Joint: **NO**
Remarks: **M-608-039**

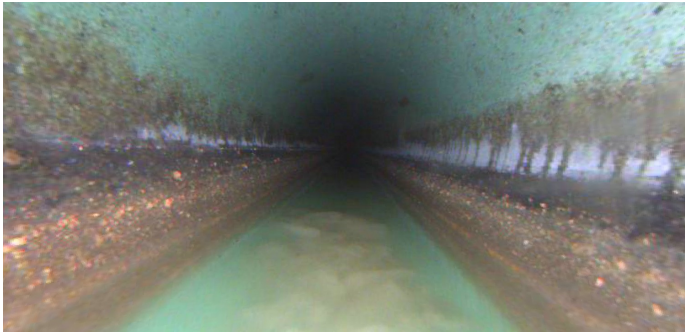
| Code: | MWL |
| Description: | Water Level |

| Value Percent: | 20.000 |

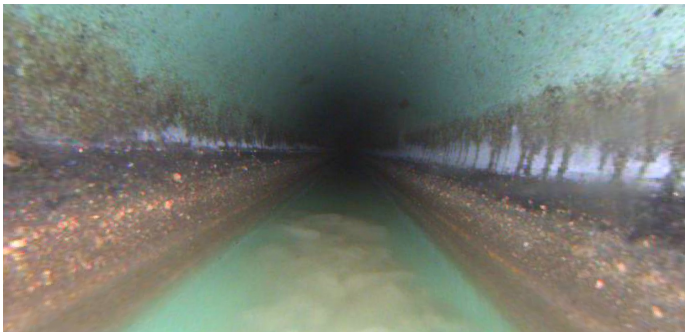
| Code: | DAGS |
| Description: | Deposits Attached Grease |

| O&M Grade: | 2 |
| Clock Start/From: | 8 |
| Clock To: | 4 |
| Value Percent: | 5.000 |

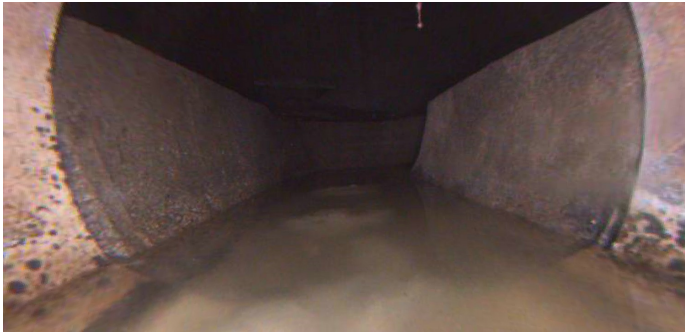
Code: **DAGS**
Description: **Deposits Attached Grease**

Distance (ft): **30.2**
Structural Grade: **0**
O&M Grade: **2**
Clock Start/From: **8**
Clock To: **4**
1st Value:
2nd Value:
Value Percent: **5.000**
Continuous Index: **F01**
Within 8" of Joint: **NO**
Remarks:

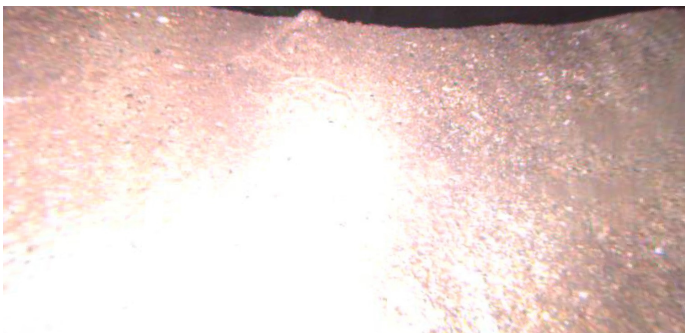
Code: **AMH**
Description: **Manhole**

Distance (ft): **32.4**
Structural Grade: **0**
O&M Grade: **0**
Clock Start/From:
Clock To:
1st Value:
2nd Value:
Value Percent:
Continuous Index:
Within 8" of Joint: **NO**
Remarks: **M-608-038**
