Profile/Ph	oto Observatior	n Report				RedZone
Date: Pipe Length (ft P.O.#:	03/30/2018): 339.2	Weather: Owner: Surveyor:	NA Mark Ru	by	Coding: Pre Clean: PSR:	PACP 6.0 No Pre-Cleaning P-608-040-041
Customer:		Clean Date	e: 01/01/1 9	000	Shape:	С
Street: WASHINGTON ST & ST MARY CIR		Flow Cont	Flow Control:			
City:	Hobart, IN		Year Rene	wed:		
Location:	Light Highway		Tape/Med	ia #:		
Purpose:	Routine Assessme	ent	Dia/Height	t:	10"	
Use:	Sanitary		Material:		PVC	
Drain Area:	NA		Lining:			
Category:	NA					
Comment:	Flow direction wro	Flow direction wrong				
Location Detail	ls:		Direction of	of Survey:	Downstream	
US MH:	M-608-041	DS MH:	M-608-040	Тс	otal Length Surveyed (ft)	: 337.8
D&M Index:	0.00	O&M Quicl	k:	0000	O&M Rating:	0.00
Structural Index:	0.00	Structural (Quick:	0000	Structural Rating:	0.00
Overall Index:	0.00	Overall Qui	ick:	0000	Overall Rating:	0.00

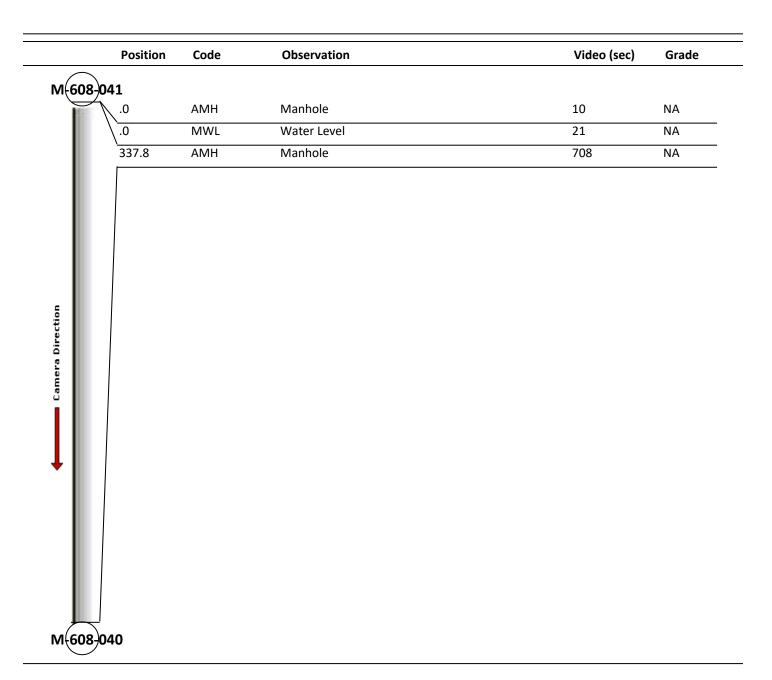
Code:	АМН	
Description:	Manhole	
Distance (ft):	.0	
Structural Grade:	0	
O&M Grade:	0	
Clock Start/From:		
Clock To:		
1st Value:		
2nd Value:		
Value Percent:		
Continuous Index:		
Within 8" of Joint:	NO	
Remarks:	M-608-041
