## Profile/Photo Observation Report

Date:	<b>10/18/2021</b>	Weather:		Coding:	<b>PACP 6.0</b>
Pipe Length (ft):		Owner:	<b>Hobart, IN</b>	Pre Clean:	<b>Not Known</b>
P.O.#:	<b>885_1</b>	Surveyor:	<b>M. Pielacha</b>	PSR:	<b>P-703-001-002</b>
Customer:	<b>Hobart, IN</b>	Clean Date:		Shape:	<b>C</b>

Street:	<b>Pheasant Run Drive</b>	Flow Control:	
City:	<b>Hobart, IN</b>	Year Renewed:	
Location:	<b>Light Highway</b>	Tape/Media #:	<b>885</b>
Purpose:	<b>Routine Assessment</b>	Dia/Height:	<b>8"</b>
Use:	<b>Sanitary</b>	Material:	<b>PVC</b>
Drain Area:		Lining:	
Category:	<b>NA</b>		
Comment:

Location Details:		Direction of Survey:	<b>Downstream</b>
US MH:	<b>M-703-2</b>	DS MH:	<b>M-703-1</b>
		Total Length Surveyed (ft):	<b>186.2</b>

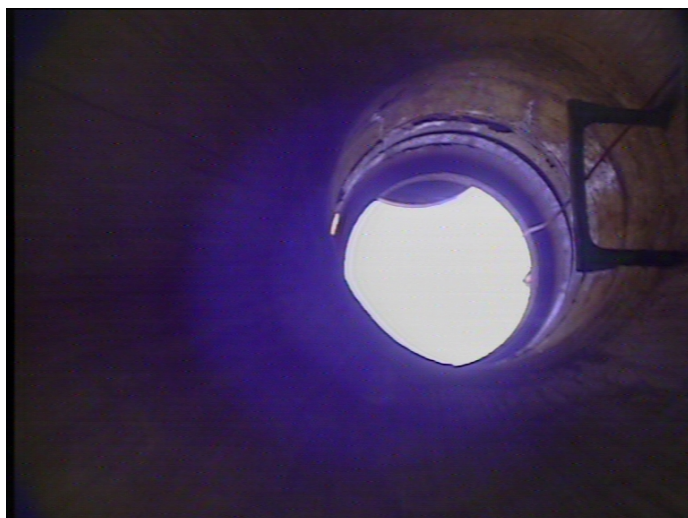
Code: **AMH**  
 Description: **Manhole**

Distance (ft): **.0**  
 Structural Grade: **0**  
 O&M Grade: **0**  
 Clock Start/From:  
 Clock To:  
 1st Value:  
 2nd Value:  
 Value Percent:  
 Continuous Index:  
 Within 8" of Joint: **NO**  
 Remarks: **M-703-2**

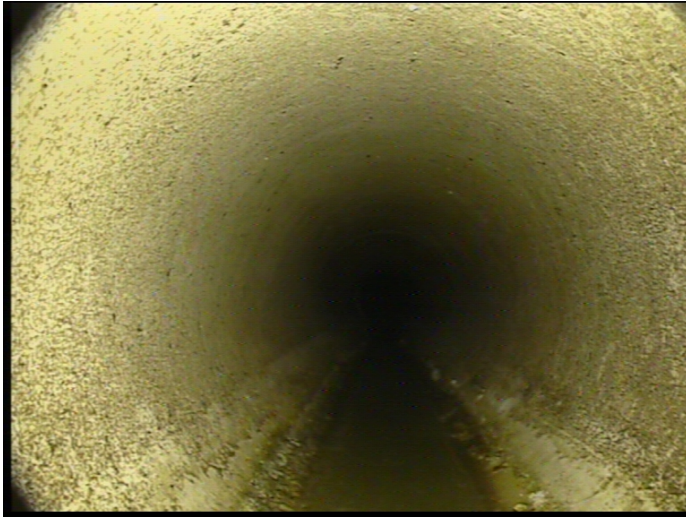
Code:	<b>MWL</b>
Description:	<b>Water Level</b>
Distance (ft):	<b>.0</b>
Structural Grade:	<b>0</b>
O&M Grade:	<b>0</b>
Clock Start/From:	
Clock To:	
1st Value:	
2nd Value:	
Value Percent:	<b>5.000</b>
Continuous Index:	
Within 8" of Joint:	<b>NO</b>
Remarks:

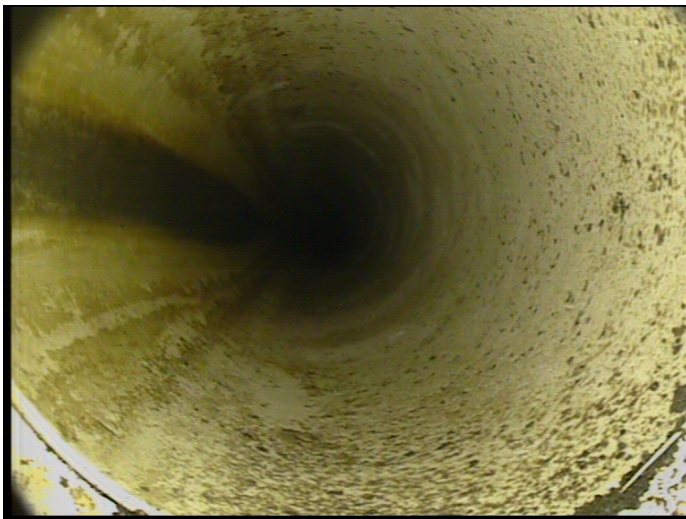
Code:	<b>TF</b>
Description:	<b>Tap Factory</b>
Distance (ft):	<b>11.8</b>
Structural Grade:	<b>0</b>
O&M Grade:	<b>0</b>
Clock Start/From:	<b>9</b>
Clock To:	
1st Value:	<b>4.000</b>
2nd Value:	
Value Percent:	
Continuous Index:	
Within 8" of Joint:	<b>NO</b>
Remarks:

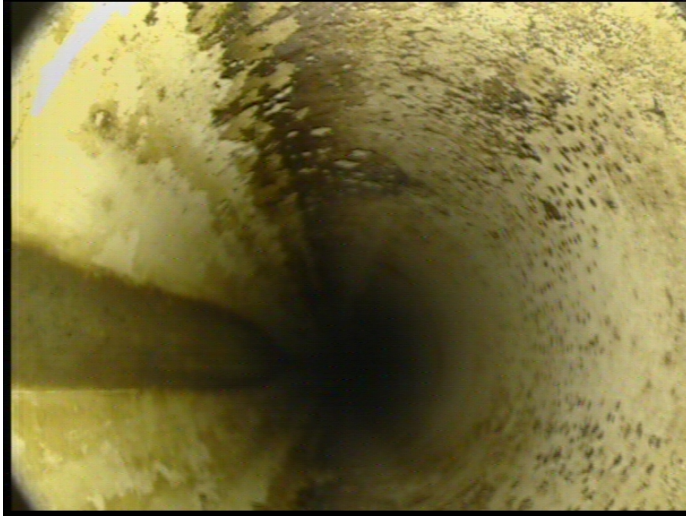
Code: **TF**  
Description: **Tap Factory**

Distance (ft): **87.1**  
Structural Grade: **0**  
O&M Grade: **0**  
Clock Start/From: **9**  
Clock To:  
1st Value: **4.000**  
2nd Value:  
Value Percent:  
Continuous Index:  
Within 8" of Joint: **NO**  
Remarks:

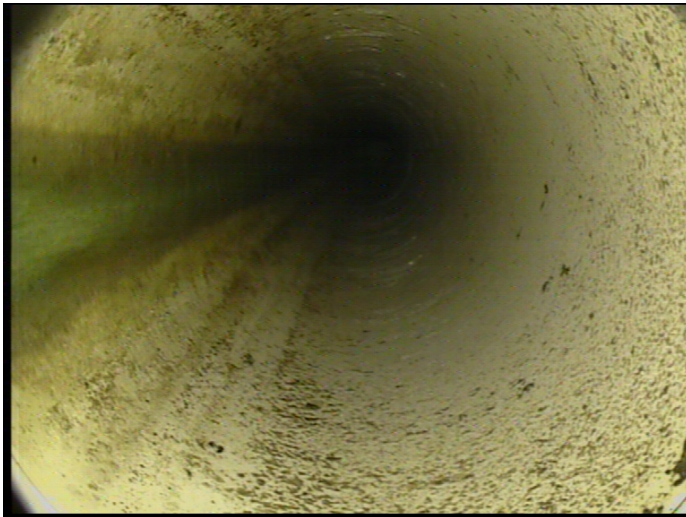
Code: **TF**  
Description: **Tap Factory**

Distance (ft): **152.3**  
Structural Grade: **0**  
O&M Grade: **0**  
Clock Start/From: **9**  
Clock To:  
1st Value: **4.000**  
2nd Value:  
Value Percent:  
Continuous Index:  
Within 8" of Joint: **NO**  
Remarks:

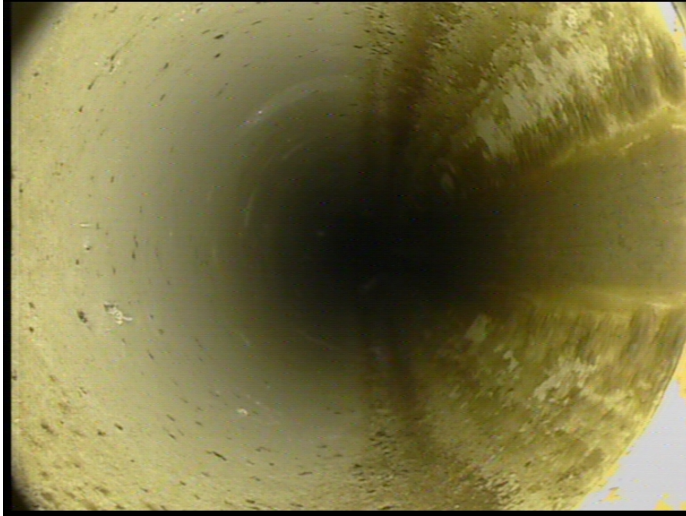
Code: **TF**  
Description: **Tap Factory**

Distance (ft): **163.1**  
Structural Grade: **0**  
O&M Grade: **0**  
Clock Start/From: **3**  
Clock To:  
1st Value: **4.000**  
2nd Value:  
Value Percent:  
Continuous Index:  
Within 8" of Joint: **NO**  
Remarks:

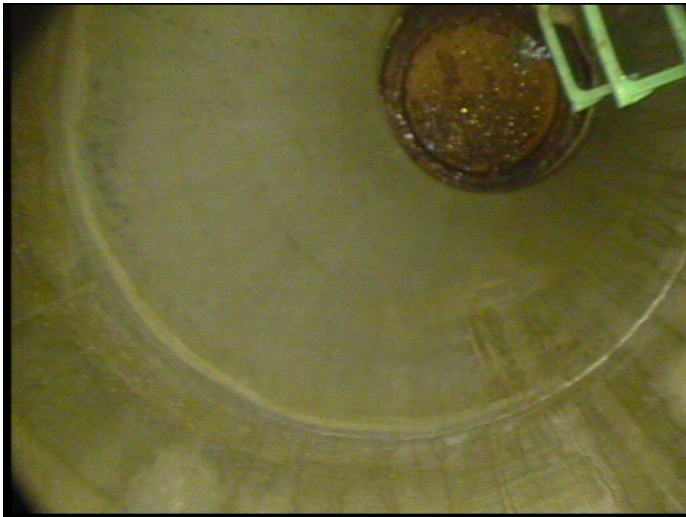
Code: **AMH**  
Description: **Manhole**

Distance (ft): **186.2**  
Structural Grade: **0**  
O&M Grade: **0**  
Clock Start/From:  
Clock To:  
1st Value:  
2nd Value:  
Value Percent:  
Continuous Index:  
Within 8" of Joint: **NO**  
Remarks: **M-703-1**
