## Profile/Photo Observation Report

| P.O.#: | | Surveyor: | <b>Justin Gonzales</b> | PSR: | <b>P-703-007-006</b> |

| Street: | <b>EDGEWATER DR</b> | Flow Control: | <b>Not Controlled</b> |

| US MH: | <b>M-703-006</b> | DS MH: | <b>M-703-007</b> |

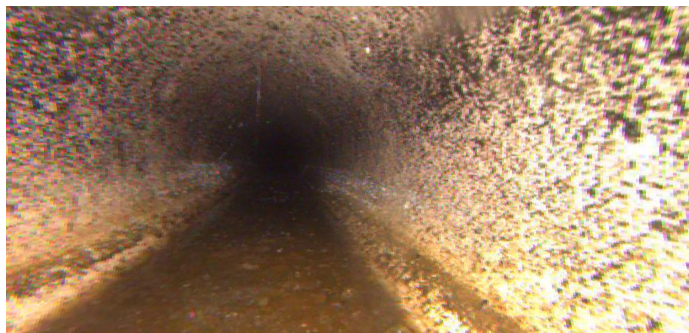
Code: **AMH**  
Description: **Manhole**

Distance (ft): **.0**  
Structural Grade: **0**  
O&M Grade: **0**  
Clock Start/From:  
Clock To:  
1st Value:  
2nd Value:  
Value Percent:  
Continuous Index:  
Within 8" of Joint: **NO**  
Remarks: **M-703-006**

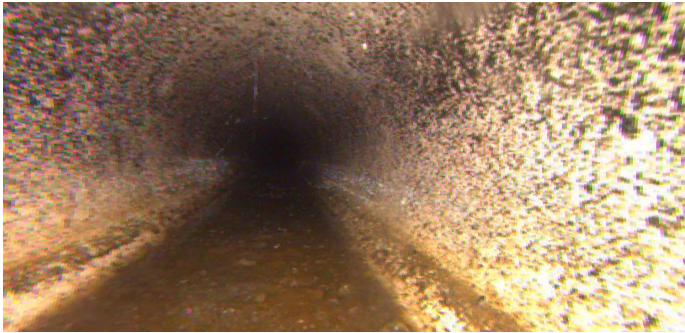
| Code: | <b>MWL</b> |
| Description: | <b>Water Level</b> |

| Value Percent: | <b>5.000</b> |

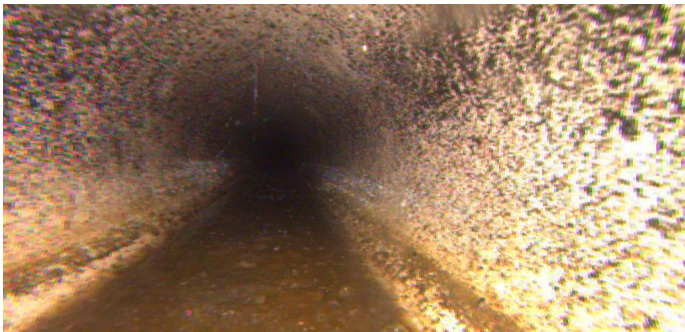
| Code: | <b>DAZ</b> |
| Description: | <b>Deposits Attached Other</b> |

| O&M Grade: | <b>2</b> |
| Clock Start/From: | <b>7</b> |
| Clock To: | <b>5</b> |
| Value Percent: | <b>5.000</b> |
| Remarks: | <b>WANDER</b> |

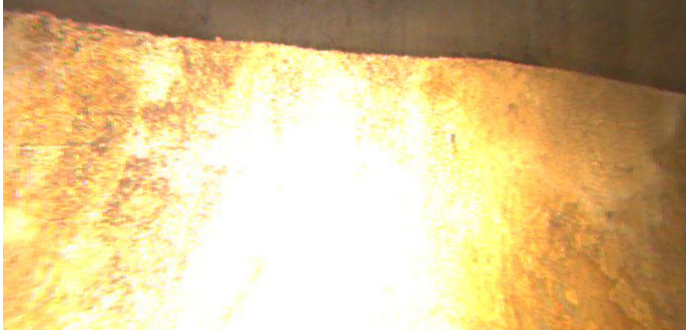
Code: **AMH**  
Description: **Manhole**

Distance (ft): **205.8**  
Structural Grade: **0**  
O&M Grade: **0**  
Clock Start/From:  
Clock To:  
1st Value:  
2nd Value:  
Value Percent:  
Continuous Index:  
Within 8" of Joint: **NO**  
Remarks: **M-703-007**

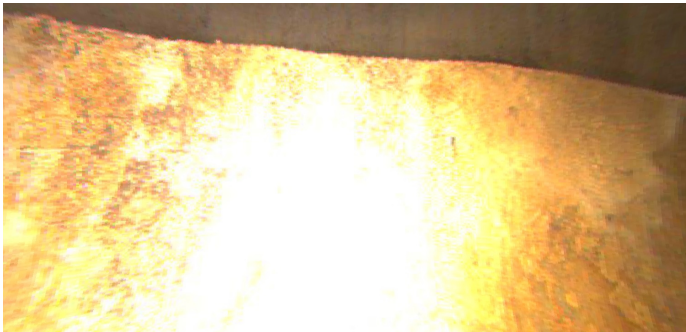
Code: **DAZ**  
Description: **Deposits Attached Other**

Distance (ft): **205.8**  
Structural Grade: **0**  
O&M Grade: **2**  
Clock Start/From: **7**  
Clock To: **5**  
1st Value:  
2nd Value:  
Value Percent: **5.000**  
Continuous Index: **F01**  
Within 8" of Joint: **YES**  
Remarks: **WANDER**
