## Profile/Photo Observation Report

Street:	<b>PHEASANT RUN DR</b>	Flow Control:	<b>Not Controlled</b>
City:	<b>Hobart, IN</b>	Year Renewed:	
Location:	<b>Other</b>	Tape/Media #:	
Purpose:	<b>Not Known</b>	Dia/Height:	<b>10"</b>
Use:	<b>Sanitary</b>	Material:	<b>PVC</b>
Drain Area:	<b>NA</b>	Lining:	
Category:	<b>NA</b>		
Comment:

Location Details:		Direction of Survey:	<b>Downstream</b>
US MH:	<b>M-703-010</b>	DS MH:	<b>M-703-011</b>
		Total Length Surveyed (ft):	<b>216.9</b>

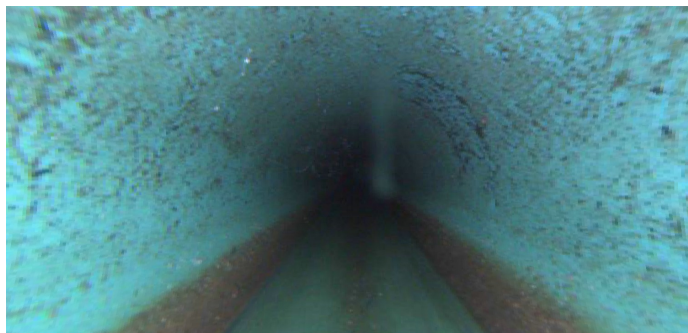
Code: **AMH**  
Description: **Manhole**

Distance (ft): **.0**  
Structural Grade: **0**  
O&M Grade: **0**  
Clock Start/From:  
Clock To:  
1st Value:  
2nd Value:  
Value Percent:  
Continuous Index:  
Within 8" of Joint: **NO**  
Remarks: **M-703-010**

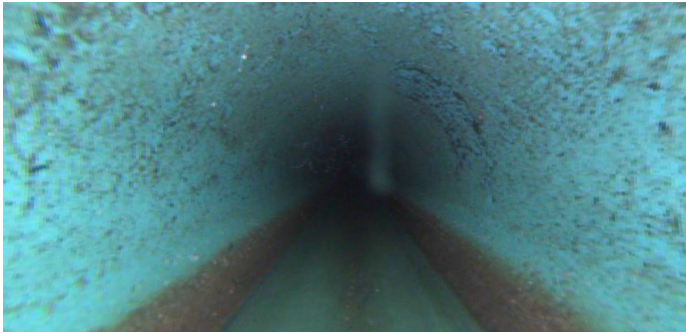
Code:	<b>MWL</b>
Description:	<b>Water Level</b>

Distance (ft):	<b>.0</b>
Structural Grade:	<b>0</b>
O&M Grade:	<b>0</b>
Clock Start/From:	
Clock To:	
1st Value:	
2nd Value:	
Value Percent:	<b>5.000</b>
Continuous Index:	
Within 8" of Joint:	<b>NO</b>
Remarks:

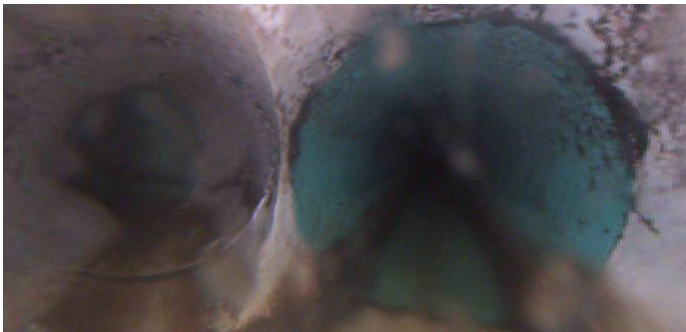
Code:	<b>TF</b>
Description:	<b>Tap Factory</b>

Distance (ft):	<b>28.7</b>
Structural Grade:	<b>0</b>
O&M Grade:	<b>0</b>
Clock Start/From:	<b>9</b>
Clock To:	
1st Value:	<b>6.000</b>
2nd Value:	
Value Percent:	
Continuous Index:	
Within 8" of Joint:	
Remarks:

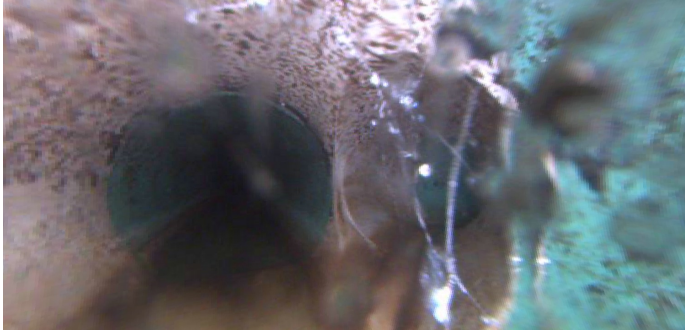
Code: **TF**  
Description: **Tap Factory**

Distance (ft): **35.2**  
Structural Grade: **0**  
O&M Grade: **0**  
Clock Start/From: **3**  
Clock To:  
1st Value: **4.000**  
2nd Value:  
Value Percent:  
Continuous Index:  
Within 8" of Joint:  
Remarks:

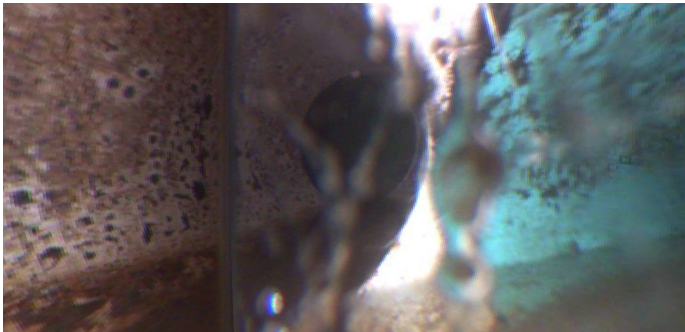
Code: **TF**  
Description: **Tap Factory**

Distance (ft): **116.5**  
Structural Grade: **0**  
O&M Grade: **0**  
Clock Start/From: **9**  
Clock To:  
1st Value: **4.000**  
2nd Value:  
Value Percent:  
Continuous Index:  
Within 8" of Joint:  
Remarks:

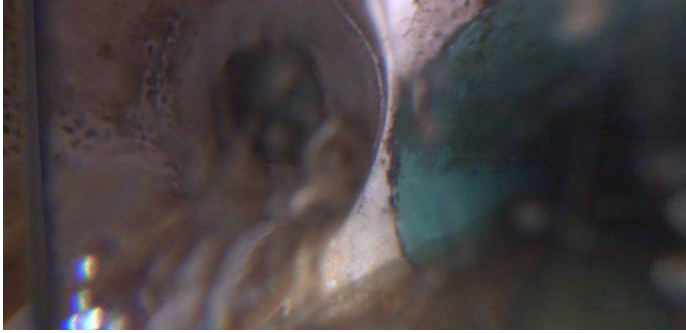
Code: **TF**  
Description: **Tap Factory**

Distance (ft): **179.5**  
Structural Grade: **0**  
O&M Grade: **0**  
Clock Start/From: **9**  
Clock To:  
1st Value: **4.000**  
2nd Value:  
Value Percent:  
Continuous Index:  
Within 8" of Joint:  
Remarks:

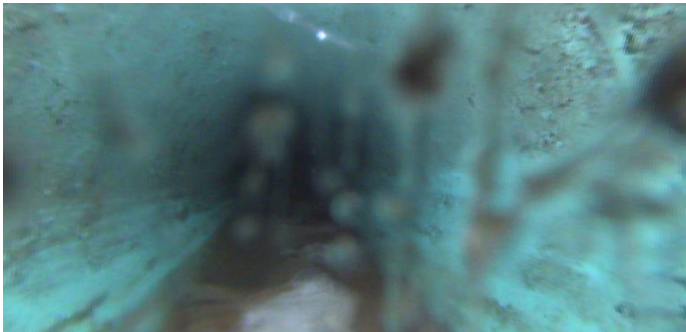
Code: **MGO**  
Description: **General Observation**

Distance (ft): **189.6**  
Structural Grade: **0**  
O&M Grade: **0**  
Clock Start/From:  
Clock To:  
1st Value:  
2nd Value:  
Value Percent:  
Continuous Index:  
Within 8" of Joint: **NO**  
Remarks: **TOILET TISSUE**
