## Profile/Photo Observation Report

Street:	<b>QUAIL DR</b>	Flow Control:	<b>Not Controlled</b>
City:	<b>Hobart, IN</b>	Year Renewed:	
Location:	<b>Other</b>	Tape/Media #:	
Purpose:	<b>Not Known</b>	Dia/Height:	<b>10"</b>
Use:	<b>Sanitary</b>	Material:	<b>PVC</b>
Drain Area:	<b>NA</b>	Lining:	
Category:	<b>NA</b>		
Comment:

Location Details:		Direction of Survey:	<b>Downstream</b>
US MH:	<b>M-703-015</b>	DS MH:	<b>M-703-014</b>
		Total Length Surveyed (ft):	<b>282.4</b>

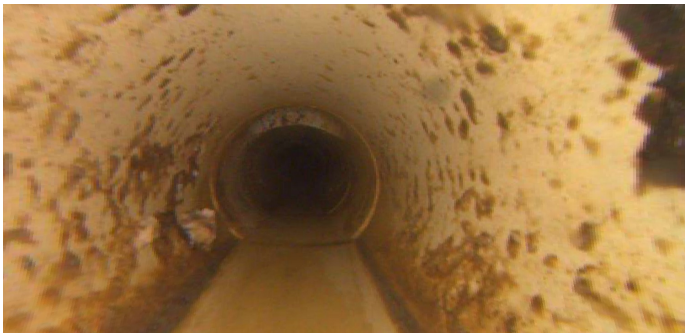
Code: **AMH**  
Description: **Manhole**

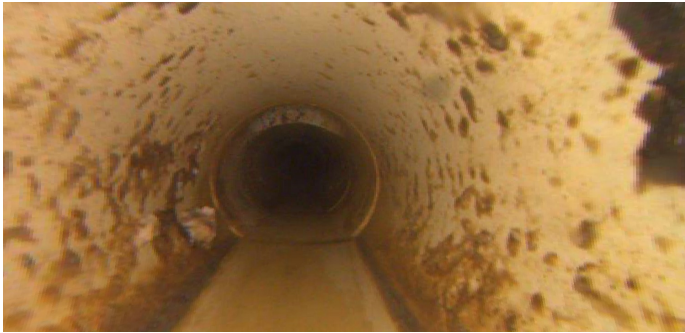
Code:	<b>MWL</b>
Description:	<b>Water Level</b>

Distance (ft):	<b>.0</b>
Structural Grade:	<b>0</b>
O&M Grade:	<b>0</b>
Clock Start/From:	
Clock To:	
1st Value:	
2nd Value:	
Value Percent:	<b>5.000</b>
Continuous Index:	
Within 8" of Joint:	<b>NO</b>
Remarks:

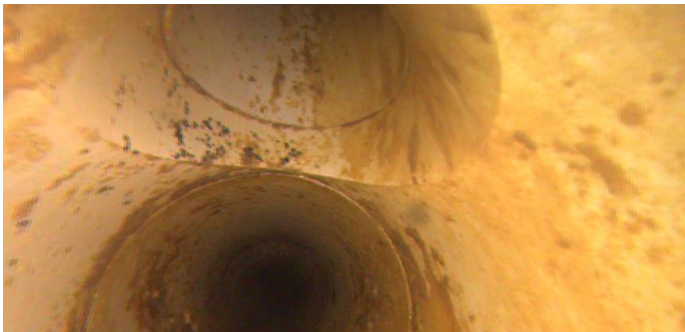
Code:	<b>TF</b>
Description:	<b>Tap Factory</b>

Distance (ft):	<b>2.5</b>
Structural Grade:	<b>0</b>
O&M Grade:	<b>0</b>
Clock Start/From:	<b>12</b>
Clock To:	
1st Value:	<b>4.000</b>
2nd Value:	
Value Percent:	
Continuous Index:	
Within 8" of Joint:	
Remarks:

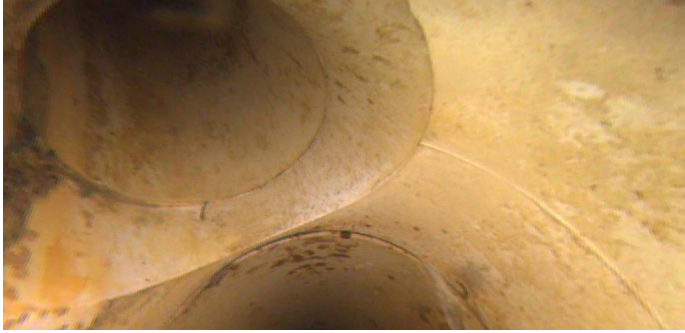
Code: **TF**  
Description: **Tap Factory**

Distance (ft): **56.6**  
Structural Grade: **0**  
O&M Grade: **0**  
Clock Start/From: **10**  
Clock To:  
1st Value: **4.000**  
2nd Value:  
Value Percent:  
Continuous Index:  
Within 8" of Joint:  
Remarks:

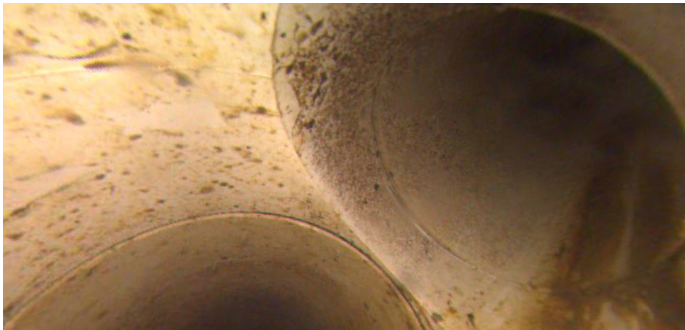
Code: **TF**  
Description: **Tap Factory**

Distance (ft): **74.7**  
Structural Grade: **0**  
O&M Grade: **0**  
Clock Start/From: **2**  
Clock To:  
1st Value: **4.000**  
2nd Value:  
Value Percent:  
Continuous Index:  
Within 8" of Joint:  
Remarks:

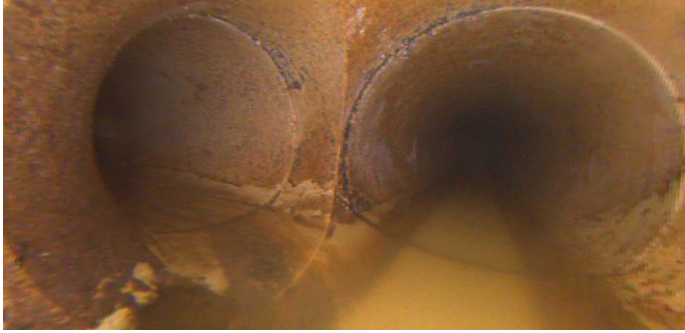
Code: **TF**  
Description: **Tap Factory**

Distance (ft): **131.9**  
Structural Grade: **0**  
O&M Grade: **0**  
Clock Start/From: **9**  
Clock To:  
1st Value: **4.000**  
2nd Value:  
Value Percent:  
Continuous Index:  
Within 8" of Joint:  
Remarks:

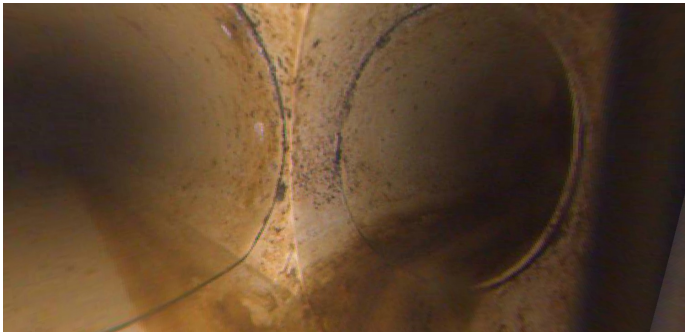
Code: **TF**  
Description: **Tap Factory**

Distance (ft): **152.8**  
Structural Grade: **0**  
O&M Grade: **0**  
Clock Start/From: **3**  
Clock To:  
1st Value: **4.000**  
2nd Value:  
Value Percent:  
Continuous Index:  
Within 8" of Joint:  
Remarks:

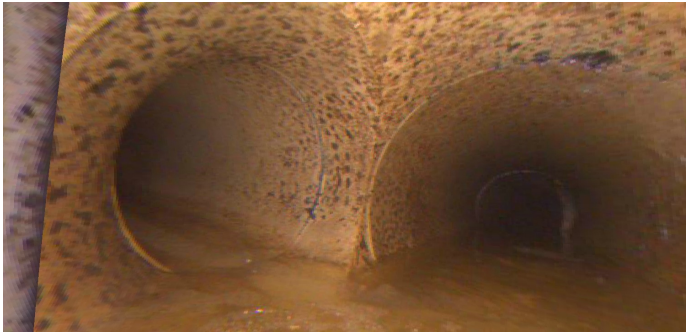
Code: **TFA**  
Description: **Tap Factory Active**

Distance (ft): **233.1**  
Structural Grade: **0**  
O&M Grade: **0**  
Clock Start/From: **9**  
Clock To:  
1st Value: **4.000**  
2nd Value:  
Value Percent:  
Continuous Index:  
Within 8" of Joint:  
Remarks:

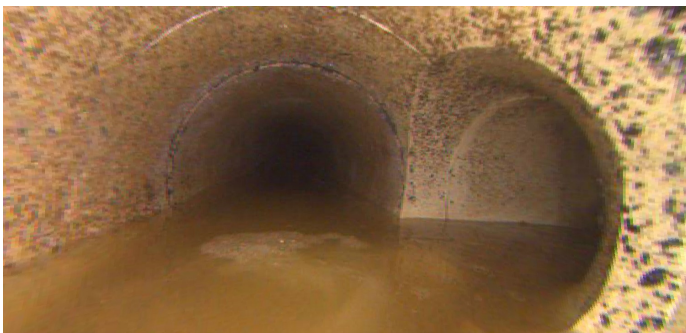
Code: **TFA**  
Description: **Tap Factory Active**

Distance (ft): **235.6**  
Structural Grade: **0**  
O&M Grade: **0**  
Clock Start/From: **3**  
Clock To:  
1st Value: **4.000**  
2nd Value:  
Value Percent:  
Continuous Index:  
Within 8" of Joint:  
Remarks:

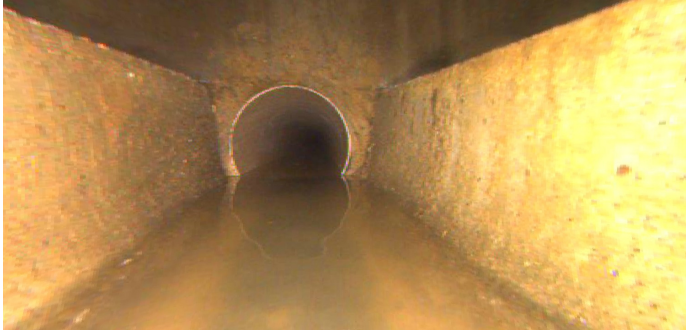
Code:	<b>AMH</b>
Description:	<b>Manhole</b>
Distance (ft):	<b>282.4</b>
Structural Grade:	<b>0</b>
O&M Grade:	<b>0</b>
Clock Start/From:	
Clock To:	
1st Value:	
2nd Value:	
Value Percent:	
Continuous Index:	
Within 8" of Joint:	<b>NO</b>
Remarks:	<b>M-703-014</b>
