Profile/Photo Observation Report

Date:	03/26/2018	Weather:		Coding:	PACP 6.0
Pipe Length (ft):	304.8	Owner:	NA	Pre Clean:	Not Known
P.O.#:		Surveyor:	JUSTIN GONZALES	PSR:	P-703-015-016
Customer:		Clean Date:	01/01/1900	Shape:	C

Street:	QUAIL DR	Flow Control:	Not Controlled
City:	Hobart, IN	Year Renewed:	
Location:	Other	Tape/Media #:	
Purpose:	Not Known	Dia/Height:	10"
Use:	Sanitary	Material:	PVC
Drain Area:	NA	Lining:	
Category:	NA		
Comment:

Location Details:		Direction of Survey:	Upstream
US MH:	M-703-016	DS MH:	M-703-015
		Total Length Surveyed (ft):	298.0

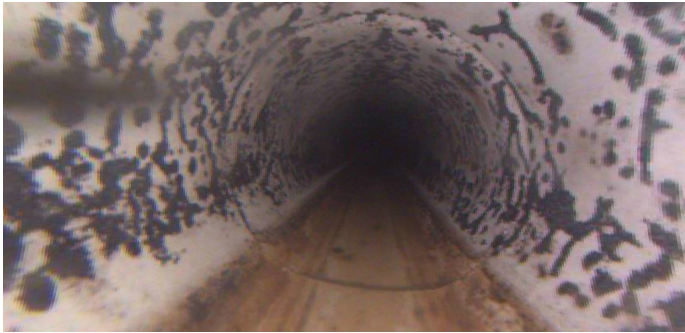
Code:	MWL
Description:	Water Level

Distance (ft):	.0
Structural Grade:	0
O&M Grade:	0
Clock Start/From:	
Clock To:	
1st Value:	
2nd Value:	
Value Percent:	5.000
Continuous Index:	
Within 8" of Joint:	NO
Remarks:

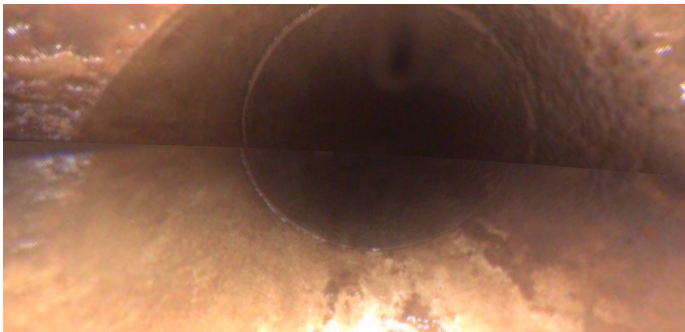
Code:	TF
Description:	Tap Factory

Distance (ft):	46.2
Structural Grade:	0
O&M Grade:	0
Clock Start/From:	12
Clock To:	
1st Value:	4.000
2nd Value:	
Value Percent:	
Continuous Index:	
Within 8" of Joint:	
Remarks:

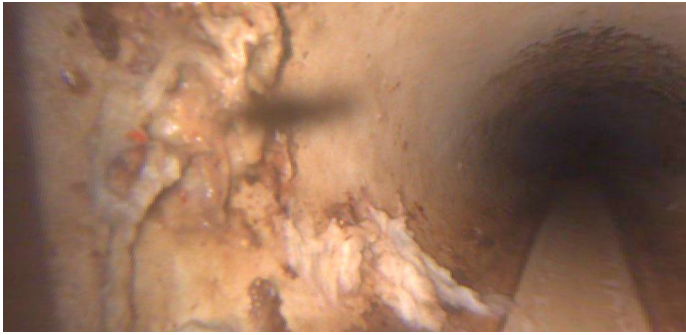
Code: **DAZ**
Description: **Deposits Attached Other**

Distance (ft): **46.9**
Structural Grade: **0**
O&M Grade: **2**
Clock Start/From: **7**
Clock To: **11**
1st Value:
2nd Value:
Value Percent: **5.000**
Continuous Index:
Within 8" of Joint: **NO**
Remarks: **TOILET TISSUE AND UNKNOWN DEPOSITS**

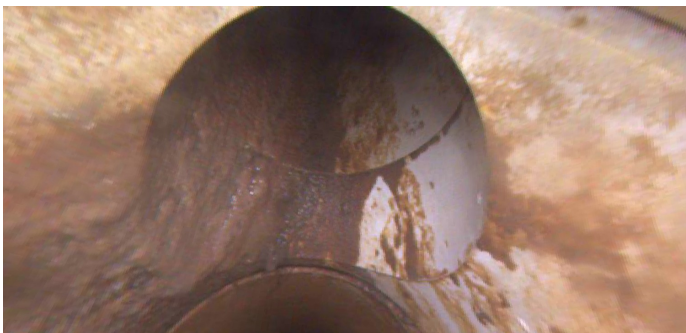
Code: **TF**
Description: **Tap Factory**

Distance (ft): **78.0**
Structural Grade: **0**
O&M Grade: **0**
Clock Start/From: **12**
Clock To:
1st Value: **4.000**
2nd Value:
Value Percent:
Continuous Index:
Within 8" of Joint:
Remarks:

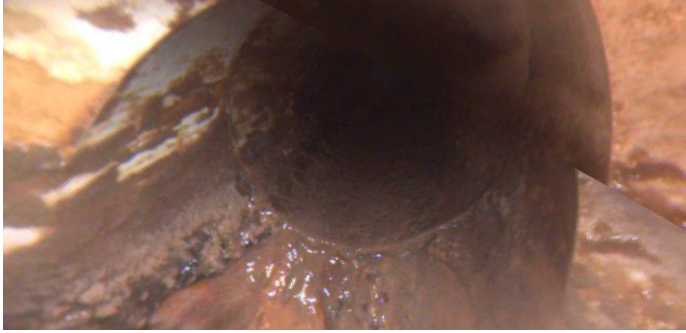
Code: **TF**
Description: **Tap Factory**

Distance (ft): **142.2**
Structural Grade: **0**
O&M Grade: **0**
Clock Start/From: **12**
Clock To:
1st Value: **4.000**
2nd Value:
Value Percent:
Continuous Index:
Within 8" of Joint:
Remarks:

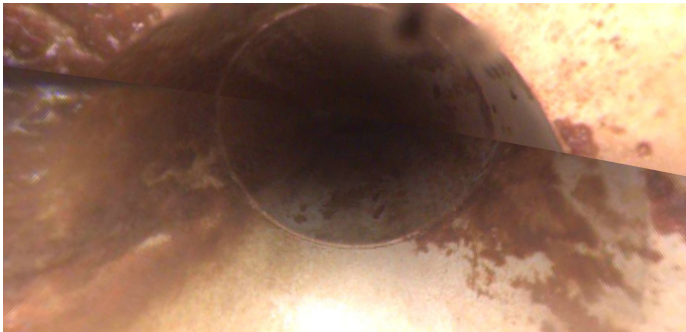
Code: **TF**
Description: **Tap Factory**

Distance (ft): **151.2**
Structural Grade: **0**
O&M Grade: **0**
Clock Start/From: **12**
Clock To:
1st Value: **4.000**
2nd Value:
Value Percent:
Continuous Index:
Within 8" of Joint:
Remarks:

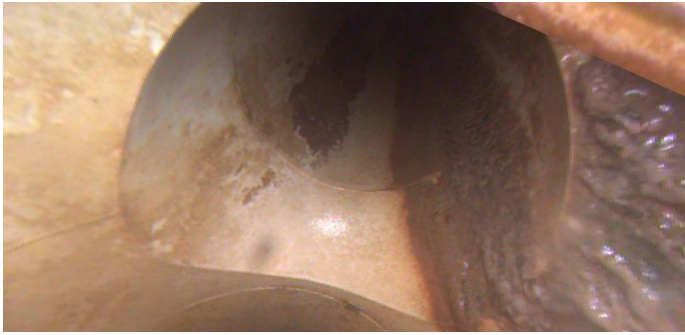
Code: **TF**
Description: **Tap Factory**

Distance (ft): **238.5**
Structural Grade: **0**
O&M Grade: **0**
Clock Start/From: **12**
Clock To:
1st Value: **4.000**
2nd Value:
Value Percent:
Continuous Index:
Within 8" of Joint:
Remarks:

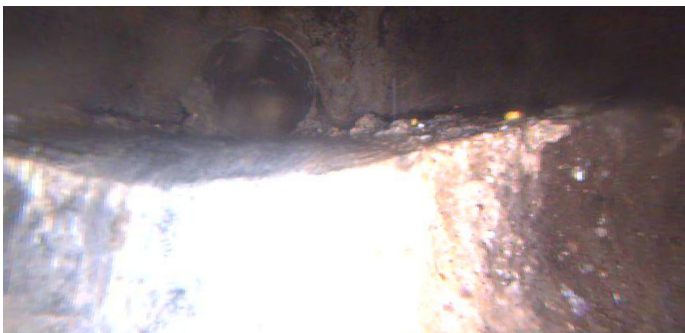
Code: **AMH**
Description: **Manhole**

Distance (ft): **298.0**
Structural Grade: **0**
O&M Grade: **0**
Clock Start/From:
Clock To:
1st Value:
2nd Value:
Value Percent:
Continuous Index:
Within 8" of Joint: **NO**
Remarks: **M-703-016**
