## Profile/Photo Observation Report

Street:	<b>quail dr</b>	Flow Control:	<b>Not Controlled</b>
City:	<b>Hobart, IN</b>	Year Renewed:	
Location:	<b>Other</b>	Tape/Media #:	
Purpose:	<b>Not Known</b>	Dia/Height:	<b>10"</b>
Use:	<b>Sanitary</b>	Material:	<b>PVC</b>
Drain Area:	<b>NA</b>	Lining:	
Category:	<b>NA</b>		
Comment:

Location Details:		Direction of Survey:	<b>Upstream</b>
US MH:	<b>M-703-016</b>	DS MH:	<b>M-703-015</b>
		Total Length Surveyed (ft):	<b>298.0</b>

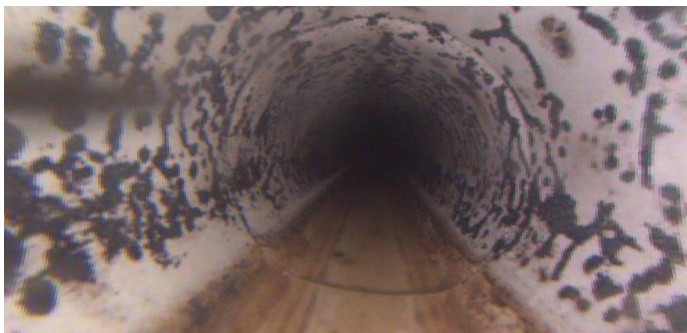
Code: **AMH**  
 Description: **Manhole**  
 Distance (ft): **.0**  
 Structural Grade: **0**  
 O&M Grade: **0**  
 Clock Start/From:  
 Clock To:  
 1st Value:  
 2nd Value:  
 Value Percent:  
 Continuous Index:  
 Within 8" of Joint: **NO**  
 Remarks: **M-703-015**

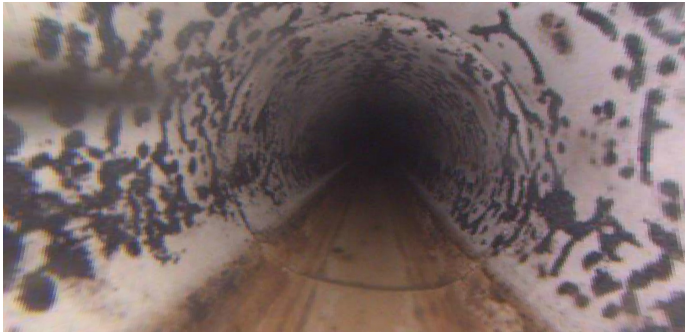
Code:	<b>MWL</b>
Description:	<b>Water Level</b>

Distance (ft):	<b>.0</b>
Structural Grade:	<b>0</b>
O&M Grade:	<b>0</b>
Clock Start/From:	
Clock To:	
1st Value:	
2nd Value:	
Value Percent:	<b>5.000</b>
Continuous Index:	
Within 8" of Joint:	<b>NO</b>
Remarks:

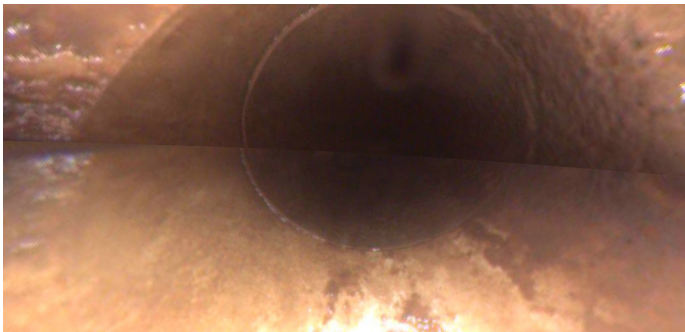
Code:	<b>TF</b>
Description:	<b>Tap Factory</b>

Distance (ft):	<b>46.2</b>
Structural Grade:	<b>0</b>
O&M Grade:	<b>0</b>
Clock Start/From:	<b>12</b>
Clock To:	
1st Value:	<b>4.000</b>
2nd Value:	
Value Percent:	
Continuous Index:	
Within 8" of Joint:	
Remarks:

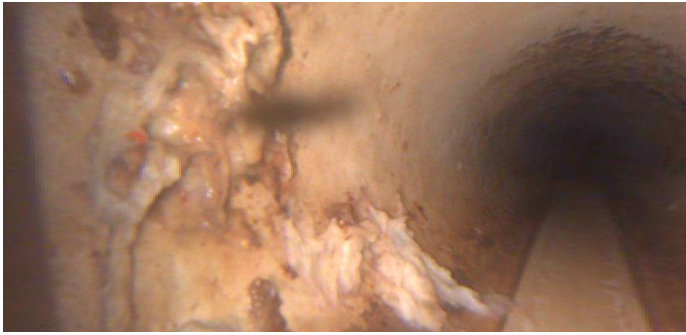
Code: **DAZ**  
Description: **Deposits Attached Other**

Distance (ft): **46.9**  
Structural Grade: **0**  
O&M Grade: **2**  
Clock Start/From: **7**  
Clock To: **11**  
1st Value:  
2nd Value:  
Value Percent: **5.000**  
Continuous Index:  
Within 8" of Joint: **NO**  
Remarks: **TOILET TISSUE AND UNKNOWN DEPOSITS**

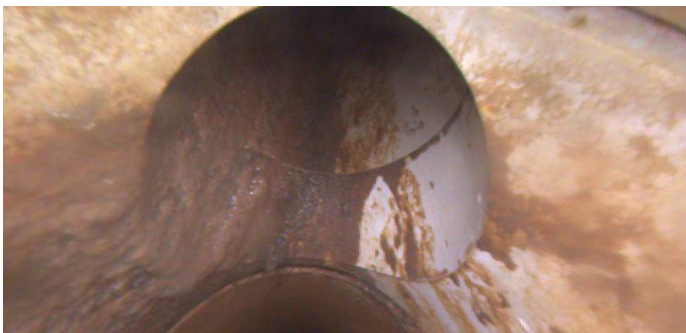
Code: **TF**  
Description: **Tap Factory**

Distance (ft): **78.0**  
Structural Grade: **0**  
O&M Grade: **0**  
Clock Start/From: **12**  
Clock To:  
1st Value: **4.000**  
2nd Value:  
Value Percent:  
Continuous Index:  
Within 8" of Joint:  
Remarks:

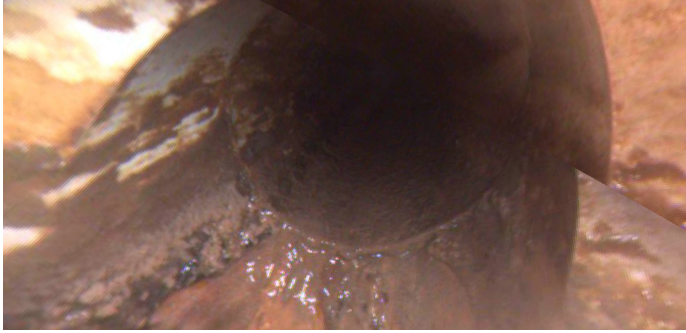
Code: **TF**  
Description: **Tap Factory**

Distance (ft): **142.2**  
Structural Grade: **0**  
O&M Grade: **0**  
Clock Start/From: **12**  
Clock To:  
1st Value: **4.000**  
2nd Value:  
Value Percent:  
Continuous Index:  
Within 8" of Joint:  
Remarks:

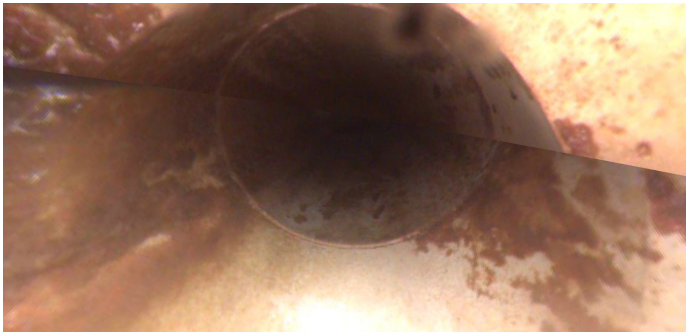
Code: **TF**  
Description: **Tap Factory**

Distance (ft): **151.2**  
Structural Grade: **0**  
O&M Grade: **0**  
Clock Start/From: **12**  
Clock To:  
1st Value: **4.000**  
2nd Value:  
Value Percent:  
Continuous Index:  
Within 8" of Joint:  
Remarks:

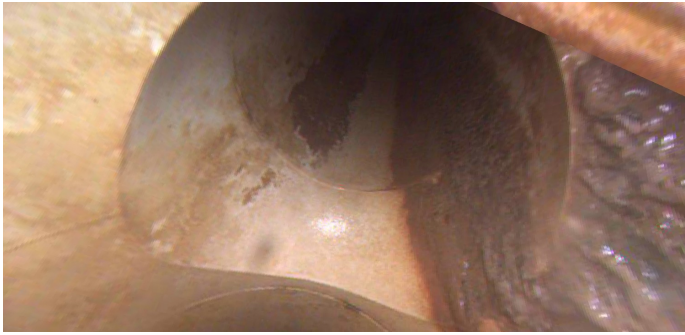
Code: **TF**  
Description: **Tap Factory**

Distance (ft): **238.5**  
Structural Grade: **0**  
O&M Grade: **0**  
Clock Start/From: **12**  
Clock To:  
1st Value: **4.000**  
2nd Value:  
Value Percent:  
Continuous Index:  
Within 8" of Joint:  
Remarks:

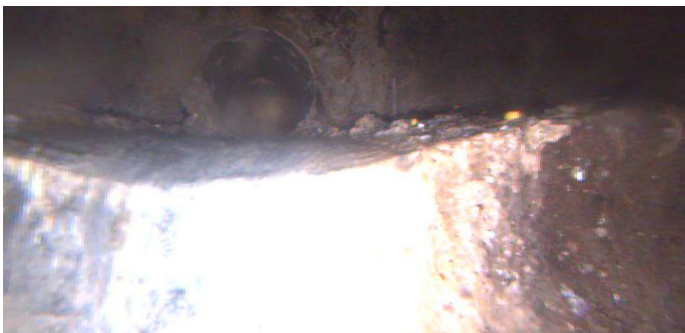
Code: **AMH**  
Description: **Manhole**

Distance (ft): **298.0**  
Structural Grade: **0**  
O&M Grade: **0**  
Clock Start/From:  
Clock To:  
1st Value:  
2nd Value:  
Value Percent:  
Continuous Index:  
Within 8" of Joint: **NO**  
Remarks: **M-703-016**
