## Profile/Photo Observation Report

| Street: | <b>hidden lake dr</b> | Flow Control: | <b>Not Controlled</b> |
| City: | <b>Hobart, IN</b> | Year Renewed: | |

| US MH: | <b>M-703-020</b> | DS MH: | <b>M-703-022</b> |

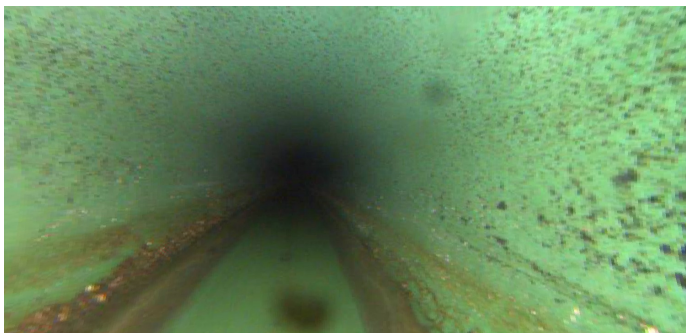
Code: **AMH**  
Description: **Manhole**

Distance (ft): **.0**  
Structural Grade: **0**  
O&M Grade: **0**  
Clock Start/From:  
Clock To:  
1st Value:  
2nd Value:  
Value Percent:  
Continuous Index:  
Within 8" of Joint: **NO**  
Remarks: **M-703-020**

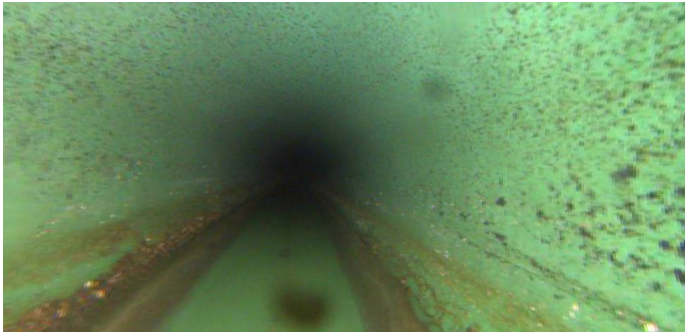
| Code: | <b>MWL</b> |
| Description: | <b>Water Level</b> |

| Distance (ft): | <b>.0</b> |
| Value Percent: | <b>5.000</b> |

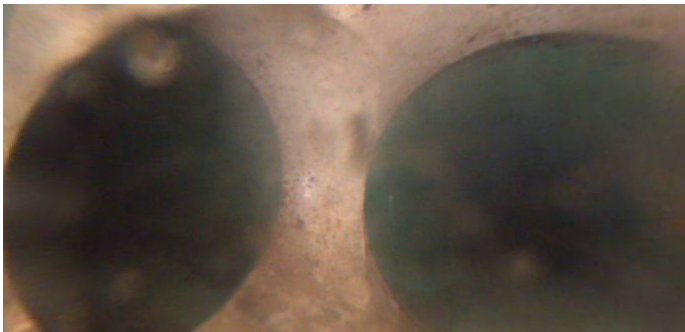
| Code: | <b>TF</b> |
| Description: | <b>Tap Factory</b> |

| Distance (ft): | <b>25.5</b> |
| Clock Start/From: | <b>3</b> |
| 1st Value: | <b>4.000</b> |

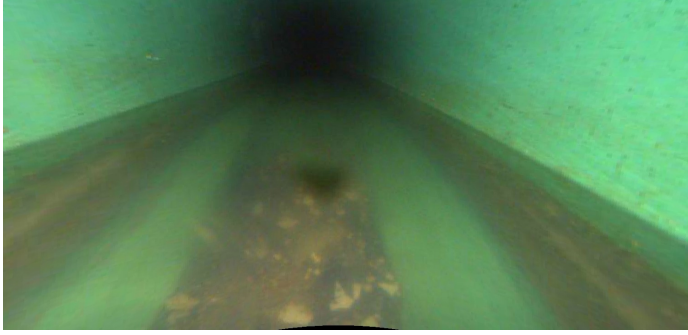
| | Position | Code | Observation | Video (sec) | Grade |
|--|---|---|---|---|---|
| | 27.7 | DSF | Deposits Settled Fine | 103 | M 2 |

Code: **DSF**  
Description: **Deposits Settled Fine**

Distance (ft): **27.7**  
Structural Grade: **0**  
O&M Grade: **2**  
Clock Start/From: **6**  
Clock To:  
1st Value:  
2nd Value:  
Value Percent: **5.000**  
Continuous Index:  
Within 8" of Joint: **NO**  
Remarks:

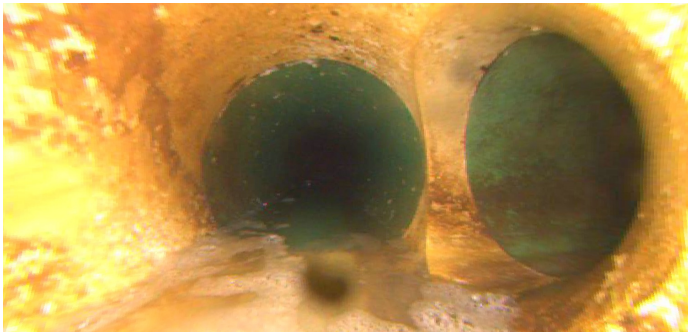
Code: **TF**  
Description: **Tap Factory**

Distance (ft): **96.3**  
Structural Grade: **0**  
O&M Grade: **0**  
Clock Start/From: **3**  
Clock To:  
1st Value: **4.000**  
2nd Value:  
Value Percent:  
Continuous Index:  
Within 8" of Joint:  
Remarks:

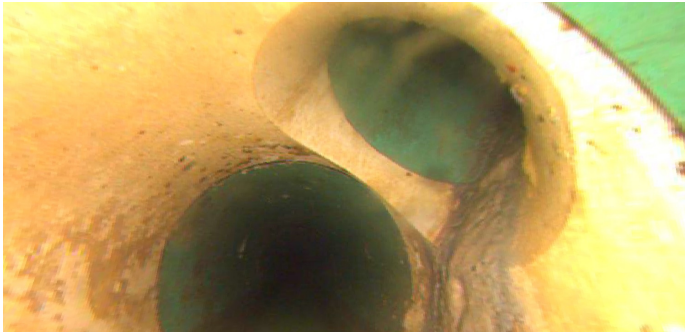
Code: **TF**  
Description: **Tap Factory**

Distance (ft): **175.4**  
Structural Grade: **0**  
O&M Grade: **0**  
Clock Start/From: **2**  
Clock To:  
1st Value: **4.000**  
2nd Value:  
Value Percent:  
Continuous Index:  
Within 8" of Joint:  
Remarks:

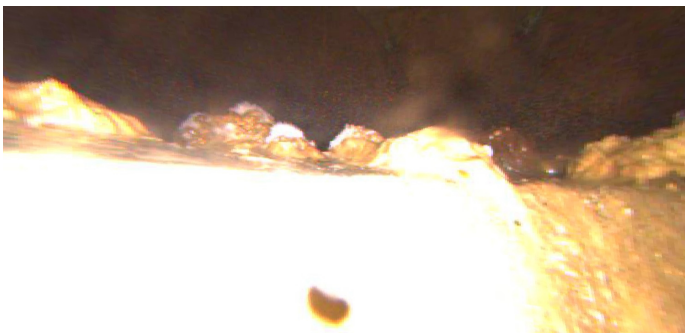
Code: **AMH**  
Description: **Manhole**

Distance (ft): **329.6**  
Structural Grade: **0**  
O&M Grade: **0**  
Clock Start/From:  
Clock To:  
1st Value:  
2nd Value:  
Value Percent:  
Continuous Index:  
Within 8" of Joint: **NO**  
Remarks: **M-703-022**
