Profile/Photo Observation Report

Date:	03/26/2018	Weather:		Coding:	PACP 6.0
Pipe Length (ft):	273.0	Owner:	NA	Pre Clean:	Not Known
P.O.#:		Surveyor:	Justin Gonzales	PSR:	P-703-032-020
Customer:		Clean Date:	01/01/1900	Shape:	C

Street:	hidden lake dr	Flow Control:	Not Controlled
City:	Hobart, IN	Year Renewed:	
Location:	Other	Tape/Media #:	
Purpose:	Not Known	Dia/Height:	10"
Use:	Sanitary	Material:	PVC
Drain Area:	NA	Lining:	
Category:	NA		
Comment:

Location Details:		Direction of Survey:	Downstream
US MH:	M-703-020	DS MH:	M-703-032
		Total Length Surveyed (ft):	266.9

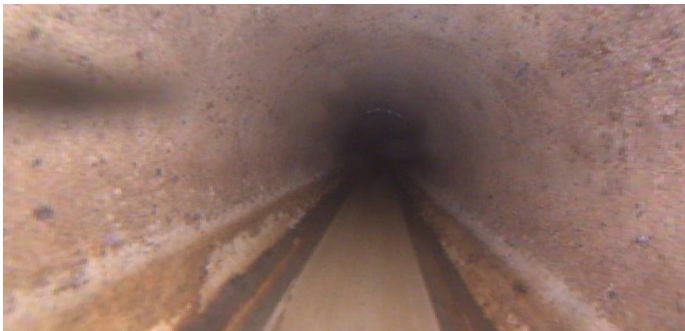
Code: **AMH**
Description: **Manhole**

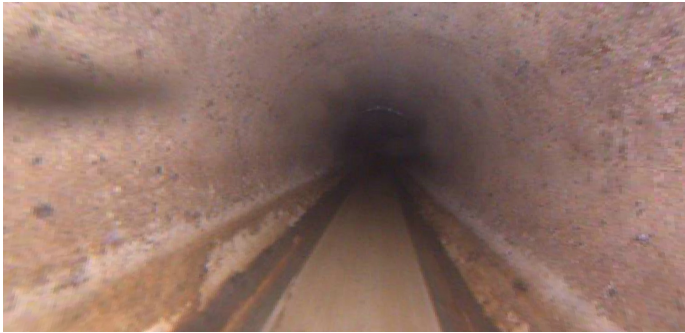
Code:	MWL
Description:	Water Level

Distance (ft):	.0
Structural Grade:	0
O&M Grade:	0
Clock Start/From:	
Clock To:	
1st Value:	
2nd Value:	
Value Percent:	5.000
Continuous Index:	
Within 8" of Joint:	NO
Remarks:

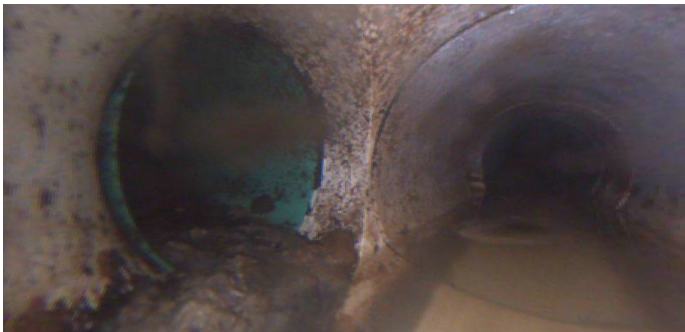
Code:	TFD
Description:	Tap Factory Defective

Distance (ft):	102.6
Structural Grade:	0
O&M Grade:	2
Clock Start/From:	9
Clock To:	
1st Value:	4.000
2nd Value:	
Value Percent:	
Continuous Index:	
Within 8" of Joint:	
Remarks:	DEPOSITS IN MOUTH OF TAP

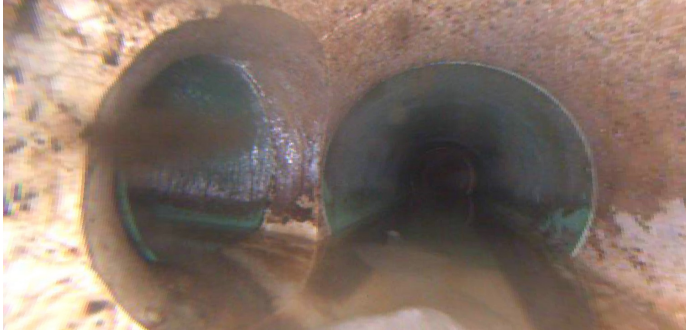
Code: **TF**
Description: **Tap Factory**

Distance (ft): **104.1**
Structural Grade: **0**
O&M Grade: **0**
Clock Start/From: **9**
Clock To:
1st Value: **4.000**
2nd Value:
Value Percent:
Continuous Index:
Within 8" of Joint:
Remarks:

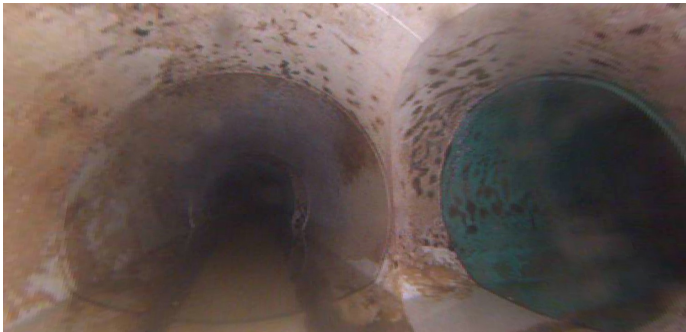
Code: **TF**
Description: **Tap Factory**

Distance (ft): **107.4**
Structural Grade: **0**
O&M Grade: **0**
Clock Start/From: **3**
Clock To:
1st Value: **4.000**
2nd Value:
Value Percent:
Continuous Index:
Within 8" of Joint:
Remarks:

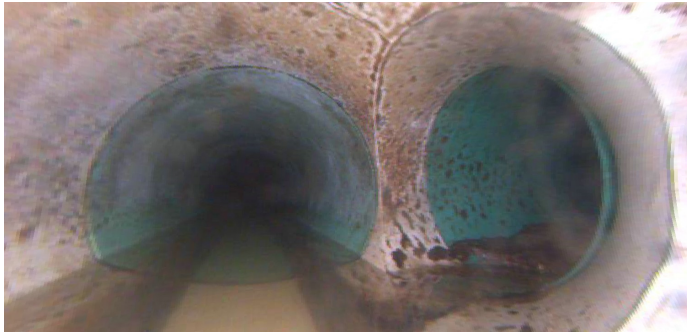
Code: **TFD**
Description: **Tap Factory Defective**

Distance (ft): **109.1**
Structural Grade: **0**
O&M Grade: **2**
Clock Start/From: **3**
Clock To:
1st Value: **3.000**
2nd Value:
Value Percent:
Continuous Index:
Within 8" of Joint:

Remarks: **DEPOSITS IN MOUTH OF TAP**

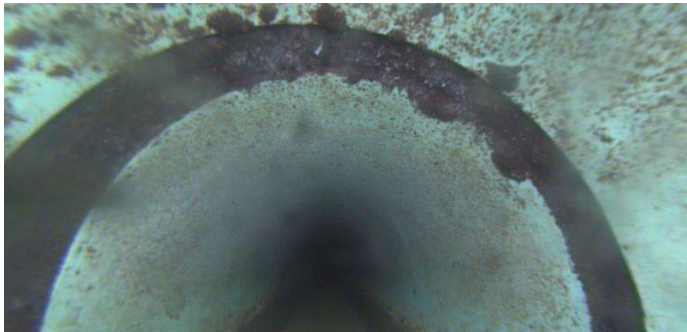
Code: **JSM**
Description: **Joint Separated Medium**

Distance (ft): **157.3**
Structural Grade: **1**
O&M Grade: **0**
Clock Start/From:
Clock To:
1st Value:
2nd Value:
Value Percent:
Continuous Index:
Within 8" of Joint: **NO**
Remarks:

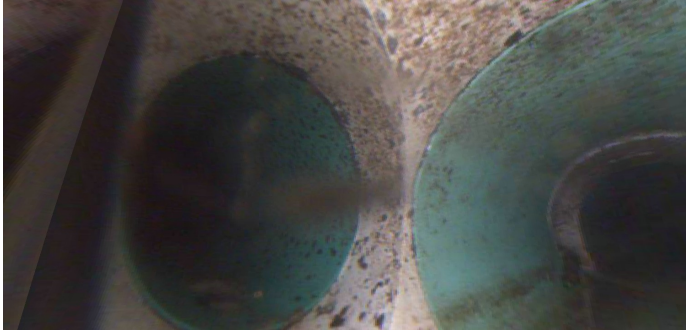
Code: **TF**
Description: **Tap Factory**

Distance (ft): **191.9**
Structural Grade: **0**
O&M Grade: **0**
Clock Start/From: **9**
Clock To:
1st Value: **4.000**
2nd Value:
Value Percent:
Continuous Index:
Within 8" of Joint:
Remarks:

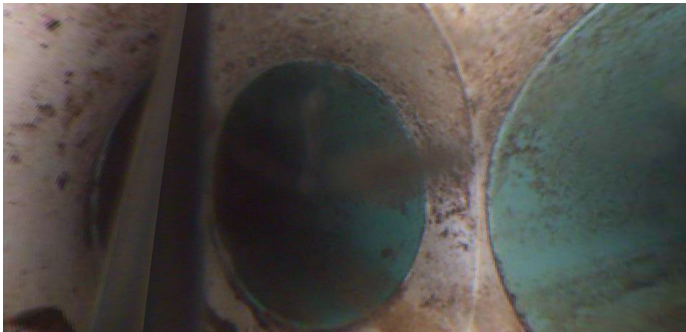
Code: **TF**
Description: **Tap Factory**

Distance (ft): **193.6**
Structural Grade: **0**
O&M Grade: **0**
Clock Start/From: **9**
Clock To:
1st Value: **4.000**
2nd Value:
Value Percent:
Continuous Index:
Within 8" of Joint:
Remarks:

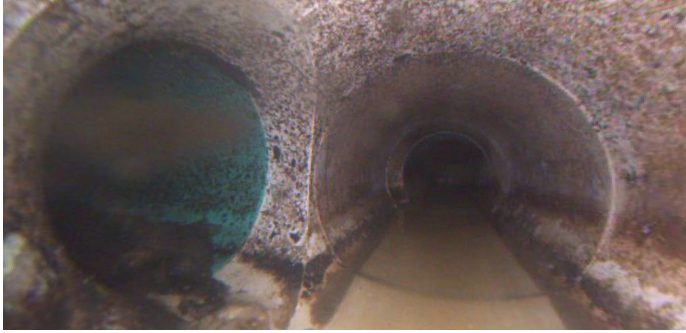
Code: **TFA**
Description: **Tap Factory Active**

Distance (ft): **260.7**
Structural Grade: **0**
O&M Grade: **0**
Clock Start/From: **9**
Clock To:
1st Value: **4.000**
2nd Value:
Value Percent:
Continuous Index:
Within 8" of Joint:
Remarks:

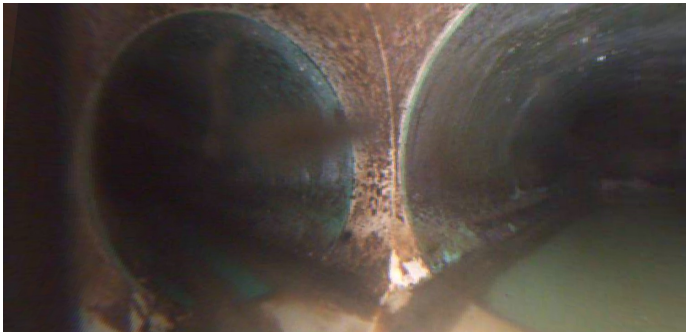
Code: **TF**
Description: **Tap Factory**

Distance (ft): **262.5**
Structural Grade: **0**
O&M Grade: **0**
Clock Start/From: **9**
Clock To:
1st Value: **4.000**
2nd Value:
Value Percent:
Continuous Index:
Within 8" of Joint:
Remarks:

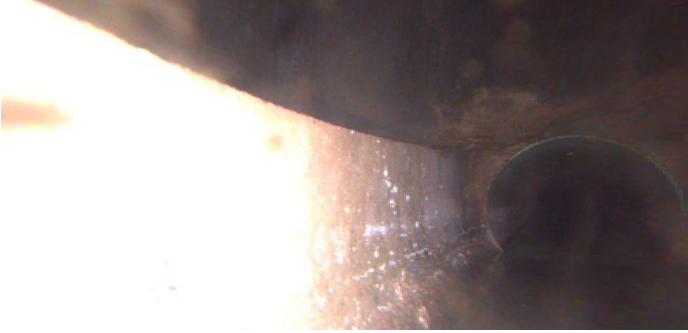
Code:	AMH
Description:	Manhole
Distance (ft):	266.9
Structural Grade:	0
O&M Grade:	0
Clock Start/From:	
Clock To:	
1st Value:	
2nd Value:	
Value Percent:	
Continuous Index:	
Within 8" of Joint:	NO
Remarks:	M-703-032
