## Profile/Photo Observation Report

Street:	<b>PHEASANT RUN DR</b>	Flow Control:	<b>Not Controlled</b>
City:	<b>Hobart, IN</b>	Year Renewed:	
Location:	<b>Other</b>	Tape/Media #:	
Purpose:	<b>Not Known</b>	Dia/Height:	<b>8"</b>
Use:	<b>Sanitary</b>	Material:	<b>PVC</b>
Drain Area:	<b>NA</b>	Lining:	
Category:	<b>NA</b>		
Comment:

Location Details:		Direction of Survey:	<b>Downstream</b>
US MH:	<b>M-703-023</b>	DS MH:	<b>M-703-025</b>
		Total Length Surveyed (ft):	<b>301.1</b>

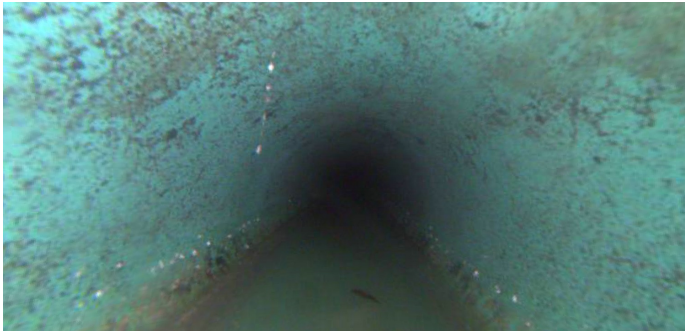
Code:	<b>MWL</b>
Description:	<b>Water Level</b>

Distance (ft):	<b>.0</b>
Structural Grade:	<b>0</b>
O&M Grade:	<b>0</b>
Clock Start/From:	
Clock To:	
1st Value:	
2nd Value:	
Value Percent:	<b>10.000</b>
Continuous Index:	
Within 8" of Joint:	<b>NO</b>
Remarks:

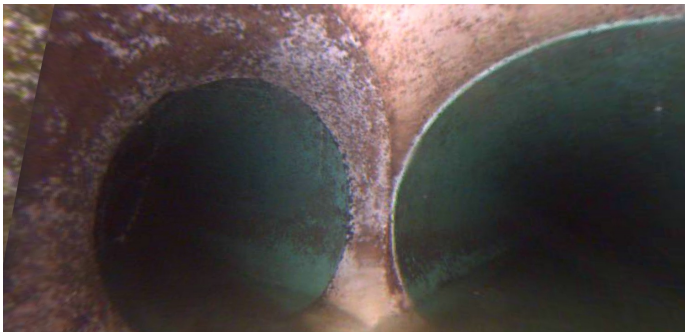
Code:	<b>TFA</b>
Description:	<b>Tap Factory Active</b>

Distance (ft):	<b>39.7</b>
Structural Grade:	<b>0</b>
O&M Grade:	<b>0</b>
Clock Start/From:	<b>9</b>
Clock To:	
1st Value:	<b>4.000</b>
2nd Value:	
Value Percent:	
Continuous Index:	
Within 8" of Joint:	
Remarks:

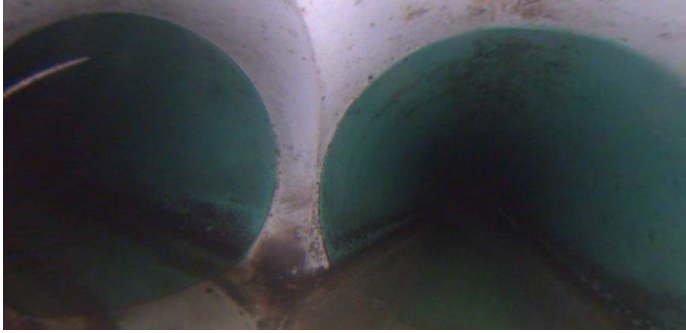
Code: **TFA**  
Description: **Tap Factory Active**

Distance (ft): **100.1**  
Structural Grade: **0**  
O&M Grade: **0**  
Clock Start/From: **9**  
Clock To:  
1st Value: **4.000**  
2nd Value:  
Value Percent:  
Continuous Index:  
Within 8" of Joint:  
Remarks:

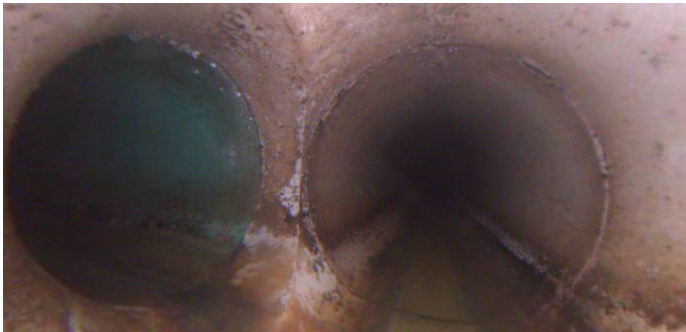
Code: **TFA**  
Description: **Tap Factory Active**

Distance (ft): **185.4**  
Structural Grade: **0**  
O&M Grade: **0**  
Clock Start/From: **9**  
Clock To:  
1st Value: **4.000**  
2nd Value:  
Value Percent:  
Continuous Index:  
Within 8" of Joint:  
Remarks:

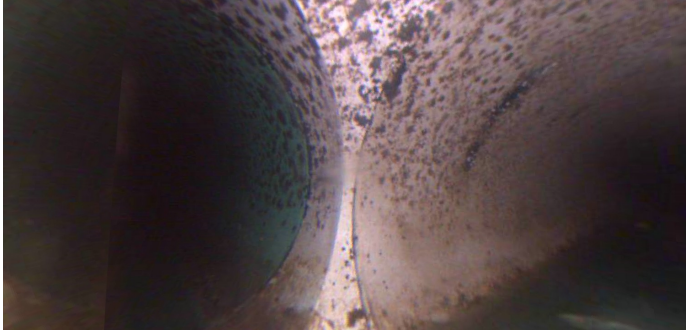
Code: **TF**  
Description: **Tap Factory**

Distance (ft): **255.4**  
Structural Grade: **0**  
O&M Grade: **0**  
Clock Start/From: **9**  
Clock To:  
1st Value: **4.000**  
2nd Value:  
Value Percent:  
Continuous Index:  
Within 8" of Joint:  
Remarks:

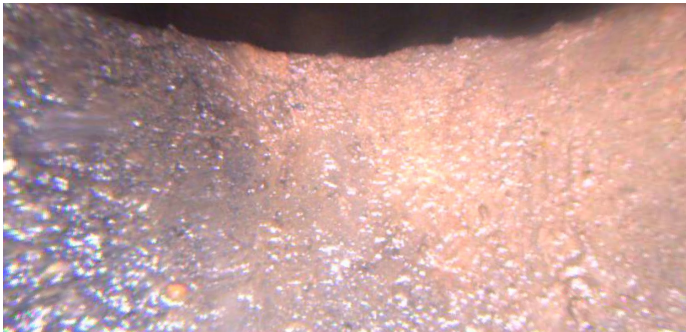
Code: **AMH**  
Description: **Manhole**

Distance (ft): **301.1**  
Structural Grade: **0**  
O&M Grade: **0**  
Clock Start/From:  
Clock To:  
1st Value:  
2nd Value:  
Value Percent:  
Continuous Index:  
Within 8" of Joint: **NO**  
Remarks: **M-703-025**
