Profile/Photo Observation Report

Date:	04/12/2018	Weather:		Coding:	PACP 6.0
Pipe Length (ft):	66.3	Owner:	NA	Pre Clean:	Not Known
P.O.#:		Surveyor:	Jen Costello	PSR:	P-703-027-028
Customer:		Clean Date:	01/01/1900	Shape:	C

Street:	MANOR DR	Flow Control:	Not Controlled
City:	Hobart, IN	Year Renewed:	
Location:	Other	Tape/Media #:	
Purpose:	Not Known	Dia/Height:	8"
Use:	Sanitary	Material:	PVC
Drain Area:	NA	Lining:	
Category:	NA		
Comment:			
Location Details:		Direction of Survey:	Downstream
US MH:	M-703-028	DS MH:	M-703-027
		Total Length Surveyed (ft):	64.8

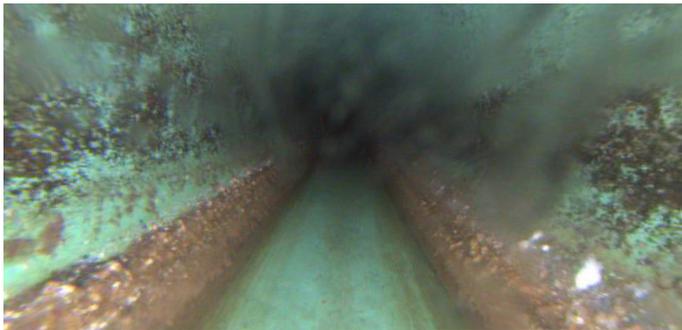
Code: **AMH**
Description: **Manhole**

Distance (ft): **.0**
Structural Grade: **0**
O&M Grade: **0**
Clock Start/From:
Clock To:
1st Value:
2nd Value:
Value Percent:
Continuous Index:
Within 8" of Joint: **NO**
Remarks: **M-703-028**

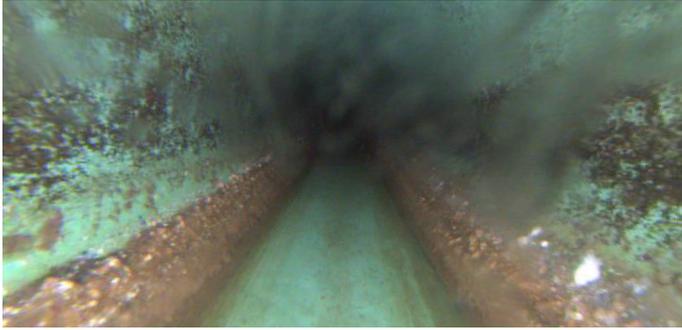
Code: **MWL**
Description: **Water Level**

Distance (ft): **.0**
Structural Grade: **0**
O&M Grade: **0**
Clock Start/From:
Clock To:
1st Value:
2nd Value:
Value Percent: **5.000**
Continuous Index:
Within 8" of Joint: **NO**
Remarks:

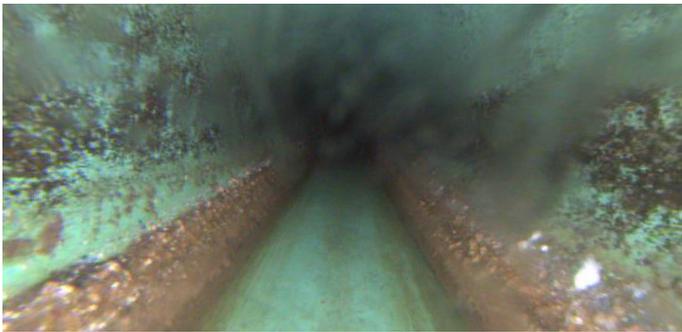
Code: **DAGS**
Description: **Deposits Attached Grease**

Distance (ft): **.0**
Structural Grade: **0**
O&M Grade: **2**
Clock Start/From: **7**
Clock To: **5**
1st Value:
2nd Value:
Value Percent: **5.000**
Continuous Index: **S01**
Within 8" of Joint: **NO**
Remarks:

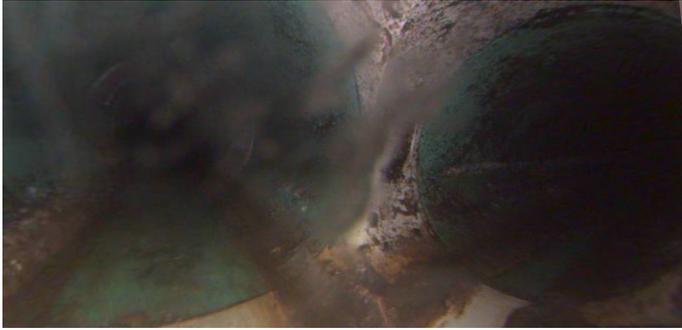
Code: **TFA**
Description: **Tap Factory Active**

Distance (ft): **4.7**
Structural Grade: **0**
O&M Grade: **0**
Clock Start/From: **3**
Clock To:
1st Value: **4.000**
2nd Value:
Value Percent:
Continuous Index:
Within 8" of Joint:
Remarks:

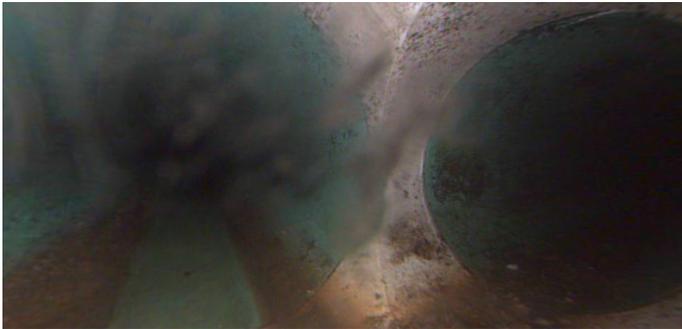
Code: **TF**
Description: **Tap Factory**

Distance (ft): **6.4**
Structural Grade: **0**
O&M Grade: **0**
Clock Start/From: **3**
Clock To:
1st Value: **4.000**
2nd Value:
Value Percent:
Continuous Index:
Within 8" of Joint:
Remarks:

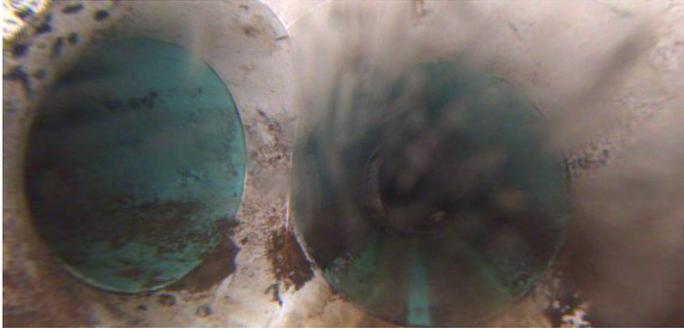
Code: **TF**
Description: **Tap Factory**

Distance (ft): **58.0**
Structural Grade: **0**
O&M Grade: **0**
Clock Start/From: **9**
Clock To:
1st Value: **4.000**
2nd Value:
Value Percent:
Continuous Index:
Within 8" of Joint:
Remarks:

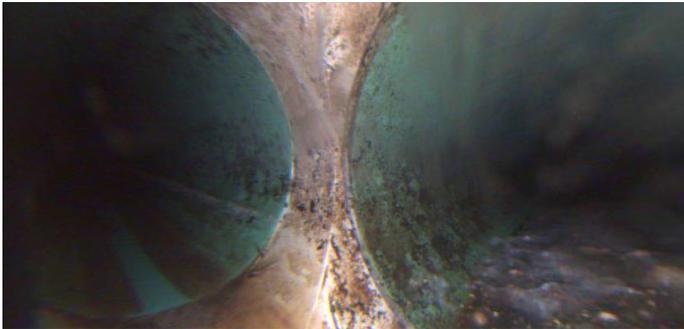
Code: **TFA**
Description: **Tap Factory Active**

Distance (ft): **60.0**
Structural Grade: **0**
O&M Grade: **0**
Clock Start/From: **9**
Clock To:
1st Value: **4.000**
2nd Value:
Value Percent:
Continuous Index:
Within 8" of Joint:
Remarks:

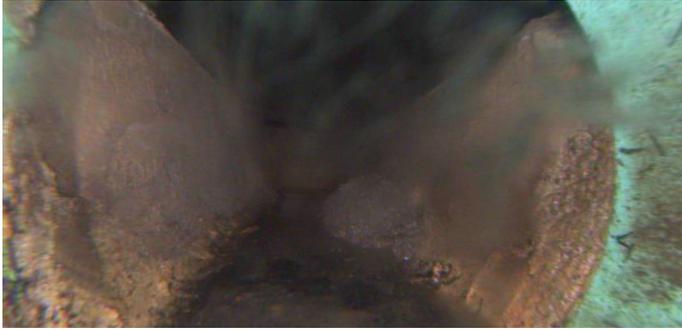
Code: **DAGS**
Description: **Deposits Attached Grease**

Distance (ft): **63.0**
Structural Grade: **0**
O&M Grade: **2**
Clock Start/From: **7**
Clock To: **5**
1st Value:
2nd Value:
Value Percent: **5.000**
Continuous Index: **F01**
Within 8" of Joint: **NO**
Remarks:
