Profile/Photo Observation Report

Street:	W 40th ave	Flow Control:	Not Controlled
City:	Hobart, IN	Year Renewed:	
Location:	Other	Tape/Media #:	
Purpose:	Not Known	Dia/Height:	8"
Use:	Sanitary	Material:	PVC
Drain Area:	NA	Lining:	
Category:	NA		
Comment:

Location Details:		Direction of Survey:	Downstream
US MH:	M-703-028	DS MH:	M-703-027
		Total Length Surveyed (ft):	64.8

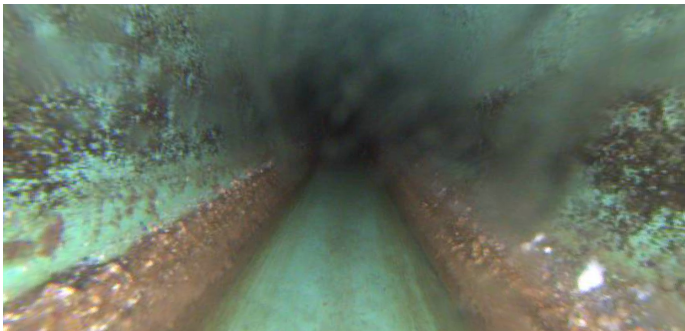
Code: **AMH**
Description: **Manhole**

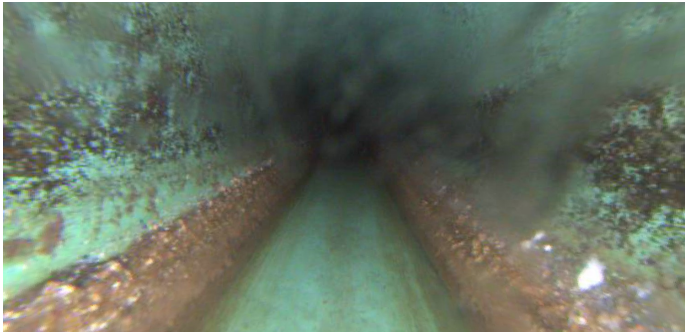
Code:	MWL
Description:	Water Level

Distance (ft):	.0
Structural Grade:	0
O&M Grade:	0
Clock Start/From:	
Clock To:	
1st Value:	
2nd Value:	
Value Percent:	5.000
Continuous Index:	
Within 8" of Joint:	NO
Remarks:

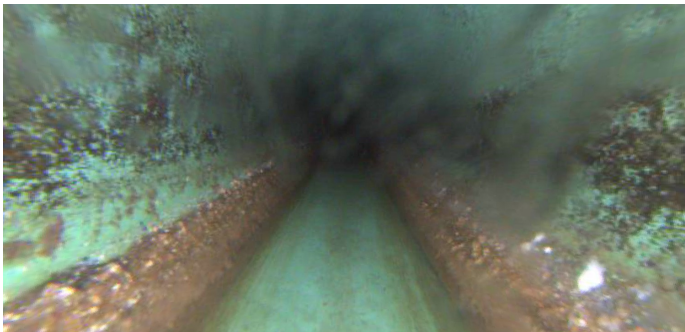
Code:	DAGS
Description:	Deposits Attached Grease

Distance (ft):	.0
Structural Grade:	0
O&M Grade:	2
Clock Start/From:	7
Clock To:	5
1st Value:	
2nd Value:	
Value Percent:	5.000
Continuous Index:	S01
Within 8" of Joint:	NO
Remarks:

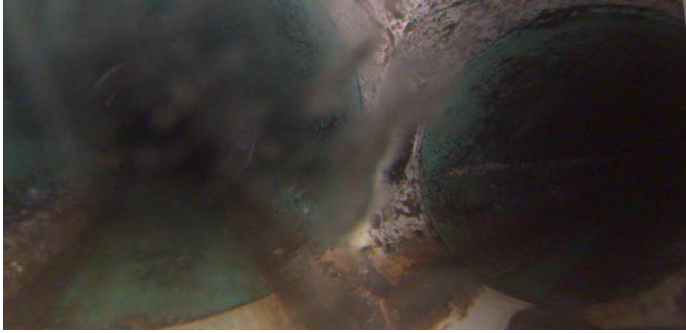
Code: **TFA**
Description: **Tap Factory Active**

Distance (ft): **4.7**
Structural Grade: **0**
O&M Grade: **0**
Clock Start/From: **3**
Clock To:
1st Value: **4.000**
2nd Value:
Value Percent:
Continuous Index:
Within 8" of Joint:
Remarks:

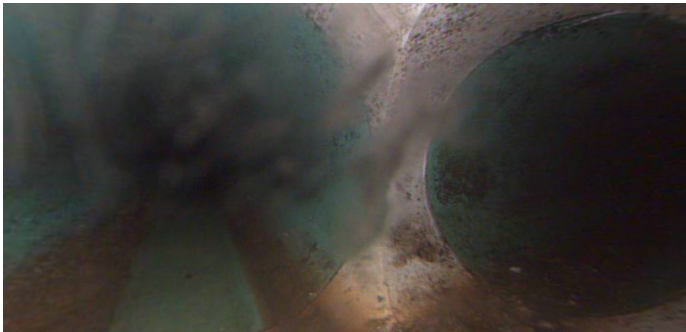
Code: **TF**
Description: **Tap Factory**

Distance (ft): **6.4**
Structural Grade: **0**
O&M Grade: **0**
Clock Start/From: **3**
Clock To:
1st Value: **4.000**
2nd Value:
Value Percent:
Continuous Index:
Within 8" of Joint:
Remarks:

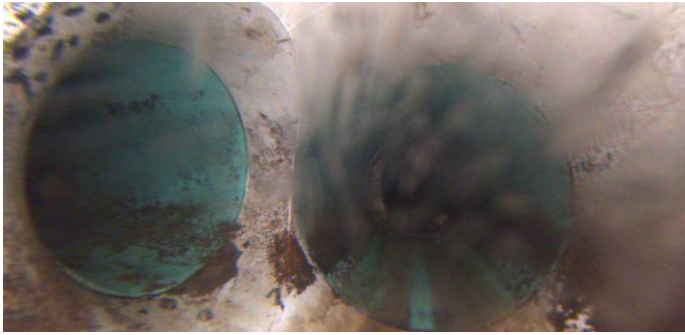
Code: **TF**
Description: **Tap Factory**

Distance (ft): **58.0**
Structural Grade: **0**
O&M Grade: **0**
Clock Start/From: **9**
Clock To:
1st Value: **4.000**
2nd Value:
Value Percent:
Continuous Index:
Within 8" of Joint:
Remarks:

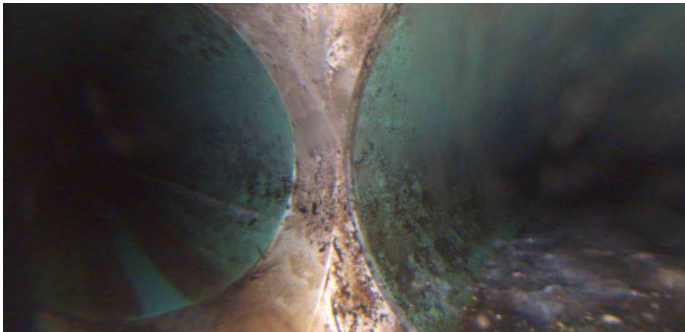
Code: **TFA**
Description: **Tap Factory Active**

Distance (ft): **60.0**
Structural Grade: **0**
O&M Grade: **0**
Clock Start/From: **9**
Clock To:
1st Value: **4.000**
2nd Value:
Value Percent:
Continuous Index:
Within 8" of Joint:
Remarks:

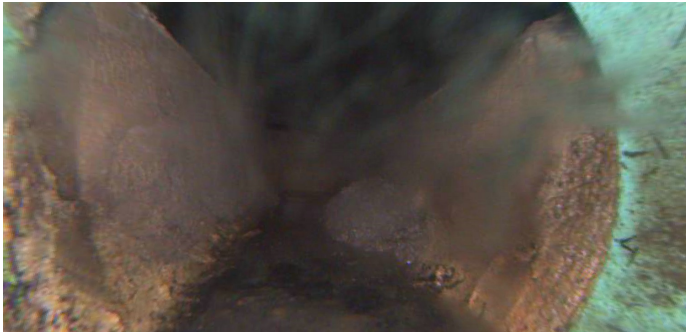
Code: **DAGS**
Description: **Deposits Attached Grease**

Distance (ft): **63.0**
Structural Grade: **0**
O&M Grade: **2**
Clock Start/From: **7**
Clock To: **5**
1st Value:
2nd Value:
Value Percent: **5.000**
Continuous Index: **F01**
Within 8" of Joint: **NO**
Remarks:

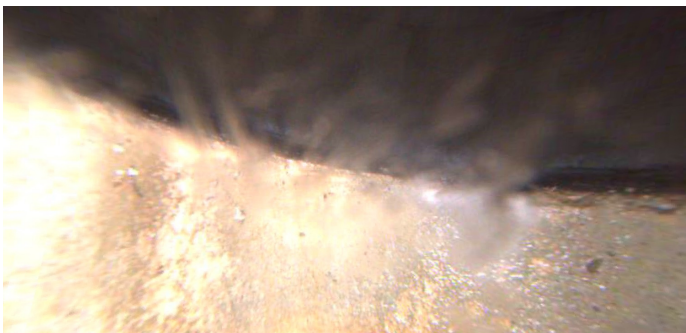
Code: **AMH**
Description: **Manhole**

Distance (ft): **64.8**
Structural Grade: **0**
O&M Grade: **0**
Clock Start/From:
Clock To:
1st Value:
2nd Value:
Value Percent:
Continuous Index:
Within 8" of Joint: **NO**
Remarks: **M-703-027**
