Profile/Photo Observation Report

Street:	MANOR DR	Flow Control:	Not Controlled
City:	Hobart, IN	Year Renewed:	
Location:	Other	Tape/Media #:	
Purpose:	Not Known	Dia/Height:	10"
Use:	Sanitary	Material:	PVC
Drain Area:	NA	Lining:	
Category:	NA		
Comment:

Location Details:		Direction of Survey:	Downstream
US MH:	M-703-030	DS MH:	M-703-029
		Total Length Surveyed (ft):	79.1

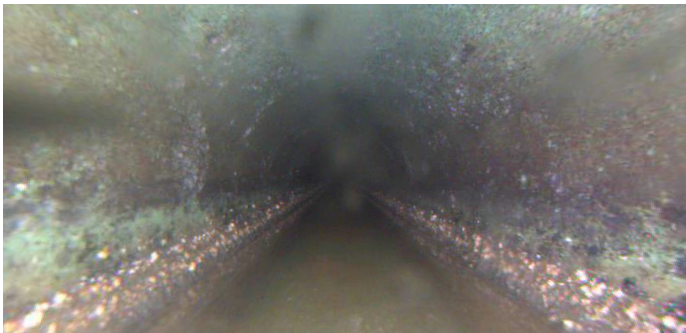
Code:	MWL
Description:	Water Level

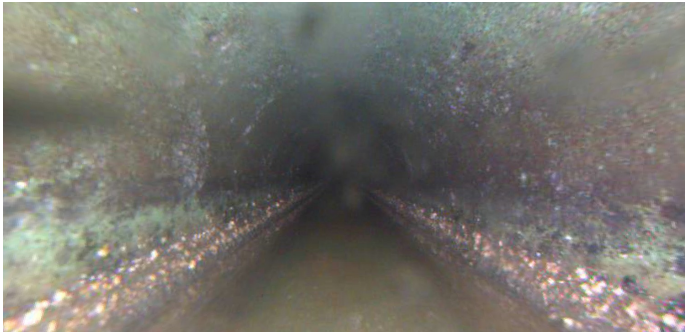
Distance (ft):	.0
Structural Grade:	0
O&M Grade:	0
Clock Start/From:	
Clock To:	
1st Value:	
2nd Value:	
Value Percent:	10.000
Continuous Index:	
Within 8" of Joint:	NO
Remarks:

Code:	DAGS
Description:	Deposits Attached Grease

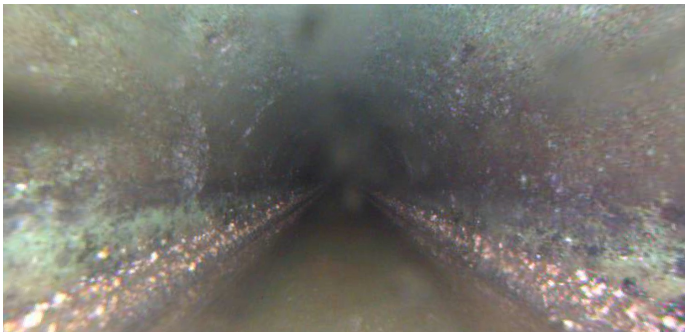
Distance (ft):	.0
Structural Grade:	0
O&M Grade:	2
Clock Start/From:	8
Clock To:	4
1st Value:	
2nd Value:	
Value Percent:	5.000
Continuous Index:	S01
Within 8" of Joint:	NO
Remarks:

Code: **DAGS**
Description: **Deposits Attached Grease**

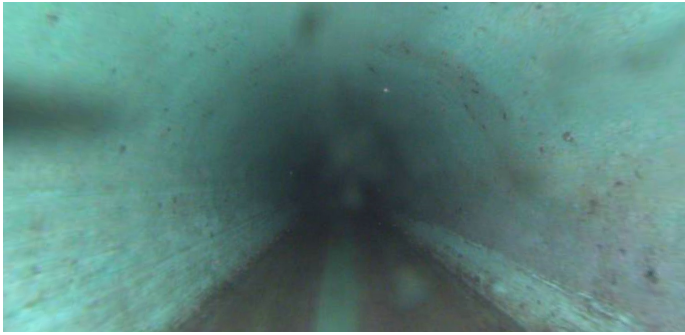
Distance (ft): **31.3**
Structural Grade: **0**
O&M Grade: **2**
Clock Start/From: **8**
Clock To: **4**
1st Value:
2nd Value:
Value Percent: **5.000**
Continuous Index: **F01**
Within 8" of Joint: **NO**
Remarks:

Code: **TFA**
Description: **Tap Factory Active**

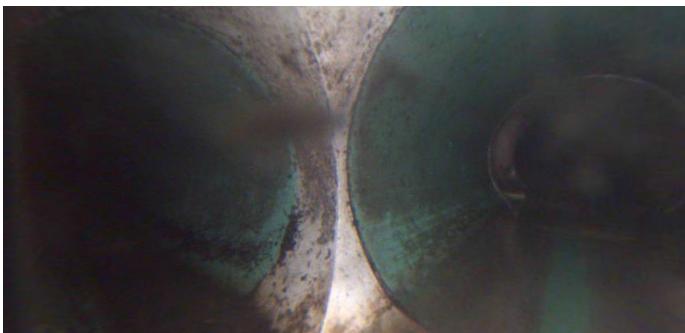
Distance (ft): **48.3**
Structural Grade: **0**
O&M Grade: **0**
Clock Start/From: **9**
Clock To:
1st Value: **4.000**
2nd Value:
Value Percent:
Continuous Index:
Within 8" of Joint:
Remarks:

Code: **TF**
Description: **Tap Factory**

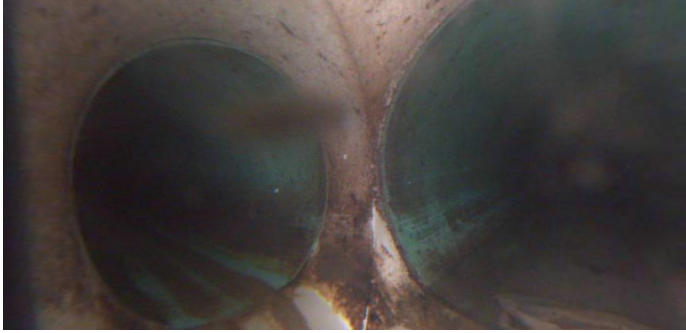
Distance (ft): **50.0**
Structural Grade: **0**
O&M Grade: **0**
Clock Start/From: **9**
Clock To:
1st Value: **4.000**
2nd Value:
Value Percent:
Continuous Index:
Within 8" of Joint:
Remarks:

Code: **OBP**
Description: **Obstacle External Pipe or Cable**

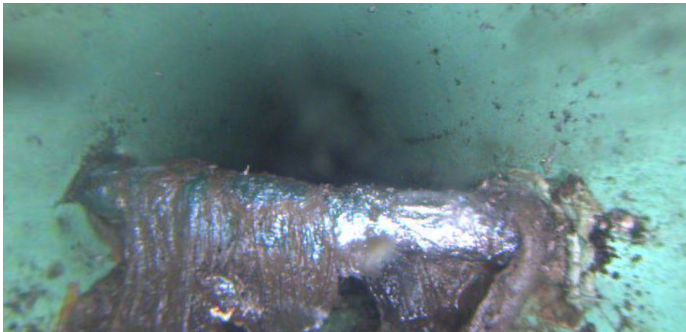
Distance (ft): **78.5**
Structural Grade: **0**
O&M Grade: **5**
Clock Start/From: **3**
Clock To: **9**
1st Value:
2nd Value:
Value Percent: **40.000**
Continuous Index:
Within 8" of Joint: **NO**
Remarks:

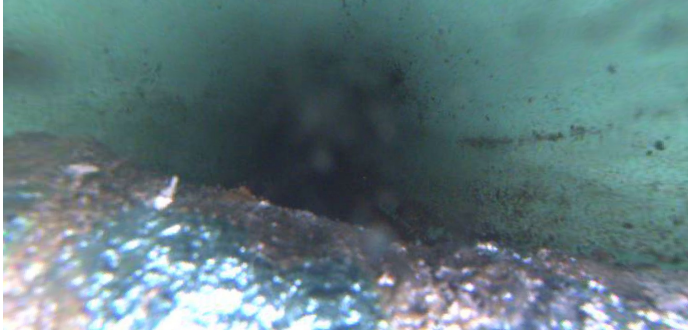
Code:	MSA
Description:	Abandoned Survey
Distance (ft):	79.1
Structural Grade:	0
O&M Grade:	0
Clock Start/From:	
Clock To:	
1st Value:	
2nd Value:	
Value Percent:	
Continuous Index:	
Within 8" of Joint:	NO
Remarks:	OBP
