Profile/Photo Observation Report

Date:	03/27/2018	Weather:		Coding:	PACP 6.0
Pipe Length (ft):	119.6	Owner:	NA	Pre Clean:	Not Known
P.O.#:		Surveyor:	Jen Costello	PSR:	P-703-029-030
Customer:		Clean Date:	01/01/1900	Shape:	C

Street:	manor dr	Flow Control:	Not Controlled
City:	Hobart, IN	Year Renewed:	
Location:	Other	Tape/Media #:	
Purpose:	Not Known	Dia/Height:	10"
Use:	Sanitary	Material:	PVC
Drain Area:	NA	Lining:	
Category:	NA		
Comment:

Location Details:		Direction of Survey:	Downstream
US MH:	M-703-030	DS MH:	M-703-029
		Total Length Surveyed (ft):	79.1

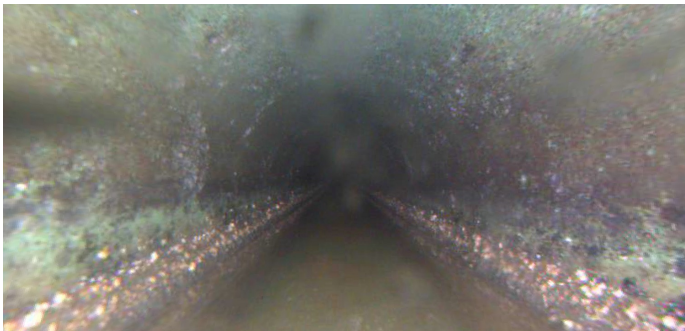
Code: **AMH**
Description: **Manhole**

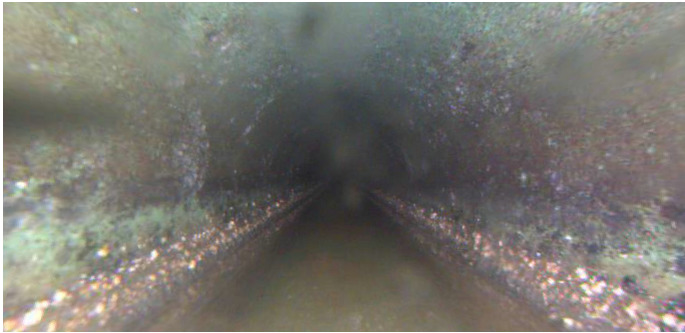
Code:	MWL
Description:	Water Level

Distance (ft):	.0
Structural Grade:	0
O&M Grade:	0
Clock Start/From:	
Clock To:	
1st Value:	
2nd Value:	
Value Percent:	10.000
Continuous Index:	
Within 8" of Joint:	NO
Remarks:

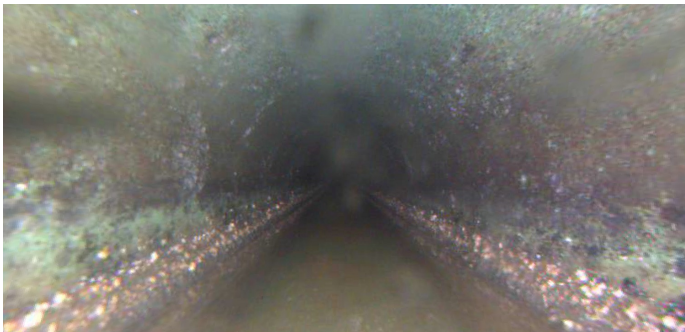
Code:	DAGS
Description:	Deposits Attached Grease

Distance (ft):	.0
Structural Grade:	0
O&M Grade:	2
Clock Start/From:	8
Clock To:	4
1st Value:	
2nd Value:	
Value Percent:	5.000
Continuous Index:	S01
Within 8" of Joint:	NO
Remarks:

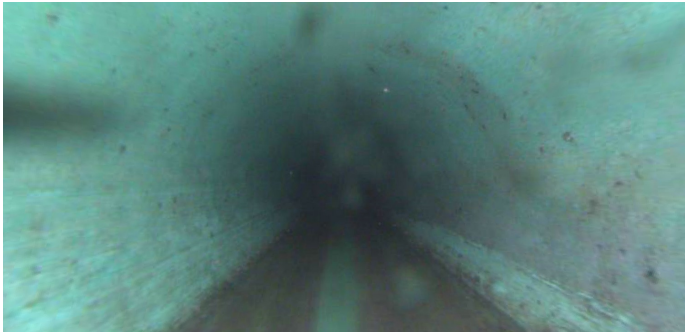
Code: **DAGS**
Description: **Deposits Attached Grease**

Distance (ft): **31.3**
Structural Grade: **0**
O&M Grade: **2**
Clock Start/From: **8**
Clock To: **4**
1st Value:
2nd Value:
Value Percent: **5.000**
Continuous Index: **F01**
Within 8" of Joint: **NO**
Remarks:

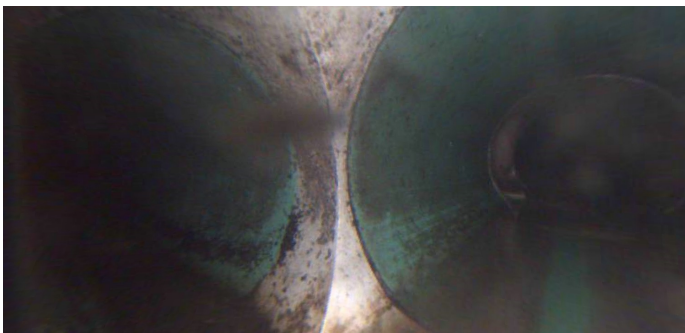
Code: **TFA**
Description: **Tap Factory Active**

Distance (ft): **48.3**
Structural Grade: **0**
O&M Grade: **0**
Clock Start/From: **9**
Clock To:
1st Value: **4.000**
2nd Value:
Value Percent:
Continuous Index:
Within 8" of Joint:
Remarks:

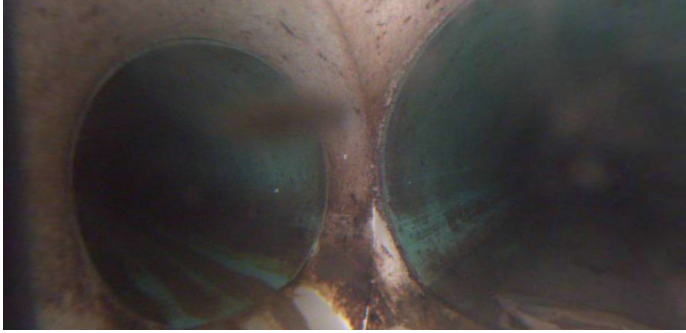
Code: **TF**
Description: **Tap Factory**

Distance (ft): **50.0**
Structural Grade: **0**
O&M Grade: **0**
Clock Start/From: **9**
Clock To:
1st Value: **4.000**
2nd Value:
Value Percent:
Continuous Index:
Within 8" of Joint:
Remarks:

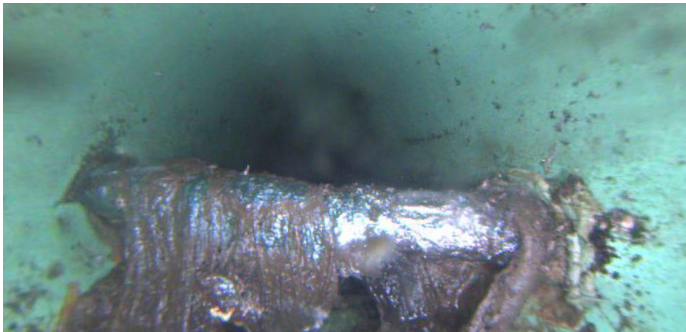
Code: **OBP**
Description: **Obstacle External Pipe or Cable**

Distance (ft): **78.5**
Structural Grade: **0**
O&M Grade: **5**
Clock Start/From: **3**
Clock To: **9**
1st Value:
2nd Value:
Value Percent: **40.000**
Continuous Index:
Within 8" of Joint: **NO**
Remarks:

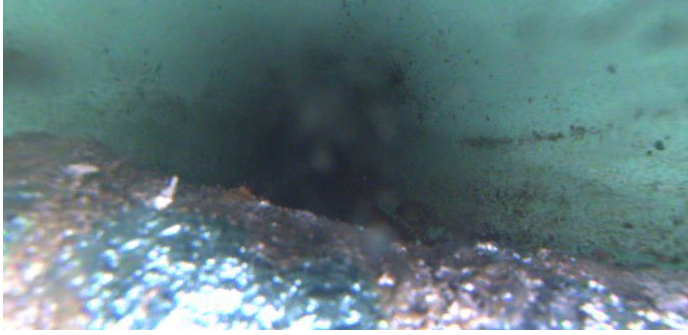
Code:	MSA
Description:	Abandoned Survey
Distance (ft):	79.1
Structural Grade:	0
O&M Grade:	0
Clock Start/From:	
Clock To:	
1st Value:	
2nd Value:	
Value Percent:	
Continuous Index:	
Within 8" of Joint:	NO
Remarks:	OBP
