Profile/Photo Observation Report

Date:	03/26/2018	Weather:		Coding:	PACP 6.0
Pipe Length (ft):	336.2	Owner:	NA	Pre Clean:	Not Known
P.O.#:		Surveyor:	Justin Gonzales	PSR:	P-703-033-034
Customer:		Clean Date:	01/01/1900	Shape:	C

Street:	hidden lake dr	Flow Control:	Not Controlled
City:	Hobart, IN	Year Renewed:	
Location:	Other	Tape/Media #:	
Purpose:	Not Known	Dia/Height:	10"
Use:	Sanitary	Material:	PVC
Drain Area:	NA	Lining:	
Category:	NA		
Comment:

Location Details:		Direction of Survey:	Downstream
US MH:	M-703-034	DS MH:	M-703-033
		Total Length Surveyed (ft):	331.0

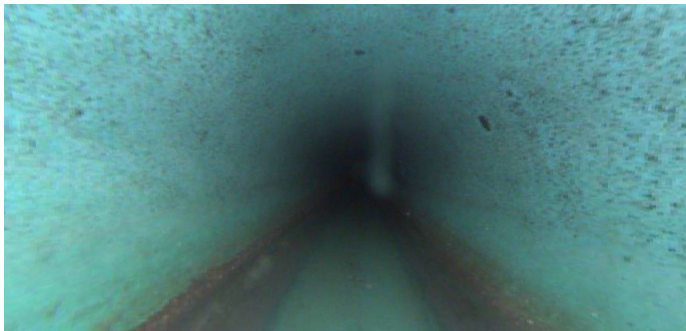
Code: **AMH**
Description: **Manhole**

Distance (ft): **.0**
Structural Grade: **0**
O&M Grade: **0**
Clock Start/From:
Clock To:
1st Value:
2nd Value:
Value Percent:
Continuous Index:
Within 8" of Joint: **NO**
Remarks: **M-703-034**

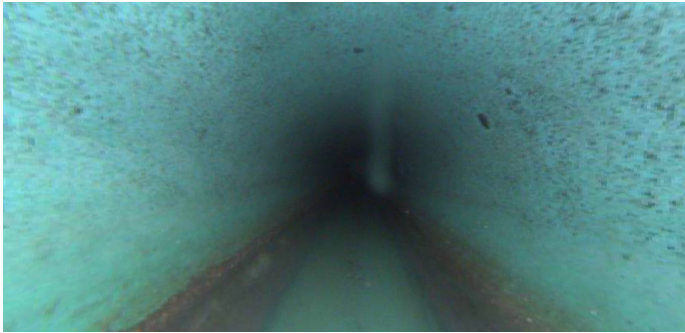
Code:	MWL
Description:	Water Level

Distance (ft):	.0
Structural Grade:	0
O&M Grade:	0
Clock Start/From:	
Clock To:	
1st Value:	
2nd Value:	
Value Percent:	10.000
Continuous Index:	
Within 8" of Joint:	NO
Remarks:

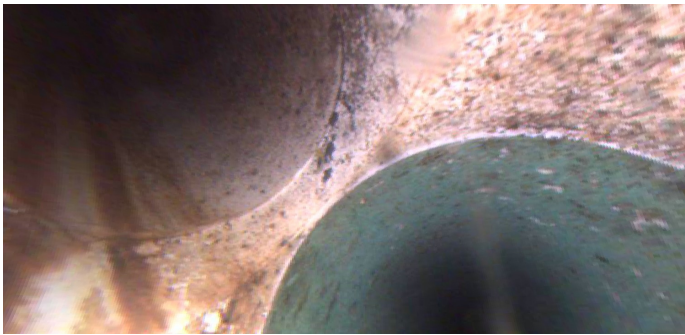
Code:	TF
Description:	Tap Factory

Distance (ft):	25.2
Structural Grade:	0
O&M Grade:	0
Clock Start/From:	10
Clock To:	
1st Value:	4.000
2nd Value:	
Value Percent:	
Continuous Index:	
Within 8" of Joint:	
Remarks:

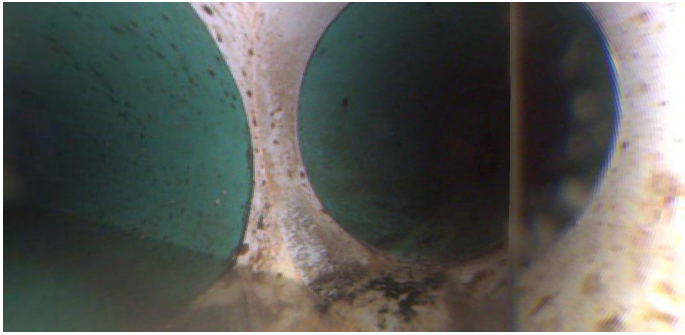
Code: **TF**
Description: **Tap Factory**

Distance (ft): **36.6**
Structural Grade: **0**
O&M Grade: **0**
Clock Start/From: **3**
Clock To:
1st Value: **4.000**
2nd Value:
Value Percent:
Continuous Index:
Within 8" of Joint:
Remarks:

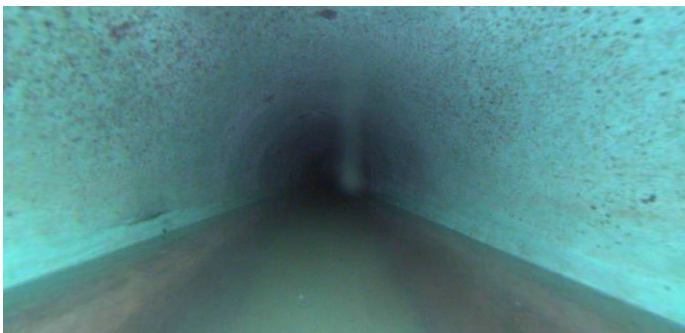
Code: **MWL**
Description: **Water Level**

Distance (ft): **67.1**
Structural Grade: **0**
O&M Grade: **0**
Clock Start/From:
Clock To:
1st Value:
2nd Value:
Value Percent: **40.000**
Continuous Index:
Within 8" of Joint: **NO**
Remarks:

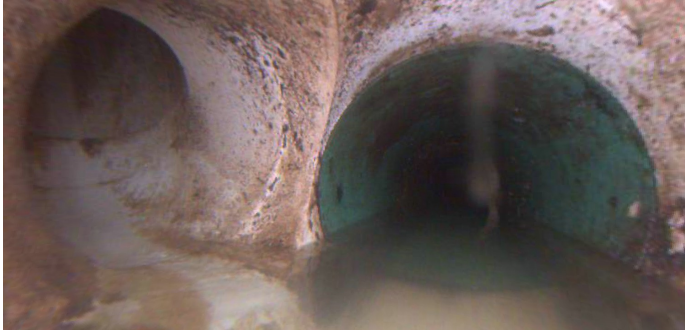
Code: **TFA**
Description: **Tap Factory Active**

Distance (ft): **110.4**
Structural Grade: **0**
O&M Grade: **0**
Clock Start/From: **9**
Clock To:
1st Value: **4.000**
2nd Value:
Value Percent:
Continuous Index:
Within 8" of Joint:
Remarks:

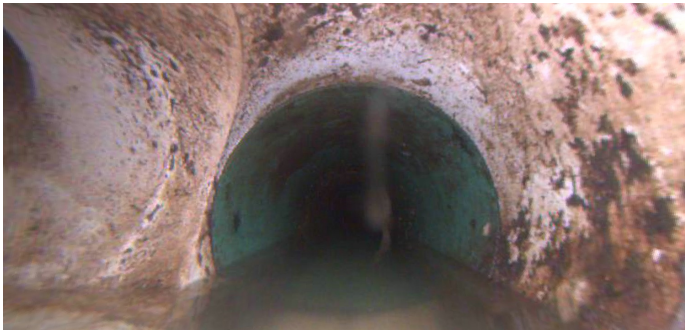
Code: **MWL**
Description: **Water Level**

Distance (ft): **110.4**
Structural Grade: **0**
O&M Grade: **0**
Clock Start/From:
Clock To:
1st Value:
2nd Value:
Value Percent: **30.000**
Continuous Index:
Within 8" of Joint: **NO**
Remarks:

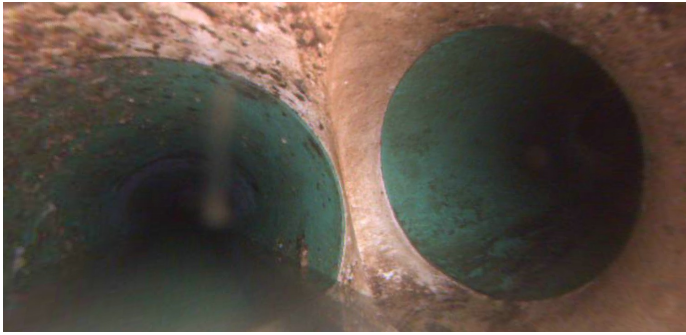
Code: **TF**
Description: **Tap Factory**

Distance (ft): **113.0**
Structural Grade: **0**
O&M Grade: **0**
Clock Start/From: **3**
Clock To:
1st Value: **4.000**
2nd Value:
Value Percent:
Continuous Index:
Within 8" of Joint:
Remarks:

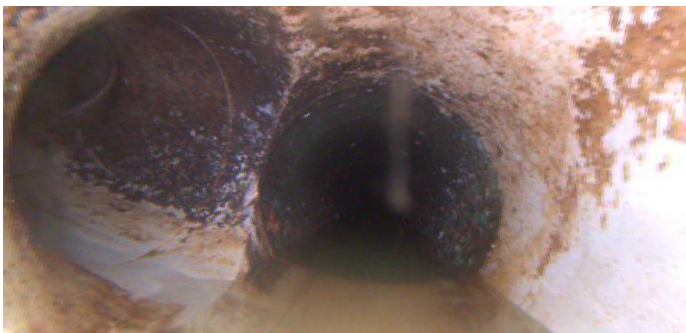
Code: **TF**
Description: **Tap Factory**

Distance (ft): **228.8**
Structural Grade: **0**
O&M Grade: **0**
Clock Start/From: **9**
Clock To:
1st Value: **4.000**
2nd Value:
Value Percent:
Continuous Index:
Within 8" of Joint:
Remarks:

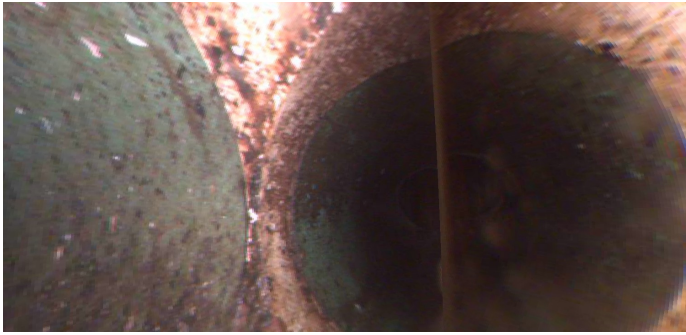
Code: **TF**
Description: **Tap Factory**

Distance (ft): **232.0**
Structural Grade: **0**
O&M Grade: **0**
Clock Start/From: **3**
Clock To:
1st Value: **4.000**
2nd Value:
Value Percent:
Continuous Index:
Within 8" of Joint:
Remarks:

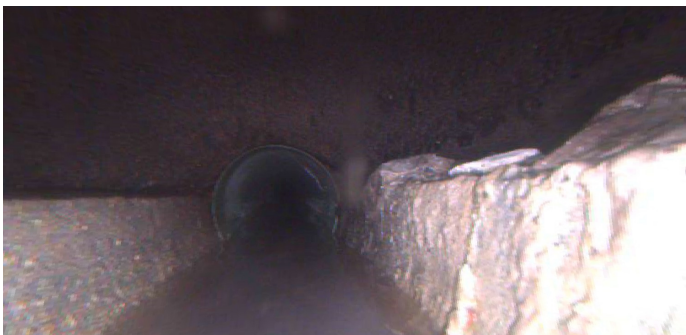
Code: **AMH**
Description: **Manhole**

Distance (ft): **331.0**
Structural Grade: **0**
O&M Grade: **0**
Clock Start/From:
Clock To:
1st Value:
2nd Value:
Value Percent:
Continuous Index:
Within 8" of Joint: **NO**
Remarks: **M-703-033**
