Profile/Photo Observation Report

Street:	quail dr	Flow Control:	Not Controlled
City:	Hobart, IN	Year Renewed:	
Location:	Other	Tape/Media #:	
Purpose:	Not Known	Dia/Height:	10"
Use:	Sanitary	Material:	PVC
Drain Area:	NA	Lining:	
Category:	NA		
Comment:

Location Details:		Direction of Survey:	Upstream
US MH:	M-703-035	DS MH:	M-703-016
		Total Length Surveyed (ft):	302.7

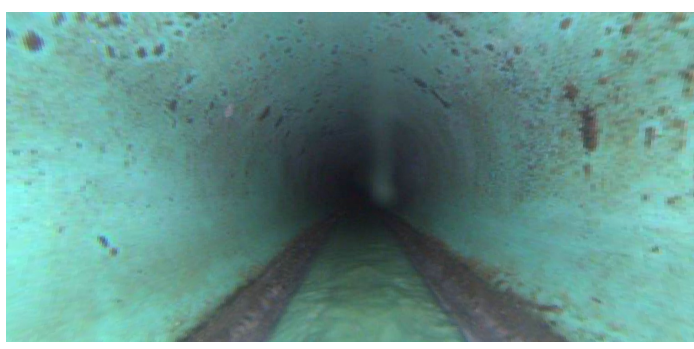
Code: **AMH**
Description: **Manhole**

Distance (ft): **.0**
Structural Grade: **0**
O&M Grade: **0**
Clock Start/From:
Clock To:
1st Value:
2nd Value:
Value Percent:
Continuous Index:
Within 8" of Joint: **NO**
Remarks: **M-703-016**

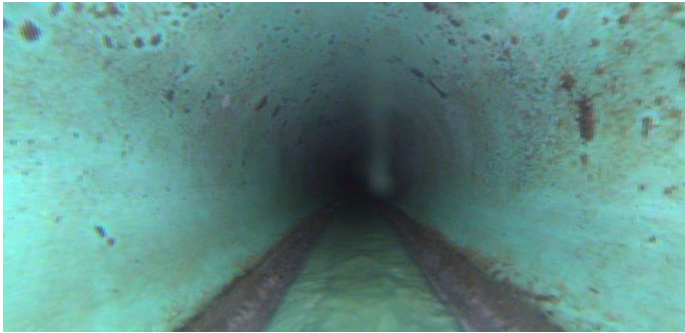
Code:	MWL
Description:	Water Level

Distance (ft):	.0
Structural Grade:	0
O&M Grade:	0
Clock Start/From:	
Clock To:	
1st Value:	
2nd Value:	
Value Percent:	5.000
Continuous Index:	
Within 8" of Joint:	NO
Remarks:

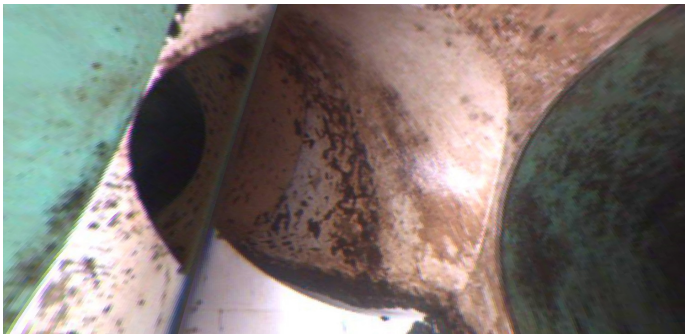
Code:	TF
Description:	Tap Factory

Distance (ft):	83.9
Structural Grade:	0
O&M Grade:	0
Clock Start/From:	10
Clock To:	
1st Value:	4.000
2nd Value:	
Value Percent:	
Continuous Index:	
Within 8" of Joint:	
Remarks:

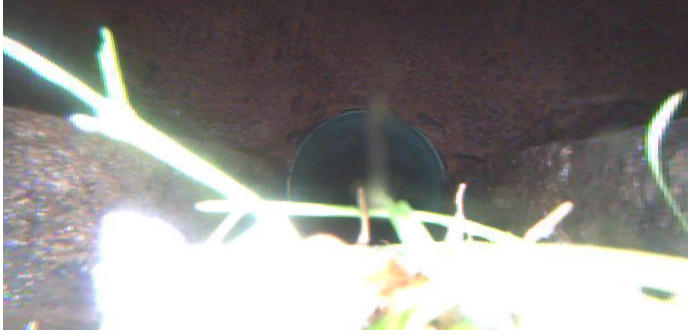
Code: **AMH**
Description: **Manhole**

Distance (ft): **302.7**
Structural Grade: **0**
O&M Grade: **0**
Clock Start/From:
Clock To:
1st Value:
2nd Value:
Value Percent:
Continuous Index:
Within 8" of Joint: **NO**
Remarks: **M-703-035**
