Profile/Photo Observation Report

Street:	hidden lake dr	Flow Control:	Not Controlled
City:	Hobart, IN	Year Renewed:	
Location:	Other	Tape/Media #:	
Purpose:	Not Known	Dia/Height:	10"
Use:	Sanitary	Material:	PVC
Drain Area:	NA	Lining:	
Category:	NA		
Comment:

Location Details:		Direction of Survey:	Downstream
US MH:	M-703-037	DS MH:	M-704-067
		Total Length Surveyed (ft):	364.3

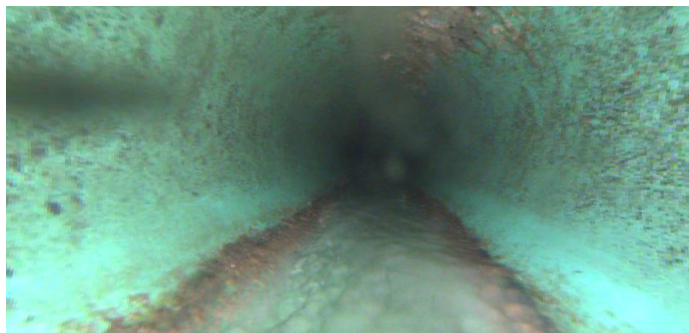
Code: **AMH**
 Description: **Manhole**

Distance (ft): **.0**
 Structural Grade: **0**
 O&M Grade: **0**
 Clock Start/From:
 Clock To:
 1st Value:
 2nd Value:
 Value Percent:
 Continuous Index:
 Within 8" of Joint: **NO**
 Remarks: **M-703-037**

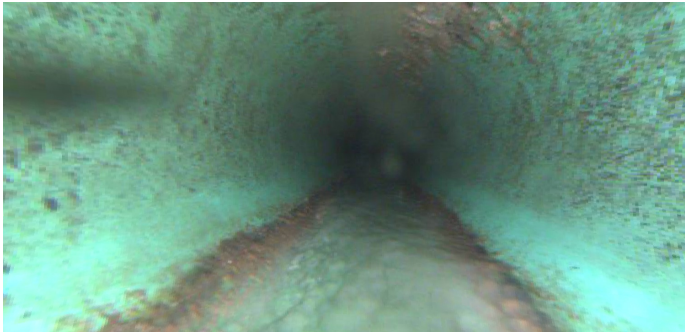
Code:	MWL
Description:	Water Level

Distance (ft):	.0
Structural Grade:	0
O&M Grade:	0
Clock Start/From:	
Clock To:	
1st Value:	
2nd Value:	
Value Percent:	10.000
Continuous Index:	
Within 8" of Joint:	NO
Remarks:

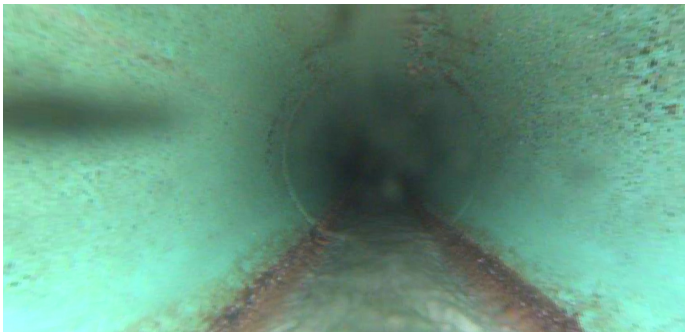
Code:	DAZ
Description:	Deposits Attached Other

Distance (ft):	5.6
Structural Grade:	0
O&M Grade:	2
Clock Start/From:	7
Clock To:	5
1st Value:	
2nd Value:	
Value Percent:	5.000
Continuous Index:	S01
Within 8" of Joint:	YES
Remarks:	WANDER

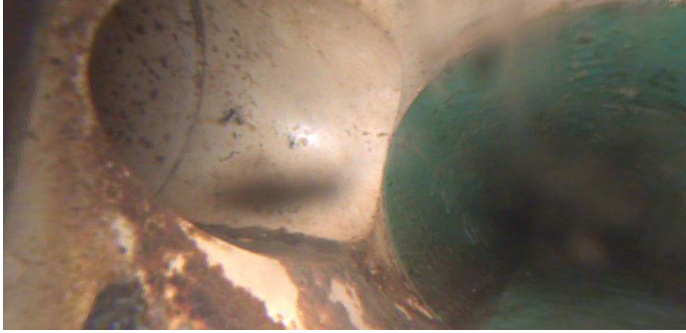
Code: **TF**
Description: **Tap Factory**

Distance (ft): **37.1**
Structural Grade: **0**
O&M Grade: **0**
Clock Start/From: **9**
Clock To:
1st Value: **4.000**
2nd Value:
Value Percent:
Continuous Index:
Within 8" of Joint:
Remarks:

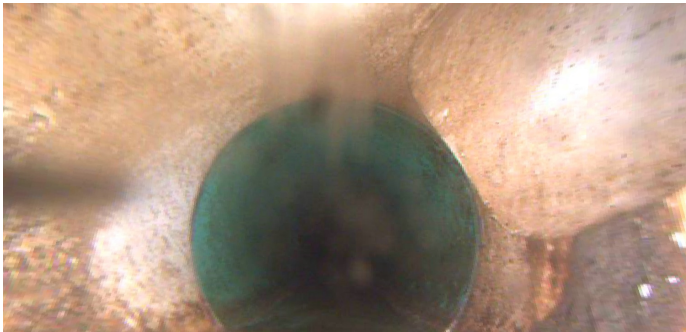
Code: **TF**
Description: **Tap Factory**

Distance (ft): **109.3**
Structural Grade: **0**
O&M Grade: **0**
Clock Start/From: **2**
Clock To:
1st Value: **4.000**
2nd Value:
Value Percent:
Continuous Index:
Within 8" of Joint:
Remarks:

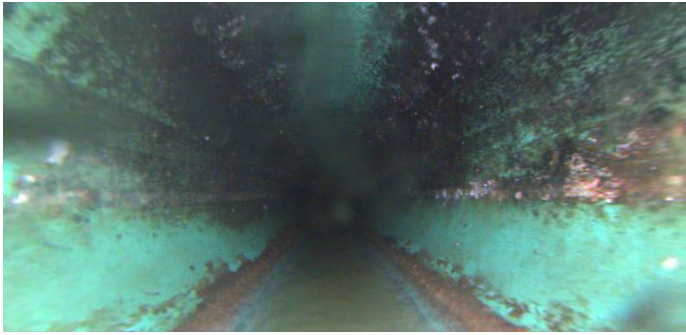
Code: **DAZ**
Description: **Deposits Attached Other**

Distance (ft): **111.8**
Structural Grade: **0**
O&M Grade: **2**
Clock Start/From: **7**
Clock To: **5**
1st Value:
2nd Value:
Value Percent: **5.000**
Continuous Index: **F01**
Within 8" of Joint: **YES**
Remarks: **WANDER**

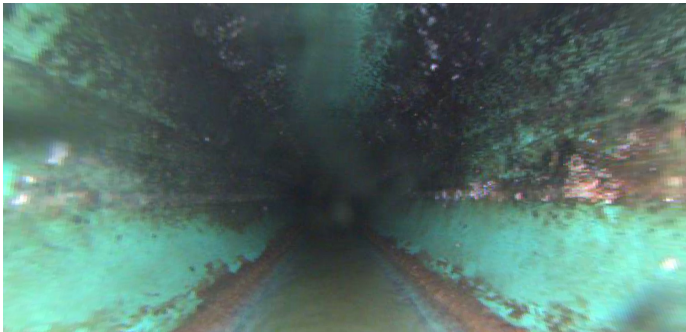
Code: **DAGS**
Description: **Deposits Attached Grease**

Distance (ft): **111.8**
Structural Grade: **0**
O&M Grade: **2**
Clock Start/From: **7**
Clock To: **5**
1st Value:
2nd Value:
Value Percent: **5.000**
Continuous Index: **S02**
Within 8" of Joint: **YES**
Remarks: **WANDER**

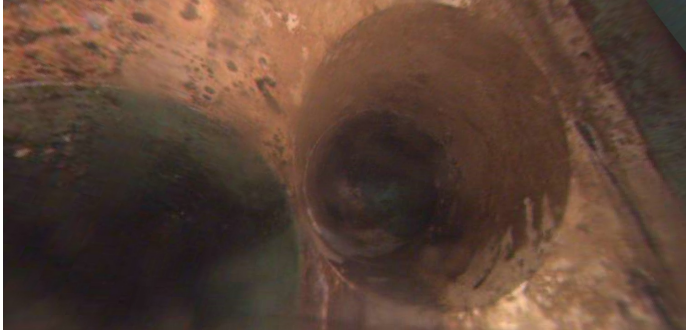
Code: **TF**
Description: **Tap Factory**

Distance (ft): **213.9**
Structural Grade: **0**
O&M Grade: **0**
Clock Start/From: **10**
Clock To:
1st Value: **4.000**
2nd Value:
Value Percent:
Continuous Index:
Within 8" of Joint:
Remarks:

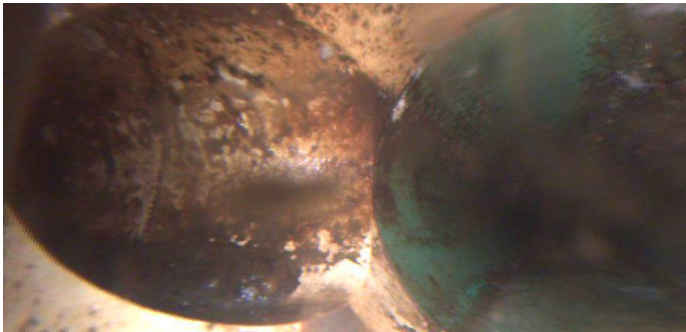
Code: **TF**
Description: **Tap Factory**

Distance (ft): **298.3**
Structural Grade: **0**
O&M Grade: **0**
Clock Start/From: **9**
Clock To:
1st Value: **4.000**
2nd Value:
Value Percent:
Continuous Index:
Within 8" of Joint:
Remarks:

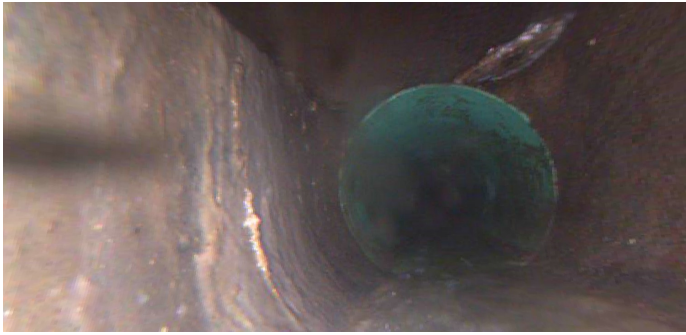
Code: **AMH**
Description: **Manhole**

Distance (ft): **364.3**
Structural Grade: **0**
O&M Grade: **0**
Clock Start/From:
Clock To:
1st Value:
2nd Value:
Value Percent:
Continuous Index:
Within 8" of Joint: **NO**
Remarks: **M-704-067**

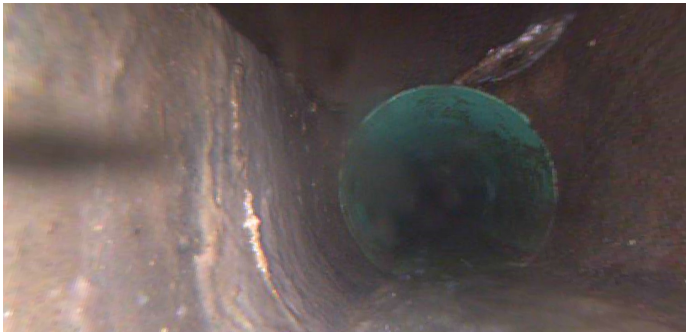
Code: **DAGS**
Description: **Deposits Attached Grease**

Distance (ft): **364.3**
Structural Grade: **0**
O&M Grade: **2**
Clock Start/From: **7**
Clock To: **5**
1st Value:
2nd Value:
Value Percent: **5.000**
Continuous Index: **F02**
Within 8" of Joint: **YES**
Remarks: **WANDER**
