Profile/Photo Observation Report

Date:	09/30/2018	Weather:		Coding:	PACP 6.0
Pipe Length (ft):	223.1	Owner:	NA	Pre Clean:	Not Known
P.O.#:		Surveyor:	Justin Gonzales	PSR:	P-703-041-040
Customer:		Clean Date:	01/01/1900	Shape:	C

Street:	NERINGA LN	Flow Control:	Not Controlled
City:	Hobart, IN	Year Renewed:	
Location:	Light Highway	Tape/Media #:	
Purpose:	Routine Assessment	Dia/Height:	8"
Use:	Sanitary	Material:	PVC
Drain Area:	NA	Lining:	
Category:	NA		
Comment:

Location Details:		Direction of Survey:	Downstream
US MH:	M-703-040	DS MH:	M-703-041
		Total Length Surveyed (ft):	216.3

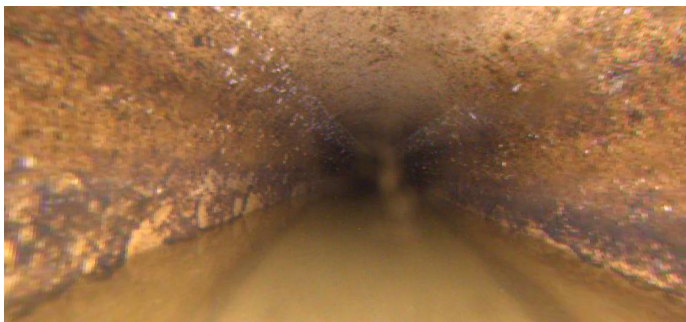
Code: **AMH**
Description: **Manhole**

Distance (ft): **.0**
Structural Grade: **0**
O&M Grade: **0**
Clock Start/From:
Clock To:
1st Value:
2nd Value:
Value Percent:
Continuous Index:
Within 8" of Joint: **NO**
Remarks: **M-703-040**

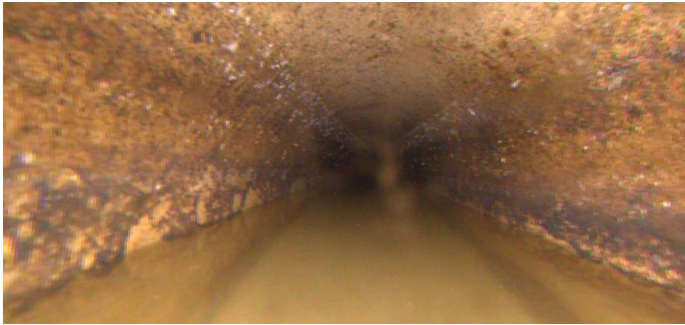
Code:	MWL
Description:	Water Level

Distance (ft):	.0
Structural Grade:	0
O&M Grade:	0
Clock Start/From:	
Clock To:	
1st Value:	
2nd Value:	
Value Percent:	10.000
Continuous Index:	
Within 8" of Joint:	NO
Remarks:

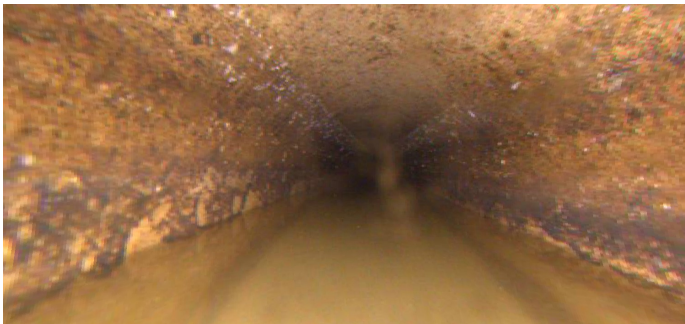
Code:	DAZ
Description:	Deposits Attached Other

Distance (ft):	.0
Structural Grade:	0
O&M Grade:	2
Clock Start/From:	7
Clock To:	5
1st Value:	
2nd Value:	
Value Percent:	5.000
Continuous Index:	S01
Within 8" of Joint:	YES
Remarks:	WANDER

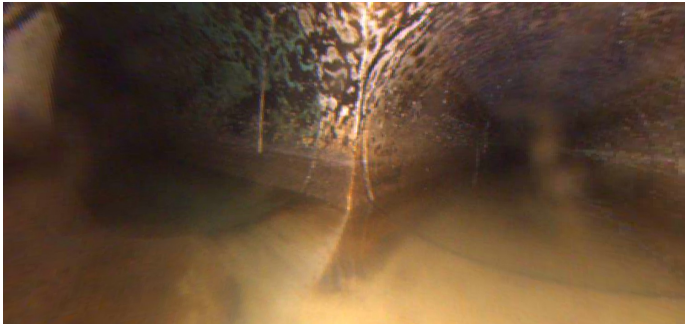
Code: **TFA**
Description: **Tap Factory Active**

Distance (ft): **27.1**
Structural Grade: **0**
O&M Grade: **0**
Clock Start/From: **9**
Clock To:
1st Value: **6.000**
2nd Value:
Value Percent:
Continuous Index:
Within 8" of Joint:
Remarks:

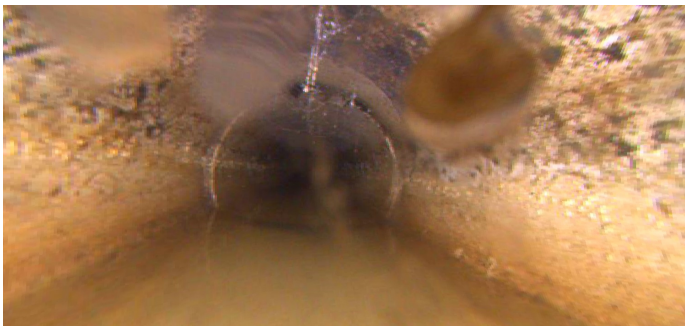
Code: **MGO**
Description: **General Observation**

Distance (ft): **37.9**
Structural Grade: **0**
O&M Grade: **0**
Clock Start/From:
Clock To:
1st Value:
2nd Value:
Value Percent:
Continuous Index:
Within 8" of Joint: **NO**
Remarks: **WATER DROPLETS AND SPIDERWEBS ON LENS**

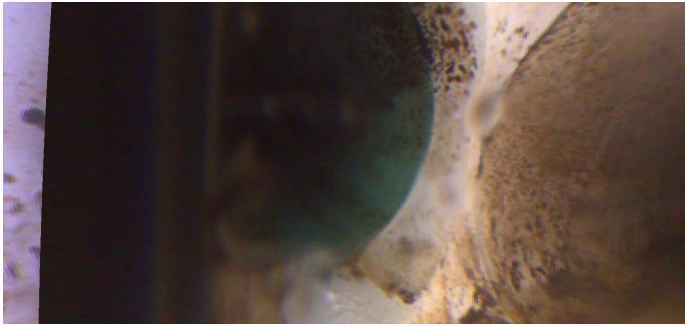
Code: **TFA**
Description: **Tap Factory Active**

Distance (ft): **106.2**
Structural Grade: **0**
O&M Grade: **0**
Clock Start/From: **9**
Clock To:
1st Value: **6.000**
2nd Value:
Value Percent:
Continuous Index:
Within 8" of Joint:
Remarks:

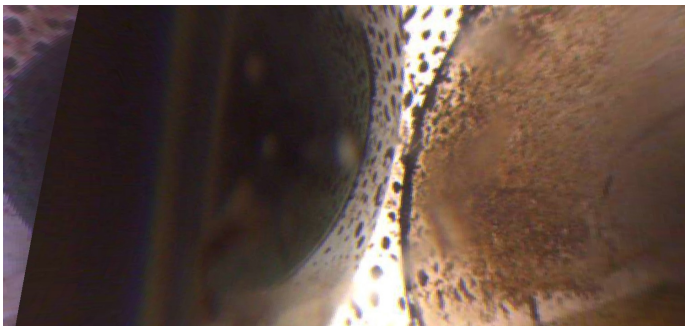
Code: **TF**
Description: **Tap Factory**

Distance (ft): **171.7**
Structural Grade: **0**
O&M Grade: **0**
Clock Start/From: **9**
Clock To:
1st Value: **6.000**
2nd Value:
Value Percent:
Continuous Index:
Within 8" of Joint:
Remarks:
