Profile/Photo Observation Report

Street:	Fox Trail Ct.	Flow Control:	Not Controlled
City:	Hobart, IN	Year Renewed:	
Location:	Light Highway	Tape/Media #:	
Purpose:	Routine Assessment	Dia/Height:	8"
Use:	Sanitary	Material:	PVC
Drain Area:	NA	Lining:	
Category:	NA		
Comment:

Location Details:		Direction of Survey:	Downstream
US MH:	M-703-040	DS MH:	M-703-041
		Total Length Surveyed (ft):	216.3

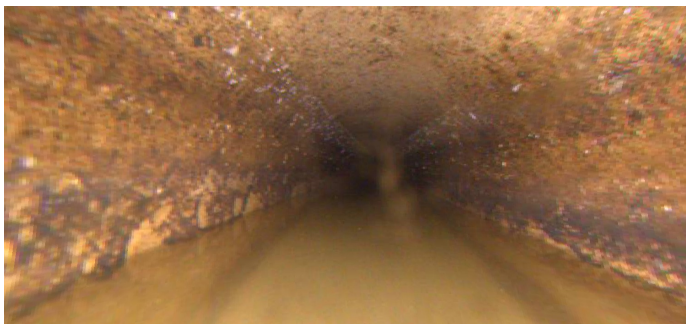
Code: **AMH**
Description: **Manhole**

Distance (ft): **.0**
Structural Grade: **0**
O&M Grade: **0**
Clock Start/From:
Clock To:
1st Value:
2nd Value:
Value Percent:
Continuous Index:
Within 8" of Joint: **NO**
Remarks: **M-703-040**

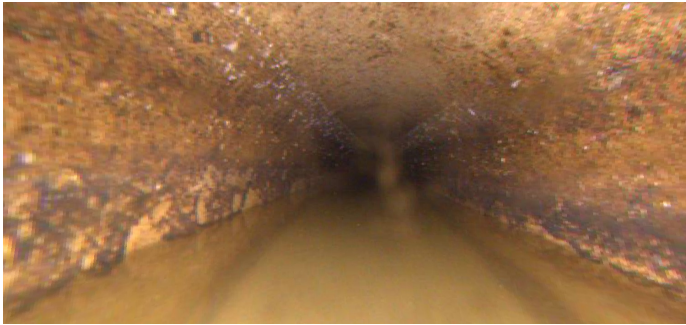
Code:	MWL
Description:	Water Level

Distance (ft):	.0
Structural Grade:	0
O&M Grade:	0
Clock Start/From:	
Clock To:	
1st Value:	
2nd Value:	
Value Percent:	10.000
Continuous Index:	
Within 8" of Joint:	NO
Remarks:

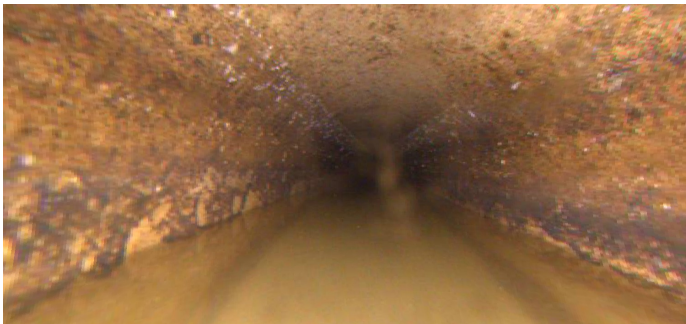
Code:	DAZ
Description:	Deposits Attached Other

Distance (ft):	.0
Structural Grade:	0
O&M Grade:	2
Clock Start/From:	7
Clock To:	5
1st Value:	
2nd Value:	
Value Percent:	5.000
Continuous Index:	S01
Within 8" of Joint:	YES
Remarks:	WANDER

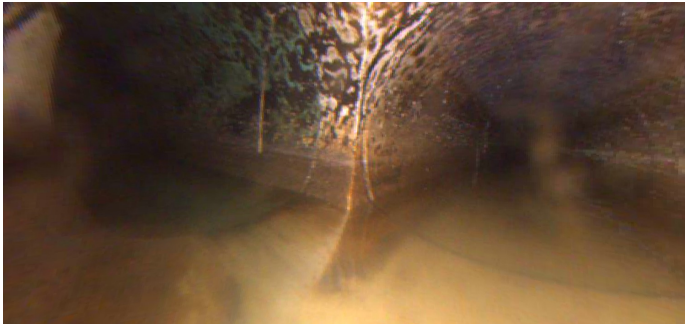
Code: **TFA**
Description: **Tap Factory Active**

Distance (ft): **27.1**
Structural Grade: **0**
O&M Grade: **0**
Clock Start/From: **9**
Clock To:
1st Value: **6.000**
2nd Value:
Value Percent:
Continuous Index:
Within 8" of Joint:
Remarks:

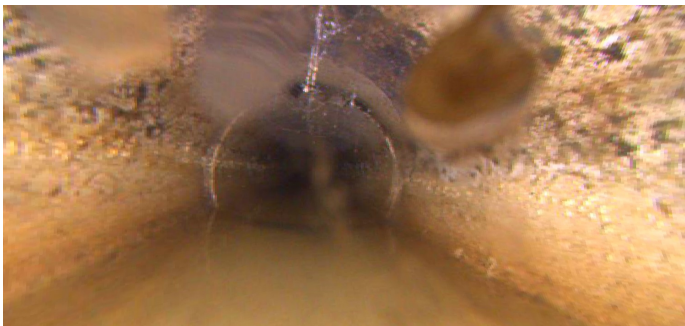
Code: **MGO**
Description: **General Observation**

Distance (ft): **37.9**
Structural Grade: **0**
O&M Grade: **0**
Clock Start/From:
Clock To:
1st Value:
2nd Value:
Value Percent:
Continuous Index:
Within 8" of Joint: **NO**
Remarks: **WATER DROPLETS AND SPIDERWEBS ON LENS**

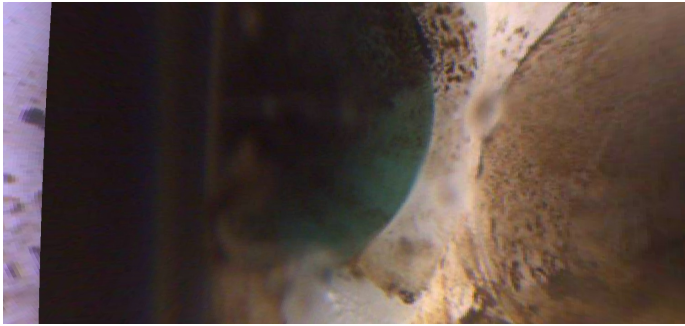
Code: **TFA**
Description: **Tap Factory Active**

Distance (ft): **106.2**
Structural Grade: **0**
O&M Grade: **0**
Clock Start/From: **9**
Clock To:
1st Value: **6.000**
2nd Value:
Value Percent:
Continuous Index:
Within 8" of Joint:
Remarks:

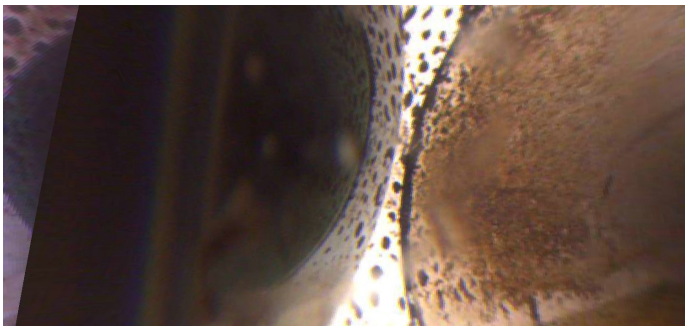
Code: **TF**
Description: **Tap Factory**

Distance (ft): **171.7**
Structural Grade: **0**
O&M Grade: **0**
Clock Start/From: **9**
Clock To:
1st Value: **6.000**
2nd Value:
Value Percent:
Continuous Index:
Within 8" of Joint:
Remarks:
