## Profile/Photo Observation Report

Date:	<b>04/25/2018</b>	Weather:		Coding:	<b>PACP 4.2</b>
Pipe Length (ft):	<b>226.0</b>	Owner:	<b>City of Hobart</b>	Pre Clean:	<b>No Pre-Cleaning</b>
P.O.#:	<b>2004</b>	Surveyor:	<b>SAN</b>	PSR:	<b>P-804-058-007</b>
Customer:	<b>Red Zone</b>	Clean Date:		Shape:	<b>C</b>

Street:	<b>215 N Linda St</b>	Flow Control:	<b>Not Controlled</b>
City:	<b>Hobart In</b>	Year Renewed:	
Location:	<b>Yard</b>	Tape/Media #:	<b>Deliverable 1</b>
Purpose:	<b>Routine Assessment</b>	Dia/Height:	<b>15"</b>
Use:	<b>Sanitary</b>	Material:	<b>VCP</b>
Drain Area:	<b>Northeast</b>	Lining:	
Category:	<b>NA</b>		
Comment:	<b>437-1/Incomplete due to roots/No reverse setup due to velocity of flow.</b>		
Location Details:	<b>Edge of walk</b>	Direction of Survey:	<b>Downstream</b>
US MH:	<b>M-804-058</b>	DS MH:	<b>M-704-007</b>
		Total Length Surveyed (ft):	<b>73.2</b>

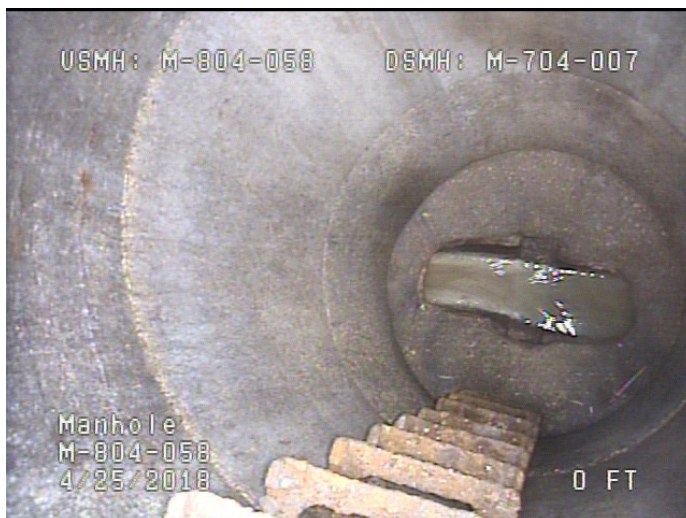
Code: **AMH**  
Description: **Manhole**

Distance (ft): **.0**  
Structural Grade: **0**  
O&M Grade: **0**  
Clock Start/From:  
Clock To:  
1st Value:  
2nd Value:  
Value Percent:  
Continuous Index:  
Within 8" of Joint: **NO**  
Remarks: **M-804-058**

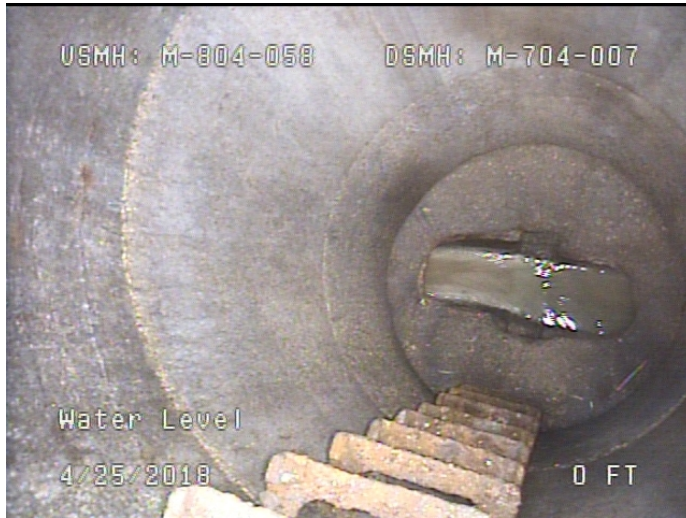
Code:	<b>MWL</b>
Description:	<b>Water Level</b>
Distance (ft):	<b>.0</b>
Structural Grade:	<b>0</b>
O&M Grade:	<b>0</b>
Clock Start/From:	
Clock To:	
1st Value:	
2nd Value:	
Value Percent:	<b>15.000</b>
Continuous Index:	
Within 8" of Joint:	<b>NO</b>
Remarks:

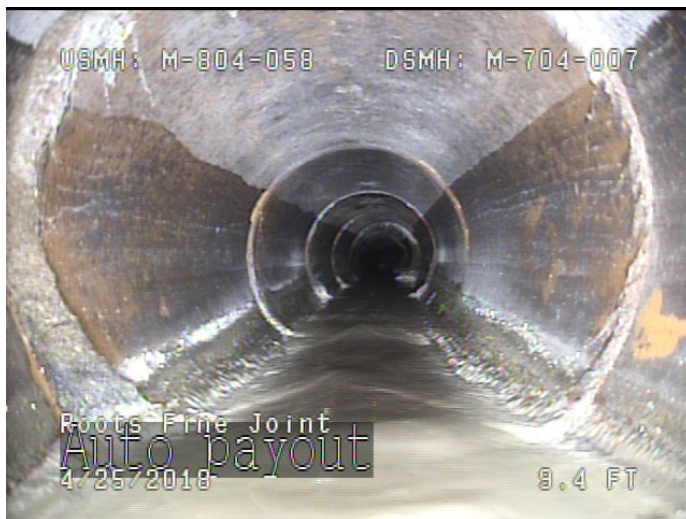
Code:	<b>RFJ</b>
Description:	<b>Roots Fine Joint</b>
Distance (ft):	<b>9.4</b>
Structural Grade:	<b>0</b>
O&M Grade:	<b>1</b>
Clock Start/From:	<b>7</b>
Clock To:	<b>3</b>
1st Value:	
2nd Value:	
Value Percent:	
Continuous Index:	<b>S01</b>
Within 8" of Joint:	<b>YES</b>
Remarks:

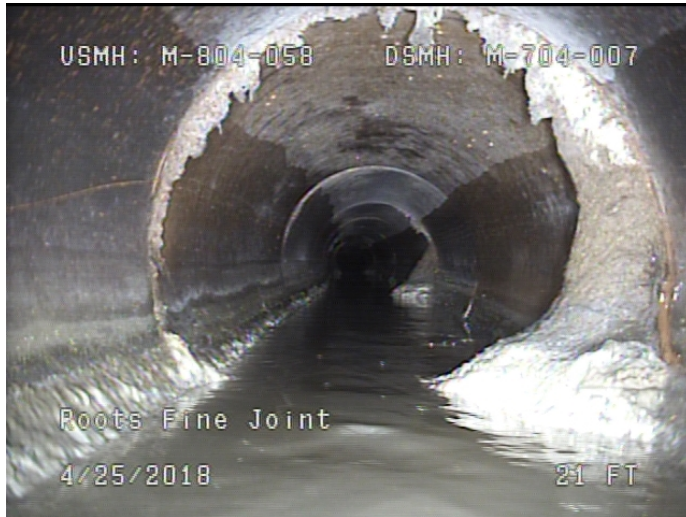
Code: **RFJ**  
 Description: **Roots Fine Joint**

Distance (ft): **21.0**  
 Structural Grade: **0**  
 O&M Grade: **1**  
 Clock Start/From: **7**  
 Clock To: **3**  
 1st Value:  
 2nd Value:  
 Value Percent:  
 Continuous Index: **F01**  
 Within 8" of Joint: **YES**  
 Remarks:

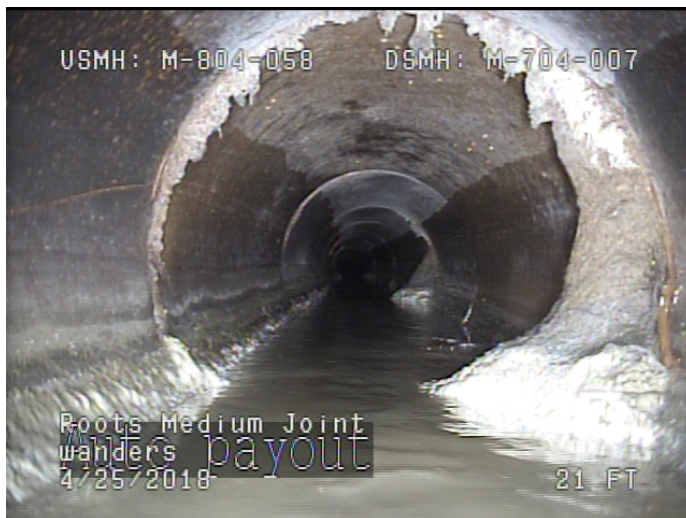
Code: **RMJ**  
 Description: **Roots Medium Joint**

Distance (ft): **21.0**  
 Structural Grade: **0**  
 O&M Grade: **3**  
 Clock Start/From: **7**  
 Clock To: **5**  
 1st Value:  
 2nd Value:  
 Value Percent: **15.000**  
 Continuous Index: **S02**  
 Within 8" of Joint: **YES**  
 Remarks: **wanders**

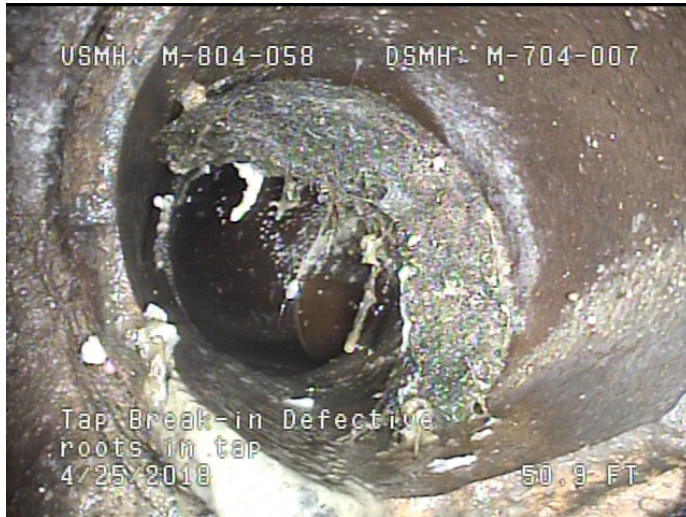
Code:	<b>TBD</b>
Description:	<b>Tap Break-in Defective</b>
Distance (ft):	<b>50.9</b>
Structural Grade:	<b>0</b>
O&M Grade:	<b>3</b>
Clock Start/From:	<b>10</b>
Clock To:	
1st Value:	<b>6.000</b>
2nd Value:	
Value Percent:	
Continuous Index:	
Within 8" of Joint:	<b>NO</b>
Remarks:	<b>roots in tap</b>

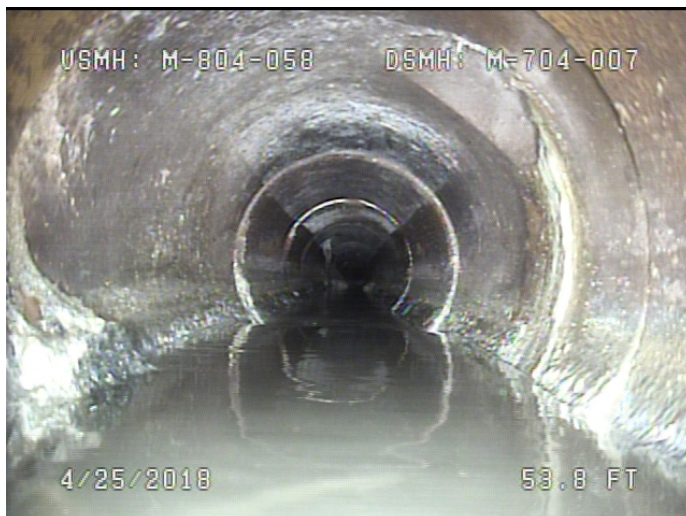
Code:	<b>TFD</b>
Description:	<b>Tap Factory Defective</b>
Distance (ft):	<b>53.8</b>
Structural Grade:	<b>0</b>
O&M Grade:	<b>2</b>
Clock Start/From:	<b>2</b>
Clock To:	
1st Value:	<b>6.000</b>
2nd Value:	
Value Percent:	
Continuous Index:	
Within 8" of Joint:	<b>NO</b>
Remarks:	<b>roots in tap</b>

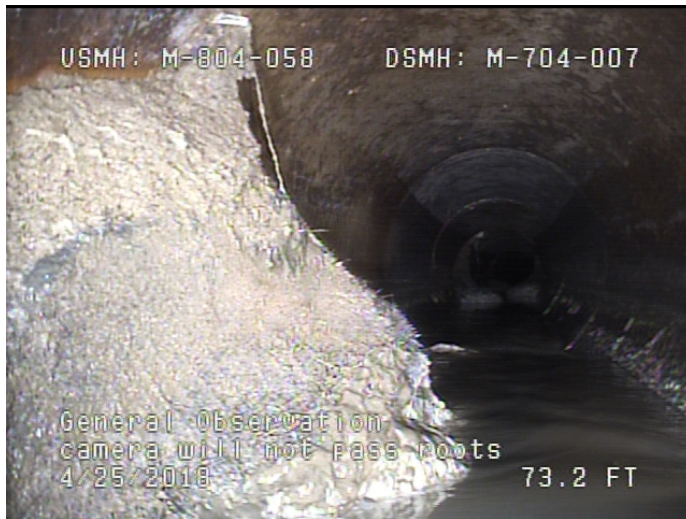
Code:	<b>MGO</b>
Description:	<b>General Observation</b>
Distance (ft):	<b>73.2</b>
Structural Grade:	<b>0</b>
O&M Grade:	<b>0</b>
Clock Start/From:	
Clock To:	
1st Value:	
2nd Value:	
Value Percent:	
Continuous Index:	
Within 8" of Joint:	<b>NO</b>
Remarks:	<b>camera will not pass roots</b>

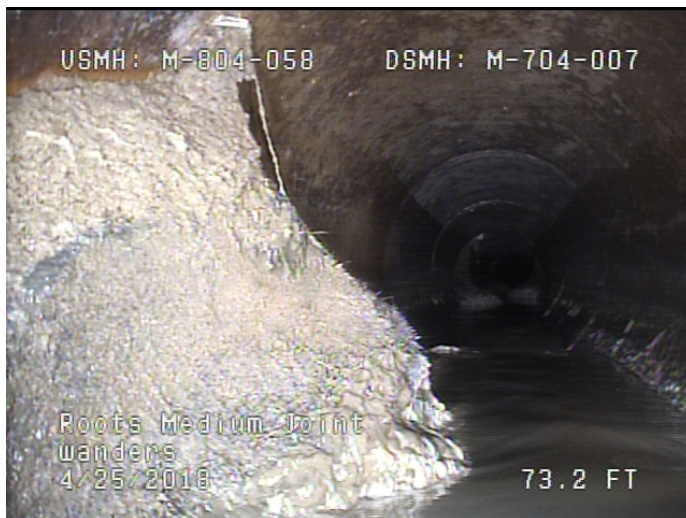
Code:	<b>RMJ</b>
Description:	<b>Roots Medium Joint</b>
Distance (ft):	<b>73.2</b>
Structural Grade:	<b>0</b>
O&M Grade:	<b>3</b>
Clock Start/From:	<b>7</b>
Clock To:	<b>5</b>
1st Value:	
2nd Value:	
Value Percent:	<b>15.000</b>
Continuous Index:	<b>F02</b>
Within 8" of Joint:	<b>YES</b>
Remarks:	<b>wanders</b>

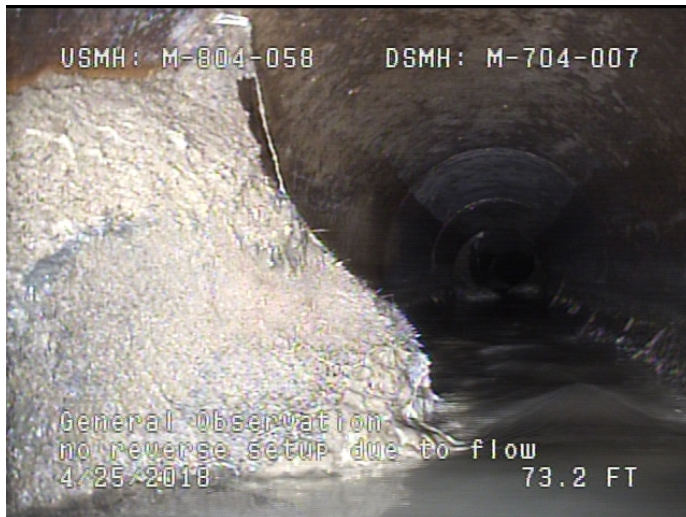
Code:	<b>MGO</b>
Description:	<b>General Observation</b>
Distance (ft):	<b>73.2</b>
Structural Grade:	<b>0</b>
O&M Grade:	<b>0</b>
Clock Start/From:	
Clock To:	
1st Value:	
2nd Value:	
Value Percent:	
Continuous Index:	
Within 8" of Joint:	<b>NO</b>
Remarks:	<b>no reverse setup due to flow</b>

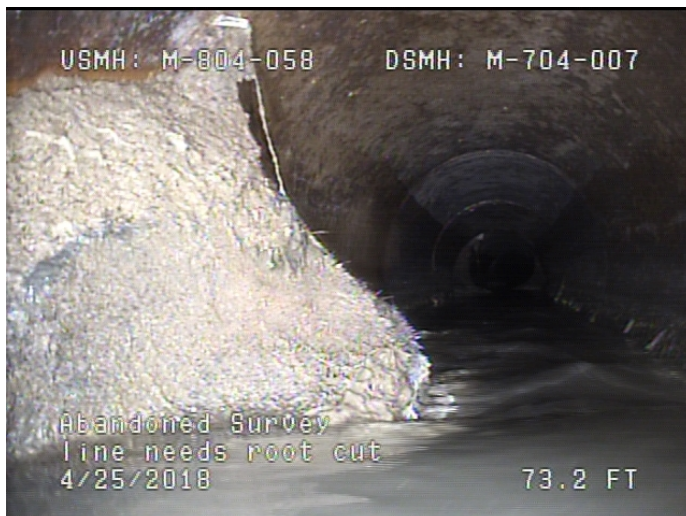
Code:	<b>MSA</b>
Description:	<b>Abandoned Survey</b>
Distance (ft):	<b>73.2</b>
Structural Grade:	<b>0</b>
O&M Grade:	<b>0</b>
Clock Start/From:	
Clock To:	
1st Value:	
2nd Value:	
Value Percent:	
Continuous Index:	
Within 8" of Joint:	<b>NO</b>
Remarks:	<b>line needs root cut</b>
