Profile/Photo Observation Report

Date:	08/12/2022	Weather:		Coding:	PACP 7.0
Pipe Length (ft):	262.0	Owner:	City of Hobart	Pre Clean:	Heavy Cleaning
P.O.#:	YES502259	Surveyor:	S. Bucklin	PSR:	P-804-058-007
Customer:	City of Hobart	Clean Date:	08/06/2022	Shape:	C

Street:	North Linda Street	Flow Control:	Not Controlled
City:	Hobart, IN	Year Renewed:	
Location:	Local rural streets with light traffic, t	Tape/Media #:	
Purpose:	Routine Assessment	Dia/Height:	15"
Use:	Sanitary Sewage Pipe	Material:	VCP
Drain Area:		Lining:	None
Category:	NA		
Comment:			
Location Details:		Direction of Survey:	Downstream
US MH:	M-704-007	DS MH:	M-804-058
		Total Length Surveyed (ft):	260.7

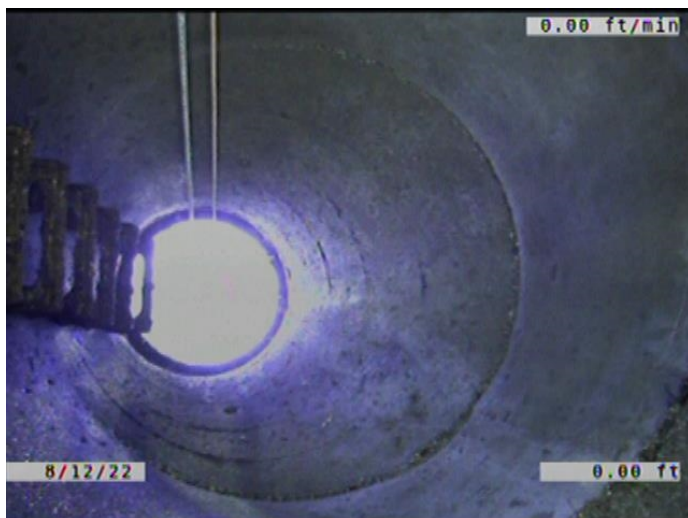
Code: **AMH**
 Description: **Manhole**

Distance (ft): **.0**
 Structural Grade: **0**
 O&M Grade: **0**
 Clock Start/From:
 Clock To:
 1st Value:
 2nd Value:
 Value Percent:
 Continuous Index:
 Within 8" of Joint: **NO**
 Remarks: **M-704-007**

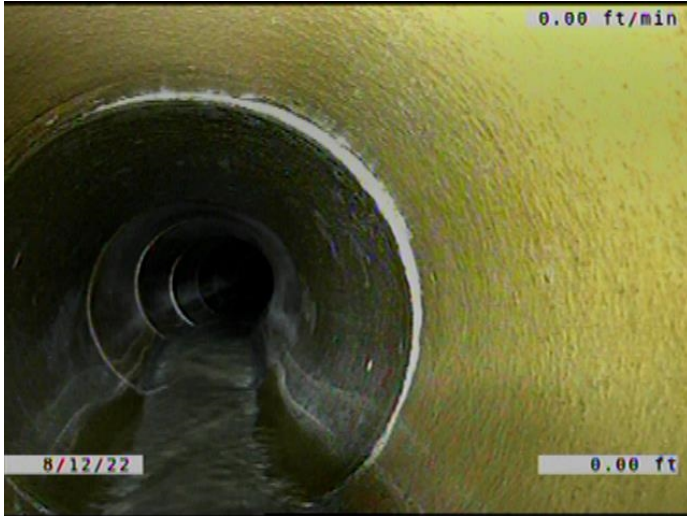
Code:	MWL
Description:	Miscellaneous Water Level
Distance (ft):	.0
Structural Grade:	0
O&M Grade:	0
Clock Start/From:	
Clock To:	
1st Value:	
2nd Value:	
Value Percent:	5.000
Continuous Index:	
Within 8" of Joint:	NO
Remarks:

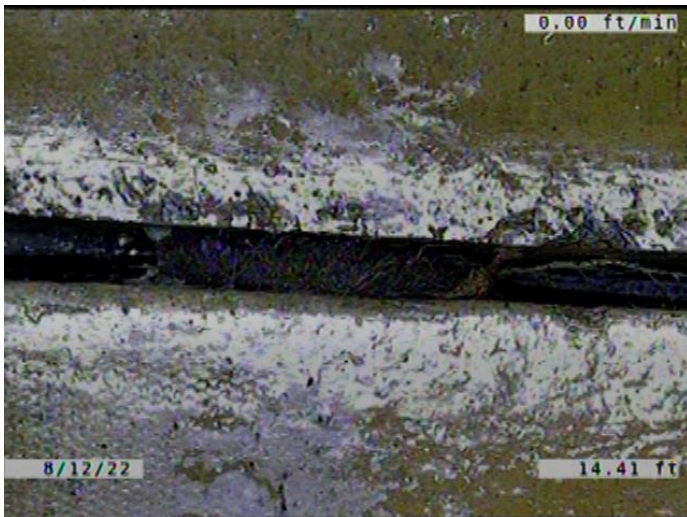
Code:	RFJ
Description:	Roots Fine Joint
Distance (ft):	14.4
Structural Grade:	0
O&M Grade:	1
Clock Start/From:	8
Clock To:	4
1st Value:	
2nd Value:	
Value Percent:	
Continuous Index:	S01
Within 8" of Joint:	YES
Remarks:

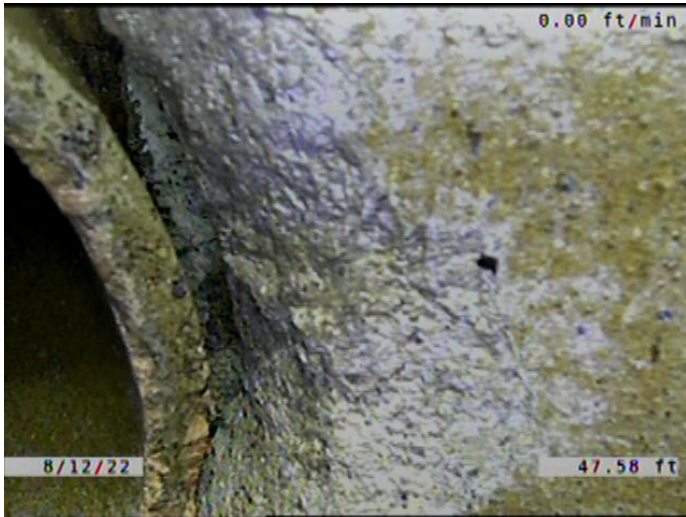
Code: **SSS**
Description: **Surface Damage Surface Spalling**

Distance (ft): **47.6**
Structural Grade: **2**
O&M Grade: **0**
Clock Start/From: **10**
Clock To: **12**
1st Value:
2nd Value:
Value Percent:
Continuous Index:
Within 8" of Joint: **YES**
Remarks:

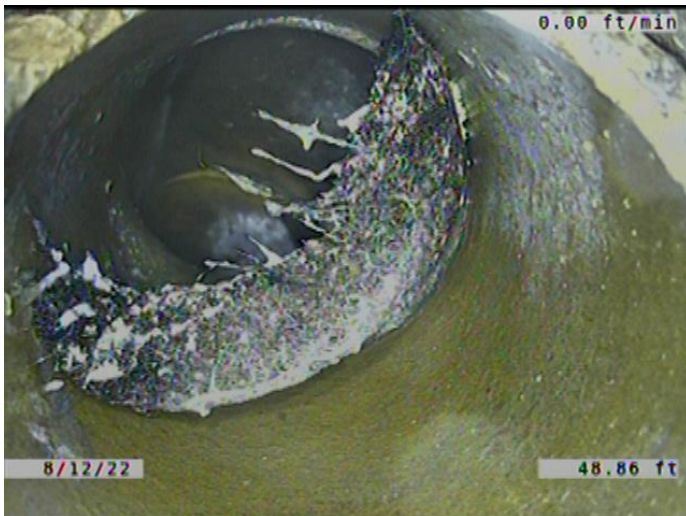
Code: **TBI**
Description: **Tap Break-in Intruding**

Distance (ft): **48.9**
Structural Grade: **0**
O&M Grade: **2**
Clock Start/From: **11**
Clock To:
1st Value: **6.000**
2nd Value: **1.000**
Value Percent:
Continuous Index:
Within 8" of Joint: **YES**
Remarks: **ROOTS GROWING IN THE JOINT.
CONSTANTLY DRIPPING WATER.**

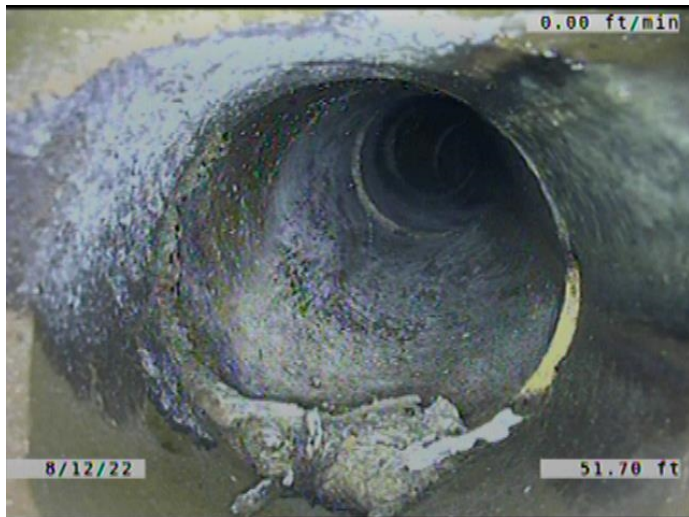
Code: **TF**
 Description: **Tap Factory**

Distance (ft): **51.7**
 Structural Grade: **0**
 O&M Grade: **0**
 Clock Start/From: **2**
 Clock To:
 1st Value: **6.000**
 2nd Value:
 Value Percent:
 Continuous Index:
 Within 8" of Joint: **YES**
 Remarks: **ROOTS GROWING IN THE JOINT.**

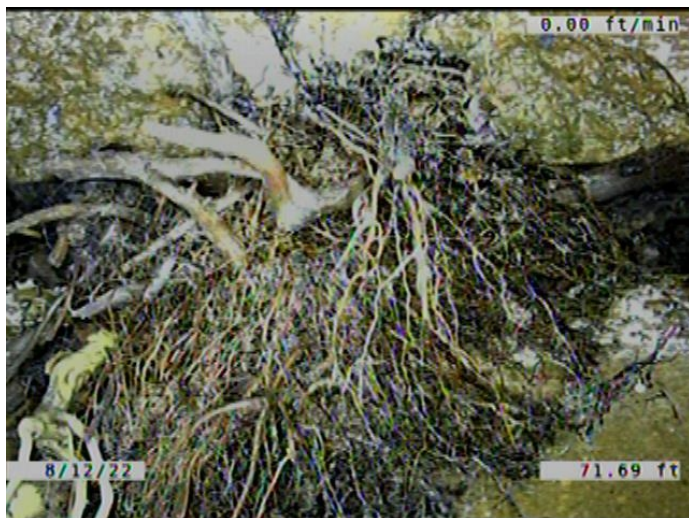
Code: **RMJ**
 Description: **Roots Medium Joint**

Distance (ft): **71.7**
 Structural Grade: **0**
 O&M Grade: **3**
 Clock Start/From: **7**
 Clock To: **1**
 1st Value:
 2nd Value:
 Value Percent: **5.000**
 Continuous Index:
 Within 8" of Joint: **YES**
 Remarks:

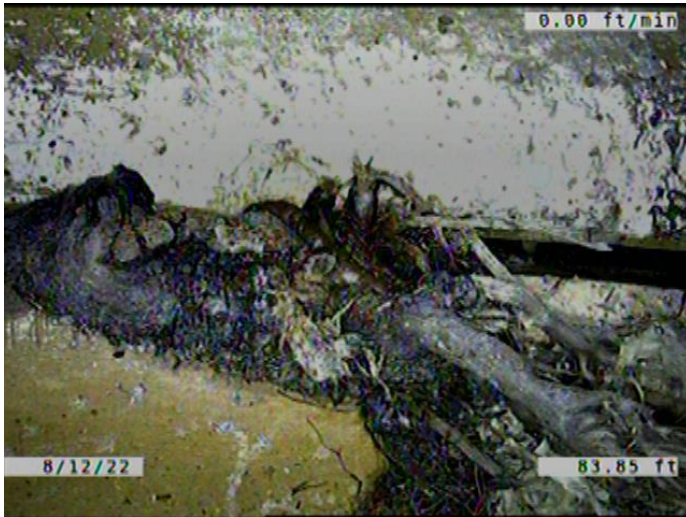
Code: **RMJ**
 Description: **Roots Medium Joint**

Distance (ft): **83.8**
 Structural Grade: **0**
 O&M Grade: **3**
 Clock Start/From: **12**
 Clock To: **4**
 1st Value:
 2nd Value:
 Value Percent: **5.000**
 Continuous Index:
 Within 8" of Joint: **YES**
 Remarks:

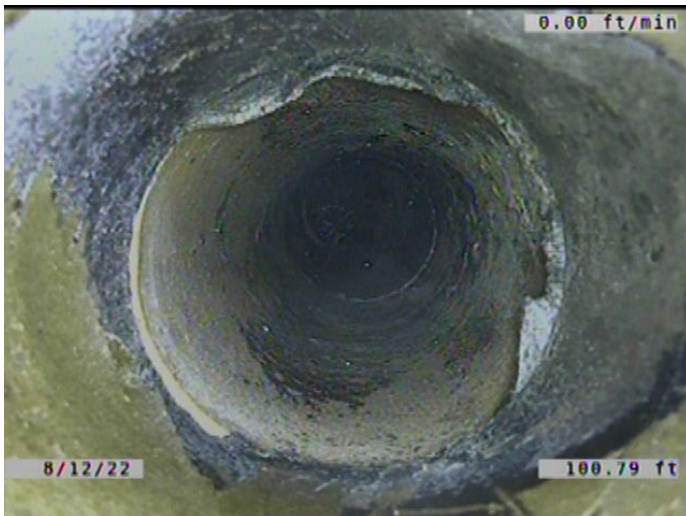
Code: **TF**
 Description: **Tap Factory**

Distance (ft): **100.8**
 Structural Grade: **0**
 O&M Grade: **0**
 Clock Start/From: **1**
 Clock To:
 1st Value: **6.000**
 2nd Value:
 Value Percent:
 Continuous Index:
 Within 8" of Joint: **YES**
 Remarks:

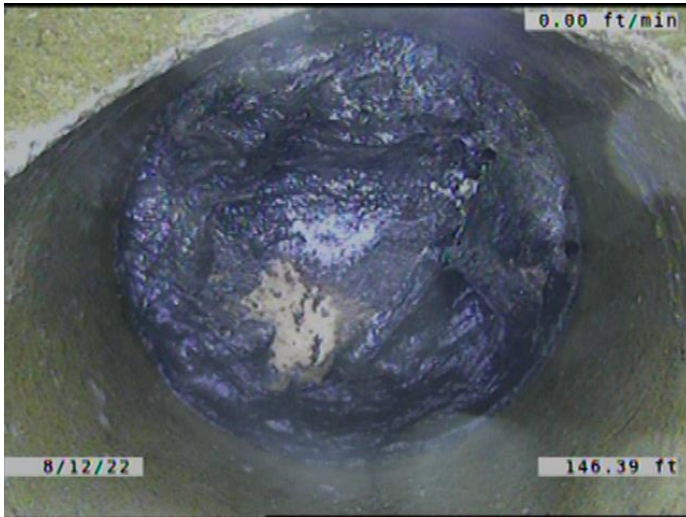
Code:	TFC
Description:	Tap Factory Capped
Distance (ft):	146.4
Structural Grade:	0
O&M Grade:	0
Clock Start/From:	11
Clock To:	
1st Value:	6.000
2nd Value:	
Value Percent:	
Continuous Index:	
Within 8" of Joint:	YES
Remarks:	CAP SEALING MATERIAL COMING IN AROUND THE CAP.

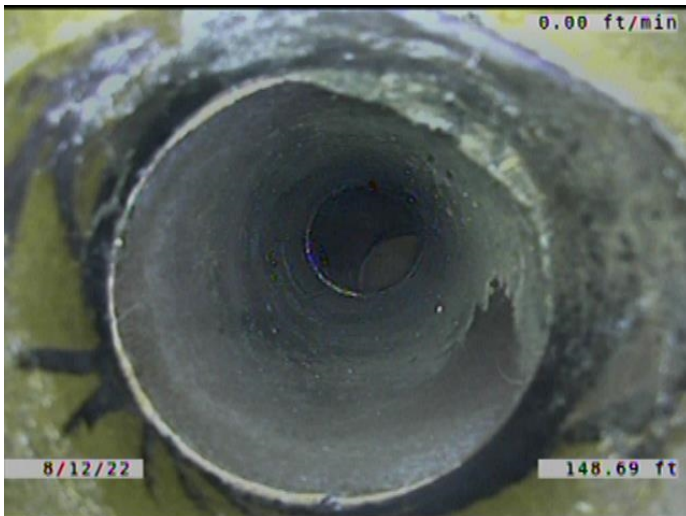
Code:	TF
Description:	Tap Factory
Distance (ft):	148.7
Structural Grade:	0
O&M Grade:	0
Clock Start/From:	1
Clock To:	
1st Value:	6.000
2nd Value:	
Value Percent:	
Continuous Index:	
Within 8" of Joint:	YES
Remarks:

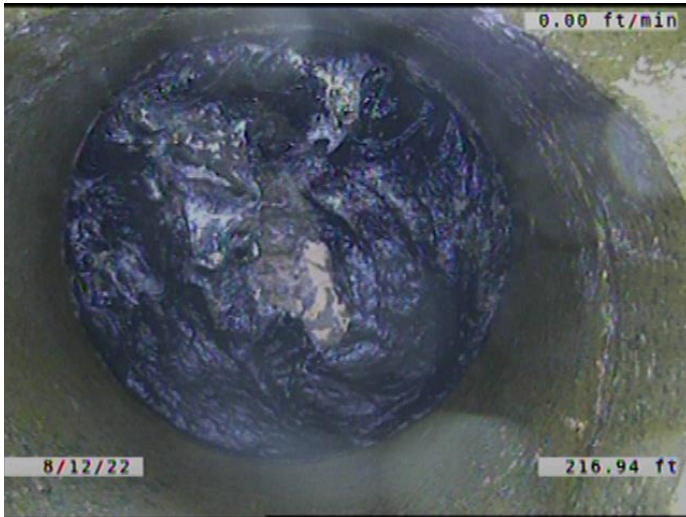
Code:	TFC
Description:	Tap Factory Capped
Distance (ft):	216.9
Structural Grade:	0
O&M Grade:	0
Clock Start/From:	11
Clock To:	
1st Value:	6.000
2nd Value:	
Value Percent:	
Continuous Index:	
Within 8" of Joint:	YES
Remarks:	CAP SEALING MATERIAL COMING AROUND THE CAP.

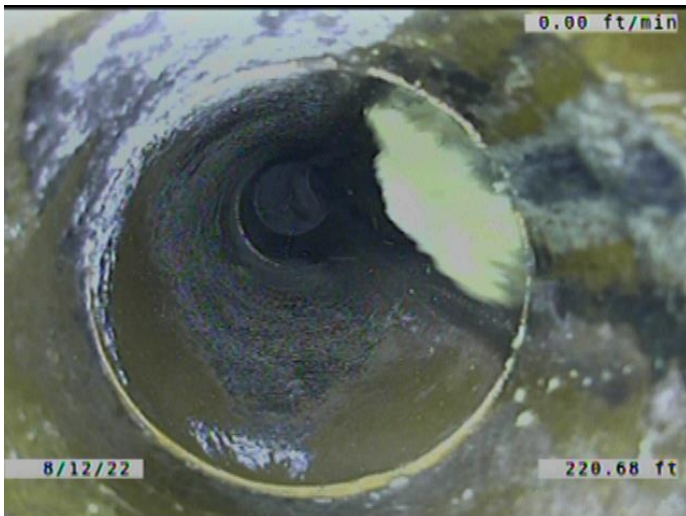
Code:	TFA
Description:	Tap Factory Activity
Distance (ft):	220.7
Structural Grade:	0
O&M Grade:	0
Clock Start/From:	1
Clock To:	
1st Value:	6.000
2nd Value:	
Value Percent:	
Continuous Index:	
Within 8" of Joint:	YES
Remarks:

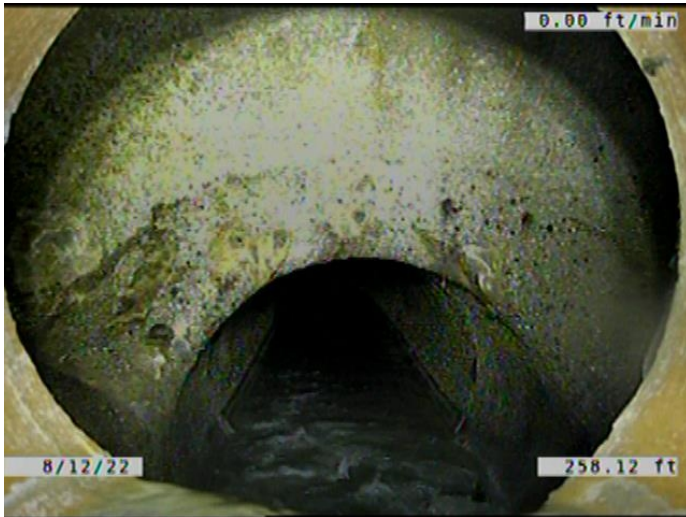
Code: **RFJ**
Description: **Roots Fine Joint**

Distance (ft): **258.1**
Structural Grade: **0**
O&M Grade: **1**
Clock Start/From: **8**
Clock To: **4**
1st Value:
2nd Value:
Value Percent:
Continuous Index: **F01**
Within 8" of Joint: **YES**
Remarks:

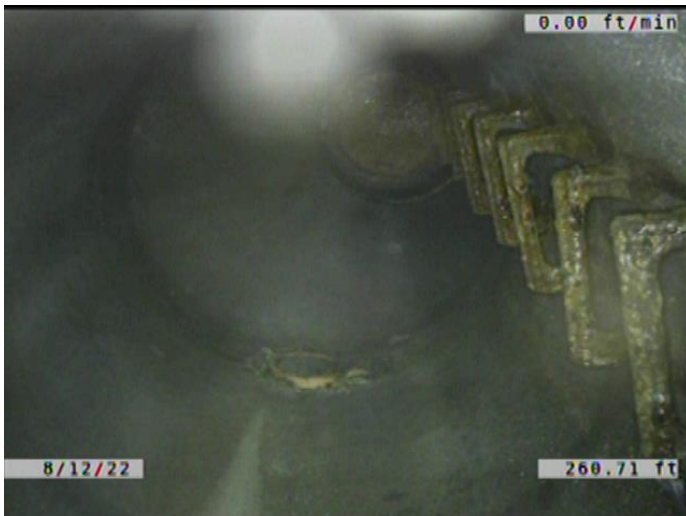
Code: **AMH**
Description: **Manhole**

Distance (ft): **260.7**
Structural Grade: **0**
O&M Grade: **0**
Clock Start/From:
Clock To:
1st Value:
2nd Value:
Value Percent:
Continuous Index:
Within 8" of Joint: **NO**
Remarks: **M-804-058**
