Profile/Photo Observation Report

Date:	10/17/2021	Weather:		Coding:	PACP 6.0
Pipe Length (ft):		Owner:	Hobart, IN	Pre Clean:	Not Known
P.O.#:	844_1	Surveyor:	M. Pielacha	PSR:	P-704-009-010
Customer:	Hobart, IN	Clean Date:		Shape:	C

Street:	Front Street	Flow Control:	
City:	Hobart, IN	Year Renewed:	
Location:	Light Highway	Tape/Media #:	844
Purpose:	Routine Assessment	Dia/Height:	24"
Use:	Sanitary	Material:	RCP
Drain Area:		Lining:

US MH: **M-704-10** DS MH: **M-704-9** Total Length Surveyed (ft): **99.2**

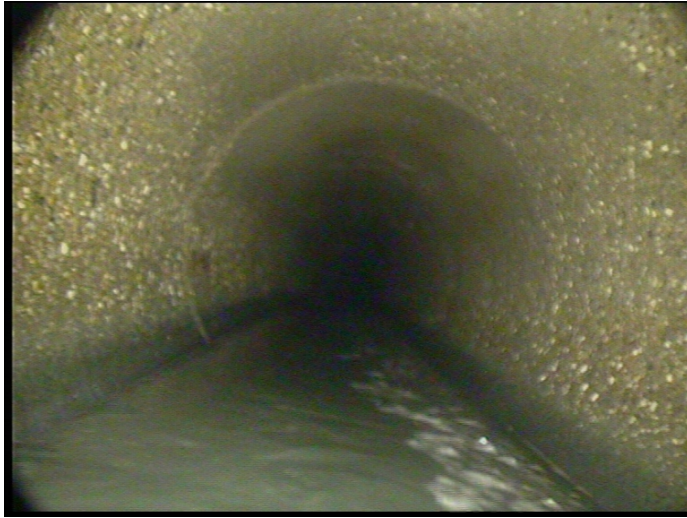
Code: **MWL**
Description: **Water Level**

Distance (ft): **.0**
Structural Grade: **0**
O&M Grade: **0**
Clock Start/From:
Clock To:
1st Value:
2nd Value:
Value Percent: **10.000**
Continuous Index:
Within 8" of Joint: **NO**
Remarks:

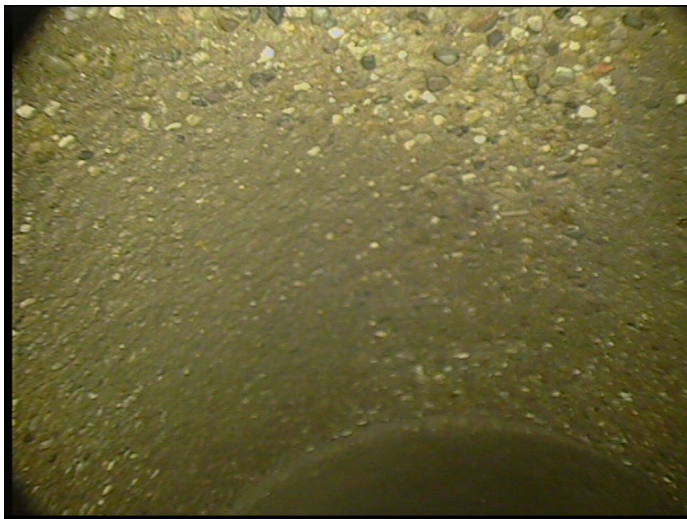
Code: **SAV**
Description: **Surface Aggregate Visible**

Distance (ft): **1.6**
Structural Grade: **3**
O&M Grade: **0**
Clock Start/From: **8**
Clock To: **4**
1st Value:
2nd Value:
Value Percent:
Continuous Index: **S01**
Within 8" of Joint: **YES**
Remarks:

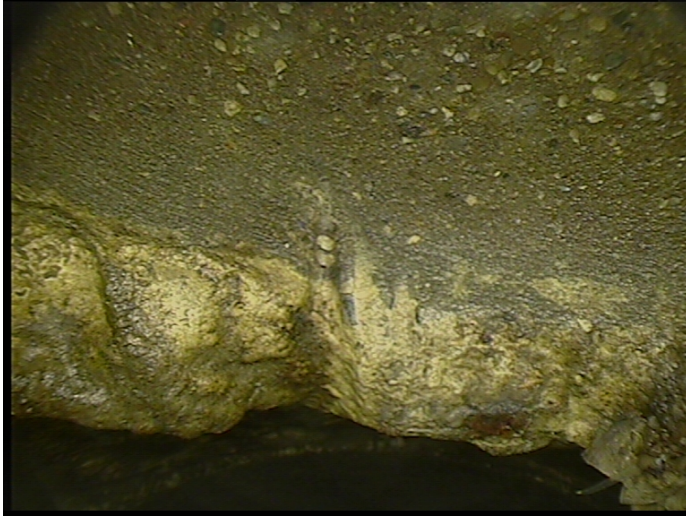
Code:	SAV
Description:	Surface Aggregate Visible
Distance (ft):	98.2
Structural Grade:	3
O&M Grade:	0
Clock Start/From:	8
Clock To:	4
1st Value:	
2nd Value:	
Value Percent:	
Continuous Index:	F01
Within 8" of Joint:	NO
Remarks:

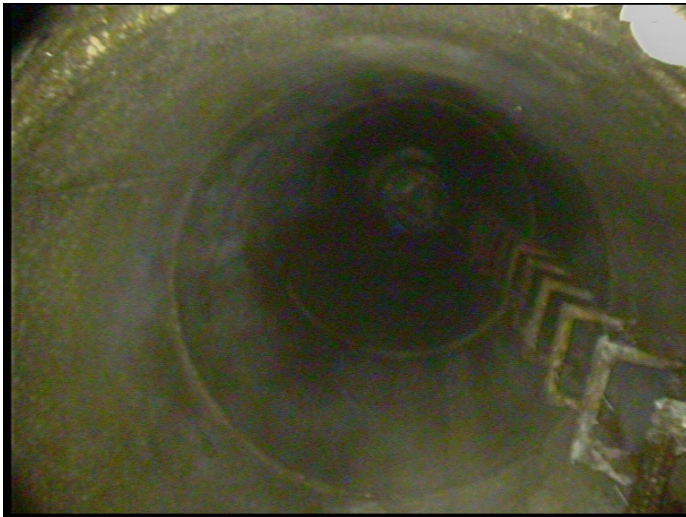
Code:	AMH
Description:	Manhole
Distance (ft):	99.2
Structural Grade:	0
O&M Grade:	0
Clock Start/From:	
Clock To:	
1st Value:	
2nd Value:	
Value Percent:	
Continuous Index:	
Within 8" of Joint:	NO
Remarks:	M-704-9
