## Profile/Photo Observation Report

Date:	<b>10/17/2021</b>	Weather:		Coding:	<b>PACP 7.0</b>
Pipe Length (ft):	<b>24.2</b>	Owner:	<b>City of Hobart</b>	Pre Clean:	<b>Heavy Cleaning</b>
P.O.#:	<b>YES502259</b>	Surveyor:	<b>S. Bucklin</b>	PSR:	<b>P-704-012-009</b>
Customer:	<b>City of Hobart</b>	Clean Date:	<b>10/12/2021</b>	Shape:	<b>C</b>

Street:	<b>East Cleveland Avenue</b>	Flow Control:	<b>Not Controlled</b>
City:	<b>Hobart, IN</b>	Year Renewed:	
Location:	<b>Local rural streets with light traffic, t</b>	Tape/Media #:	
Purpose:	<b>Routine Assessment</b>	Dia/Height:	<b>10"</b>
Use:	<b>Sanitary Sewage Pipe</b>	Material:	<b>VCP</b>
Drain Area:		Lining:	
Category:	<b>NA</b>		
Comment:			
Location Details:		Direction of Survey:	<b>Downstream</b>
US MH:	<b>M-704-012</b>	DS MH:	<b>M-704-009</b>
		Total Length Surveyed (ft):	<b>24.2</b>

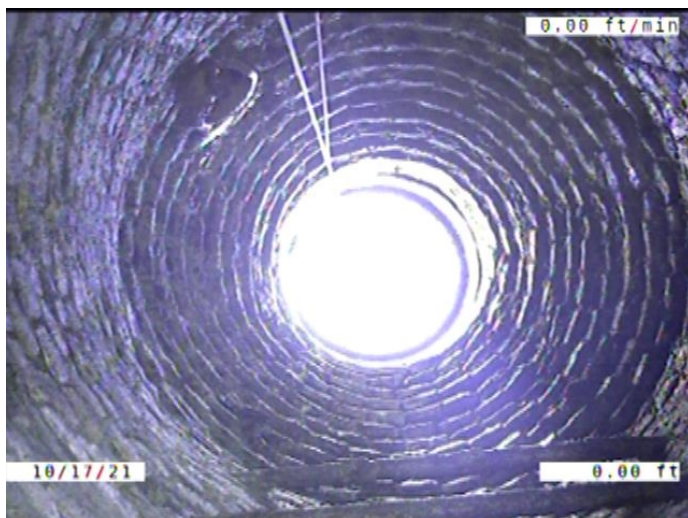
Code: **AMH**  
 Description: **Manhole**

Distance (ft): **.0**  
 Structural Grade: **0**  
 O&M Grade: **0**  
 Clock Start/From:  
 Clock To:  
 1st Value:  
 2nd Value:  
 Value Percent:  
 Continuous Index:  
 Within 8" of Joint: **NO**  
 Remarks: **M-704-012**

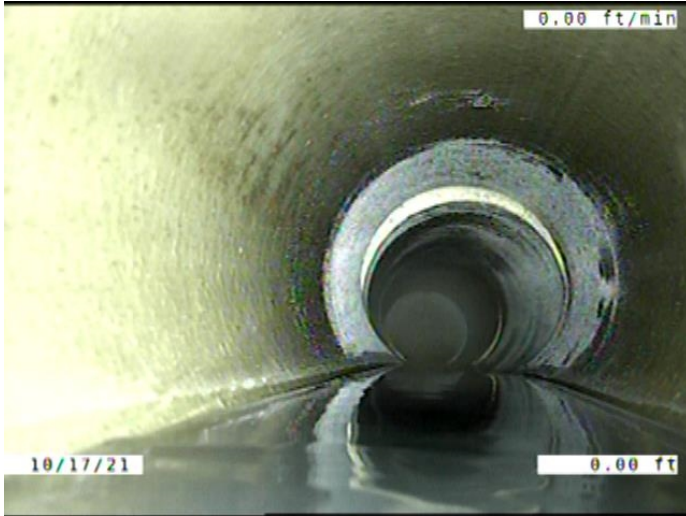
Code: **MWL**  
Description: **Miscellaneous Water Level**

Distance (ft): **.0**  
Structural Grade: **0**  
O&M Grade: **0**  
Clock Start/From:  
Clock To:  
1st Value:  
2nd Value:  
Value Percent: **5.000**  
Continuous Index:  
Within 8" of Joint: **NO**  
Remarks:

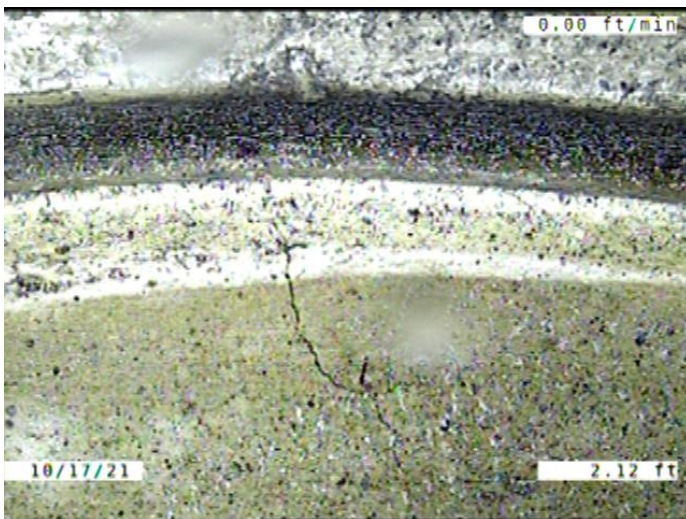
Code: **CL**  
Description: **Crack Longitudinal**

Distance (ft): **2.1**  
Structural Grade: **2**  
O&M Grade: **0**  
Clock Start/From: **1**  
Clock To:  
1st Value:  
2nd Value:  
Value Percent:  
Continuous Index:  
Within 8" of Joint: **YES**  
Remarks:

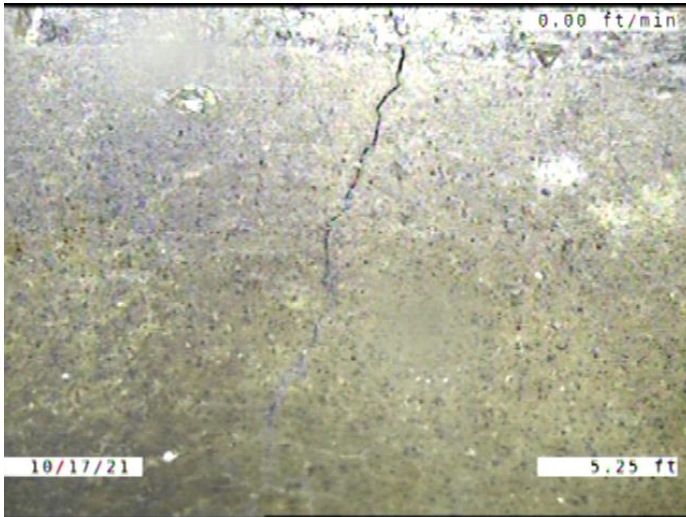
Code: **CM**  
Description: **Crack Multiple**

Distance (ft): **5.3**  
Structural Grade: **3**  
O&M Grade: **0**  
Clock Start/From: **9**  
Clock To: **3**  
1st Value:  
2nd Value:  
Value Percent:  
Continuous Index:  
Within 8" of Joint: **YES**  
Remarks:

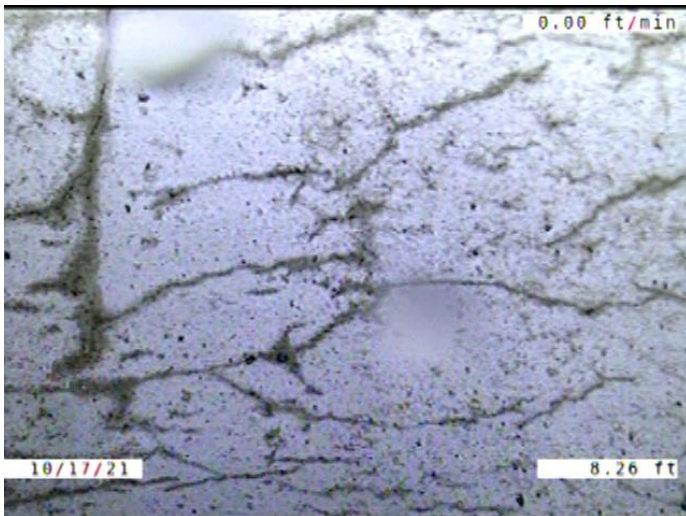
Code: **CM**  
Description: **Crack Multiple**

Distance (ft): **8.3**  
Structural Grade: **3**  
O&M Grade: **0**  
Clock Start/From: **8**  
Clock To: **4**  
1st Value:  
2nd Value:  
Value Percent:  
Continuous Index:  
Within 8" of Joint: **YES**  
Remarks:

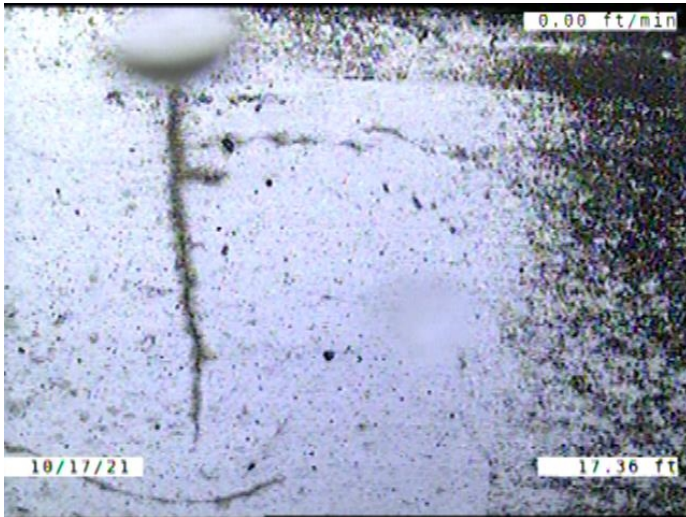
Code: **CM**  
 Description: **Crack Multiple**

Distance (ft): **17.4**  
 Structural Grade: **3**  
 O&M Grade: **0**  
 Clock Start/From: **7**  
 Clock To: **2**  
 1st Value:  
 2nd Value:  
 Value Percent:  
 Continuous Index:  
 Within 8" of Joint: **YES**  
 Remarks:

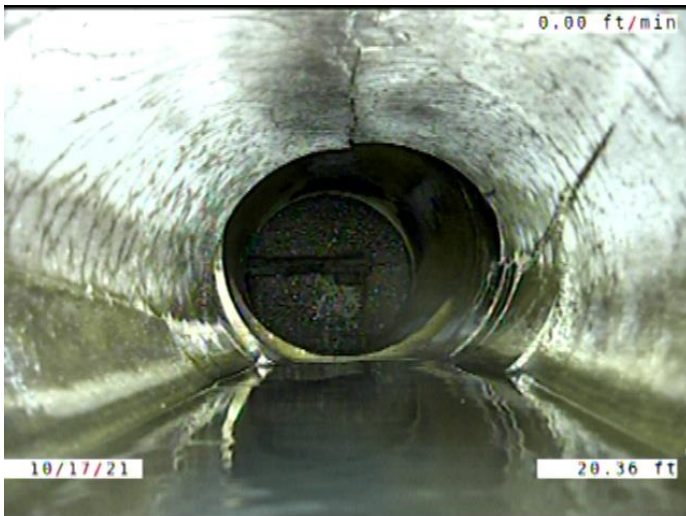
Code: **DR**  
 Description: **Deformed Rigid**

Distance (ft): **20.4**  
 Structural Grade: **5**  
 O&M Grade: **0**  
 Clock Start/From:  
 Clock To:  
 1st Value:  
 2nd Value:  
 Value Percent: **10.000**  
 Continuous Index: **S01**  
 Within 8" of Joint: **NO**  
 Remarks:

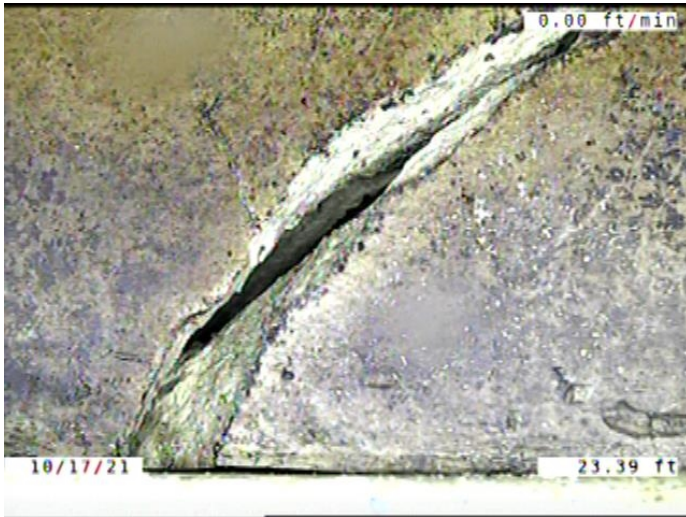
Code: **BSV**  
Description: **Broken Soil Visible**

Distance (ft): **23.4**  
Structural Grade: **5**  
O&M Grade: **0**  
Clock Start/From: **1**  
Clock To: **11**  
1st Value:  
2nd Value:  
Value Percent:  
Continuous Index:  
Within 8" of Joint: **YES**  
Remarks:

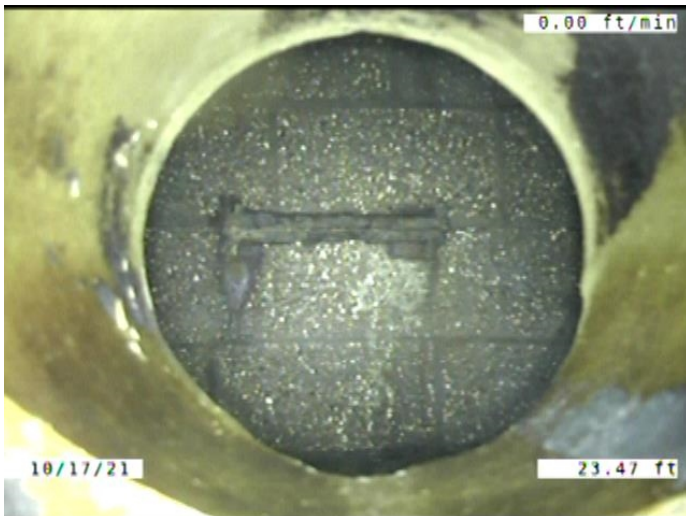
Code: **DR**  
Description: **Deformed Rigid**

Distance (ft): **23.5**  
Structural Grade: **5**  
O&M Grade: **0**  
Clock Start/From:  
Clock To:  
1st Value:  
2nd Value:  
Value Percent: **10.000**  
Continuous Index: **F01**  
Within 8" of Joint: **NO**  
Remarks:

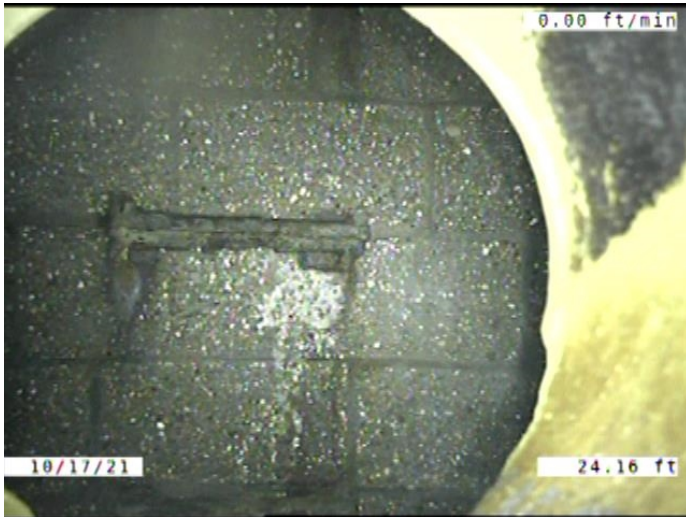
Code:	<b>AMH</b>
Description:	<b>Manhole</b>
Distance (ft):	<b>24.2</b>
Structural Grade:	<b>0</b>
O&M Grade:	<b>0</b>
Clock Start/From:	
Clock To:	
1st Value:	
2nd Value:	
Value Percent:	
Continuous Index:	
Within 8" of Joint:	<b>NO</b>
Remarks:	<b>M-704-009</b>
