Profile/Photo Observation Report

Date:	10/17/2021	Weather:		Coding:	PACP 7.0
Pipe Length (ft):	24.2	Owner:	City of Hobart	Pre Clean:	Heavy Cleaning
P.O.#:	YES502259	Surveyor:	S. Bucklin	PSR:	P-704-012-009
Customer:	City of Hobart	Clean Date:	10/12/2021	Shape:	C

Street:	East Cleveland Avenue	Flow Control:	Not Controlled
City:	Hobart, IN	Year Renewed:	
Location:	Local rural streets with light traffic, t	Tape/Media #:	
Purpose:	Routine Assessment	Dia/Height:	10"
Use:	Sanitary Sewage Pipe	Material:	VCP
Drain Area:		Lining:	
Category:	NA		
Comment:			
Location Details:		Direction of Survey:	Downstream
US MH:	M-704-012	DS MH:	M-704-009
		Total Length Surveyed (ft):	24.2

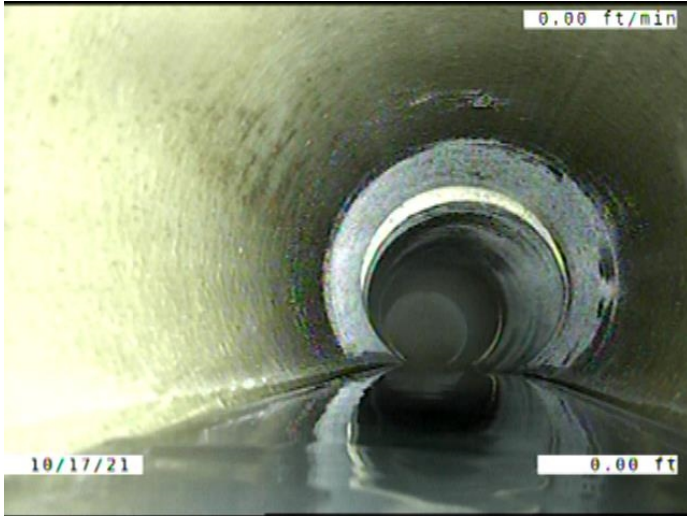
Code: **MWL**
Description: **Miscellaneous Water Level**

Distance (ft): **.0**
Structural Grade: **0**
O&M Grade: **0**
Clock Start/From:
Clock To:
1st Value:
2nd Value:
Value Percent: **5.000**
Continuous Index:
Within 8" of Joint: **NO**
Remarks:

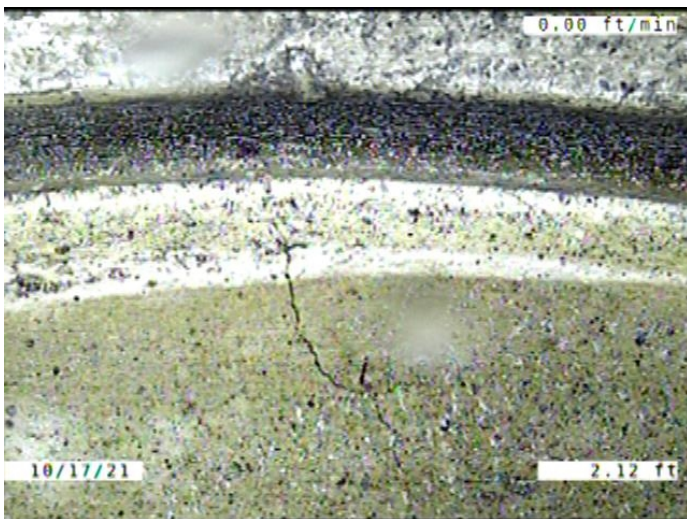
Code: **CL**
Description: **Crack Longitudinal**

Distance (ft): **2.1**
Structural Grade: **2**
O&M Grade: **0**
Clock Start/From: **1**
Clock To:
1st Value:
2nd Value:
Value Percent:
Continuous Index:
Within 8" of Joint: **YES**
Remarks:

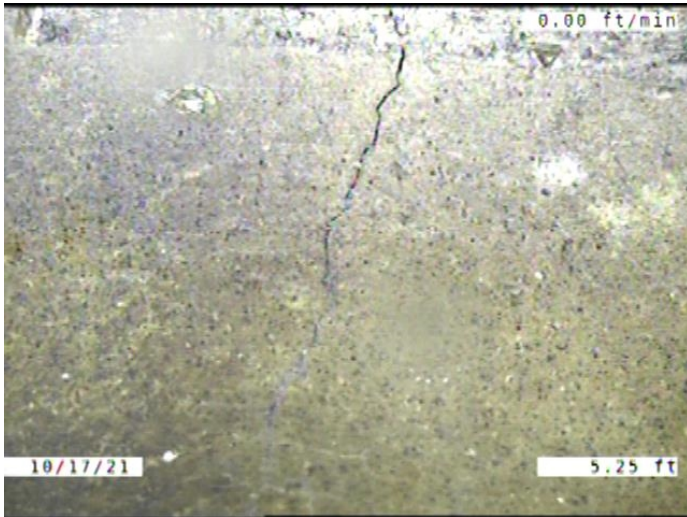
Code: **CM**
Description: **Crack Multiple**

Distance (ft): **5.3**
Structural Grade: **3**
O&M Grade: **0**
Clock Start/From: **9**
Clock To: **3**
1st Value:
2nd Value:
Value Percent:
Continuous Index:
Within 8" of Joint: **YES**
Remarks:

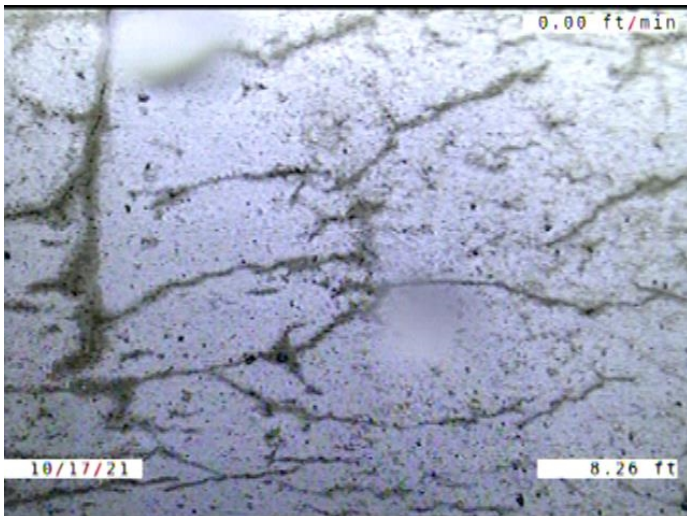
Code: **CM**
Description: **Crack Multiple**

Distance (ft): **8.3**
Structural Grade: **3**
O&M Grade: **0**
Clock Start/From: **8**
Clock To: **4**
1st Value:
2nd Value:
Value Percent:
Continuous Index:
Within 8" of Joint: **YES**
Remarks:
