Profile/Photo Observation Report

Date:	10/17/2021	Weather:		Coding:	PACP 7.0
Pipe Length (ft):	341.0	Owner:	City of Hobart	Pre Clean:	Heavy Cleaning
P.O.#:	YES502259	Surveyor:	S. Bucklin	PSR:	P-704-011-012
Customer:	City of Hobart	Clean Date:	10/12/2021	Shape:	C

Street:	East Cleveland Avenue	Flow Control:	Not Controlled
City:	Hobart, IN	Year Renewed:	
Location:	Local rural streets with light traffic, t	Tape/Media #:	
Purpose:	Routine Assessment	Dia/Height:	8"
Use:	Sanitary Sewage Pipe	Material:	VCP
Drain Area:		Lining:	
Category:	NA		
Comment:			
Location Details:		Direction of Survey:	Upstream
US MH:	M-704-012	DS MH:	M-704-011
		Total Length Surveyed (ft):	104.9

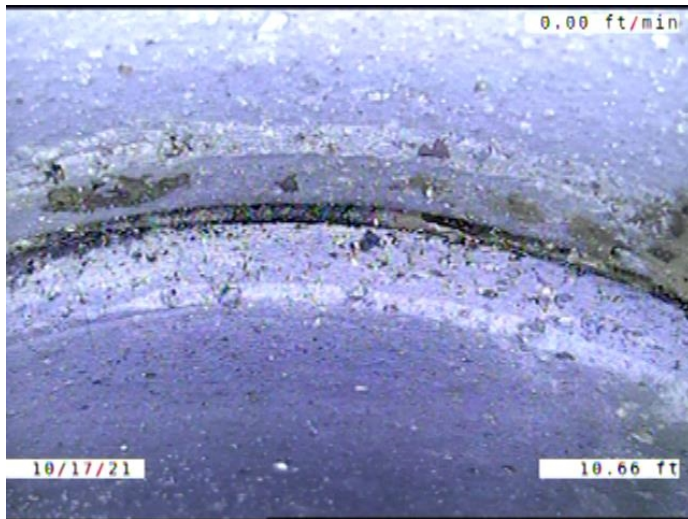
Code: **JOM**
 Description: **Joint Offset Medium**

Distance (ft): **10.7**
 Structural Grade: **3**
 O&M Grade: **0**
 Clock Start/From:
 Clock To:
 1st Value:
 2nd Value:
 Value Percent:
 Continuous Index:
 Within 8" of Joint: **NO**
 Remarks:

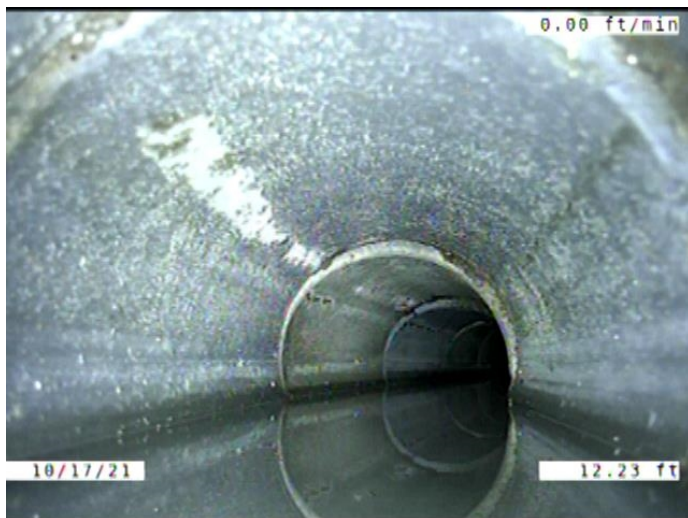
Code: **LR**
 Description: **Line Right**

Distance (ft): **12.2**
 Structural Grade: **0**
 O&M Grade: **1**
 Clock Start/From:
 Clock To:
 1st Value:
 2nd Value:
 Value Percent: **10.000**
 Continuous Index:
 Within 8" of Joint: **NO**
 Remarks:

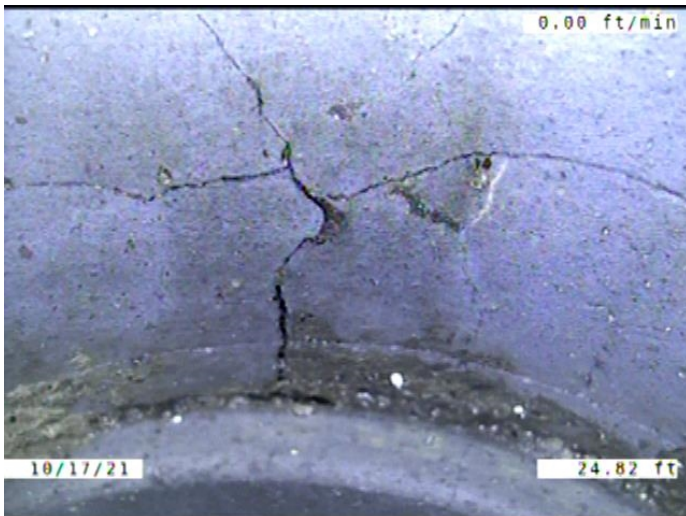
Code: **FM**
Description: **Fracture Multiple**

Distance (ft): **24.8**
Structural Grade: **4**
O&M Grade: **0**
Clock Start/From: **9**
Clock To: **3**
1st Value:
2nd Value:
Value Percent:
Continuous Index: **S02**
Within 8" of Joint: **YES**
Remarks:

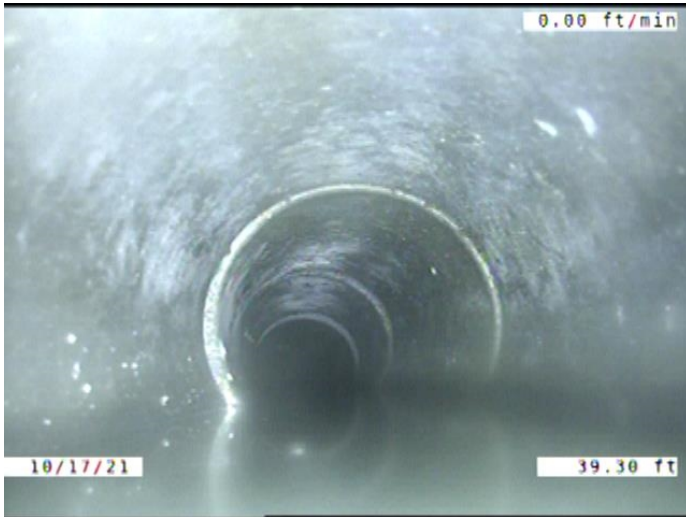
Code: **MCU**
Description: **Miscellaneous Camera Underwater**

Distance (ft): **39.3**
Structural Grade: **0**
O&M Grade: **4**
Clock Start/From:
Clock To:
1st Value:
2nd Value:
Value Percent:
Continuous Index: **F03**
Within 8" of Joint: **NO**
Remarks:

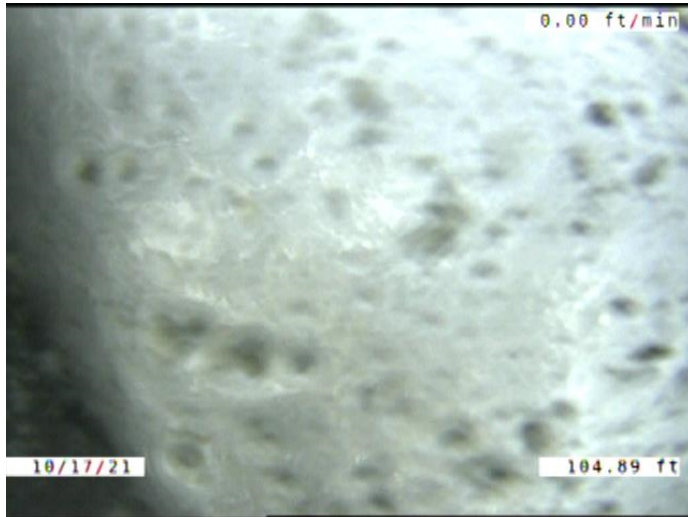
Code: **MWLS**
 Description: **Miscellaneous Water Level Sag**

Distance (ft): **104.9**
 Structural Grade: **2**
 O&M Grade: **0**
 Clock Start/From:
 Clock To:
 1st Value:
 2nd Value:
 Value Percent: **30.000**
 Continuous Index: **F04**
 Within 8" of Joint: **NO**
 Remarks:

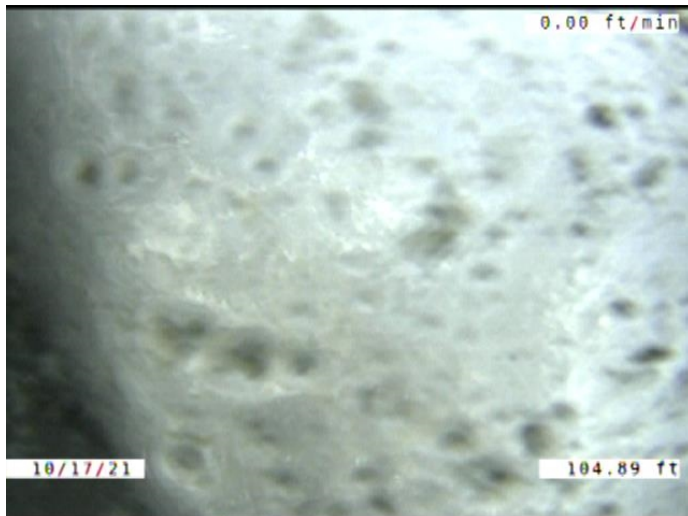
Code: **MCU**
 Description: **Miscellaneous Camera Underwater**

Distance (ft): **104.9**
 Structural Grade: **0**
 O&M Grade: **4**
 Clock Start/From:
 Clock To:
 1st Value:
 2nd Value:
 Value Percent:
 Continuous Index:
 Within 8" of Joint: **NO**
 Remarks:
