Profile/Photo Observation Report

Date:	10/17/2021	Weather:		Coding:	PACP 7.0
Pipe Length (ft):	341.0	Owner:	City of Hobart	Pre Clean:	Heavy Cleaning
P.O.#:	YES502259	Surveyor:	S. Bucklin	PSR:	P-704-011-012
Customer:	City of Hobart	Clean Date:	10/12/2021	Shape:	C

Street:	East Cleveland Avenue	Flow Control:	Not Controlled
City:	Hobart, IN	Year Renewed:	
Location:	Local rural streets with light traffic, t	Tape/Media #:	
Purpose:	Routine Assessment	Dia/Height:	8"
Use:	Sanitary Sewage Pipe	Material:	VCP
Drain Area:		Lining:	
Category:	NA		
Comment:			
Location Details:		Direction of Survey:	Upstream
US MH:	M-704-012	DS MH:	M-704-011
		Total Length Surveyed (ft):	104.9

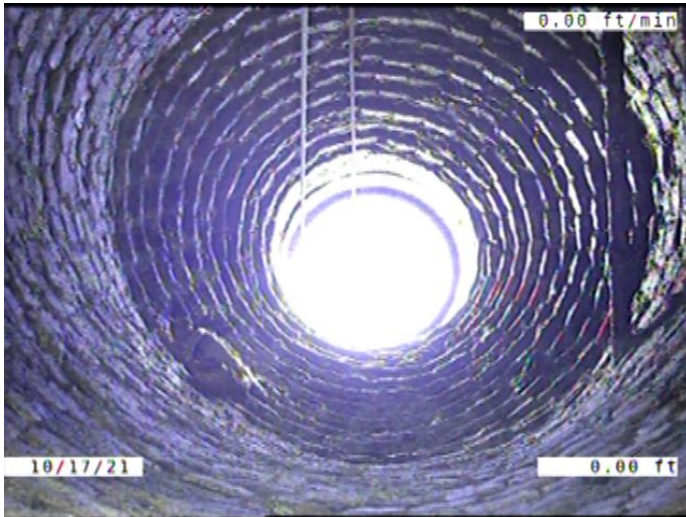
Code: **AMH**
 Description: **Manhole**

Distance (ft): **.0**
 Structural Grade: **0**
 O&M Grade: **0**
 Clock Start/From:
 Clock To:
 1st Value:
 2nd Value:
 Value Percent:
 Continuous Index:
 Within 8" of Joint: **NO**
 Remarks: **M-704-011**

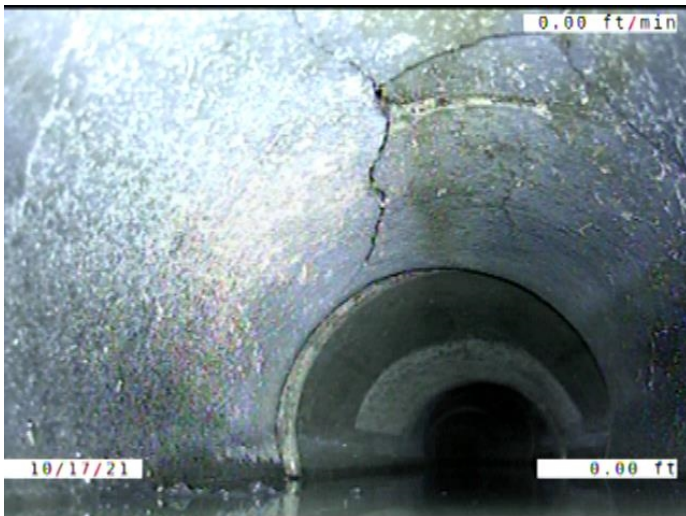
Code: **MWL**
 Description: **Miscellaneous Water Level**

Distance (ft): **.0**
 Structural Grade: **0**
 O&M Grade: **0**
 Clock Start/From:
 Clock To:
 1st Value:
 2nd Value:
 Value Percent: **15.000**
 Continuous Index:
 Within 8" of Joint: **NO**
 Remarks:

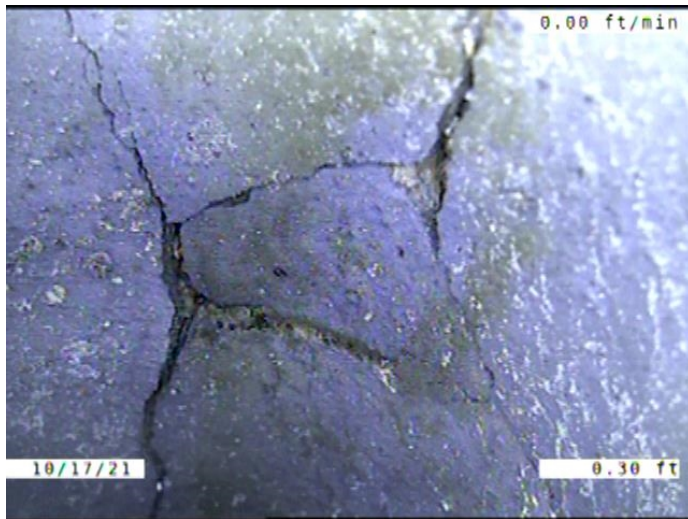
Code: **B**
 Description: **Broken**

Distance (ft): **.3**
 Structural Grade: **4**
 O&M Grade: **0**
 Clock Start/From: **8**
 Clock To: **4**
 1st Value:
 2nd Value:
 Value Percent:
 Continuous Index:
 Within 8" of Joint: **YES**
 Remarks:

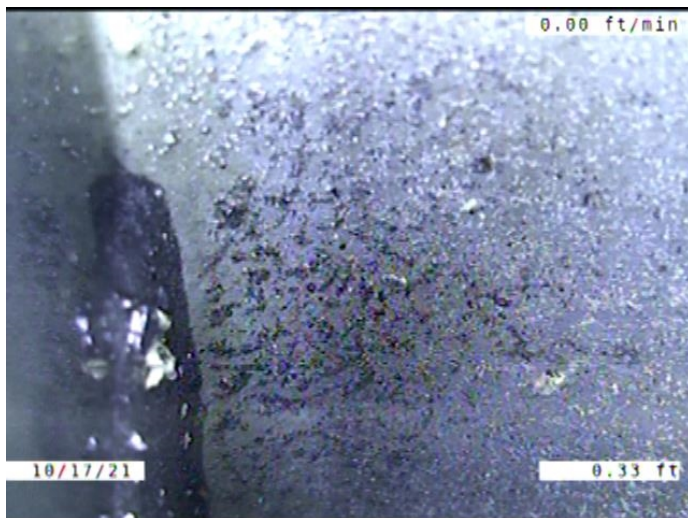
Code: **DSF**
 Description: **Deposits Settled Fine**

Distance (ft): **.3**
 Structural Grade: **0**
 O&M Grade: **2**
 Clock Start/From: **5**
 Clock To: **8**
 1st Value:
 2nd Value:
 Value Percent: **5.000**
 Continuous Index:
 Within 8" of Joint: **YES**
 Remarks:

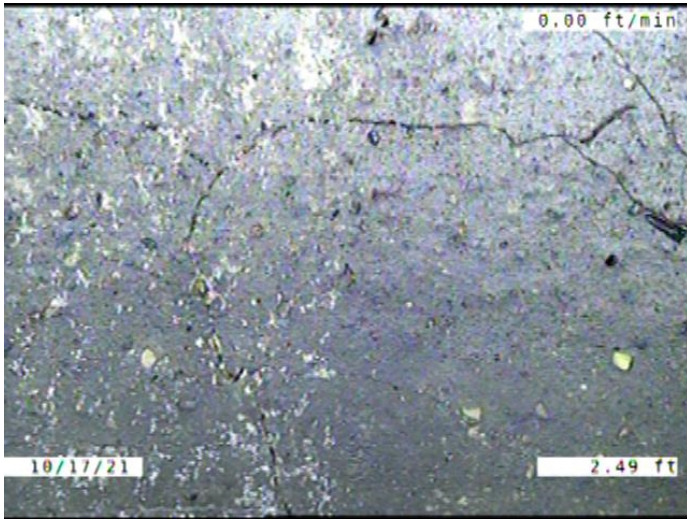
Code: **FM**
 Description: **Fracture Multiple**

Distance (ft): **2.5**
 Structural Grade: **4**
 O&M Grade: **0**
 Clock Start/From: **8**
 Clock To: **4**
 1st Value:
 2nd Value:
 Value Percent:
 Continuous Index:
 Within 8" of Joint: **YES**
 Remarks:

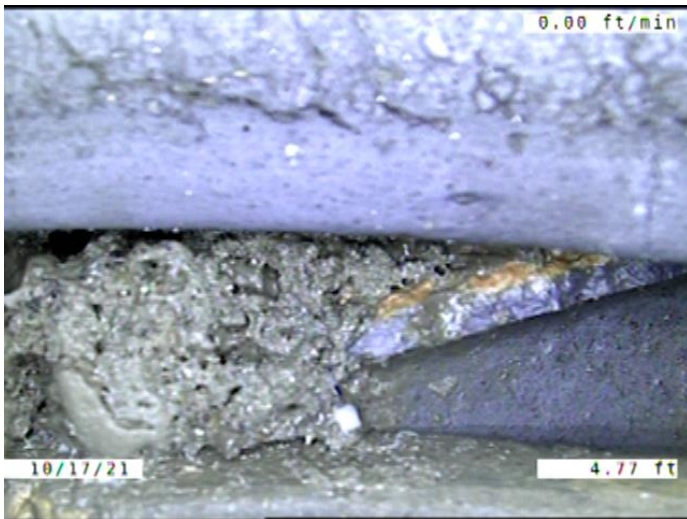
Code: **BSV**
 Description: **Broken Soil Visible**

Distance (ft): **4.8**
 Structural Grade: **5**
 O&M Grade: **0**
 Clock Start/From: **9**
 Clock To: **3**
 1st Value:
 2nd Value:
 Value Percent:
 Continuous Index:
 Within 8" of Joint: **YES**
 Remarks:

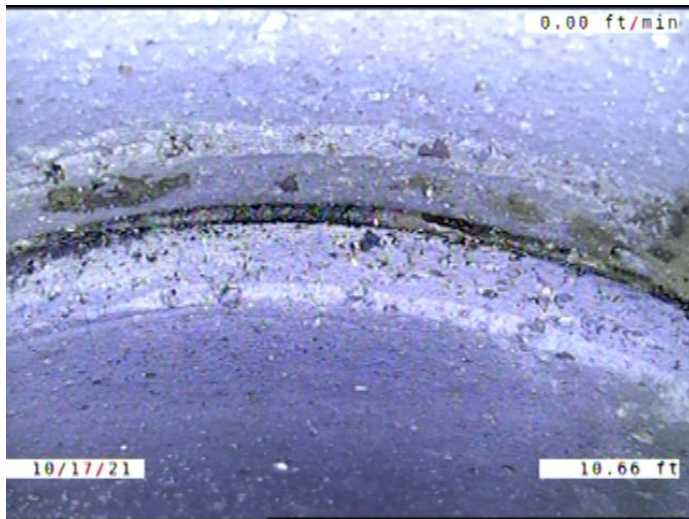
Code: **JOM**
 Description: **Joint Offset Medium**

Distance (ft): **10.7**
 Structural Grade: **3**
 O&M Grade: **0**
 Clock Start/From:
 Clock To:
 1st Value:
 2nd Value:
 Value Percent:
 Continuous Index:
 Within 8" of Joint: **NO**
 Remarks:

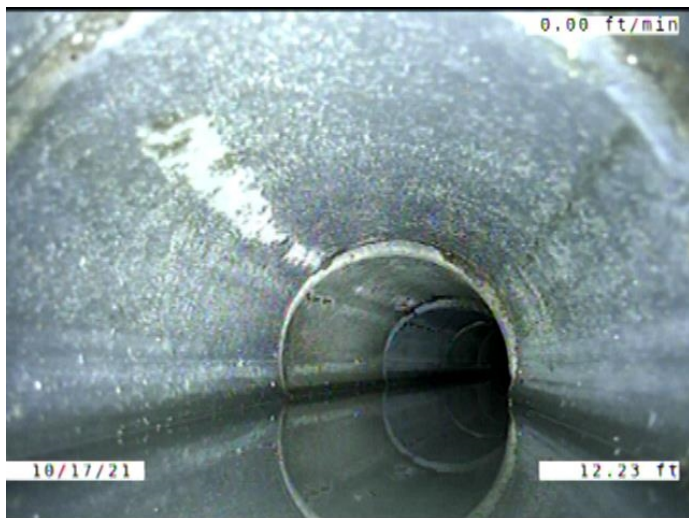
Code: **LR**
 Description: **Line Right**

Distance (ft): **12.2**
 Structural Grade: **0**
 O&M Grade: **1**
 Clock Start/From:
 Clock To:
 1st Value:
 2nd Value:
 Value Percent: **10.000**
 Continuous Index:
 Within 8" of Joint: **NO**
 Remarks:

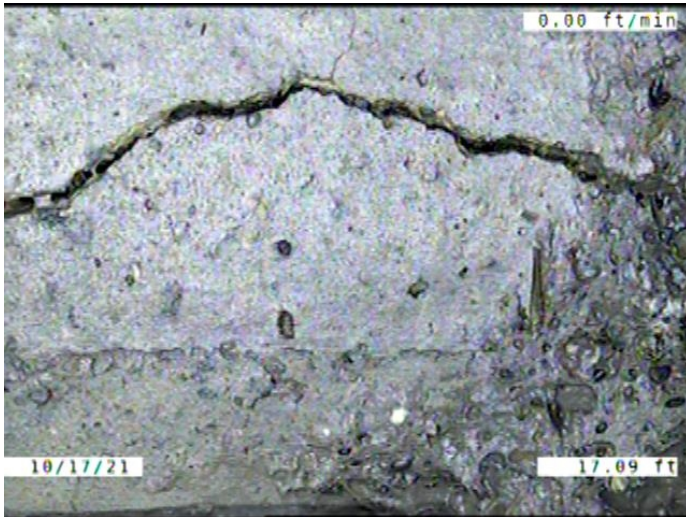
Code: **FM**
 Description: **Fracture Multiple**

Distance (ft): **17.1**
 Structural Grade: **4**
 O&M Grade: **0**
 Clock Start/From: **8**
 Clock To: **4**
 1st Value:
 2nd Value:
 Value Percent:
 Continuous Index:
 Within 8" of Joint: **YES**
 Remarks:

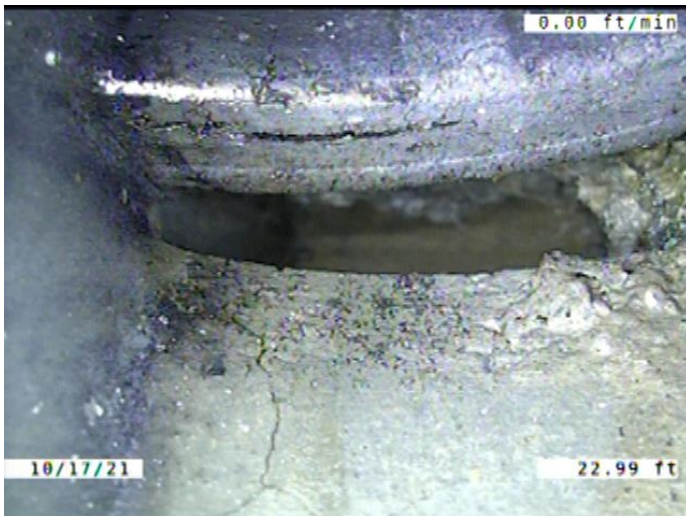
Code: **JOMD**
 Description: **Joint Offset Medium Defective**

Distance (ft): **23.0**
 Structural Grade: **3**
 O&M Grade: **0**
 Clock Start/From:
 Clock To:
 1st Value:
 2nd Value:
 Value Percent:
 Continuous Index:
 Within 8" of Joint: **NO**
 Remarks: **SOIL VISIBLE**

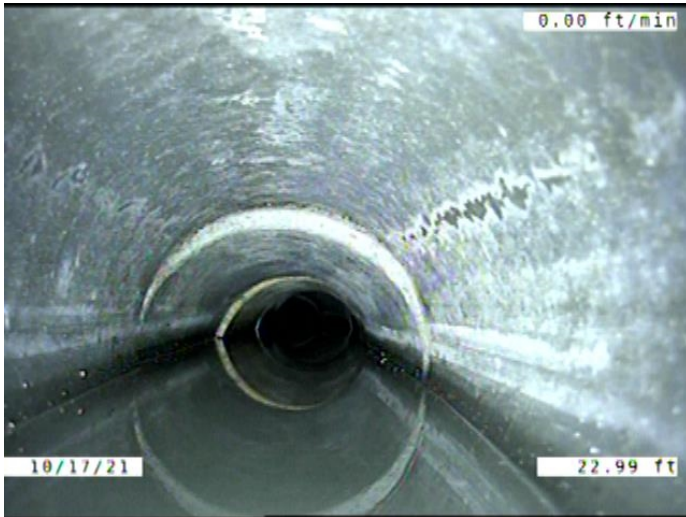
Code: **MWLS**
 Description: **Miscellaneous Water Level Sag**

Distance (ft): **23.0**
 Structural Grade: **2**
 O&M Grade: **0**
 Clock Start/From:
 Clock To:
 1st Value:
 2nd Value:
 Value Percent: **30.000**
 Continuous Index: **S01**
 Within 8" of Joint: **NO**
 Remarks:

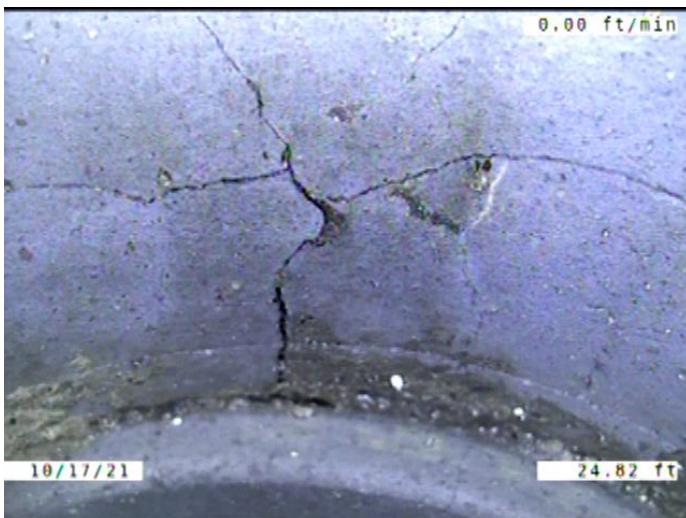
Code: **FM**
 Description: **Fracture Multiple**

Distance (ft): **24.8**
 Structural Grade: **4**
 O&M Grade: **0**
 Clock Start/From: **9**
 Clock To: **3**
 1st Value:
 2nd Value:
 Value Percent:
 Continuous Index: **S02**
 Within 8" of Joint: **YES**
 Remarks:

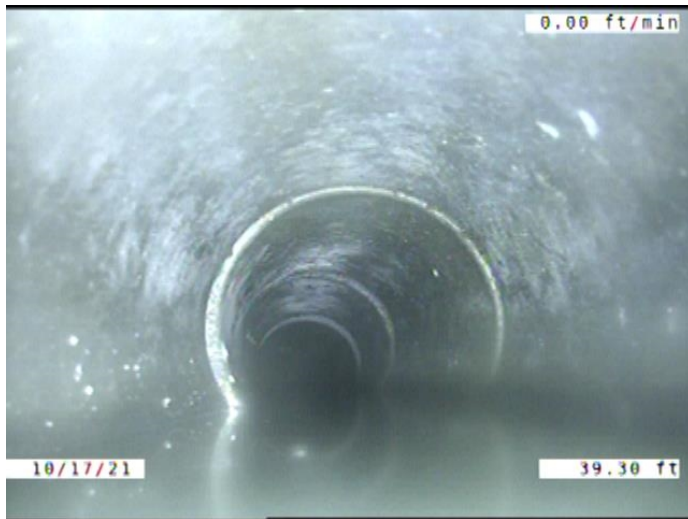
Code:	MCU
Description:	Miscellaneous Camera Underwater
Distance (ft):	39.3
Structural Grade:	0
O&M Grade:	4
Clock Start/From:	
Clock To:	
1st Value:	
2nd Value:	
Value Percent:	
Continuous Index:	F03
Within 8" of Joint:	NO
Remarks:

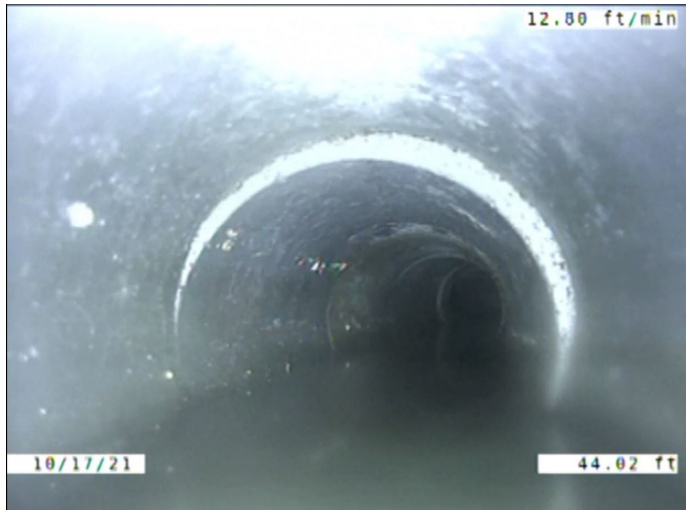
Code: **LR**
Description: **Line Right**

Distance (ft): **44.0**
Structural Grade: **0**
O&M Grade: **1**
Clock Start/From:
Clock To:
1st Value:
2nd Value:
Value Percent: **5.000**
Continuous Index:
Within 8" of Joint: **NO**
Remarks:

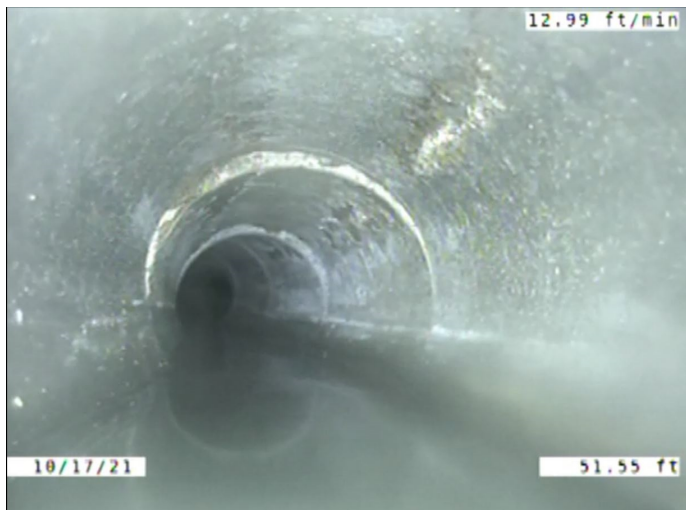
Code: **LL**
Description: **Line Left**

Distance (ft): **51.6**
Structural Grade: **0**
O&M Grade: **1**
Clock Start/From:
Clock To:
1st Value:
2nd Value:
Value Percent: **5.000**
Continuous Index:
Within 8" of Joint: **NO**
Remarks:

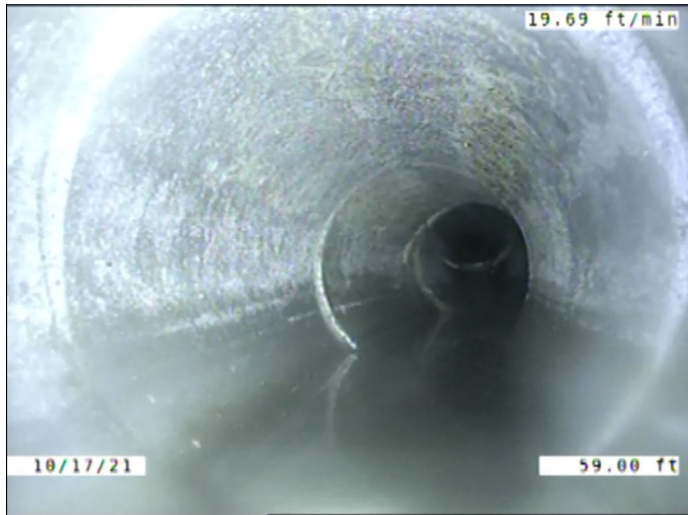
Code: **LR**
 Description: **Line Right**

Distance (ft): **59.0**
 Structural Grade: **0**
 O&M Grade: **1**
 Clock Start/From:
 Clock To:
 1st Value:
 2nd Value:
 Value Percent: **5.000**
 Continuous Index:
 Within 8" of Joint: **NO**
 Remarks:

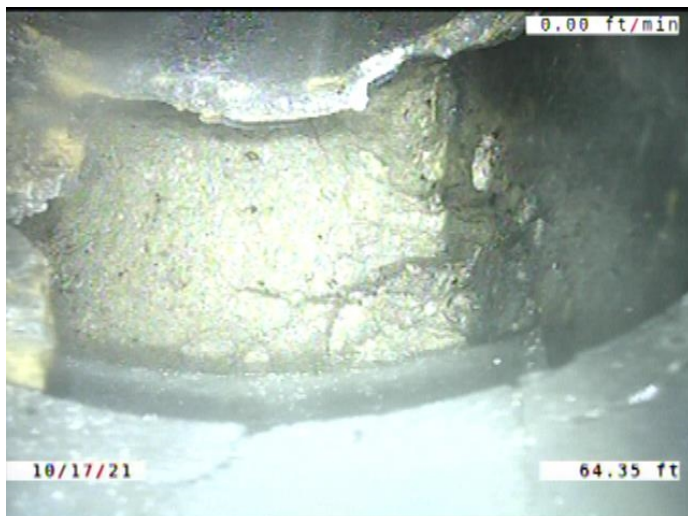
Code: **HVV**
 Description: **Hole Void Visible**

Distance (ft): **64.3**
 Structural Grade: **5**
 O&M Grade: **0**
 Clock Start/From: **6**
 Clock To: **9**
 1st Value:
 2nd Value:
 Value Percent:
 Continuous Index:
 Within 8" of Joint: **YES**
 Remarks: **SOIL AND VOID VISIBLE**

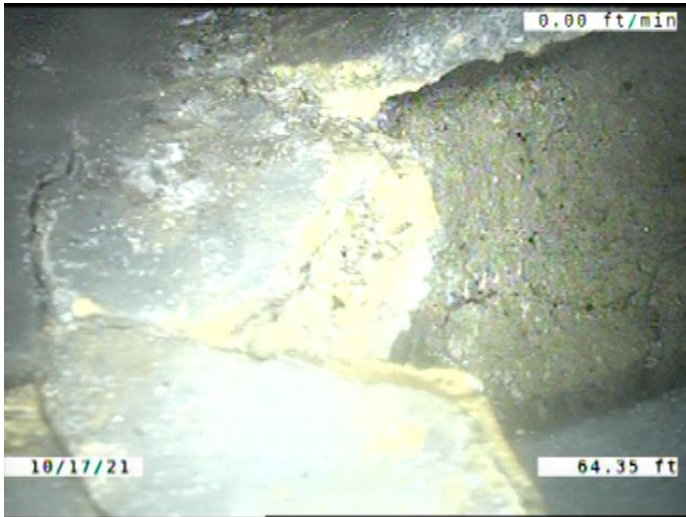
Code: **BSV**
 Description: **Broken Soil Visible**

Distance (ft): **64.3**
 Structural Grade: **5**
 O&M Grade: **0**
 Clock Start/From: **10**
 Clock To: **11**
 1st Value:
 2nd Value:
 Value Percent:
 Continuous Index:
 Within 8" of Joint: **YES**
 Remarks:

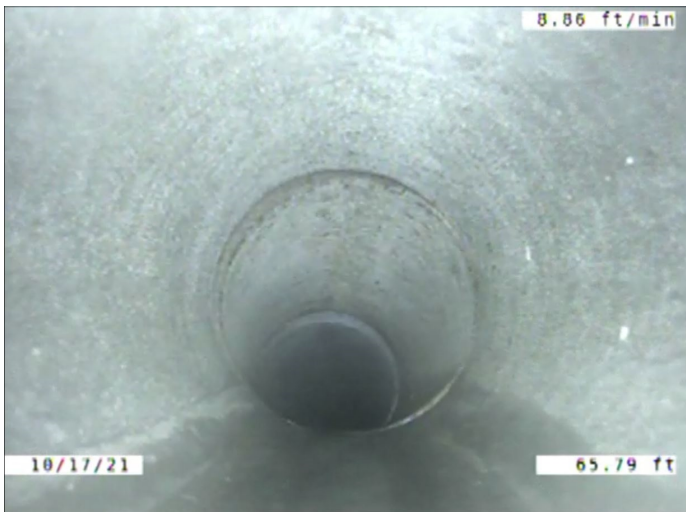
Code: **LU**
 Description: **Line Up**

Distance (ft): **65.8**
 Structural Grade: **0**
 O&M Grade: **2**
 Clock Start/From:
 Clock To:
 1st Value:
 2nd Value:
 Value Percent: **15.000**
 Continuous Index:
 Within 8" of Joint: **NO**
 Remarks:

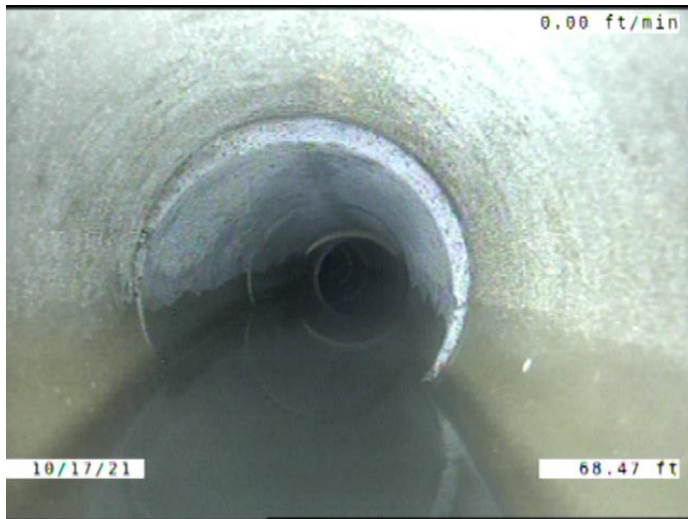
Code: **MWLS**
 Description: **Miscellaneous Water Level Sag**

Distance (ft): **68.5**
 Structural Grade: **2**
 O&M Grade: **0**
 Clock Start/From:
 Clock To:
 1st Value:
 2nd Value:
 Value Percent: **30.000**
 Continuous Index: **S04**
 Within 8" of Joint: **NO**
 Remarks:

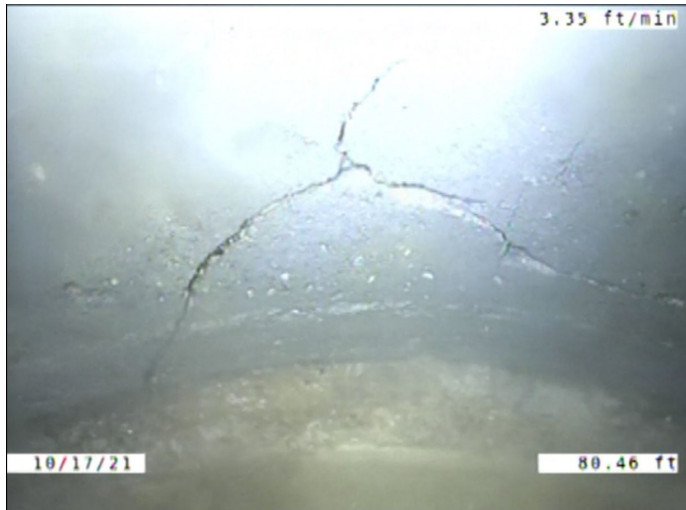
Code: **FM**
Description: **Fracture Multiple**

Distance (ft): **80.5**
Structural Grade: **4**
O&M Grade: **0**
Clock Start/From: **11**
Clock To: **1**
1st Value:
2nd Value:
Value Percent:
Continuous Index:
Within 8" of Joint: **YES**
Remarks:

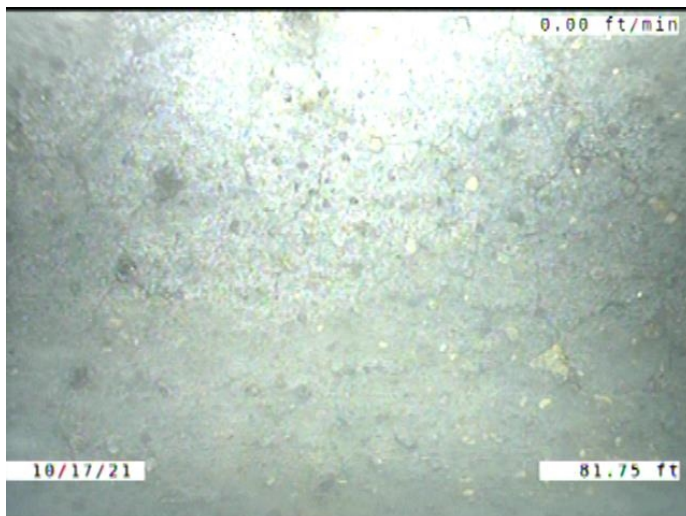
Code: **MCU**
Description: **Miscellaneous Camera Underwater**

Distance (ft): **81.8**
Structural Grade: **0**
O&M Grade: **4**
Clock Start/From:
Clock To:
1st Value:
2nd Value:
Value Percent:
Continuous Index: **S05**
Within 8" of Joint: **NO**
Remarks:

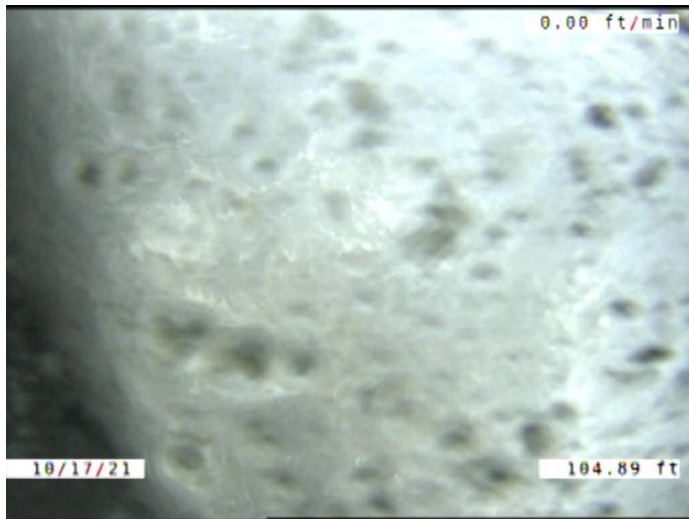
Code: **MWLS**
 Description: **Miscellaneous Water Level Sag**

Distance (ft): **104.9**
 Structural Grade: **2**
 O&M Grade: **0**
 Clock Start/From:
 Clock To:
 1st Value:
 2nd Value:
 Value Percent: **30.000**
 Continuous Index: **F04**
 Within 8" of Joint: **NO**
 Remarks:

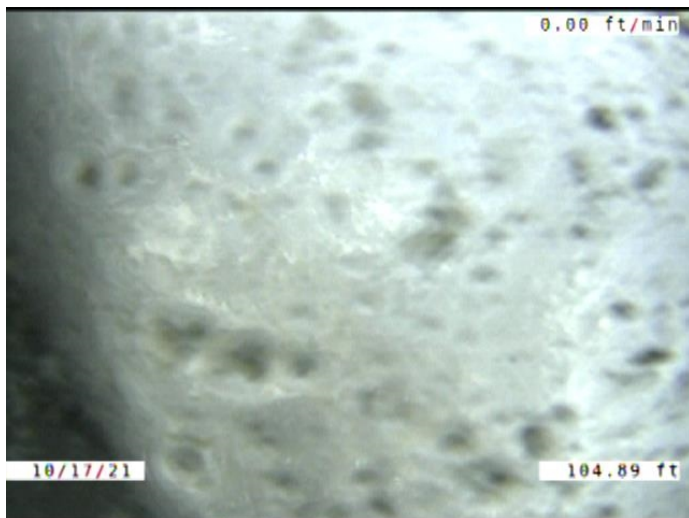
Code: **MCU**
 Description: **Miscellaneous Camera Underwater**

Distance (ft): **104.9**
 Structural Grade: **0**
 O&M Grade: **4**
 Clock Start/From:
 Clock To:
 1st Value:
 2nd Value:
 Value Percent:
 Continuous Index:
 Within 8" of Joint: **NO**
 Remarks:

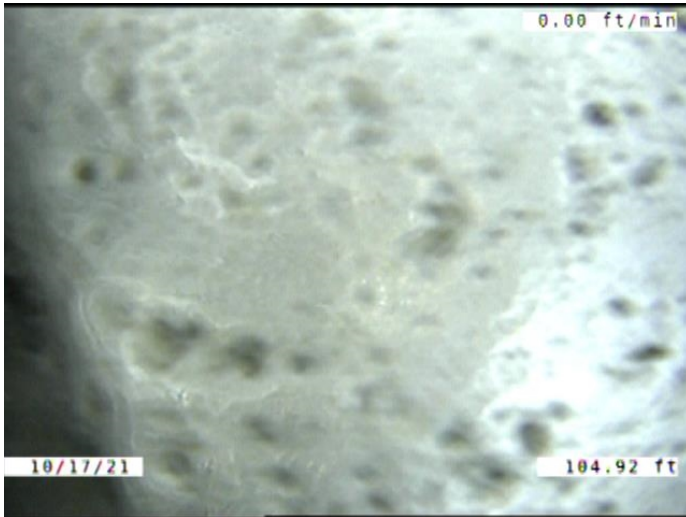
Code:	MSA
Description:	Miscellaneous Survey Abandoned
Distance (ft):	104.9
Structural Grade:	0
O&M Grade:	0
Clock Start/From:	
Clock To:	
1st Value:	
2nd Value:	
Value Percent:	
Continuous Index:	
Within 8" of Joint:	NO
Remarks:	CAMERA WENT UNDER WATER. WATER NOT CLEAR ENOUGH TO CO
