Profile/Photo Observation Report

| Street: | E CLEVELAND AVE & N MICHIGAN A | Flow Control: | Not Controlled |
| City: | Hobart, IN | Year Renewed: | |

| US MH: | M-704-013 | DS MH: | M-704-012 |

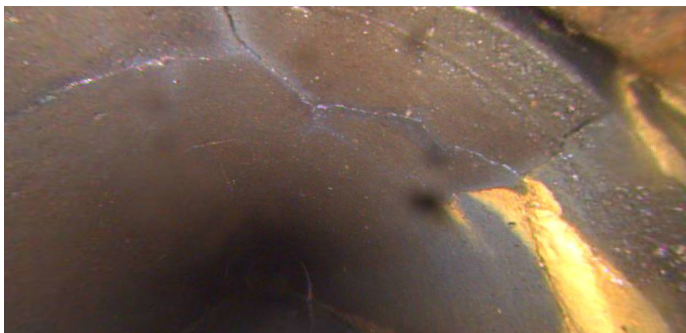
Code: **AMH**
Description: **Manhole**

Distance (ft): **.0**
Structural Grade: **0**
O&M Grade: **0**
Clock Start/From:
Clock To:
1st Value:
2nd Value:
Value Percent:
Continuous Index:
Within 8" of Joint: **NO**
Remarks: **M-704-013**

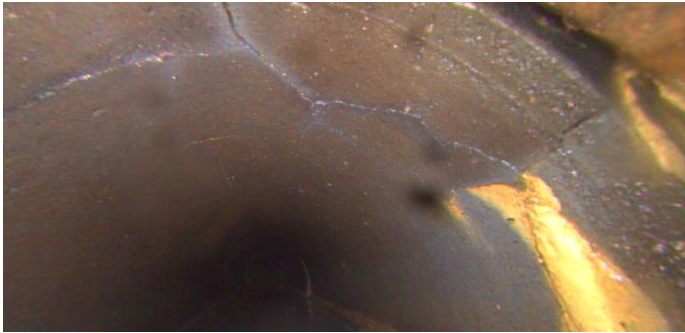
| Code: | MWL |
| Description: | Water Level |

| Value Percent: | 20.000 |

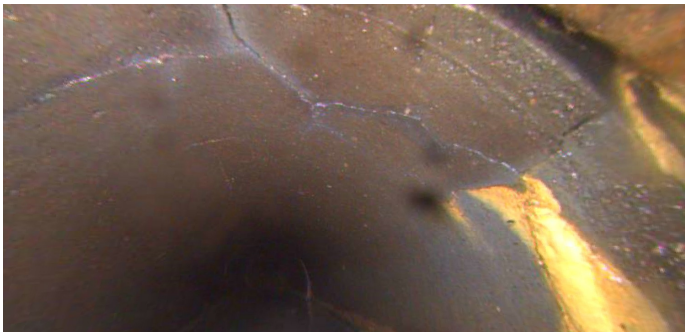
| Code: | FM |
| Description: | Fracture Multiple |

| Structural Grade: | 4 |
| Clock Start/From: | 8 |
| Clock To: | 4 |
| Within 8" of Joint: | YES |

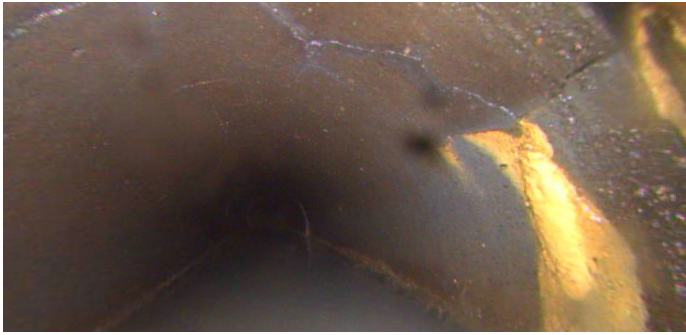
Code: **DAE**
Description: **Deposits Attached Encrustation**

Distance (ft): **.0**
Structural Grade: **0**
O&M Grade: **2**
Clock Start/From: **2**
Clock To: **3**
1st Value:
2nd Value:
Value Percent: **5.000**
Continuous Index:
Within 8" of Joint: **NO**
Remarks:

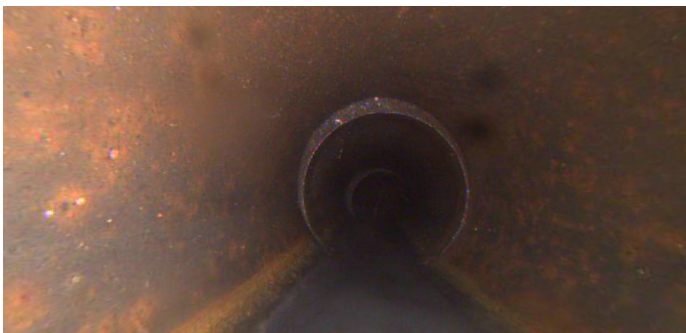
Code: **MSA**
Description: **Abandoned Survey**

Distance (ft): **5.2**
Structural Grade: **0**
O&M Grade: **0**
Clock Start/From:
Clock To:
1st Value:
2nd Value:
Value Percent:
Continuous Index:
Within 8" of Joint: **NO**
Remarks: **unknown**
