Date:	04/21/2018	Weather:			Coding:	PACP 6.0
Pipe Length (ft)	: 350.9	Owner:	NA		Pre Clean:	Not Known
P.O.#:		Surveyor:	Jen Costello		PSR:	P-704-013-012
Customer:		Clean Date:	01/01/1900		Shape:	С
Street:	N Michigan Ave		Flow Control:		Not Controlled	
City:	Hobart, IN		Year Renewed:			
Location:	Other		Tape/Media #:			
Purpose:	Not Known		Dia/Height:		8"	
Use:	Sanitary		Material:		VCP	
Drain Area:	NA		Lining:			
Category:	NA					
Comment:						
Location Details	5:		Direction of Sur	vey:	Downstream	
US MH:	M-704-013	DS MH:	M-704-012	Total Len	gth Surveyed (ft):	5.2
0&M Index:	2.00	O&M Quick:	210	00 C	0&M Rating:	2.00
Structural Index:	4.00	Structural Qu	uick: 410		tructural Rating:	4.00
Overall Index:	3.00	Overall Quick)verall Rating:	6.00

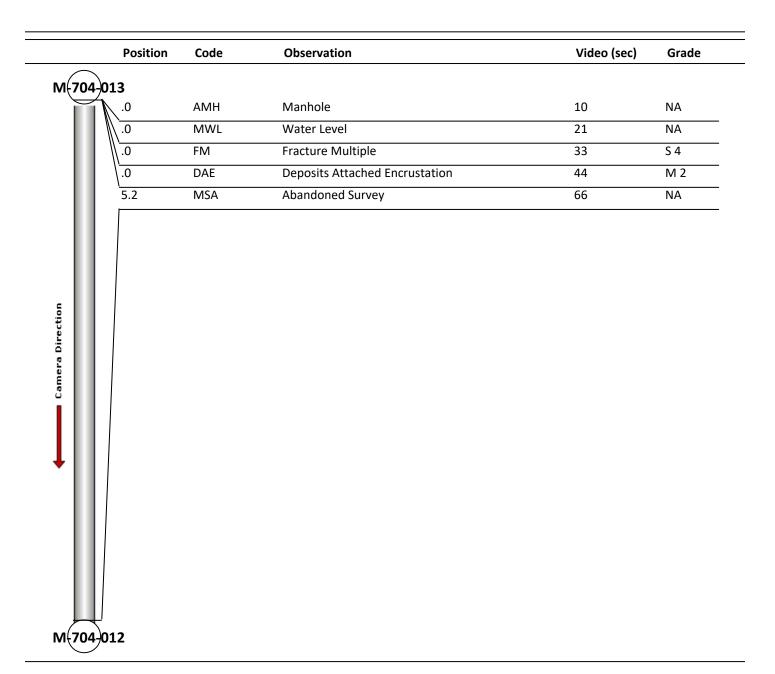
Code: Description:	FM Fracture Multiple
Distance (ft):	.0
Structural Grade:	4
O&M Grade:	0
Clock Start/From:	8
Clock To:	4
1st Value:	
2nd Value:	
Value Percent:	
Continuous Index:	
Within 8" of Joint:	YES
Remarks:

Code:DAEDescription:Deposits Attached Encrustation

Distance (ft):	.0
Structural Grade:	0
O&M Grade:	2
Clock Start/From:	2
Clock To:	3
1st Value:	
2nd Value:	
Value Percent:	5.000
Continuous Index:	
Within 8" of Joint:	NO
Remarks:
