Profile/Photo Observation Report

| Pipe Length (ft): | 343.5 | Owner: | City of Hobart | Pre Clean: | Heavy Cleaning |

| Street: | North Michigan Avenue | Flow Control: | Not Controlled |
| US MH: | M-704-013 | DS MH: | M-704-012 |

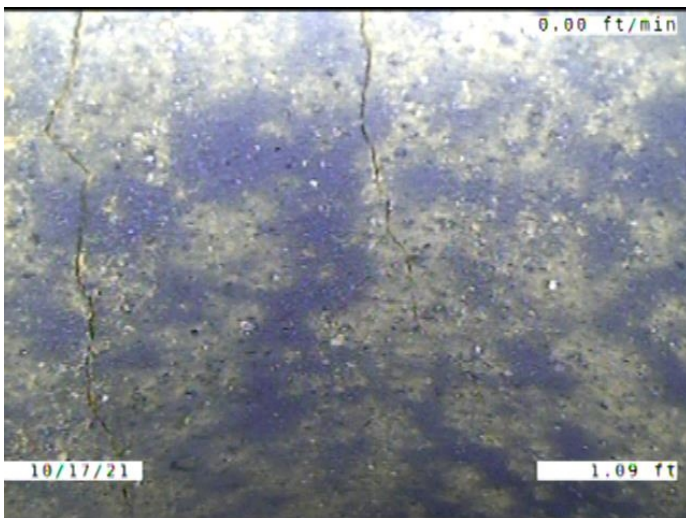
Code: **CM**
 Description: **Crack Multiple**

Distance (ft): **1.1**
 Structural Grade: **3**
 O&M Grade: **0**
 Clock Start/From: **8**
 Clock To: **4**
 1st Value:
 2nd Value:
 Value Percent:
 Continuous Index:
 Within 8" of Joint: **YES**
 Remarks:

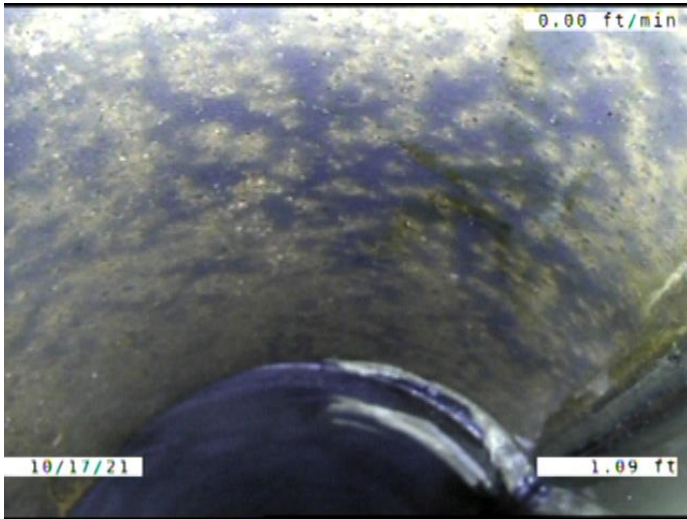
Code: **ISB**
Description: **Infiltration Stain Barrel**

Distance (ft): **1.1**
Structural Grade: **0**
O&M Grade: **1**
Clock Start/From: **2**
Clock To: **4**
1st Value:
2nd Value:
Value Percent:
Continuous Index:
Within 8" of Joint: **YES**
Remarks:

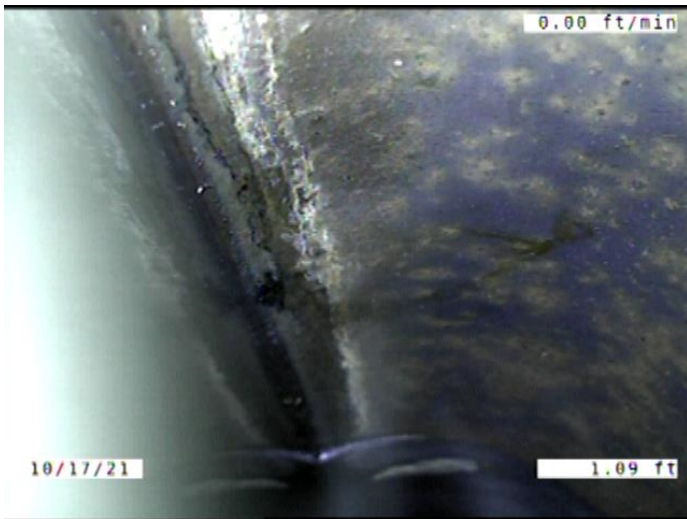
Code: **ISB**
Description: **Infiltration Stain Barrel**

Distance (ft): **1.1**
Structural Grade: **0**
O&M Grade: **1**
Clock Start/From: **8**
Clock To: **11**
1st Value:
2nd Value:
Value Percent:
Continuous Index:
Within 8" of Joint: **YES**
Remarks:

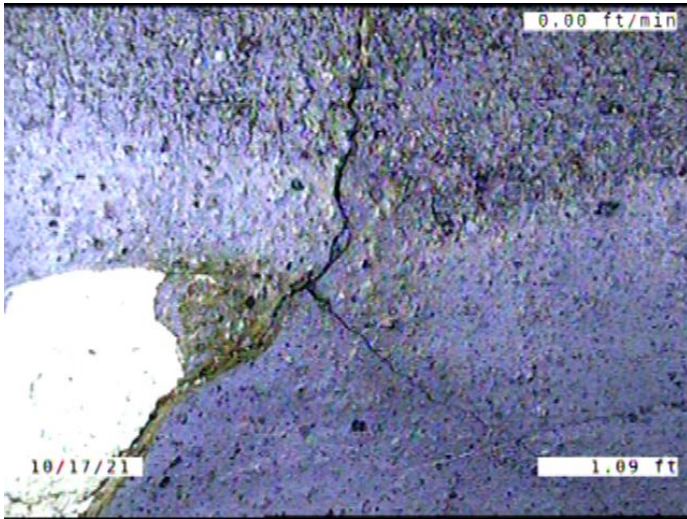
Code: **FM**
 Description: **Fracture Multiple**

Distance (ft): **1.1**
 Structural Grade: **4**
 O&M Grade: **0**
 Clock Start/From: **8**
 Clock To: **4**
 1st Value:
 2nd Value:
 Value Percent:
 Continuous Index:
 Within 8" of Joint: **YES**
 Remarks:

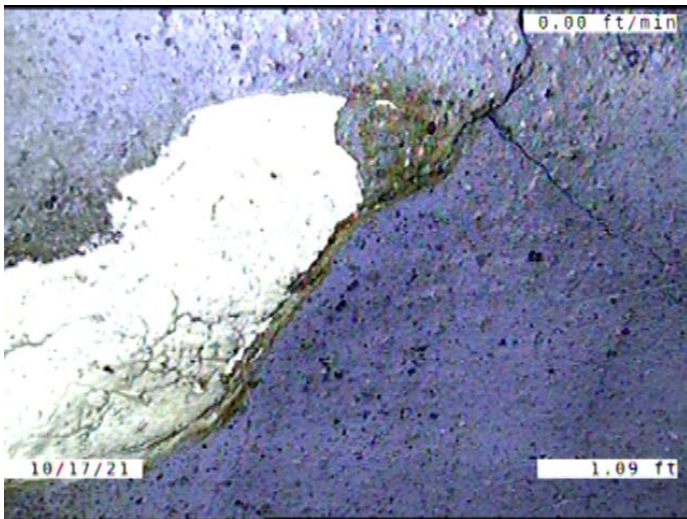
Code: **DAE**
 Description: **Deposits Attached Encrustation**

Distance (ft): **1.1**
 Structural Grade: **0**
 O&M Grade: **2**
 Clock Start/From: **8**
 Clock To: **4**
 1st Value:
 2nd Value:
 Value Percent: **5.000**
 Continuous Index:
 Within 8" of Joint: **YES**
 Remarks:

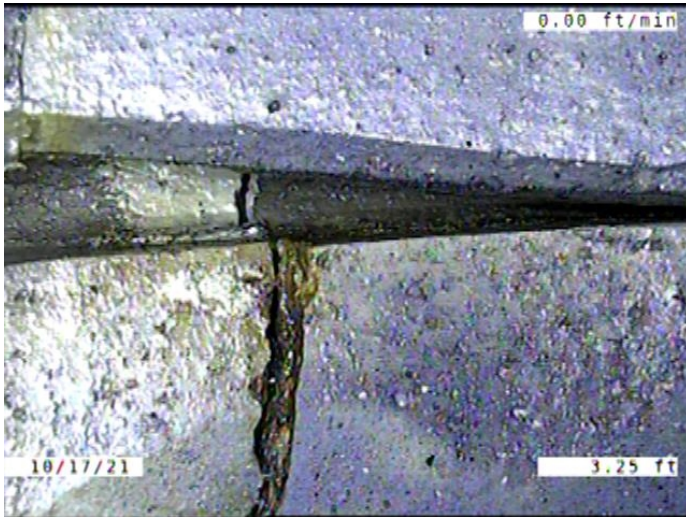
Code: **B**
Description: **Broken**

Distance (ft): **3.2**
Structural Grade: **4**
O&M Grade: **0**
Clock Start/From: **9**
Clock To:
1st Value:
2nd Value:
Value Percent:
Continuous Index:
Within 8" of Joint: **YES**
Remarks:

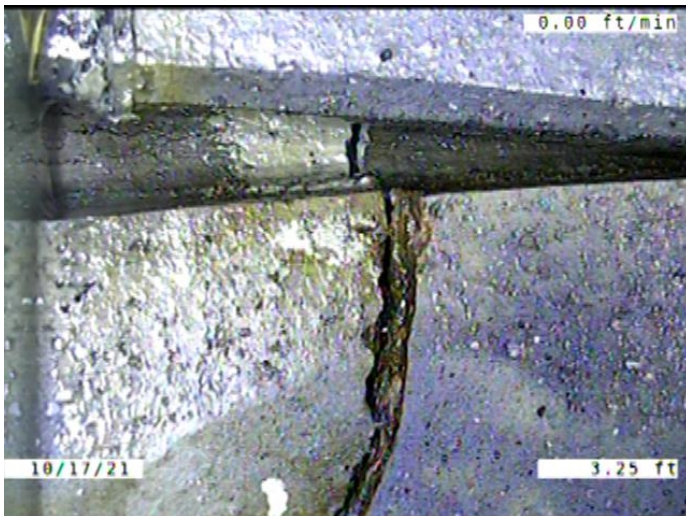
Code: **ISB**
Description: **Infiltration Stain Barrel**

Distance (ft): **3.2**
Structural Grade: **0**
O&M Grade: **1**
Clock Start/From: **9**
Clock To: **10**
1st Value:
2nd Value:
Value Percent:
Continuous Index:
Within 8" of Joint: **YES**
Remarks:

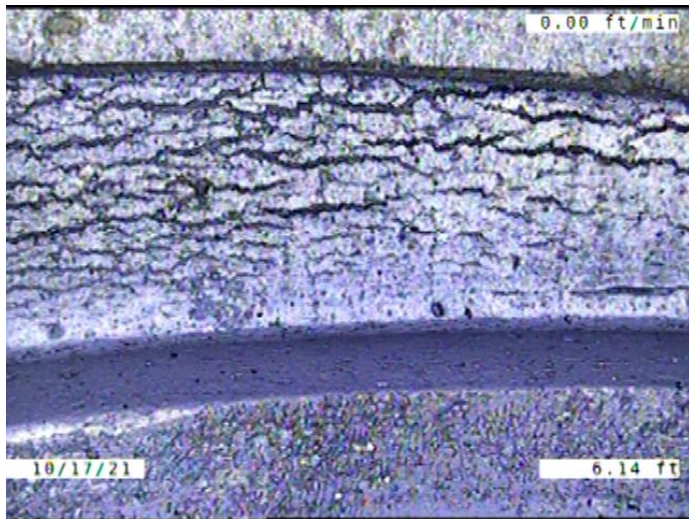
Code: **JAL**
Description: **Joint Angular Large**

Distance (ft): **6.1**
Structural Grade: **4**
O&M Grade: **0**
Clock Start/From:
Clock To:
1st Value:
2nd Value:
Value Percent:
Continuous Index:
Within 8" of Joint: **NO**
Remarks:

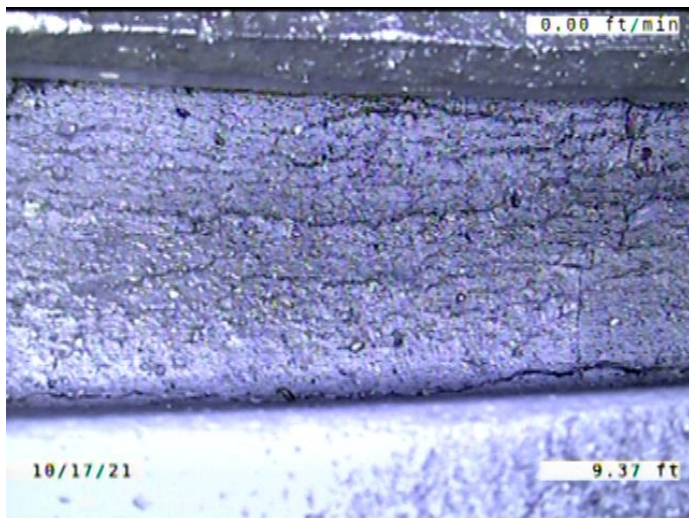
Code: **JAL**
Description: **Joint Angular Large**

Distance (ft): **9.4**
Structural Grade: **4**
O&M Grade: **0**
Clock Start/From:
Clock To:
1st Value:
2nd Value:
Value Percent:
Continuous Index:
Within 8" of Joint: **NO**
Remarks:

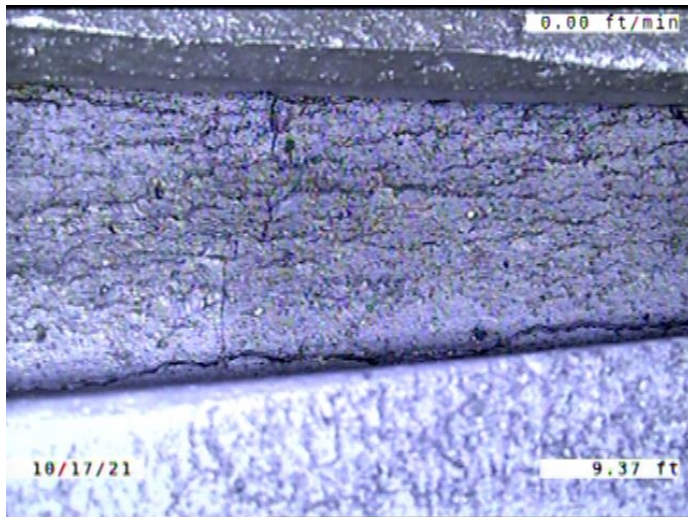
Code: **FM**
 Description: **Fracture Multiple**

Distance (ft): **9.4**
 Structural Grade: **4**
 O&M Grade: **0**
 Clock Start/From: **8**
 Clock To: **2**
 1st Value:
 2nd Value:
 Value Percent:
 Continuous Index:
 Within 8" of Joint: **YES**
 Remarks:

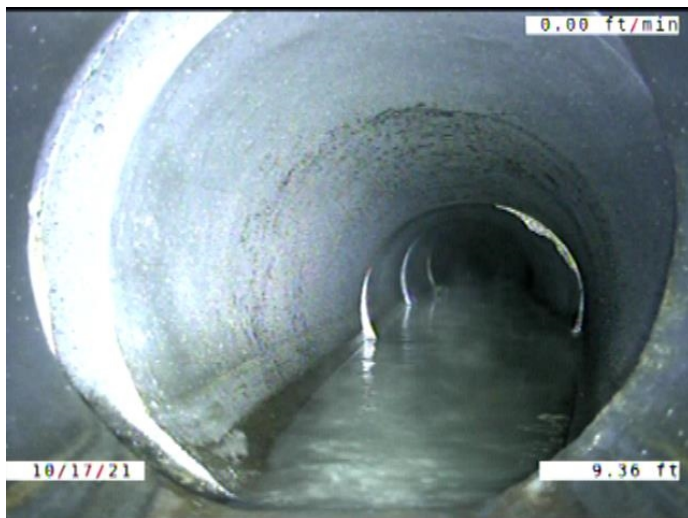
Code: **JOMD**
 Description: **Joint Offset Medium Defective**

Distance (ft): **9.4**
 Structural Grade: **3**
 O&M Grade: **0**
 Clock Start/From:
 Clock To:
 1st Value:
 2nd Value:
 Value Percent:
 Continuous Index:
 Within 8" of Joint: **NO**
 Remarks:

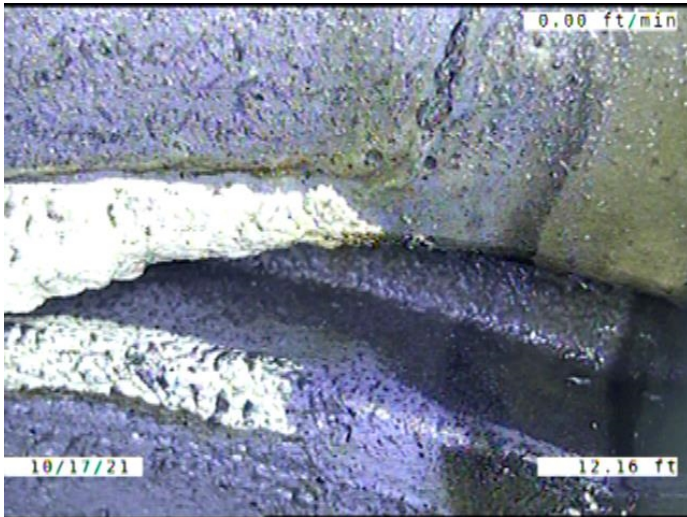
Code: **JAM**
 Description: **Joint Angular Medium**

Distance (ft): **12.2**
 Structural Grade: **3**
 O&M Grade: **0**
 Clock Start/From:
 Clock To:
 1st Value:
 2nd Value:
 Value Percent:
 Continuous Index:
 Within 8" of Joint: **NO**
 Remarks:

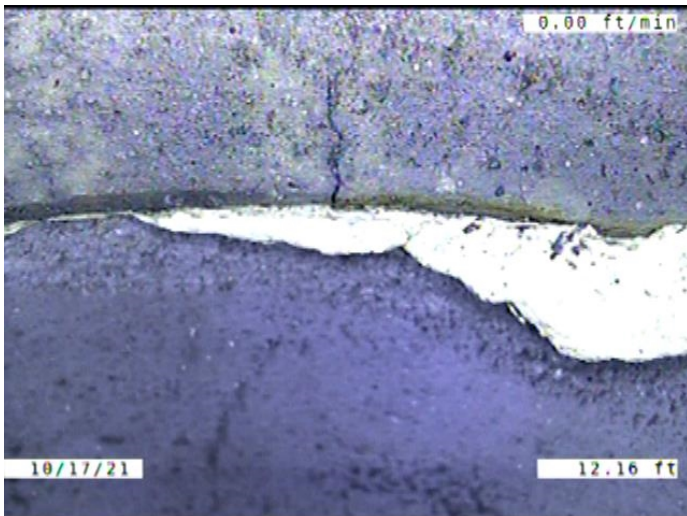
Code: **CL**
 Description: **Crack Longitudinal**

Distance (ft): **12.2**
 Structural Grade: **2**
 O&M Grade: **0**
 Clock Start/From: **1**
 Clock To:
 1st Value:
 2nd Value:
 Value Percent:
 Continuous Index:
 Within 8" of Joint: **YES**
 Remarks:

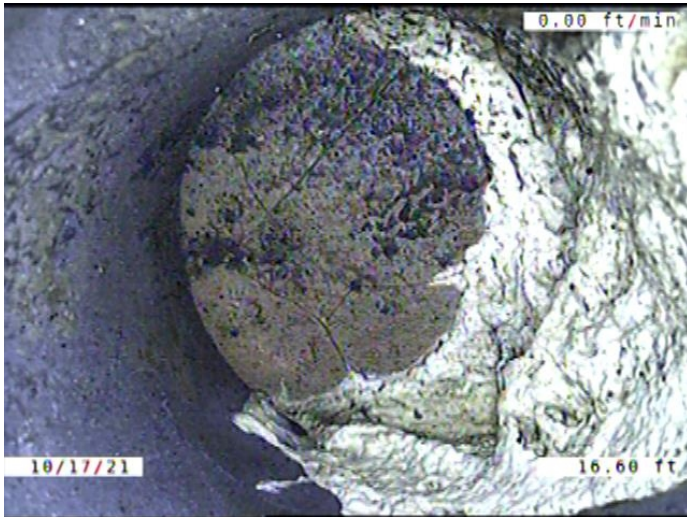
Code: **TFD**
 Description: **Tap Factory Defective**

Distance (ft): **16.6**
 Structural Grade: **0**
 O&M Grade: **3**
 Clock Start/From: **1**
 Clock To:
 1st Value: **4.000**
 2nd Value:
 Value Percent:
 Continuous Index:
 Within 8" of Joint: **YES**
 Remarks: **ENCUSTATION AROUND THE CAP.
CAP CRACKED**

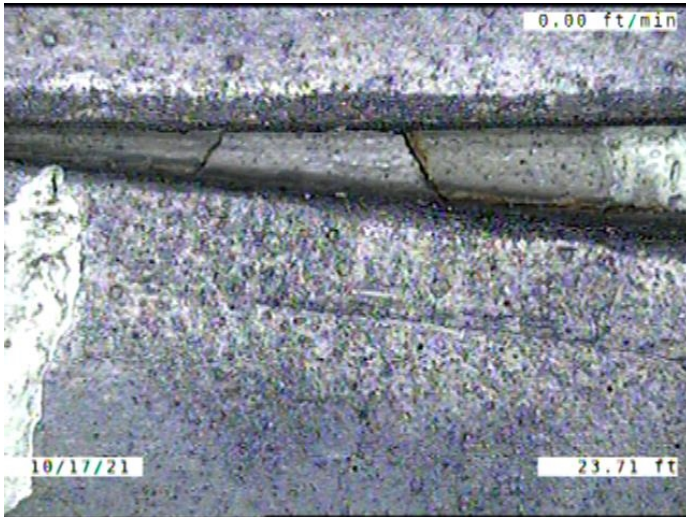
Code: **FM**
 Description: **Fracture Multiple**

Distance (ft): **23.7**
 Structural Grade: **4**
 O&M Grade: **0**
 Clock Start/From: **1**
 Clock To: **3**
 1st Value:
 2nd Value:
 Value Percent:
 Continuous Index:
 Within 8" of Joint: **YES**
 Remarks:

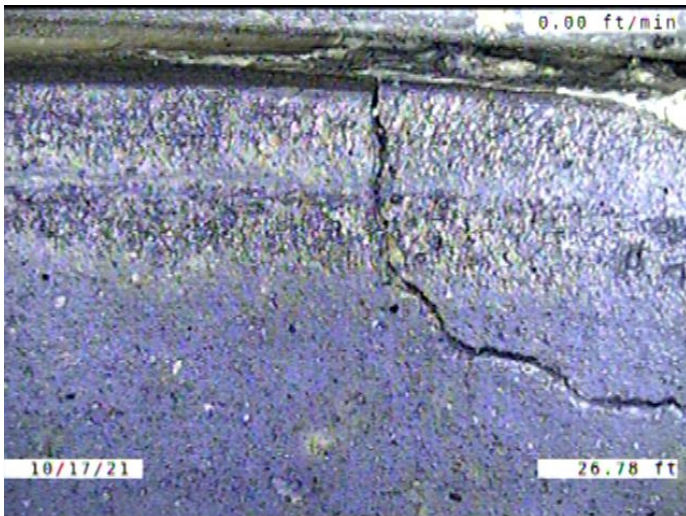
Code: **B**
 Description: **Broken**

Distance (ft): **26.8**
 Structural Grade: **4**
 O&M Grade: **0**
 Clock Start/From: **2**
 Clock To: **3**
 1st Value:
 2nd Value:
 Value Percent:
 Continuous Index:
 Within 8" of Joint: **YES**
 Remarks:

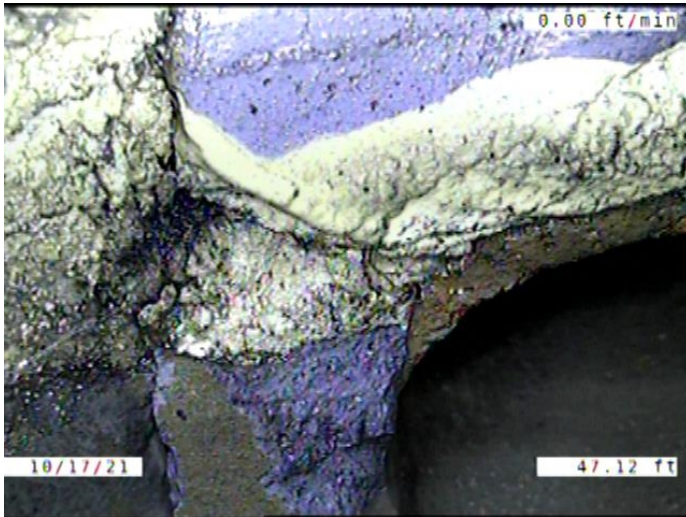
Code: **B**
 Description: **Broken**

Distance (ft): **47.1**
 Structural Grade: **4**
 O&M Grade: **0**
 Clock Start/From: **8**
 Clock To: **3**
 1st Value:
 2nd Value:
 Value Percent:
 Continuous Index:
 Within 8" of Joint: **YES**
 Remarks:

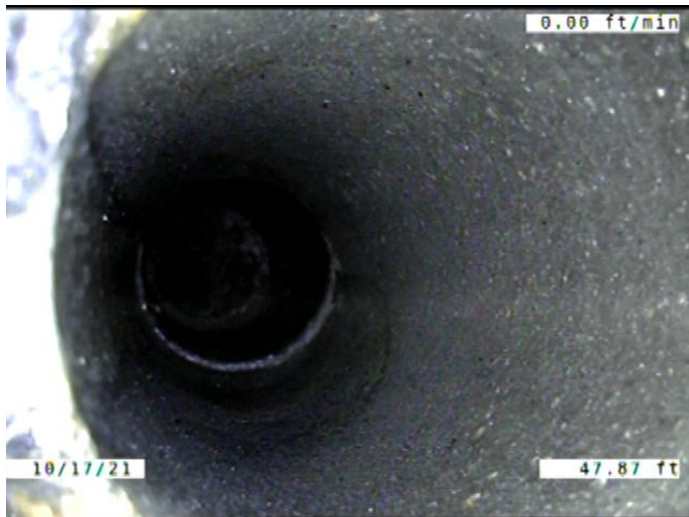
Code: **TBD**
 Description: **Tap Break-in/Hammer Defective**

Distance (ft): **47.9**
 Structural Grade: **0**
 O&M Grade: **3**
 Clock Start/From: **11**
 Clock To:
 1st Value: **4.000**
 2nd Value:
 Value Percent:
 Continuous Index:
 Within 8" of Joint: **YES**
 Remarks: **CONSTANTLY RUNNING WATER**

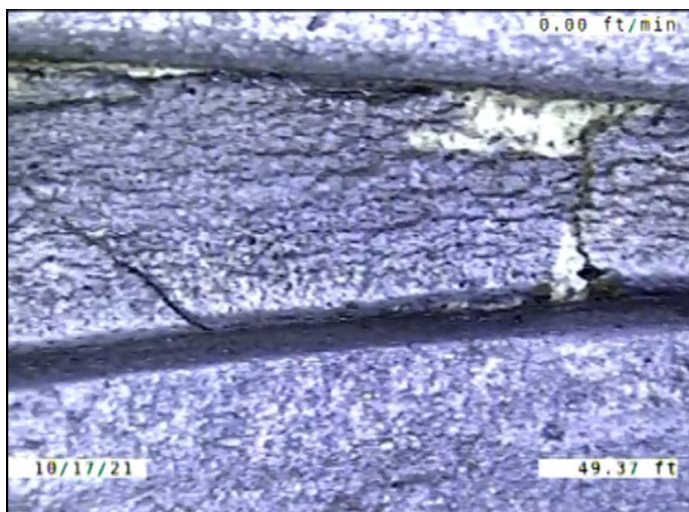
Code: **FM**
 Description: **Fracture Multiple**

Distance (ft): **49.4**
 Structural Grade: **4**
 O&M Grade: **0**
 Clock Start/From: **8**
 Clock To: **11**
 1st Value:
 2nd Value:
 Value Percent:
 Continuous Index:
 Within 8" of Joint: **YES**
 Remarks:

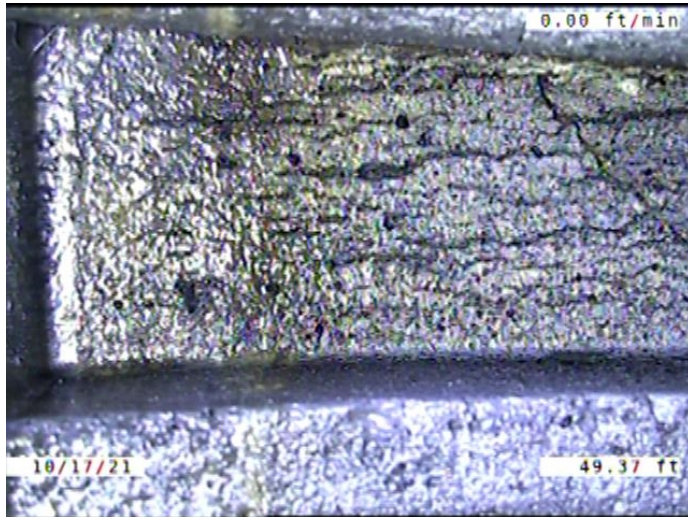
Code: **JAL**
 Description: **Joint Angular Large**

Distance (ft): **49.4**
 Structural Grade: **4**
 O&M Grade: **0**
 Clock Start/From:
 Clock To:
 1st Value:
 2nd Value:
 Value Percent:
 Continuous Index:
 Within 8" of Joint: **NO**
 Remarks:

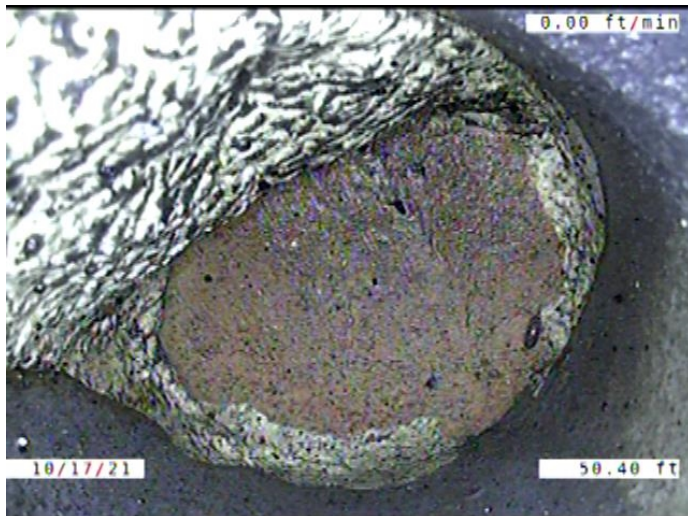
Code: **TFD**
 Description: **Tap Factory Defective**

Distance (ft): **50.4**
 Structural Grade: **0**
 O&M Grade: **3**
 Clock Start/From: **11**
 Clock To:
 1st Value: **4.000**
 2nd Value:
 Value Percent:
 Continuous Index:
 Within 8" of Joint: **YES**
 Remarks: **ENCrustATION AROUND THE CAP.
 CAP CRACKED**

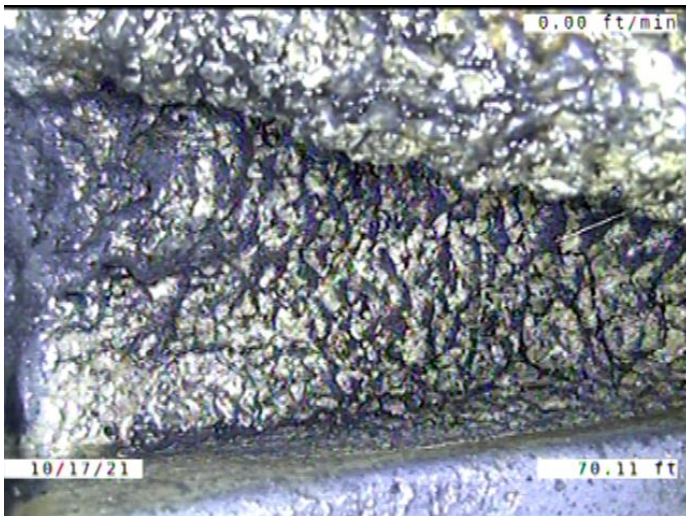
Code: **JAL**
 Description: **Joint Angular Large**

Distance (ft): **70.1**
 Structural Grade: **4**
 O&M Grade: **0**
 Clock Start/From:
 Clock To:
 1st Value:
 2nd Value:
 Value Percent:
 Continuous Index:
 Within 8" of Joint: **NO**
 Remarks:

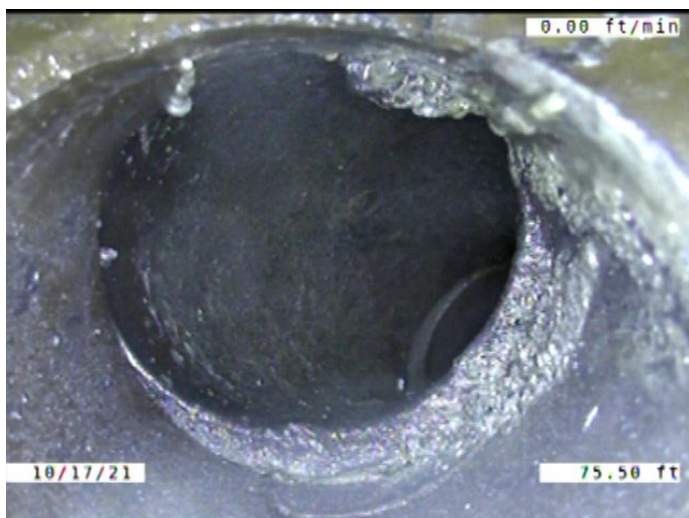
Code: **TFD**
 Description: **Tap Factory Defective**

Distance (ft): **75.5**
 Structural Grade: **0**
 O&M Grade: **3**
 Clock Start/From: **1**
 Clock To:
 1st Value: **4.000**
 2nd Value:
 Value Percent:
 Continuous Index:
 Within 8" of Joint: **YES**
 Remarks: **Defective**

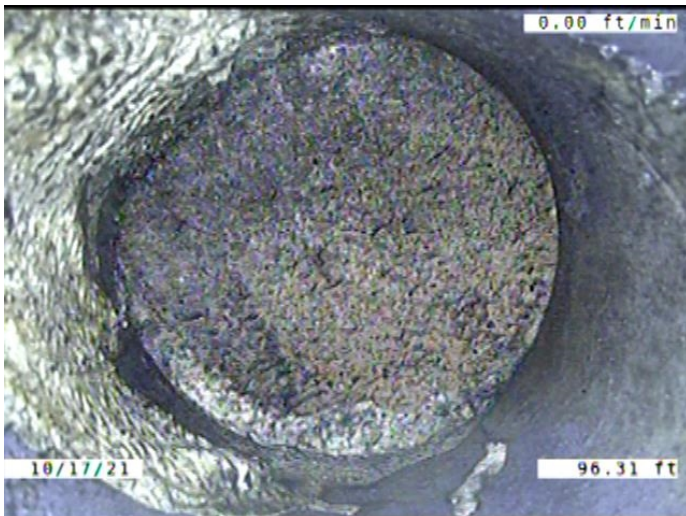
Code: **TFD**
 Description: **Tap Factory Defective**

Distance (ft): **96.3**
 Structural Grade: **0**
 O&M Grade: **3**
 Clock Start/From: **11**
 Clock To:
 1st Value: **4.000**
 2nd Value:
 Value Percent:
 Continuous Index:
 Within 8" of Joint: **YES**
 Remarks: **ENCRUSTATION AROUND THE CAP.**

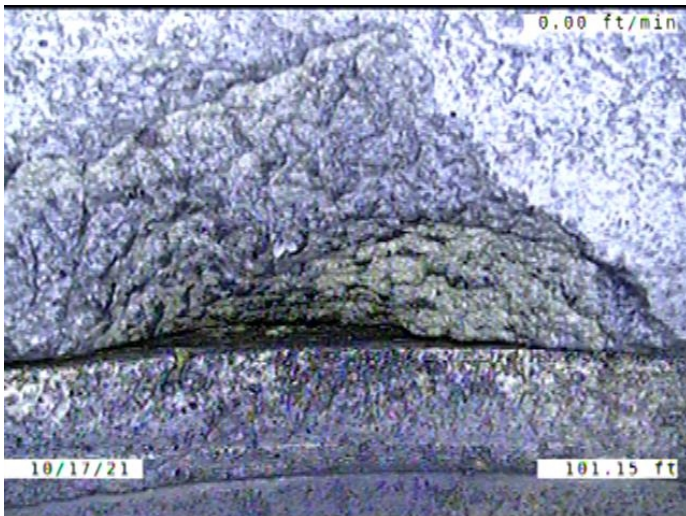
Code: **SZ**
 Description: **Surface Damage Other**

Distance (ft): **101.1**
 Structural Grade: **0**
 O&M Grade: **0**
 Clock Start/From: **11**
 Clock To:
 1st Value:
 2nd Value:
 Value Percent:
 Continuous Index:
 Within 8" of Joint: **YES**
 Remarks: **A PIECE CHIPPED AWAY FROM THE JOINT**

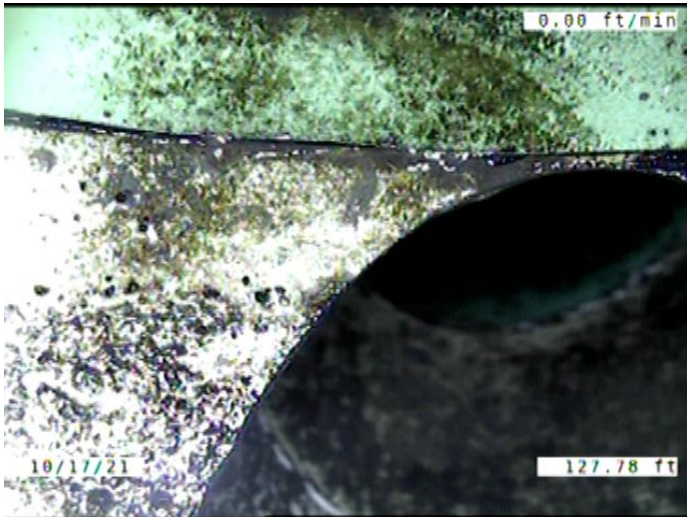
Code: **IRJ**
 Description: **Infiltration Runner Joint**

Distance (ft): **127.8**
 Structural Grade: **0**
 O&M Grade: **4**
 Clock Start/From: **11**
 Clock To: **1**
 1st Value:
 2nd Value:
 Value Percent:
 Continuous Index:
 Within 8" of Joint: **YES**
 Remarks:

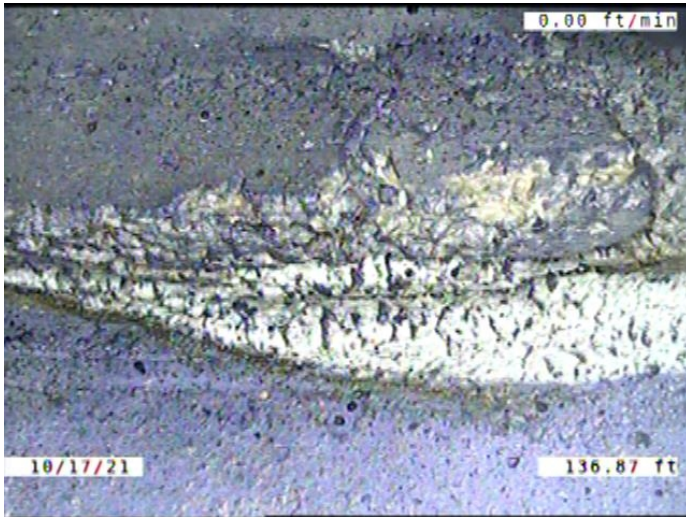
Code: **B**
Description: **Broken**

Distance (ft): **136.9**
Structural Grade: **4**
O&M Grade: **0**
Clock Start/From: **2**
Clock To: **3**
1st Value:
2nd Value:
Value Percent:
Continuous Index:
Within 8" of Joint: **YES**
Remarks:

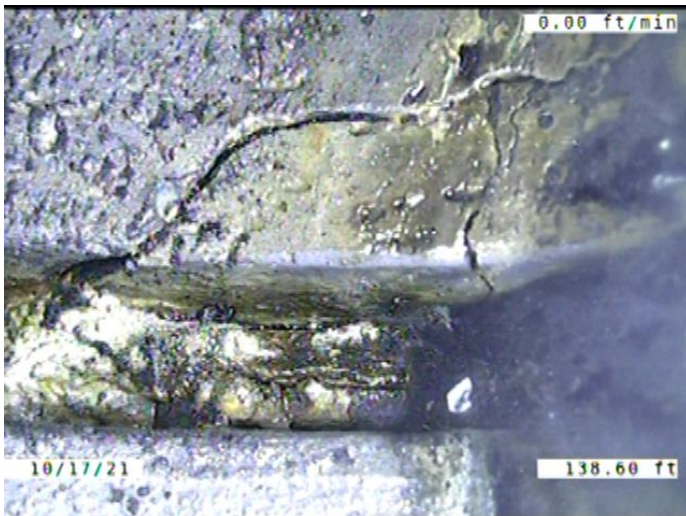
Code: **B**
Description: **Broken**

Distance (ft): **138.6**
Structural Grade: **4**
O&M Grade: **0**
Clock Start/From: **7**
Clock To: **9**
1st Value:
2nd Value:
Value Percent:
Continuous Index:
Within 8" of Joint: **YES**
Remarks:

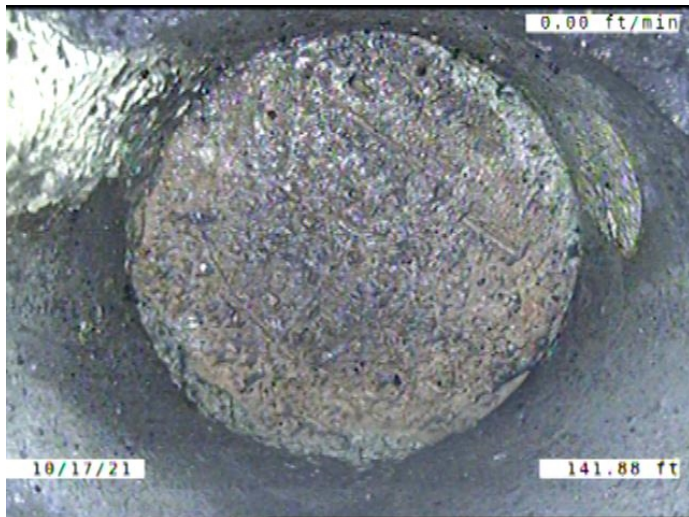
| Code: | TFC |
| Remarks: | ENCRUSTATION AROUND THE CAP. |

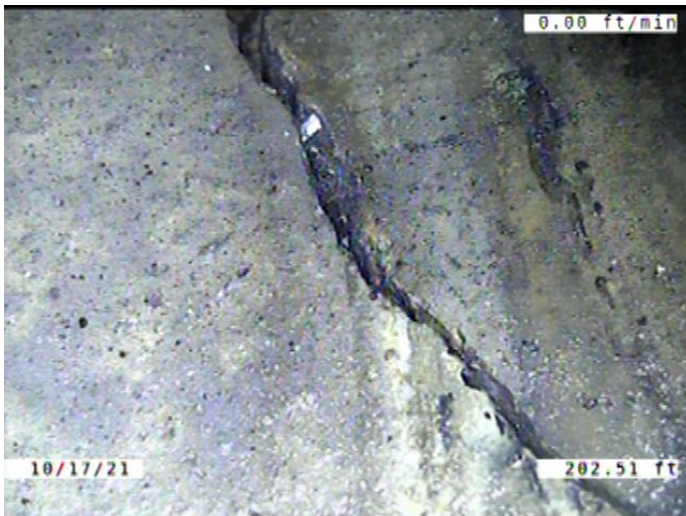
Code: **B**
 Description: **Broken**

Distance (ft): **202.5**
 Structural Grade: **4**
 O&M Grade: **0**
 Clock Start/From: **4**
 Clock To: **9**
 1st Value:
 2nd Value:
 Value Percent:
 Continuous Index:
 Within 8" of Joint: **YES**
 Remarks:

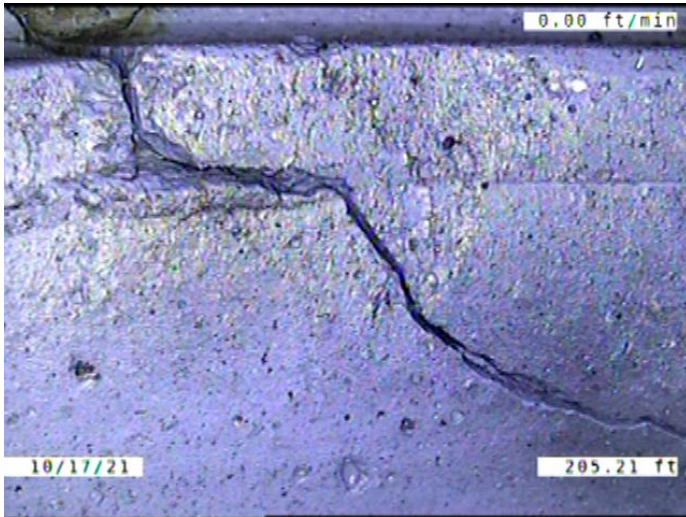
Code: **B**
Description: **Broken**

Distance (ft): **205.2**
Structural Grade: **4**
O&M Grade: **0**
Clock Start/From: **8**
Clock To: **1**
1st Value:
2nd Value:
Value Percent:
Continuous Index:
Within 8" of Joint: **YES**
Remarks:
