Profile/Photo Observation Report

Date:	10/17/2021	Weather:		Coding:	PACP 7.0
Pipe Length (ft):	343.5	Owner:	City of Hobart	Pre Clean:	Heavy Cleaning
P.O.#:	YES502259	Surveyor:	S. Bucklin	PSR:	P-704-013-012
Customer:	City of Hobart	Clean Date:	10/13/2021	Shape:	C

Street:	North Michigan Avenue	Flow Control:	Not Controlled
City:	Hobart, IN	Year Renewed:	
Location:	Local rural streets with light traffic, t	Tape/Media #:	
Purpose:	Routine Assessment	Dia/Height:	12"
Use:	Sanitary Sewage Pipe	Material:	VCP
Drain Area:		Lining:	
Category:	NA		
Comment:			
Location Details:		Direction of Survey:	Downstream
US MH:	M-704-013	DS MH:	M-704-012
		Total Length Surveyed (ft):	343.5

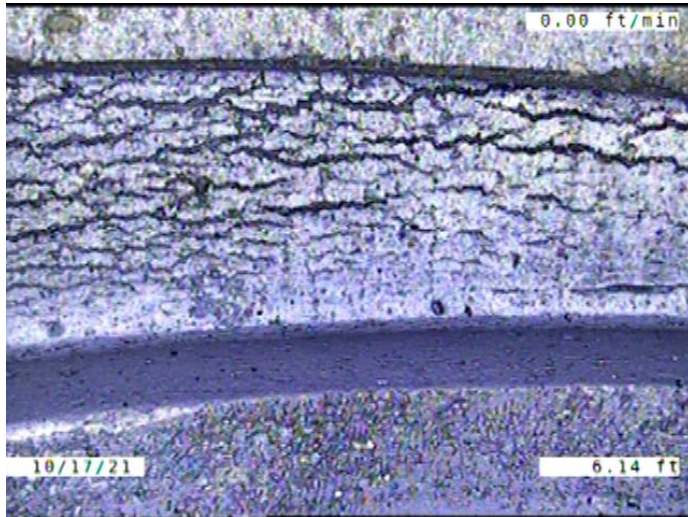
Code: **JAL**
Description: **Joint Angular Large**

Distance (ft): **6.1**
Structural Grade: **4**
O&M Grade: **0**
Clock Start/From:
Clock To:
1st Value:
2nd Value:
Value Percent:
Continuous Index:
Within 8" of Joint: **NO**
Remarks:

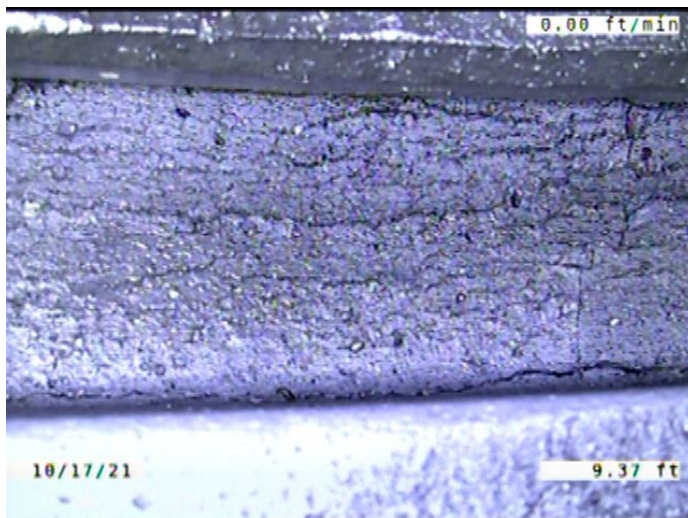
Code: **JAL**
Description: **Joint Angular Large**

Distance (ft): **9.4**
Structural Grade: **4**
O&M Grade: **0**
Clock Start/From:
Clock To:
1st Value:
2nd Value:
Value Percent:
Continuous Index:
Within 8" of Joint: **NO**
Remarks:

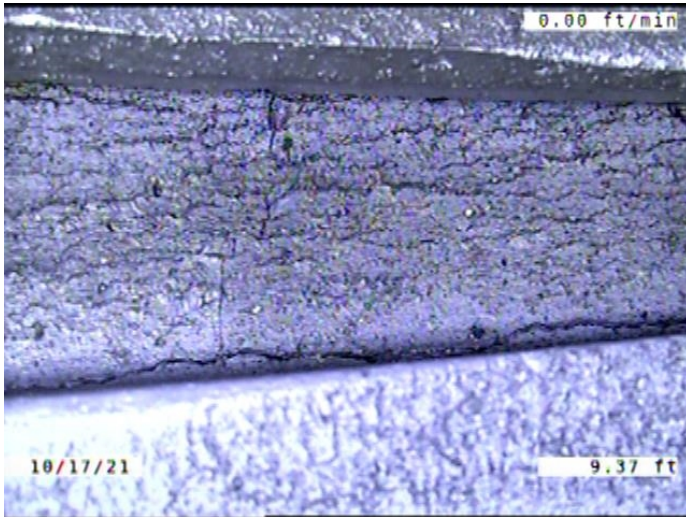
Code: **FM**
 Description: **Fracture Multiple**

Distance (ft): **9.4**
 Structural Grade: **4**
 O&M Grade: **0**
 Clock Start/From: **8**
 Clock To: **2**
 1st Value:
 2nd Value:
 Value Percent:
 Continuous Index:
 Within 8" of Joint: **YES**
 Remarks:

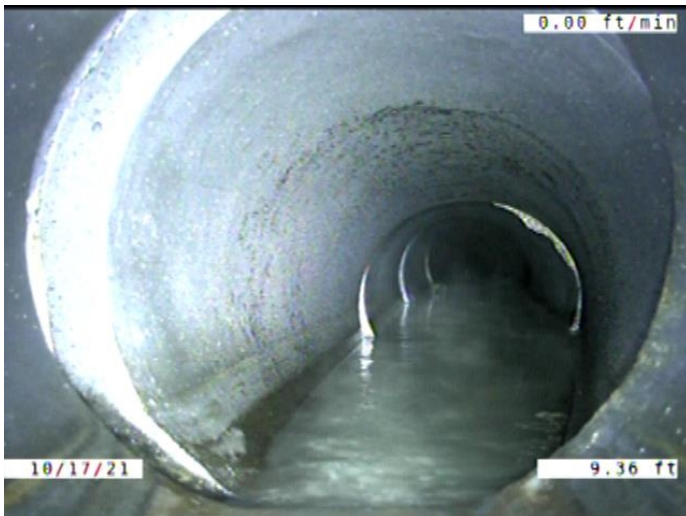
Code: **JOMD**
 Description: **Joint Offset Medium Defective**

Distance (ft): **9.4**
 Structural Grade: **3**
 O&M Grade: **0**
 Clock Start/From:
 Clock To:
 1st Value:
 2nd Value:
 Value Percent:
 Continuous Index:
 Within 8" of Joint: **NO**
 Remarks:

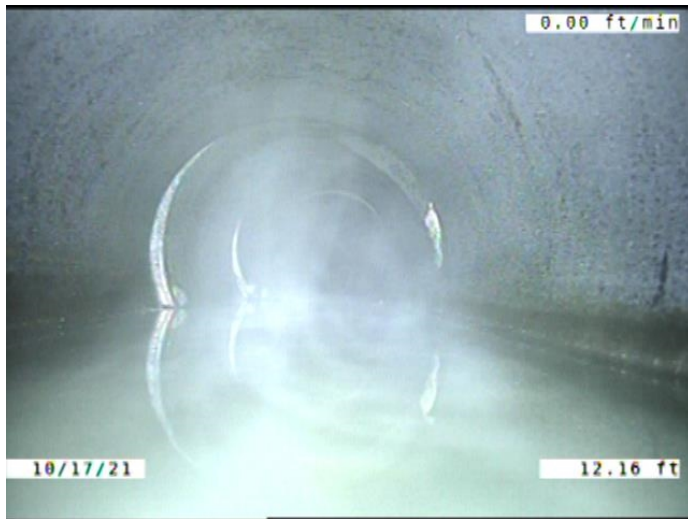
Code: **MWLS**
 Description: **Miscellaneous Water Level Sag**

Distance (ft): **12.2**
 Structural Grade: **2**
 O&M Grade: **0**
 Clock Start/From:
 Clock To:
 1st Value:
 2nd Value:
 Value Percent: **15.000**
 Continuous Index: **S01**
 Within 8" of Joint: **NO**
 Remarks:

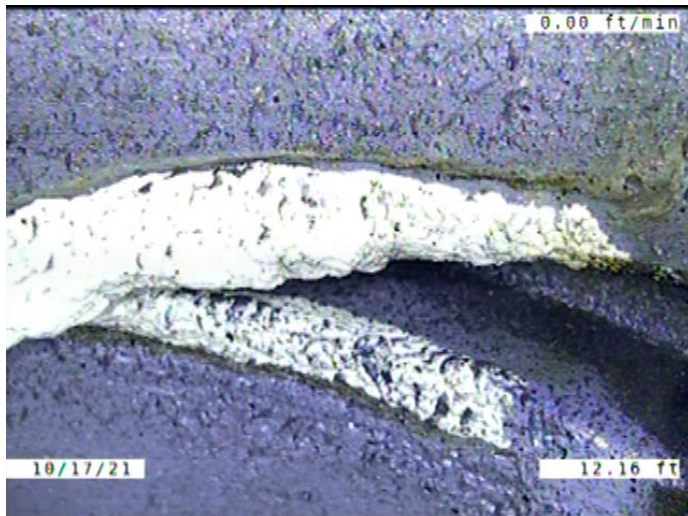
Code: **DAE**
 Description: **Deposits Attached Encrustation**

Distance (ft): **12.2**
 Structural Grade: **0**
 O&M Grade: **2**
 Clock Start/From: **9**
 Clock To: **3**
 1st Value:
 2nd Value:
 Value Percent: **5.000**
 Continuous Index:
 Within 8" of Joint: **YES**
 Remarks:

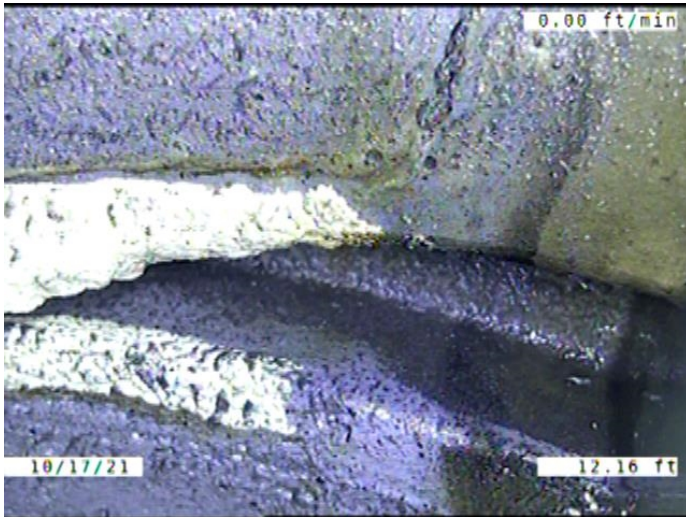
Code: **JAM**
 Description: **Joint Angular Medium**

Distance (ft): **12.2**
 Structural Grade: **3**
 O&M Grade: **0**
 Clock Start/From:
 Clock To:
 1st Value:
 2nd Value:
 Value Percent:
 Continuous Index:
 Within 8" of Joint: **NO**
 Remarks:

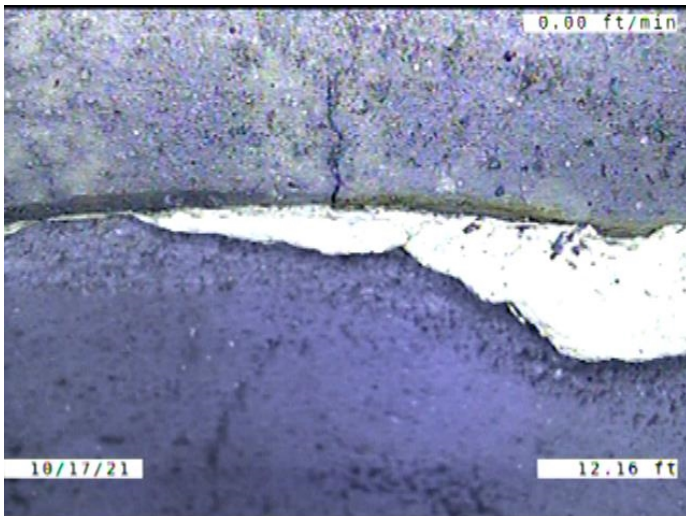
Code: **CL**
 Description: **Crack Longitudinal**

Distance (ft): **12.2**
 Structural Grade: **2**
 O&M Grade: **0**
 Clock Start/From: **1**
 Clock To:
 1st Value:
 2nd Value:
 Value Percent:
 Continuous Index:
 Within 8" of Joint: **YES**
 Remarks:

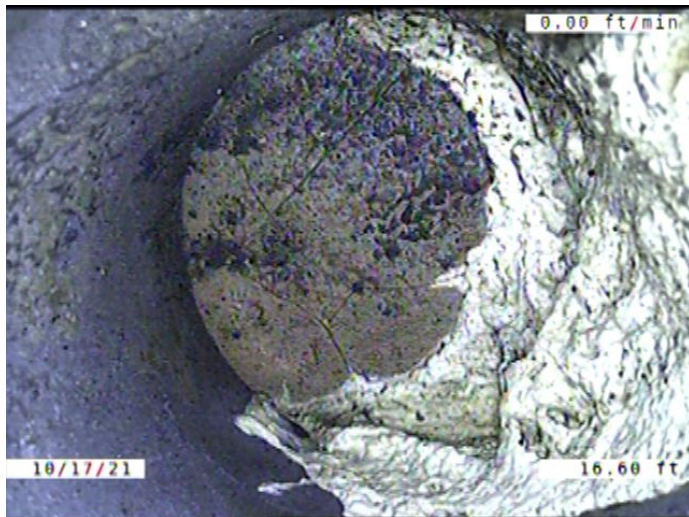
Code: **TFD**
 Description: **Tap Factory Defective**

Distance (ft): **16.6**
 Structural Grade: **0**
 O&M Grade: **3**
 Clock Start/From: **1**
 Clock To:
 1st Value: **4.000**
 2nd Value:
 Value Percent:
 Continuous Index:
 Within 8" of Joint: **YES**
 Remarks: **ENCUSTATION AROUND THE CAP.
CAP CRACKED**

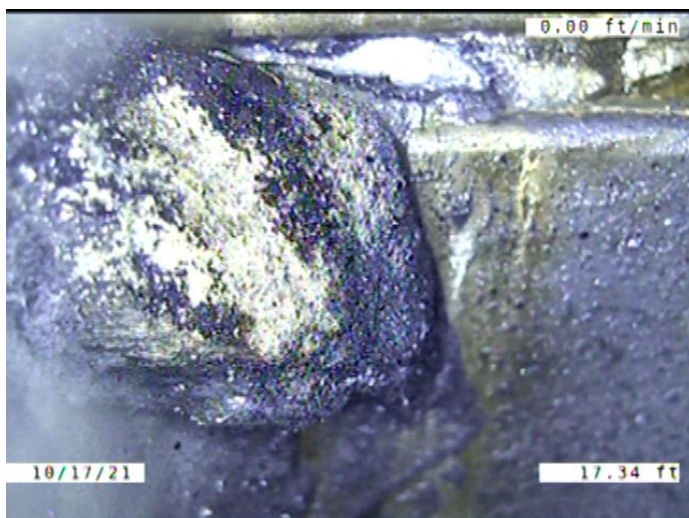
Code: **DAE**
 Description: **Deposits Attached Encrustation**

Distance (ft): **17.3**
 Structural Grade: **0**
 O&M Grade: **2**
 Clock Start/From: **8**
 Clock To: **9**
 1st Value:
 2nd Value:
 Value Percent: **5.000**
 Continuous Index:
 Within 8" of Joint: **YES**
 Remarks:

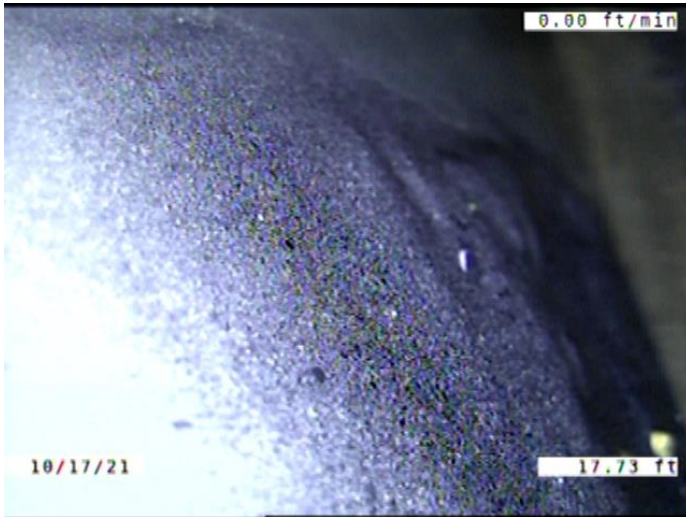
Code: **DSF**
 Description: **Deposits Settled Fine**

Distance (ft): **17.7**
 Structural Grade: **0**
 O&M Grade: **2**
 Clock Start/From: **4**
 Clock To: **6**
 1st Value:
 2nd Value:
 Value Percent: **5.000**
 Continuous Index:
 Within 8" of Joint: **YES**
 Remarks:

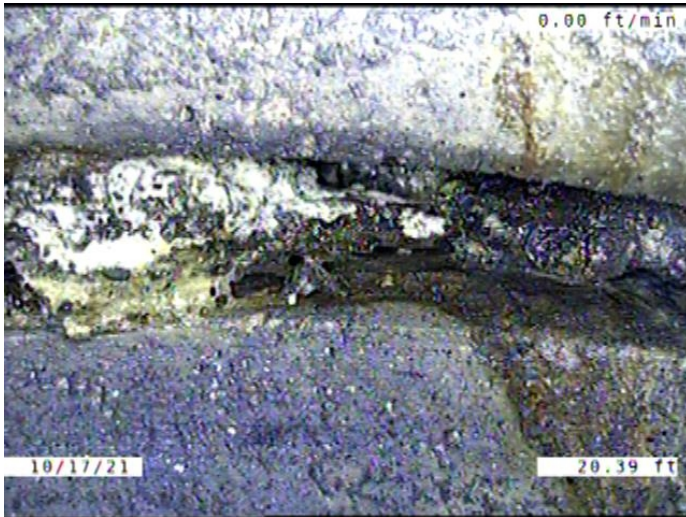
Code: **DAE**
 Description: **Deposits Attached Encrustation**

Distance (ft): **20.4**
 Structural Grade: **0**
 O&M Grade: **2**
 Clock Start/From: **12**
 Clock To: **4**
 1st Value:
 2nd Value:
 Value Percent: **5.000**
 Continuous Index: **S02**
 Within 8" of Joint: **YES**
 Remarks:

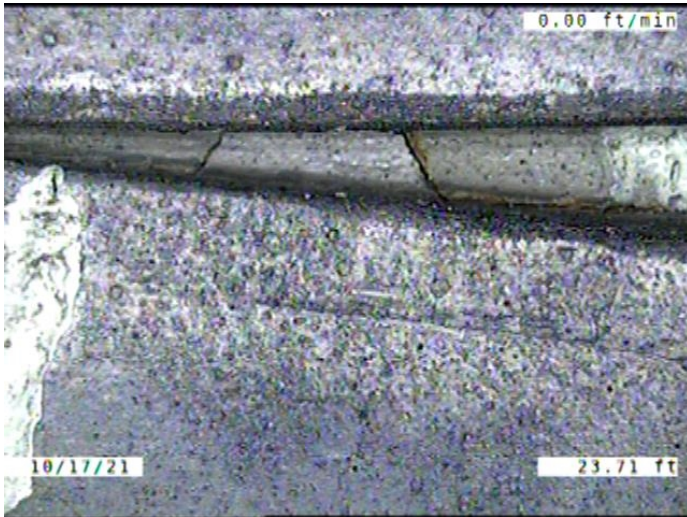
Code: **FM**
 Description: **Fracture Multiple**

Distance (ft): **23.7**
 Structural Grade: **4**
 O&M Grade: **0**
 Clock Start/From: **1**
 Clock To: **3**
 1st Value:
 2nd Value:
 Value Percent:
 Continuous Index:
 Within 8" of Joint: **YES**
 Remarks:

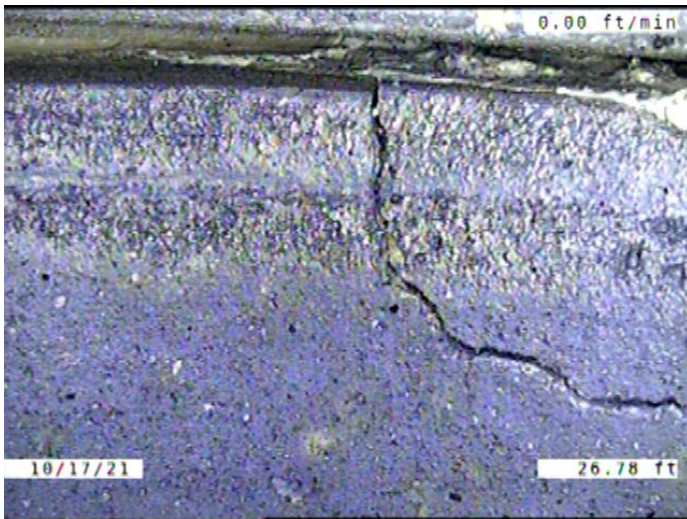
Code: **B**
 Description: **Broken**

Distance (ft): **26.8**
 Structural Grade: **4**
 O&M Grade: **0**
 Clock Start/From: **2**
 Clock To: **3**
 1st Value:
 2nd Value:
 Value Percent:
 Continuous Index:
 Within 8" of Joint: **YES**
 Remarks:

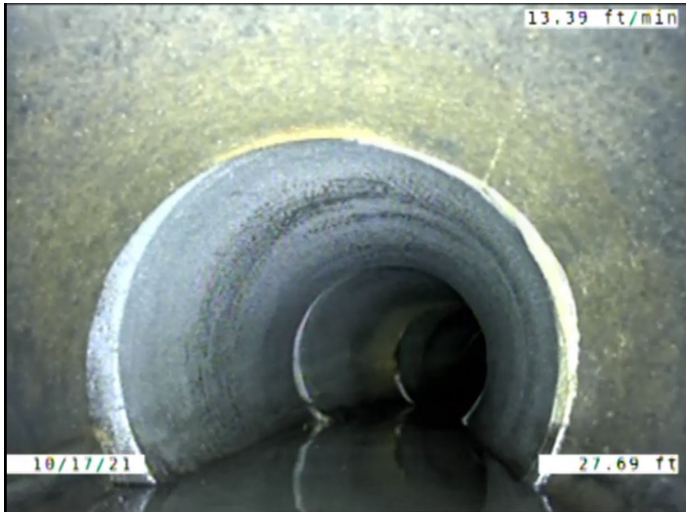
Code: **LR**
Description: **Line Right**

Distance (ft): **27.7**
Structural Grade: **0**
O&M Grade: **1**
Clock Start/From:
Clock To:
1st Value:
2nd Value:
Value Percent: **5.000**
Continuous Index:
Within 8" of Joint: **NO**
Remarks:

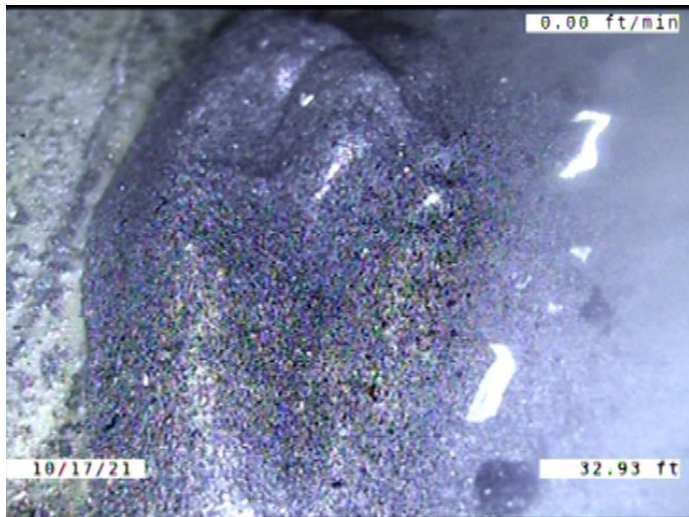
Code: **DSF**
 Description: **Deposits Settled Fine**

Distance (ft): **32.9**
 Structural Grade: **0**
 O&M Grade: **2**
 Clock Start/From: **6**
 Clock To: **8**
 1st Value:
 2nd Value:
 Value Percent: **5.000**
 Continuous Index:
 Within 8" of Joint: **YES**
 Remarks:

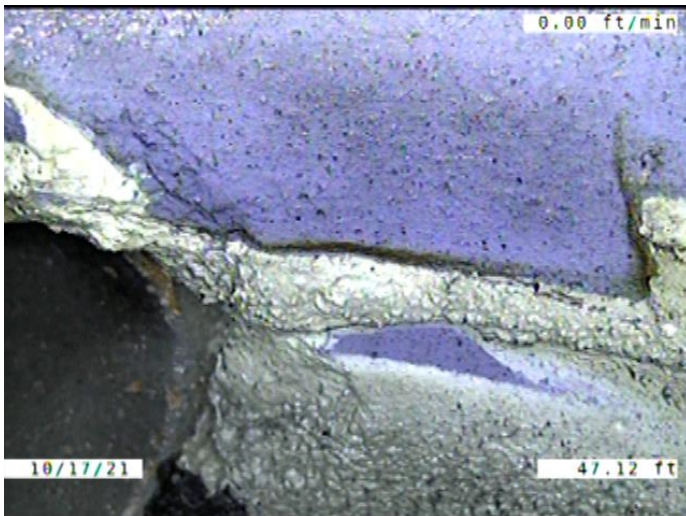
Code: **DAE**
 Description: **Deposits Attached Encrustation**

Distance (ft): **47.1**
 Structural Grade: **0**
 O&M Grade: **2**
 Clock Start/From: **9**
 Clock To: **3**
 1st Value:
 2nd Value:
 Value Percent: **5.000**
 Continuous Index:
 Within 8" of Joint: **YES**
 Remarks:

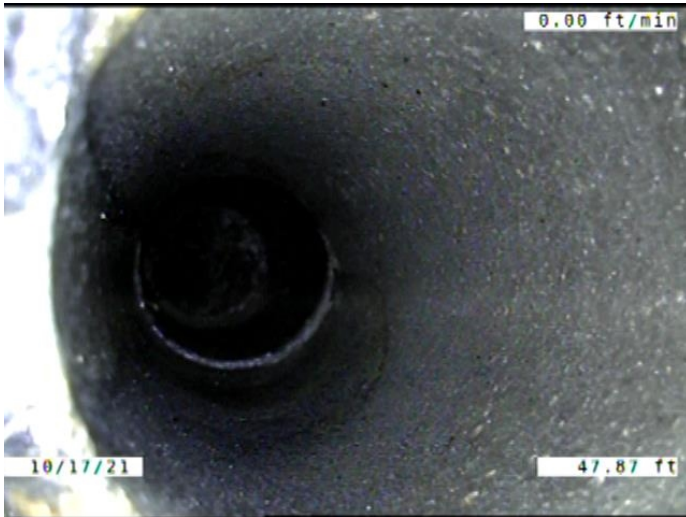
Code: **TBD**
 Description: **Tap Break-in/Hammer Defective**

Distance (ft): **47.9**
 Structural Grade: **0**
 O&M Grade: **3**
 Clock Start/From: **11**
 Clock To:
 1st Value: **4.000**
 2nd Value:
 Value Percent:
 Continuous Index:
 Within 8" of Joint: **YES**
 Remarks: **CONSTANTLY RUNNING WATER**

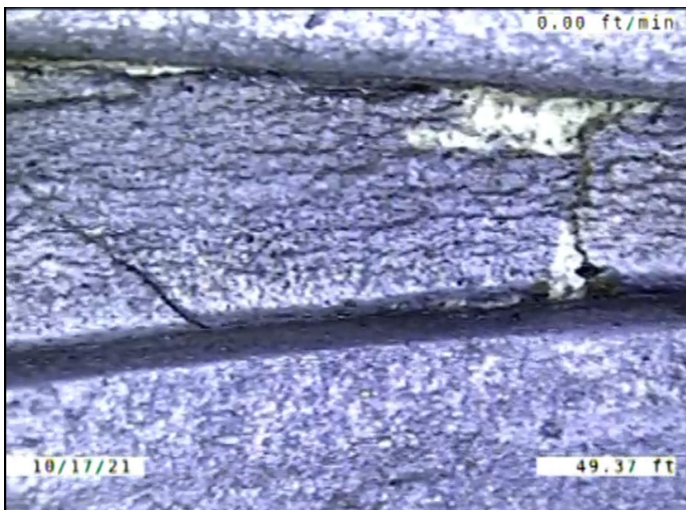
Code: **FM**
 Description: **Fracture Multiple**

Distance (ft): **49.4**
 Structural Grade: **4**
 O&M Grade: **0**
 Clock Start/From: **8**
 Clock To: **11**
 1st Value:
 2nd Value:
 Value Percent:
 Continuous Index:
 Within 8" of Joint: **YES**
 Remarks:

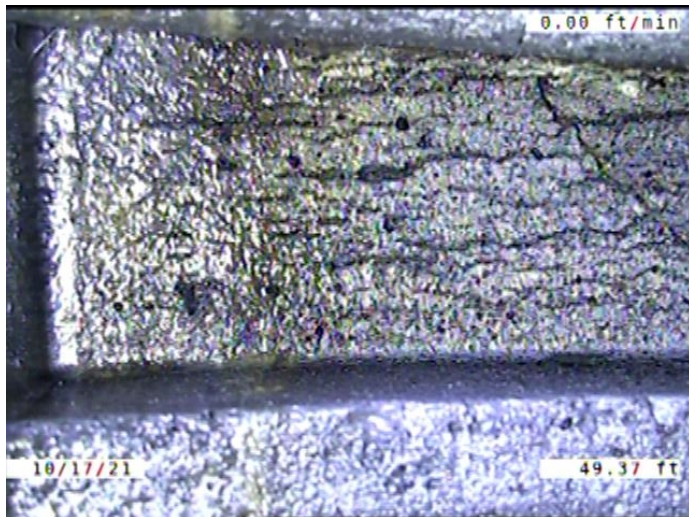
Code: **JAL**
 Description: **Joint Angular Large**

Distance (ft): **49.4**
 Structural Grade: **4**
 O&M Grade: **0**
 Clock Start/From:
 Clock To:
 1st Value:
 2nd Value:
 Value Percent:
 Continuous Index:
 Within 8" of Joint: **NO**
 Remarks:

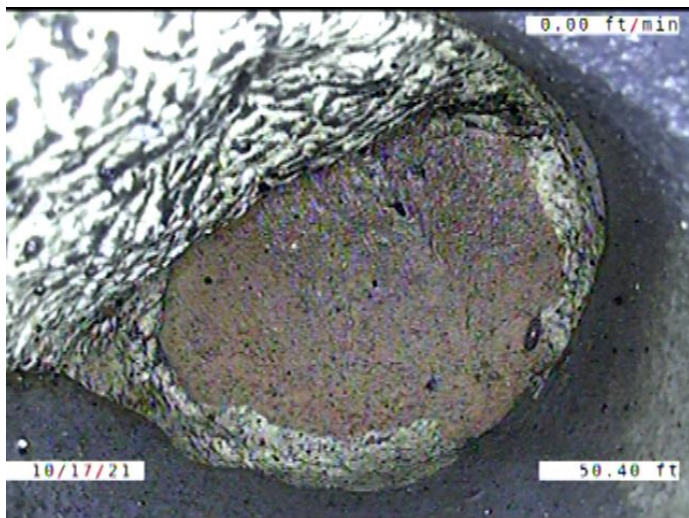
Code: **TFD**
 Description: **Tap Factory Defective**

Distance (ft): **50.4**
 Structural Grade: **0**
 O&M Grade: **3**
 Clock Start/From: **11**
 Clock To:
 1st Value: **4.000**
 2nd Value:
 Value Percent:
 Continuous Index:
 Within 8" of Joint: **YES**
 Remarks: **ENCrustATION AROUND THE CAP.
CAP CRACKED**

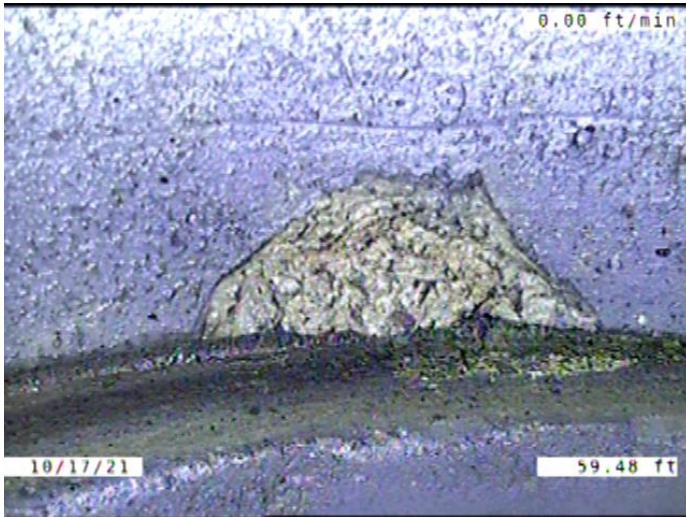
Code: **SSS**
 Description: **Surface Damage Surface Spalling**

Distance (ft): **59.5**
 Structural Grade: **2**
 O&M Grade: **0**
 Clock Start/From: **10**
 Clock To:
 1st Value:
 2nd Value:
 Value Percent:
 Continuous Index:
 Within 8" of Joint: **YES**
 Remarks:

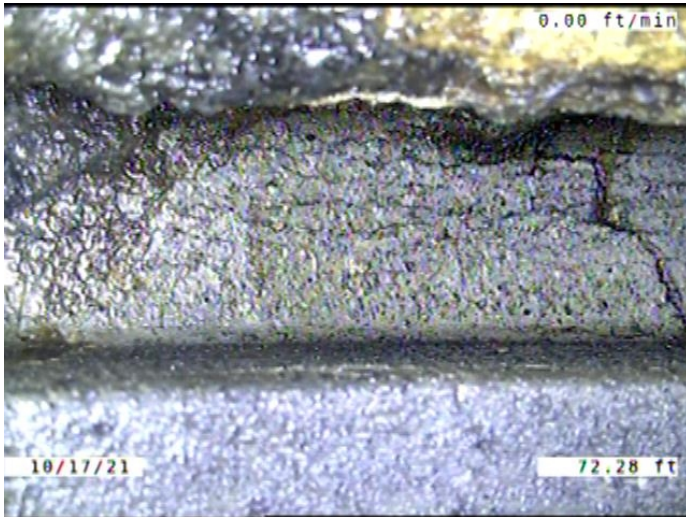
Code: **JAM**
 Description: **Joint Angular Medium**

Distance (ft): **72.3**
 Structural Grade: **3**
 O&M Grade: **0**
 Clock Start/From:
 Clock To:
 1st Value:
 2nd Value:
 Value Percent:
 Continuous Index: **S05**
 Within 8" of Joint: **NO**
 Remarks:

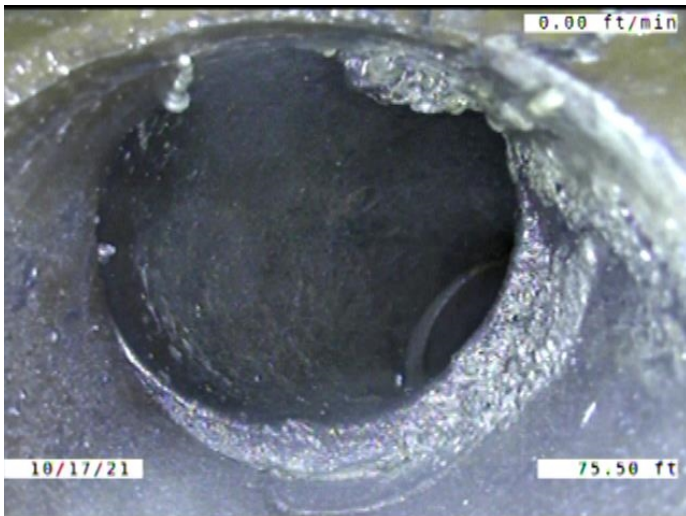
Code: **TFD**
 Description: **Tap Factory Defective**

Distance (ft): **75.5**
 Structural Grade: **0**
 O&M Grade: **3**
 Clock Start/From: **1**
 Clock To:
 1st Value: **4.000**
 2nd Value:
 Value Percent:
 Continuous Index:
 Within 8" of Joint: **YES**
 Remarks: **Defective**

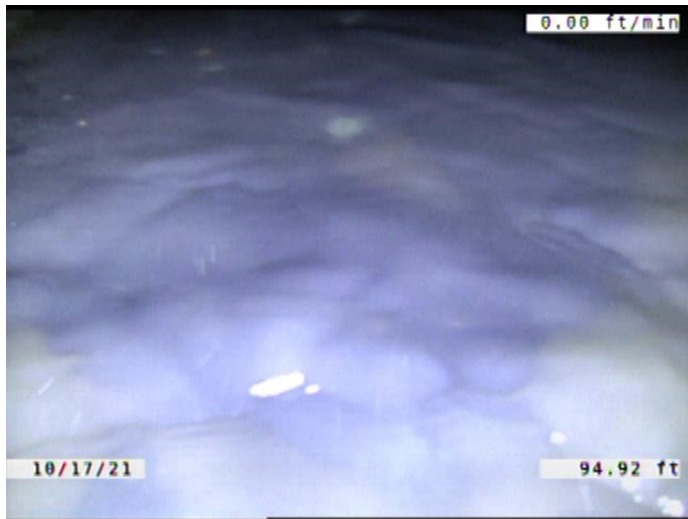
Code: **DSF**
 Description: **Deposits Settled Fine**

Distance (ft): **94.9**
 Structural Grade: **0**
 O&M Grade: **2**
 Clock Start/From: **4**
 Clock To: **8**
 1st Value:
 2nd Value:
 Value Percent: **5.000**
 Continuous Index: **S06**
 Within 8" of Joint: **YES**
 Remarks:

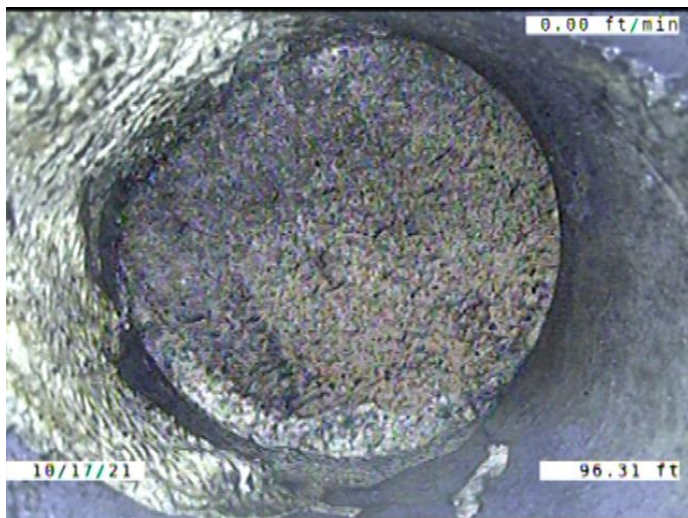
Code: **TFD**
 Description: **Tap Factory Defective**

Distance (ft): **96.3**
 Structural Grade: **0**
 O&M Grade: **3**
 Clock Start/From: **11**
 Clock To:
 1st Value: **4.000**
 2nd Value:
 Value Percent:
 Continuous Index:
 Within 8" of Joint: **YES**
 Remarks: **ENCRUSTATION AROUND THE CAP.**

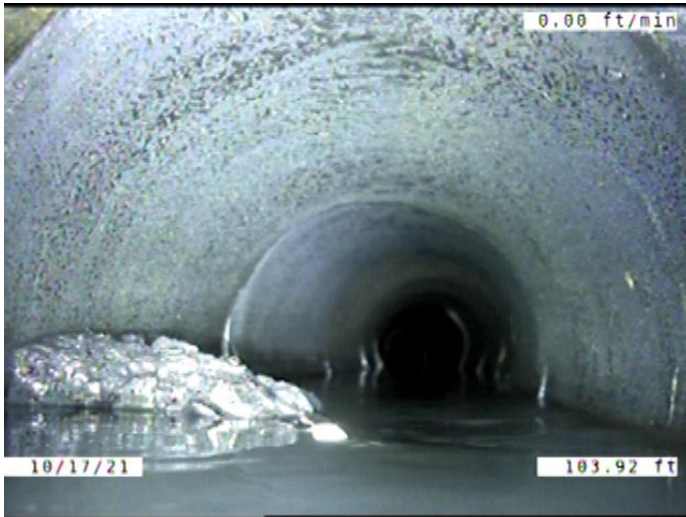
Code: **DSC**
 Description: **Deposits Settled Hard/Compacted**

Distance (ft): **103.9**
 Structural Grade: **0**
 O&M Grade: **2**
 Clock Start/From: **5**
 Clock To: **9**
 1st Value:
 2nd Value:
 Value Percent: **10.000**
 Continuous Index:
 Within 8" of Joint: **YES**
 Remarks:

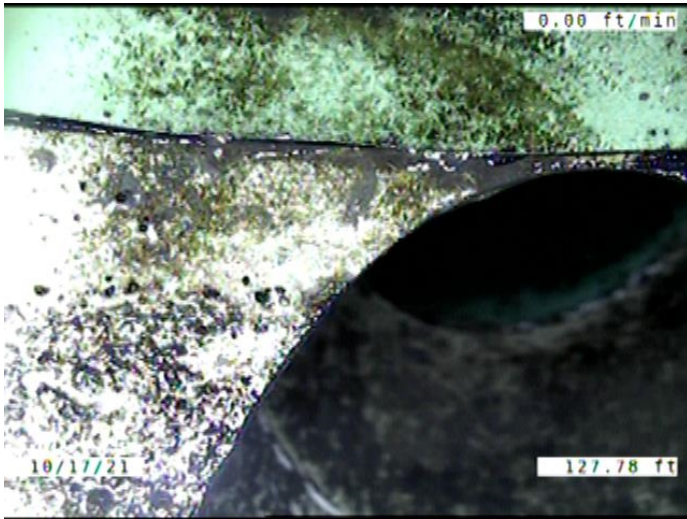
Code: **IRJ**
 Description: **Infiltration Runner Joint**

Distance (ft): **127.8**
 Structural Grade: **0**
 O&M Grade: **4**
 Clock Start/From: **11**
 Clock To: **1**
 1st Value:
 2nd Value:
 Value Percent:
 Continuous Index:
 Within 8" of Joint: **YES**
 Remarks:

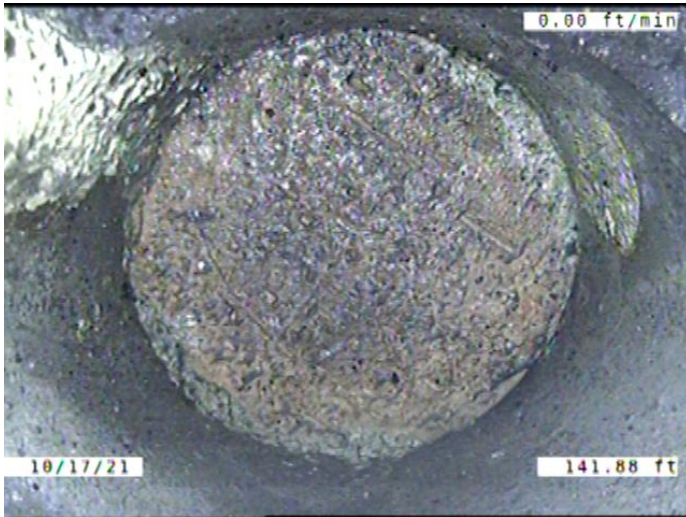
Code:	TFC
Description:	Tap Factory Capped
Distance (ft):	141.9
Structural Grade:	0
O&M Grade:	0
Clock Start/From:	11
Clock To:	
1st Value:	4.000
2nd Value:	
Value Percent:	
Continuous Index:	
Within 8" of Joint:	YES
Remarks:	ENCRUSTATION AROUND THE CAP.

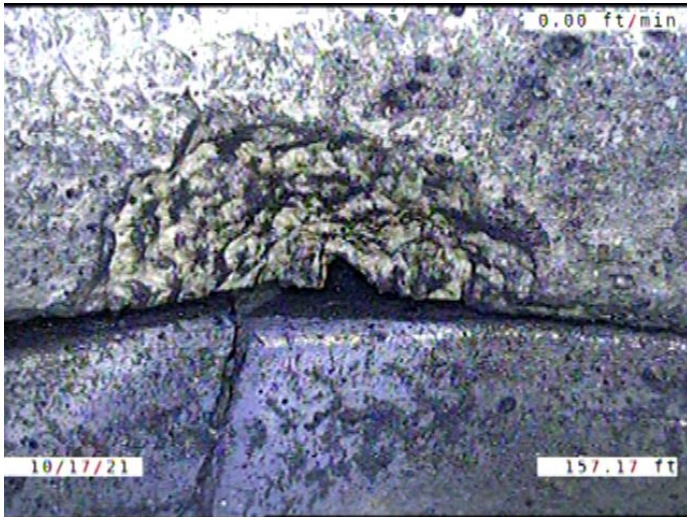
Code: **SSS**
 Description: **Surface Damage Surface Spalling**

Distance (ft): **157.2**
 Structural Grade: **2**
 O&M Grade: **0**
 Clock Start/From: **12**
 Clock To:
 1st Value:
 2nd Value:
 Value Percent:
 Continuous Index:
 Within 8" of Joint: **YES**
 Remarks:

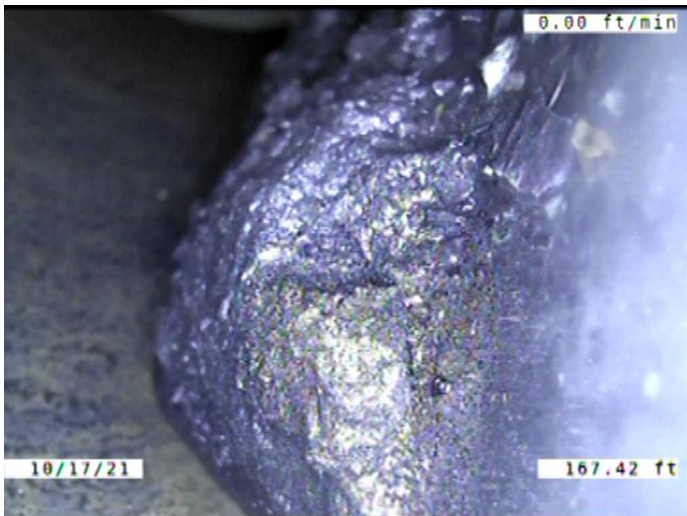
Code: **DSC**
 Description: **Deposits Settled Hard/Compacted**

Distance (ft): **167.4**
 Structural Grade: **0**
 O&M Grade: **2**
 Clock Start/From: **6**
 Clock To: **8**
 1st Value:
 2nd Value:
 Value Percent: **5.000**
 Continuous Index:
 Within 8" of Joint: **YES**
 Remarks:

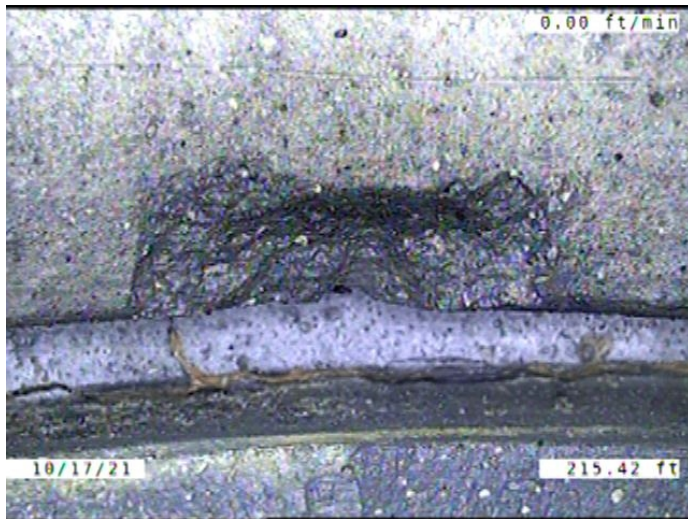
Code: **SSS**
 Description: **Surface Damage Surface Spalling**

Distance (ft): **215.4**
 Structural Grade: **2**
 O&M Grade: **0**
 Clock Start/From: **11**
 Clock To:
 1st Value:
 2nd Value:
 Value Percent:
 Continuous Index:
 Within 8" of Joint: **YES**
 Remarks: **A PIECE CHIPPED AWAY FROM THE JOINT**

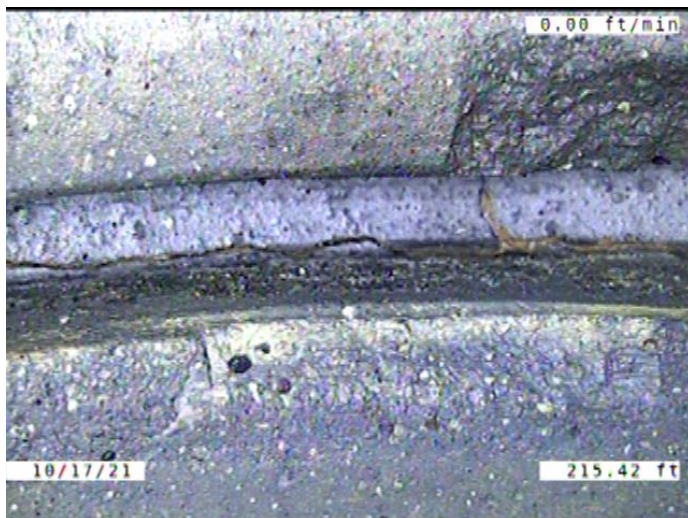
Code: **FM**
 Description: **Fracture Multiple**

Distance (ft): **215.4**
 Structural Grade: **4**
 O&M Grade: **0**
 Clock Start/From: **9**
 Clock To: **1**
 1st Value:
 2nd Value:
 Value Percent:
 Continuous Index:
 Within 8" of Joint: **YES**
 Remarks:

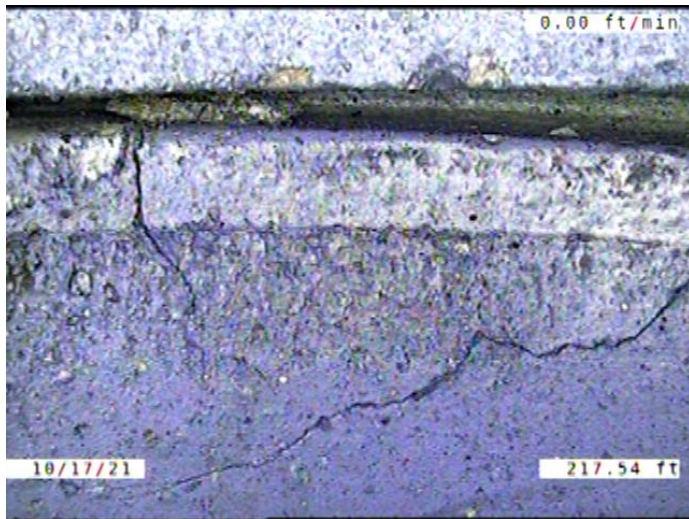
Code: **FM**
 Description: **Fracture Multiple**

Distance (ft): **217.5**
 Structural Grade: **4**
 O&M Grade: **0**
 Clock Start/From: **9**
 Clock To: **4**
 1st Value:
 2nd Value:
 Value Percent:
 Continuous Index:
 Within 8" of Joint: **YES**
 Remarks:

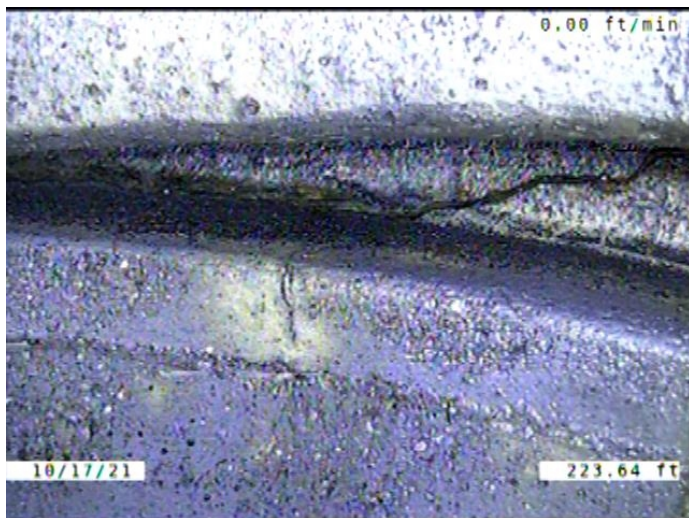
Code: **FM**
 Description: **Fracture Multiple**

Distance (ft): **223.6**
 Structural Grade: **4**
 O&M Grade: **0**
 Clock Start/From: **1**
 Clock To: **3**
 1st Value:
 2nd Value:
 Value Percent:
 Continuous Index:
 Within 8" of Joint: **YES**
 Remarks:

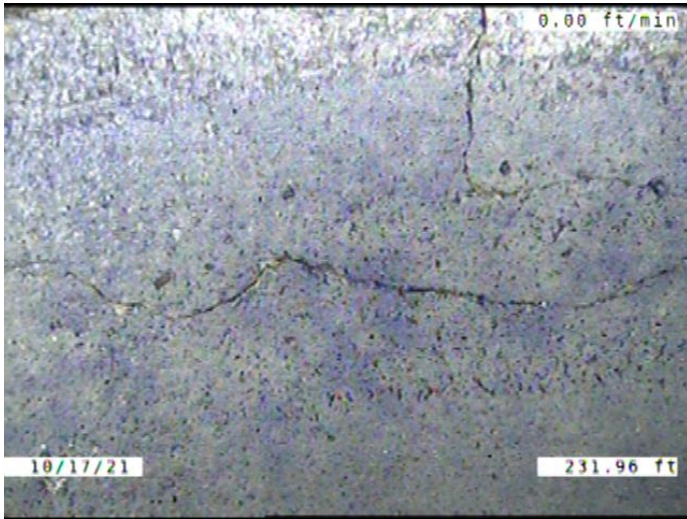
Code: **CM**
Description: **Crack Multiple**

Distance (ft): **232.0**
Structural Grade: **3**
O&M Grade: **0**
Clock Start/From: **9**
Clock To: **1**
1st Value:
2nd Value:
Value Percent:
Continuous Index:
Within 8" of Joint: **YES**
Remarks:

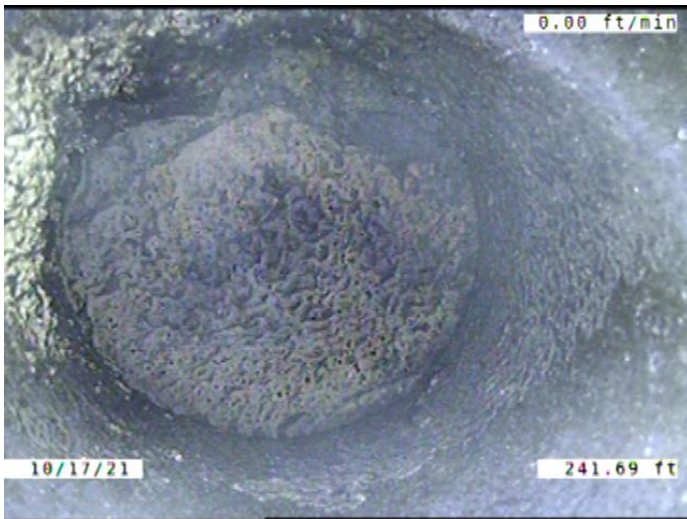
Code: **TFC**
Description: **Tap Factory Capped**

Distance (ft): **241.7**
Structural Grade: **0**
O&M Grade: **0**
Clock Start/From: **11**
Clock To:
1st Value: **4.000**
2nd Value:
Value Percent:
Continuous Index:
Within 8" of Joint: **YES**
Remarks: **ENCRUSTATION AROUND THE CAP.**

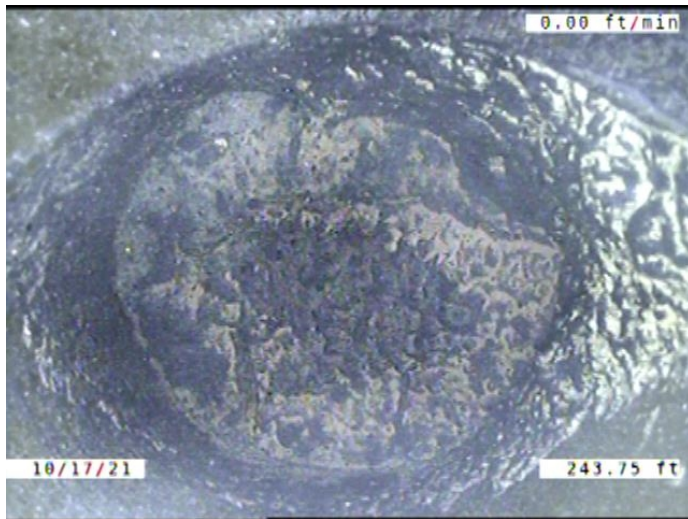
Code: **TFC**
 Description: **Tap Factory Capped**

Distance (ft): **243.7**
 Structural Grade: **0**
 O&M Grade: **0**
 Clock Start/From: **1**
 Clock To:
 1st Value: **4.000**
 2nd Value:
 Value Percent:
 Continuous Index:
 Within 8" of Joint: **YES**
 Remarks: **ENCrustATION AROUND THE CAP.**

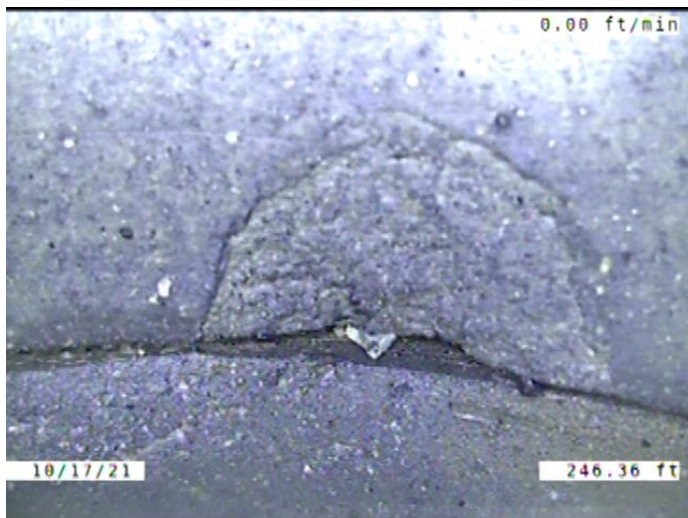
Code: **SSS**
 Description: **Surface Damage Surface Spalling**

Distance (ft): **246.4**
 Structural Grade: **2**
 O&M Grade: **0**
 Clock Start/From: **10**
 Clock To: **12**
 1st Value:
 2nd Value:
 Value Percent:
 Continuous Index:
 Within 8" of Joint: **YES**
 Remarks: **A COUPLE PIECES CHIPPED AWAY FROM THE JOINT**

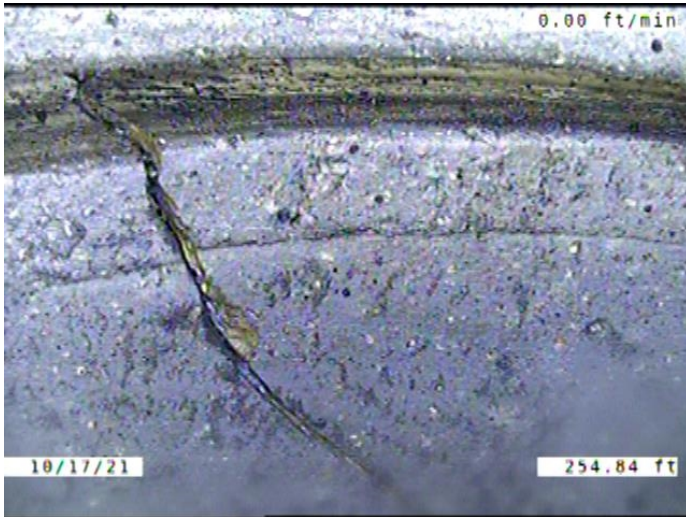
Code: **B**
 Description: **Broken**

Distance (ft): **254.8**
 Structural Grade: **4**
 O&M Grade: **0**
 Clock Start/From: **11**
 Clock To: **3**
 1st Value:
 2nd Value:
 Value Percent:
 Continuous Index:
 Within 8" of Joint: **YES**
 Remarks:

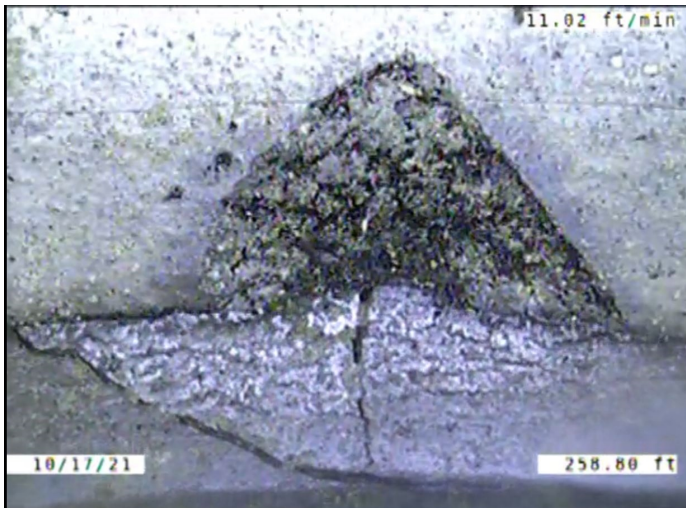
Code: **SSS**
 Description: **Surface Damage Surface Spalling**

Distance (ft): **258.8**
 Structural Grade: **2**
 O&M Grade: **0**
 Clock Start/From: **12**
 Clock To:
 1st Value:
 2nd Value:
 Value Percent:
 Continuous Index:
 Within 8" of Joint: **YES**
 Remarks:

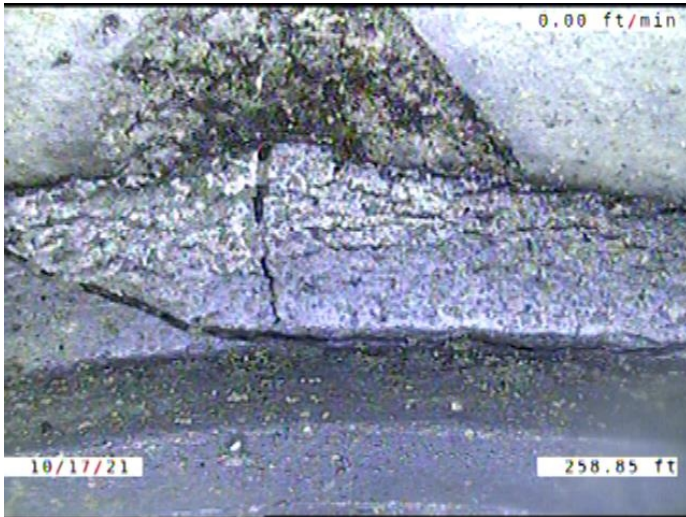
Code: **B**
Description: **Broken**

Distance (ft): **258.8**
Structural Grade: **4**
O&M Grade: **0**
Clock Start/From: **12**
Clock To: **2**
1st Value:
2nd Value:
Value Percent:
Continuous Index:
Within 8" of Joint: **YES**
Remarks:
