Profile/Photo Observation Report

Date:	04/21/2018	Weather:		Coding:	PACP 6.0
Pipe Length (ft):	306.8	Owner:	NA	Pre Clean:	Not Known
P.O.#:		Surveyor:	Nikola	PSR:	P-704-014-013
Customer:		Clean Date:	01/01/1900	Shape:	C

Street:	N MICHIGAN AVE & E HOME AVE	Flow Control:	Not Controlled
City:	Hobart, IN	Year Renewed:	
Location:	Other	Tape/Media #:	
Purpose:	Not Known	Dia/Height:	12"
Use:	Sanitary	Material:	VCP
Drain Area:	NA	Lining:	
Category:	NA		
Comment:

Location Details:		Direction of Survey:	Downstream
US MH:	M-704-014	DS MH:	M-704-013
		Total Length Surveyed (ft):	58.0

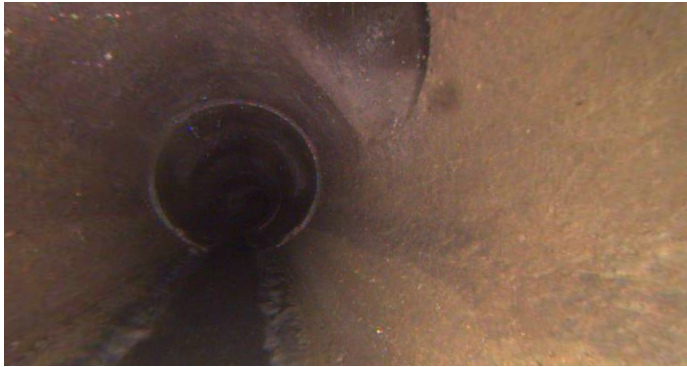
Code: **MWL**
Description: **Water Level**

Distance (ft): **.0**
Structural Grade: **0**
O&M Grade: **0**
Clock Start/From:
Clock To:
1st Value:
2nd Value:
Value Percent: **10.000**
Continuous Index:
Within 8" of Joint: **NO**
Remarks:

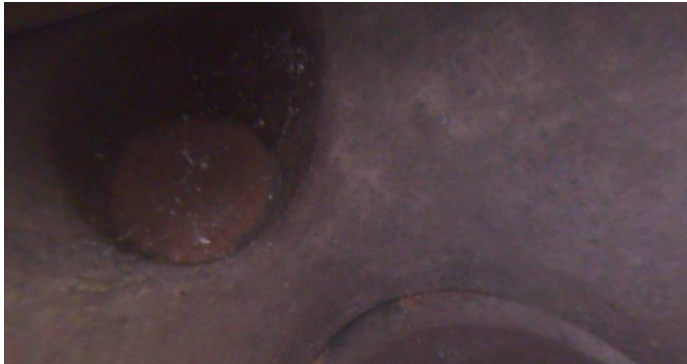
Code: **TFC**
Description: **Tap Factory Capped**

Distance (ft): **2.4**
Structural Grade: **0**
O&M Grade: **0**
Clock Start/From: **2**
Clock To:
1st Value: **4.000**
2nd Value:
Value Percent:
Continuous Index:
Within 8" of Joint:
Remarks:

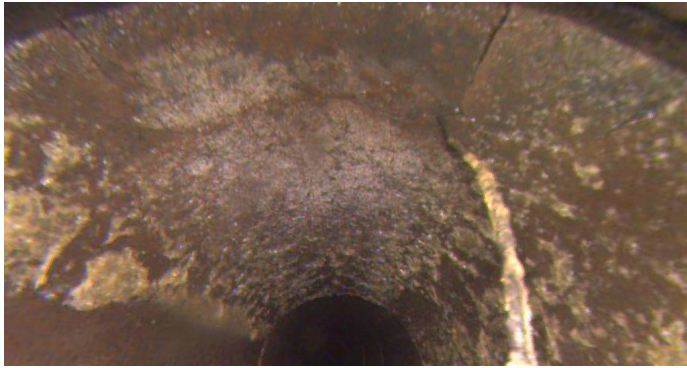
Code: **CL**
Description: **Crack Longitudinal**

Distance (ft): **9.3**
Structural Grade: **2**
O&M Grade: **0**
Clock Start/From: **1**
Clock To:
1st Value:
2nd Value:
Value Percent:
Continuous Index:
Within 8" of Joint: **YES**
Remarks:

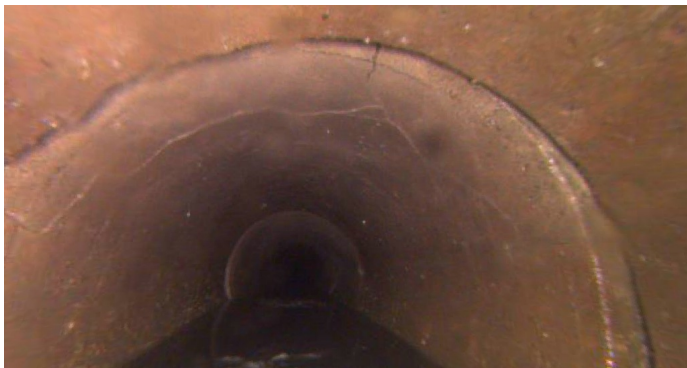
Code: **CM**
Description: **Crack Multiple**

Distance (ft): **13.3**
Structural Grade: **3**
O&M Grade: **0**
Clock Start/From: **7**
Clock To: **5**
1st Value:
2nd Value:
Value Percent:
Continuous Index:
Within 8" of Joint: **YES**
Remarks:

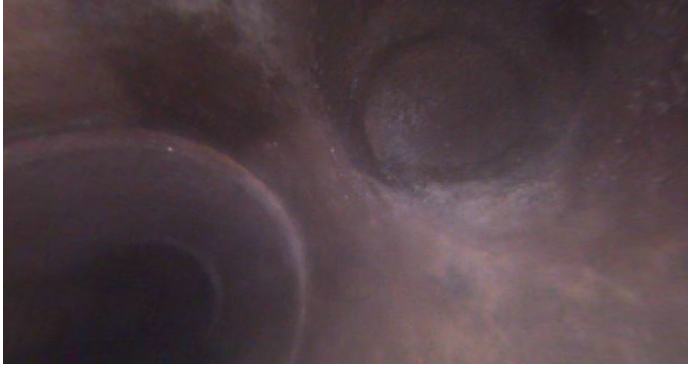
Code: **TFC**
Description: **Tap Factory Capped**

Distance (ft): **31.7**
Structural Grade: **0**
O&M Grade: **0**
Clock Start/From: **10**
Clock To:
1st Value: **4.000**
2nd Value:
Value Percent:
Continuous Index:
Within 8" of Joint:
Remarks:

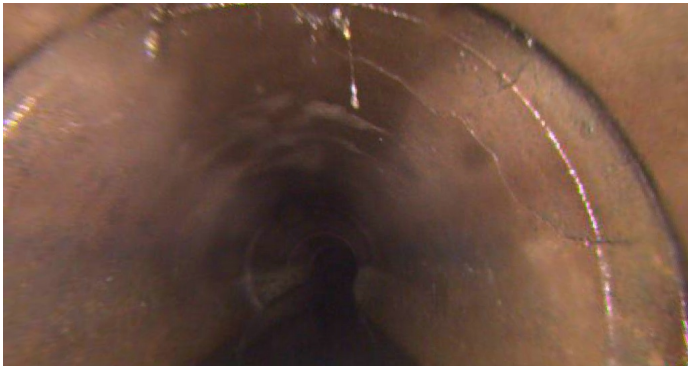
Code: **CM**
Description: **Crack Multiple**

Distance (ft): **44.6**
Structural Grade: **3**
O&M Grade: **0**
Clock Start/From: **12**
Clock To: **5**
1st Value:
2nd Value:
Value Percent:
Continuous Index:
Within 8" of Joint: **YES**
Remarks:

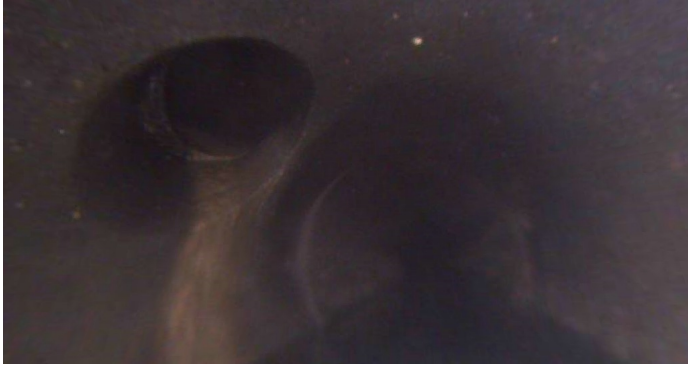
Code: **TF**
Description: **Tap Factory**

Distance (ft): **52.8**
Structural Grade: **0**
O&M Grade: **0**
Clock Start/From: **2**
Clock To:
1st Value: **4.000**
2nd Value:
Value Percent:
Continuous Index:
Within 8" of Joint:
Remarks:

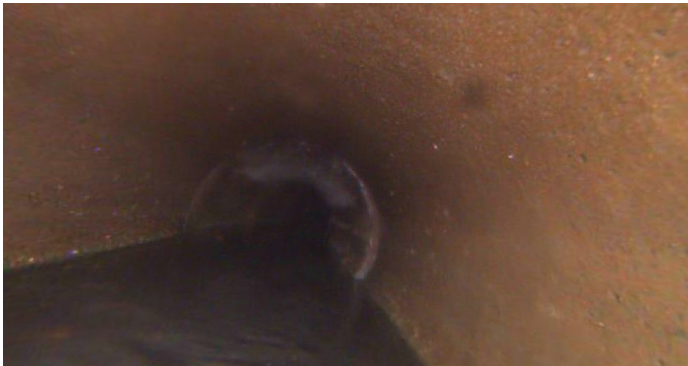
Code: **MSA**
Description: **Abandoned Survey**

Distance (ft): **58.0**
Structural Grade: **0**
O&M Grade: **0**
Clock Start/From:
Clock To:
1st Value:
2nd Value:
Value Percent:
Continuous Index:
Within 8" of Joint: **NO**
Remarks: **Debris**
