Profile/Photo Observation Report

Date:	04/21/2018	Weather:		Coding:	PACP 6.0
Pipe Length (ft):	306.8	Owner:	NA	Pre Clean:	Not Known
P.O.#:		Surveyor:	Nikola	PSR:	P-704-014-013
Customer:		Clean Date:	01/01/1900	Shape:	C

Street:	E Home Ave	Flow Control:	Not Controlled
City:	Hobart, IN	Year Renewed:	
Location:	Other	Tape/Media #:	
Purpose:	Not Known	Dia/Height:	12"
Use:	Sanitary	Material:	VCP
Drain Area:	NA	Lining:	
Category:	NA		
Comment:

Location Details:		Direction of Survey:	Downstream
US MH:	M-704-014	DS MH:	M-704-013
		Total Length Surveyed (ft):	58.0

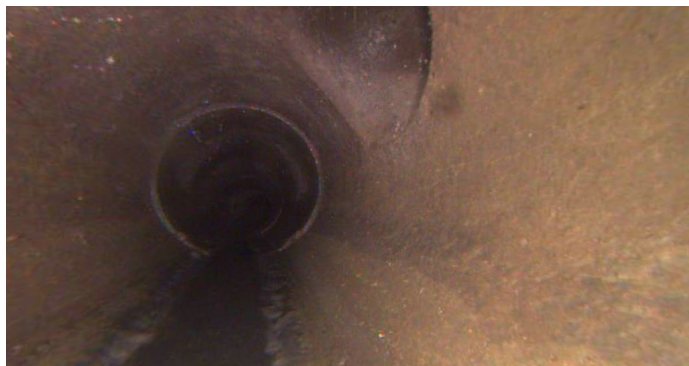
Code: **AMH**
 Description: **Manhole**

Distance (ft): **.0**
 Structural Grade: **0**
 O&M Grade: **0**
 Clock Start/From:
 Clock To:
 1st Value:
 2nd Value:
 Value Percent:
 Continuous Index:
 Within 8" of Joint: **NO**
 Remarks: **M-704-014**

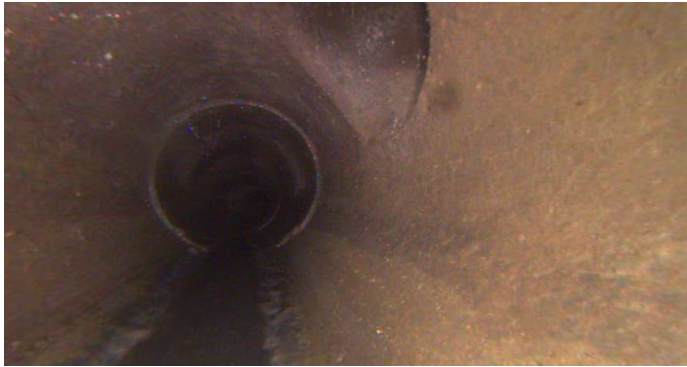
Code: **MWL**
Description: **Water Level**

Distance (ft): **.0**
Structural Grade: **0**
O&M Grade: **0**
Clock Start/From:
Clock To:
1st Value:
2nd Value:
Value Percent: **10.000**
Continuous Index:
Within 8" of Joint: **NO**
Remarks:

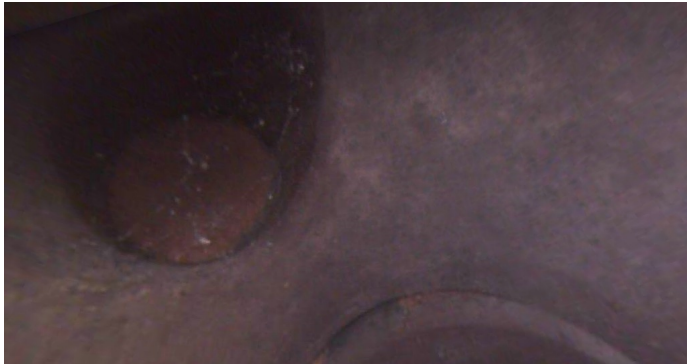
Code: **TFC**
Description: **Tap Factory Capped**

Distance (ft): **2.4**
Structural Grade: **0**
O&M Grade: **0**
Clock Start/From: **2**
Clock To:
1st Value: **4.000**
2nd Value:
Value Percent:
Continuous Index:
Within 8" of Joint:
Remarks:

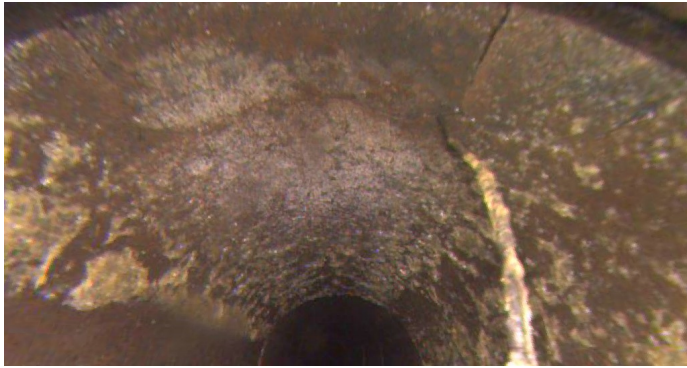
Code: **CL**
Description: **Crack Longitudinal**

Distance (ft): **9.3**
Structural Grade: **2**
O&M Grade: **0**
Clock Start/From: **1**
Clock To:
1st Value:
2nd Value:
Value Percent:
Continuous Index:
Within 8" of Joint: **YES**
Remarks:

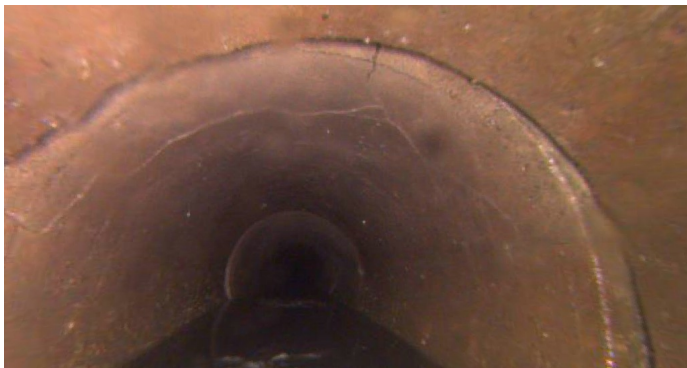
Code: **CM**
Description: **Crack Multiple**

Distance (ft): **13.3**
Structural Grade: **3**
O&M Grade: **0**
Clock Start/From: **7**
Clock To: **5**
1st Value:
2nd Value:
Value Percent:
Continuous Index:
Within 8" of Joint: **YES**
Remarks:

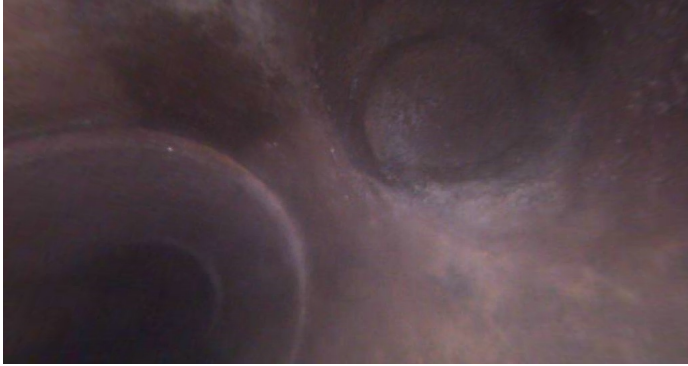
Code: **TFC**
Description: **Tap Factory Capped**

Distance (ft): **31.7**
Structural Grade: **0**
O&M Grade: **0**
Clock Start/From: **10**
Clock To:
1st Value: **4.000**
2nd Value:
Value Percent:
Continuous Index:
Within 8" of Joint:
Remarks:

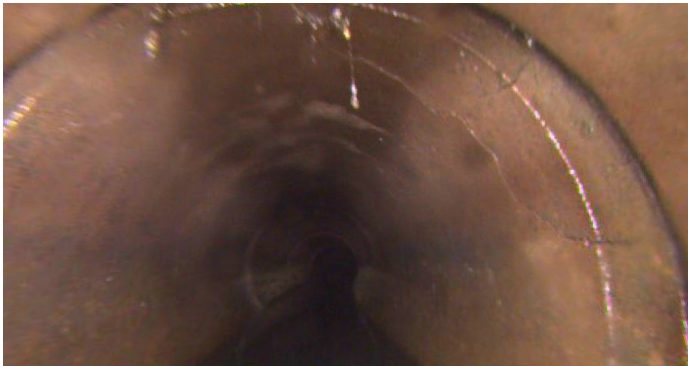
Code: **CM**
Description: **Crack Multiple**

Distance (ft): **44.6**
Structural Grade: **3**
O&M Grade: **0**
Clock Start/From: **12**
Clock To: **5**
1st Value:
2nd Value:
Value Percent:
Continuous Index:
Within 8" of Joint: **YES**
Remarks:

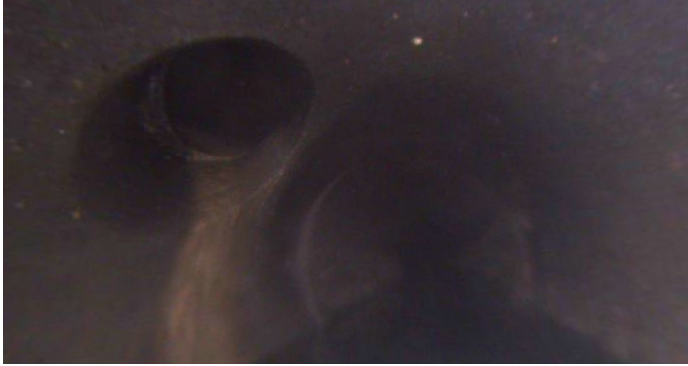
Code: **TF**
Description: **Tap Factory**

Distance (ft): **52.8**
Structural Grade: **0**
O&M Grade: **0**
Clock Start/From: **2**
Clock To:
1st Value: **4.000**
2nd Value:
Value Percent:
Continuous Index:
Within 8" of Joint:
Remarks:

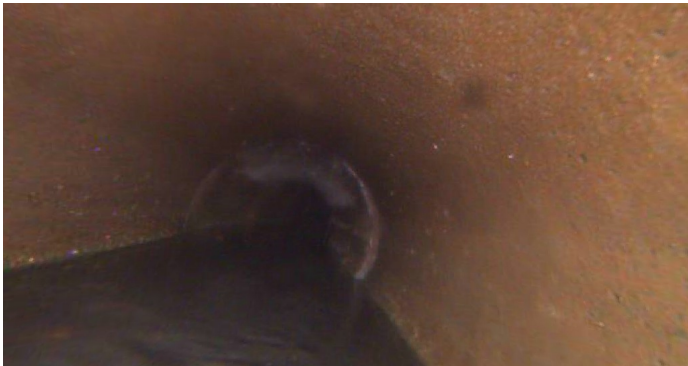
Code: **MSA**
Description: **Abandoned Survey**

Distance (ft): **58.0**
Structural Grade: **0**
O&M Grade: **0**
Clock Start/From:
Clock To:
1st Value:
2nd Value:
Value Percent:
Continuous Index:
Within 8" of Joint: **NO**
Remarks: **Debris**
