Profile/Photo Observation Report

Street:	N MICHIGAN AVE & E HOME AVE	Flow Control:	Not Controlled
City:	Hobart, IN	Year Renewed:	
Location:	Other	Tape/Media #:	
Purpose:	Not Known	Dia/Height:	8"
Use:	Sanitary	Material:	VCP
Drain Area:	NA	Lining:	Other
Category:	NA		
Comment:

Location Details:		Direction of Survey:	Upstream
US MH:	M-704-014	DS MH:	M-704-013
		Total Length Surveyed (ft):	10.6

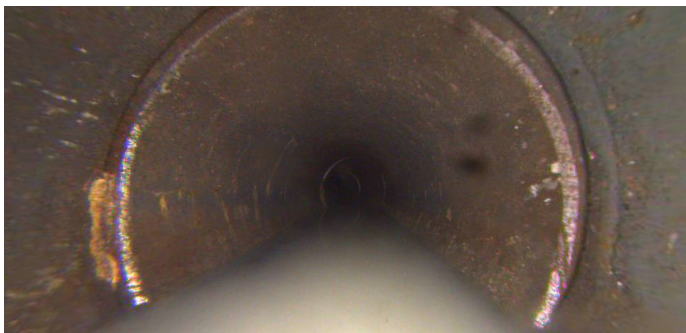
Code: **AMH**
Description: **Manhole**

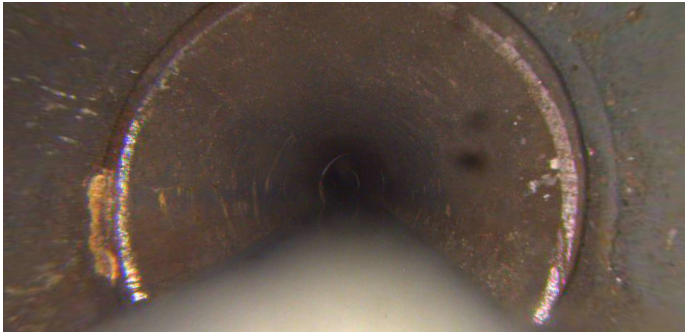
Code:	MWL
Description:	Water Level

Distance (ft):	.0
Structural Grade:	0
O&M Grade:	0
Clock Start/From:	
Clock To:	
1st Value:	
2nd Value:	
Value Percent:	10.000
Continuous Index:	
Within 8" of Joint:	NO
Remarks:

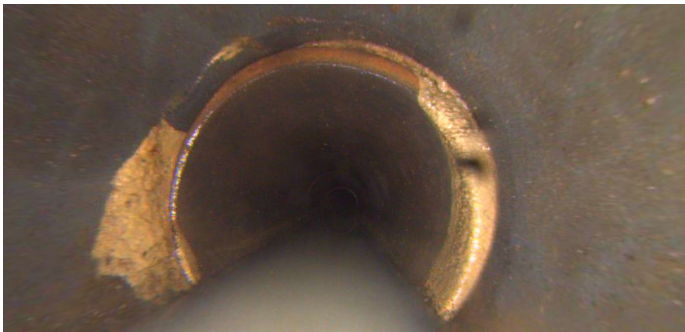
Code:	DAE
Description:	Deposits Attached Encrustation

Distance (ft):	7.4
Structural Grade:	0
O&M Grade:	2
Clock Start/From:	8
Clock To:	4
1st Value:	
2nd Value:	
Value Percent:	5.000
Continuous Index:	
Within 8" of Joint:	YES
Remarks:

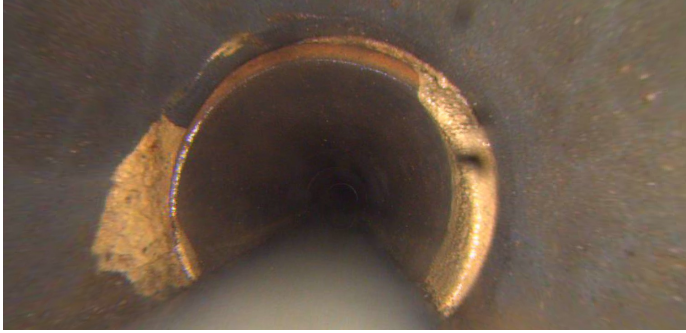
Code: **FC**
Description: **Fracture Circumferential**

Distance (ft): **7.4**
Structural Grade: **2**
O&M Grade: **0**
Clock Start/From: **10**
Clock To: **12**
1st Value:
2nd Value:
Value Percent:
Continuous Index:
Within 8" of Joint: **YES**
Remarks:

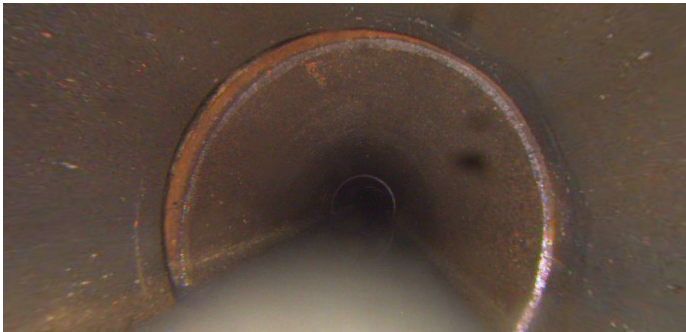
Code: **MSA**
Description: **Abandoned Survey**

Distance (ft): **10.6**
Structural Grade: **0**
O&M Grade: **0**
Clock Start/From:
Clock To:
1st Value:
2nd Value:
Value Percent:
Continuous Index:
Within 8" of Joint: **NO**
Remarks: **DEBRIS UNDER WATER**
