## Profile/Photo Observation Report

Street:	<b>N Michigan Ave</b>	Flow Control:	<b>Not Controlled</b>
City:	<b>Hobart, IN</b>	Year Renewed:	
Location:	<b>Other</b>	Tape/Media #:	
Purpose:	<b>Not Known</b>	Dia/Height:	<b>8"</b>
Use:	<b>Sanitary</b>	Material:	<b>VCP</b>
Drain Area:	<b>NA</b>	Lining:	
Category:	<b>NA</b>		
Comment:

Location Details:		Direction of Survey:	<b>Upstream</b>
US MH:	<b>M-704-014</b>	DS MH:	<b>M-704-013</b>
		Total Length Surveyed (ft):	<b>10.6</b>

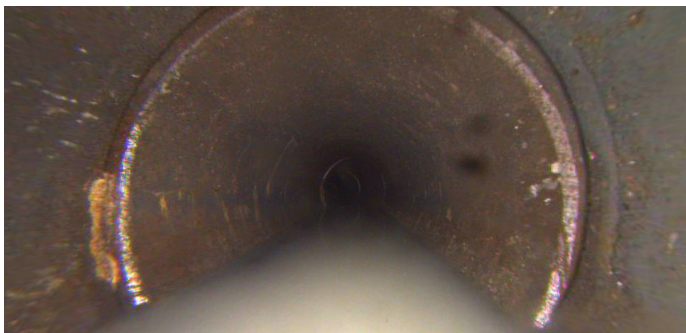
Code: **AMH**  
Description: **Manhole**

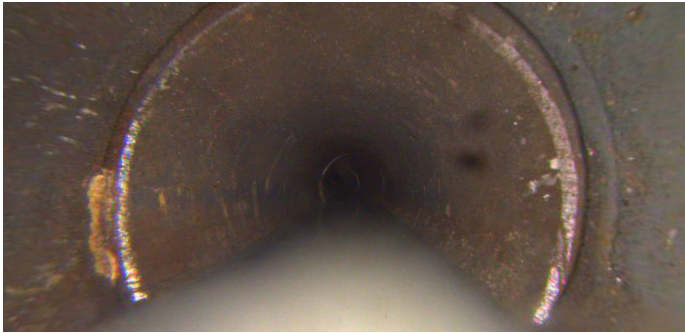
Code:	<b>MWL</b>
Description:	<b>Water Level</b>

Distance (ft):	<b>.0</b>
Structural Grade:	<b>0</b>
O&M Grade:	<b>0</b>
Clock Start/From:	
Clock To:	
1st Value:	
2nd Value:	
Value Percent:	<b>10.000</b>
Continuous Index:	
Within 8" of Joint:	<b>NO</b>
Remarks:

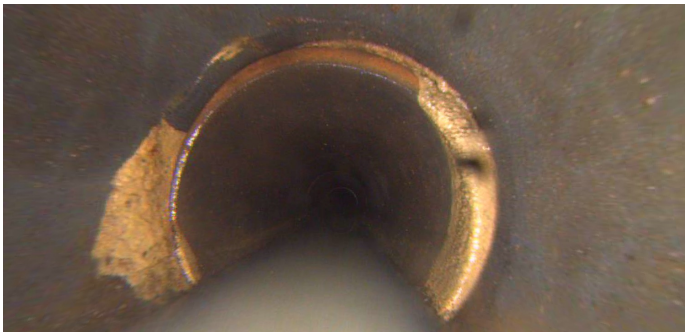
Code:	<b>DAE</b>
Description:	<b>Deposits Attached Encrustation</b>

Distance (ft):	<b>7.4</b>
Structural Grade:	<b>0</b>
O&M Grade:	<b>2</b>
Clock Start/From:	<b>8</b>
Clock To:	<b>4</b>
1st Value:	
2nd Value:	
Value Percent:	<b>5.000</b>
Continuous Index:	
Within 8" of Joint:	<b>YES</b>
Remarks:

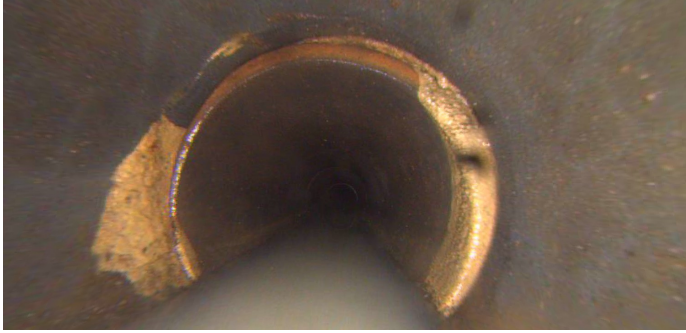
Code: **FC**  
Description: **Fracture Circumferential**

Distance (ft): **7.4**  
Structural Grade: **2**  
O&M Grade: **0**  
Clock Start/From: **10**  
Clock To: **12**  
1st Value:  
2nd Value:  
Value Percent:  
Continuous Index:  
Within 8" of Joint: **YES**  
Remarks:

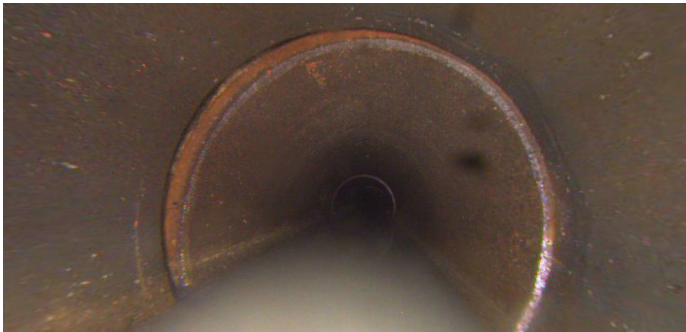
Code: **MSA**  
Description: **Abandoned Survey**

Distance (ft): **10.6**  
Structural Grade: **0**  
O&M Grade: **0**  
Clock Start/From:  
Clock To:  
1st Value:  
2nd Value:  
Value Percent:  
Continuous Index:  
Within 8" of Joint: **NO**  
Remarks: **DEBRIS UNDER WATER**
