Profile/Photo Observation Report

Customer: City of Hobart Clean Date: 10/13/2021 Shape: C

Street: North Michigan Avenue Flow Control: Not Controlled

US MH: M-704-014 DS MH: M-704-013 Total Length Surveyed (ft): 262.2

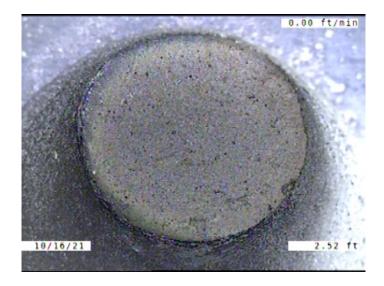
Code: TFC

Description: Tap Factory Capped

Distance (ft): 2.5
Structural Grade: 0
O&M Grade: 0
Clock Start/From: 1

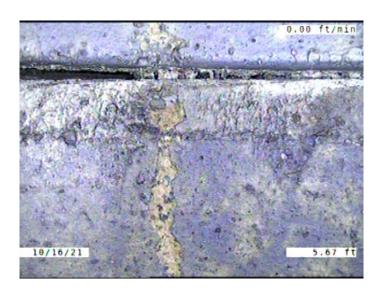
Code: SSS

Description: Surface Damage Surface Spalling

Distance (ft): 5.7
Structural Grade: 2
O&M Grade: 0
Clock Start/From: 1
Clock To:
1st Value:
2nd Value:

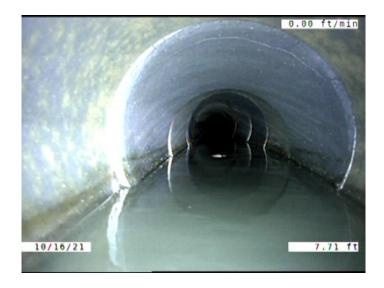
Code: MWLS

Description: Miscellaneous Water Level Sag

Distance (ft): 7.7
Structural Grade: 2
O&M Grade: 0

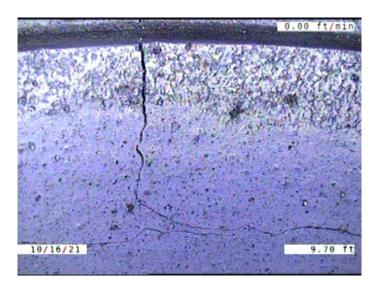
Code: FM

Description: Fracture Multiple

Distance (ft): 9.7
Structural Grade: 4

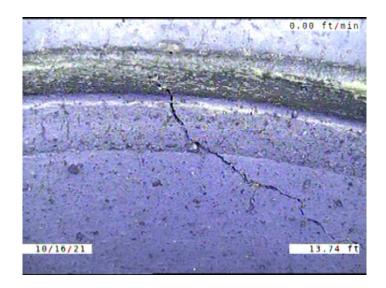
Code: FM
Description: Fracture Multiple

Distance (ft): 13.7 Structural Grade: 4 0 O&M Grade: Clock Start/From: 12 Clock To: 3 1st Value: 2nd Value: Value Percent: Continuous Index: Within 8" of Joint: YES

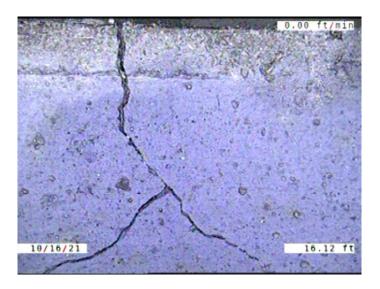
Code: **FM**

Description: Fracture Multiple

Distance (ft): 16.1 Structural Grade: 4 O&M Grade: 0 Clock Start/From: 10 2 Clock To: 1st Value: 2nd Value: Value Percent: Continuous Index: Within 8" of Joint: YES

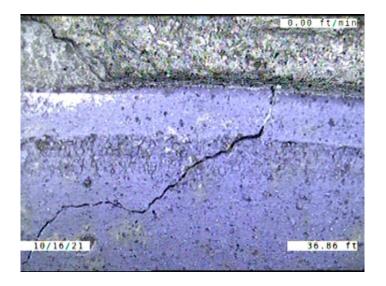
Code: **FM**

Description: Fracture Multiple

Distance (ft): 36.9
Structural Grade: 4

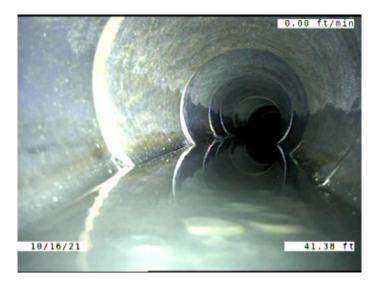
Code: **DSF**

Description: Deposits Settled Fine

Distance (ft): 41.4
Structural Grade: 0

O&M Grade: 2

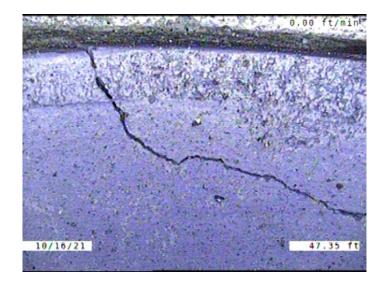
Code: Description: Broken

Distance (ft): 47.4 Structural Grade: 4 O&M Grade: 0 Clock Start/From: 12 Clock To: 3 1st Value: 2nd Value: Value Percent:

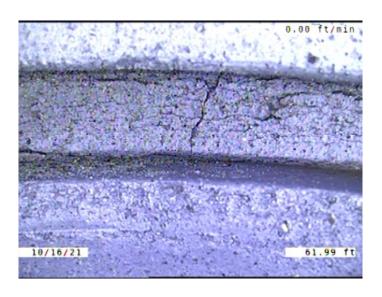
Code: JSM

Description: **Joint Separated Medium**

Distance (ft): 62.0
Structural Grade: 3
O&M Grade: 0

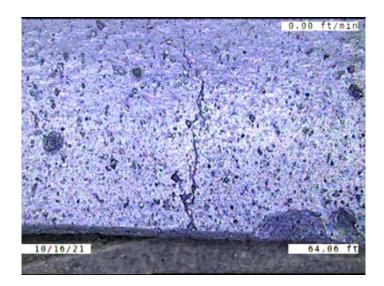
Code: CL

Description: **Crack Longitudinal**

Distance (ft): 64.1 Structural Grade: 2 O&M Grade: 0 Clock Start/From: 12

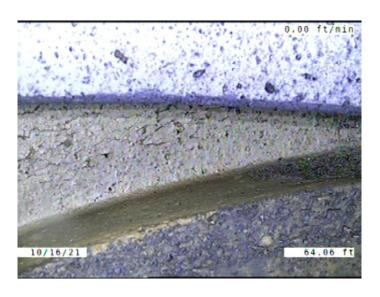
JAL Code:

Description: Joint Angular Large

Distance (ft): 64.1 Structural Grade: 4 O&M Grade: 0

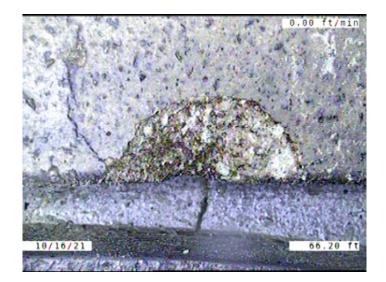
Code: SSS

Description: Surface Damage Surface Spalling

Distance (ft): 66.2
Structural Grade: 2
O&M Grade: 0
Clock Start/From: 10

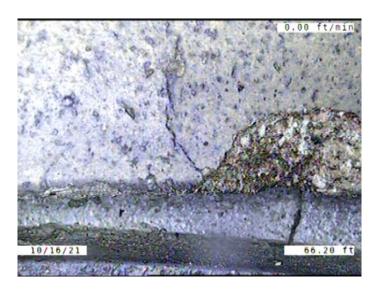
Code: CL

Description: Crack Longitudinal

Distance (ft): 66.2
Structural Grade: 2
O&M Grade: 0
Clock Start/From: 10

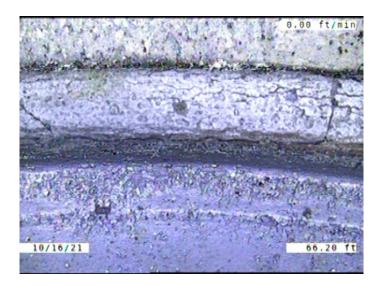
Code: CM

Description: **Crack Multiple**

Distance (ft): 66.2 Structural Grade: 3 O&M Grade: 0 Clock Start/From: 9 Clock To: 1

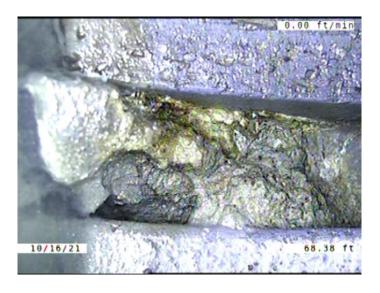
Code: DAE

Description: **Deposits Attached Encrustation**

Distance (ft): 68.4 Structural Grade: 0 O&M Grade: 2 Clock Start/From: 3 Clock To: 4 1st Value:

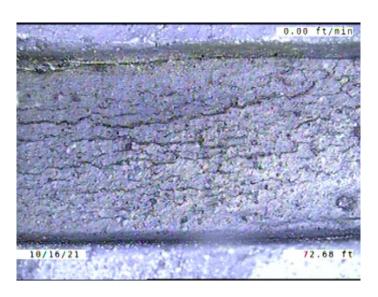
Code: JAL

Description: Joint Angular Large

Distance (ft): 72.7
Structural Grade: 4
O&M Grade: 0

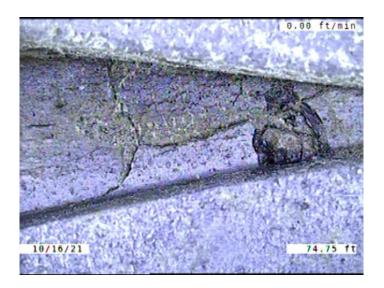
Code: CM

Description: **Crack Multiple**

Distance (ft): 74.7 Structural Grade: 3 O&M Grade: 0 Clock Start/From: 8 Clock To: 11

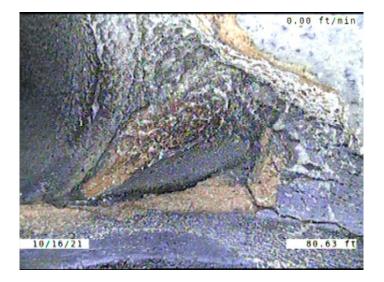
Code: B
Description: Broken

Distance (ft): 80.6
Structural Grade: 4

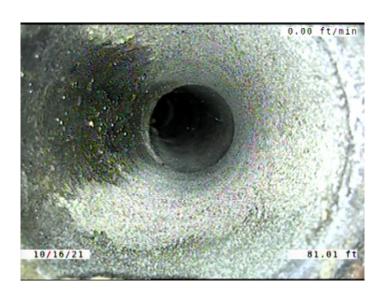
Code: TBD
Description: Tap Break-in/Hammer Defective

Distance (ft): 81.0
Structural Grade: 0
O&M Grade: 3
Clock Start/From: 10

Remarks: **Defective**

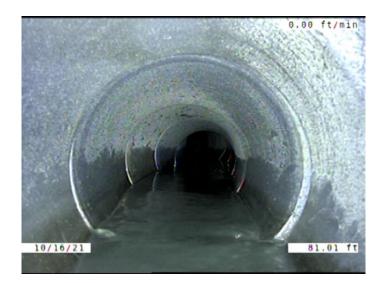
Code: JAL

Description: Joint Angular Large

Distance (ft): 81.0
Structural Grade: 4
O&M Grade: 0

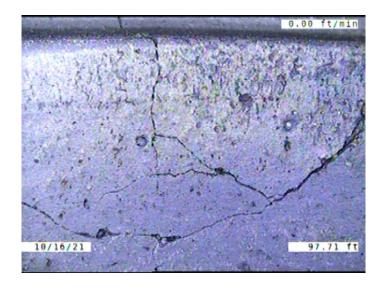
Code: FM

Description: Fracture Multiple

Distance (ft): 97.7
Structural Grade: 4
O&M Grade: 0
Clock Start/From: 9
Clock To: 1

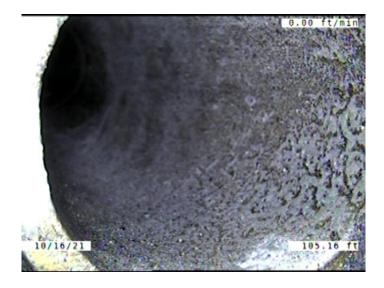
Code: TBI

Description: Tap Break-in Intruding

Distance (ft): 105.2
Structural Grade: 0
O&M Grade: 2
Clock Start/From: 11

Remarks: CONSTANTLY RUNNING WATER

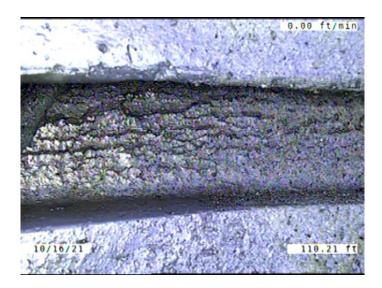
Code: JAM

Description: Joint Angular Medium

Distance (ft): 110.2
Structural Grade: 3
O&M Grade: 0

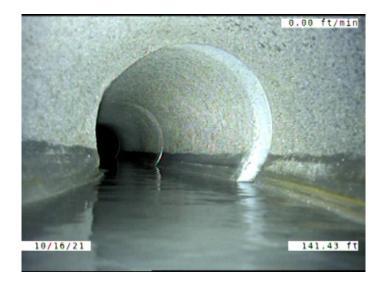
Code: SZ

Description: Surface Damage Other

Remarks: **GROOVE IN THE WALL OF THE PIPE.**

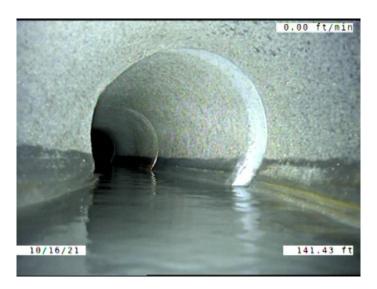
Code: SZ

Description: Surface Damage Other

Remarks: **GROOVE IN THE WALL OF THE PIPE.**

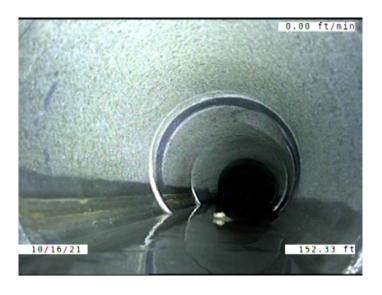
Code: SZ

Description: Surface Damage Other

Remarks: **GROOVE IN THE WALL OF THE PIPE.**

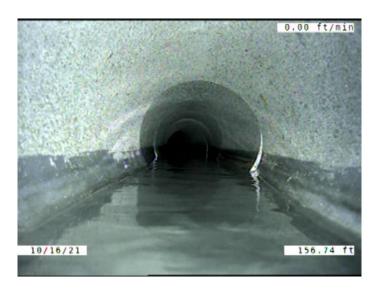
Code: SZ

Description: Surface Damage Other

Remarks: **GROOVE IN THE WALL OF THE PIPE.**

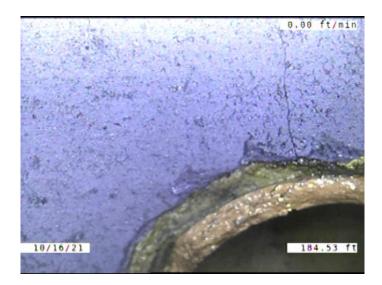
Code: CM

Description: Crack Multiple

Structural Grade: **3**O&M Grade: **0**

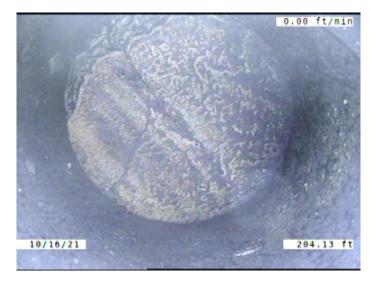
Code: **TFD**

Description: Tap Factory Defective

Remarks: CAP BROKEN

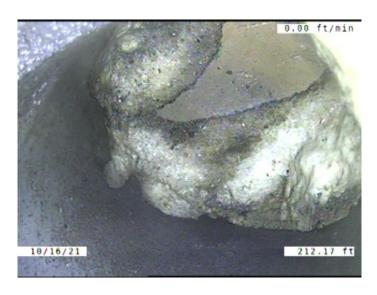
Code: **TFD**

Description: Tap Factory Defective

Remarks: **LEAKING AROUND THE CAP.**

ENCRUSTATION AROUND THE CAP

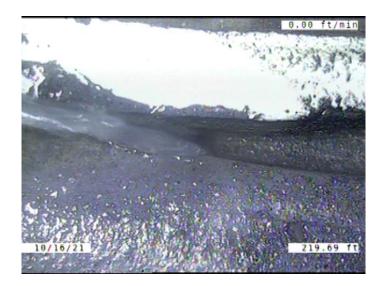
IGJ Code:

Description: **Infiltration Gusher Joint**

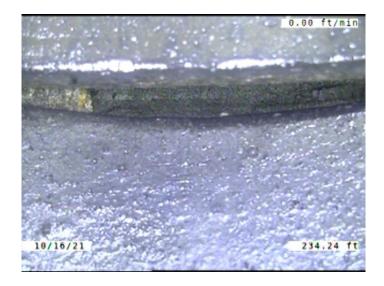
Code: JAL

Description: Joint Angular Large

Remarks: **SOIL VISIBLE**

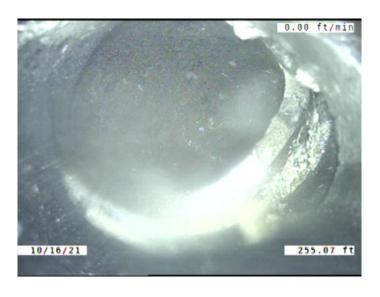
Code: **TFD**

Description: Tap Factory Defective

Remarks: **Defective**
