Street:	North Michigan Avenue		Flow Control:	Not Controlled	
City:	Hobart, IN		Year Renewed:		
Location:	Local rural streets with light traffic, t		Tape/Media #:		
Purpose:	Routine Assessment		Dia/Height:	12"	
Use:	Sanitary Sewage Pipe		Material:	VCP	
Drain Area:			Lining:		
Category:	NA				
Comment:					
Location Details:			Direction of Survey:	Downstream	
US MH:	M-704-014	DS MH:	M-704-013	Total Length Surveyed (ft):	262.2

**Thursday, December 30, 2021**

**M-704-013**

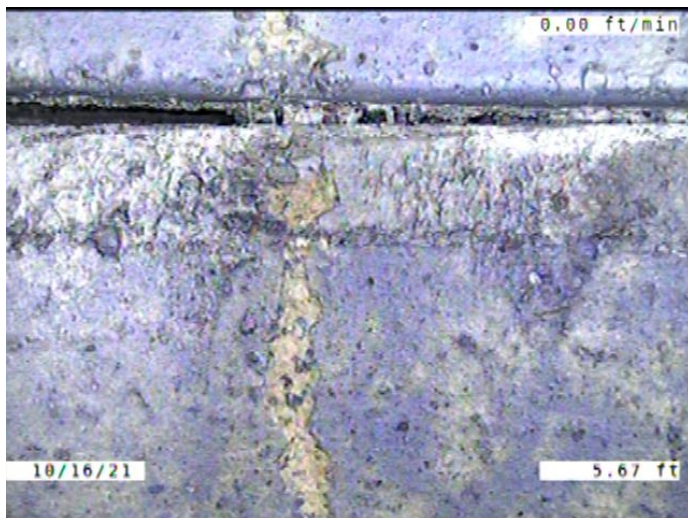
Code: **SSS**  
 Description: **Surface Damage Surface Spalling**

Distance (ft): **5.7**  
 Structural Grade: **2**  
 O&M Grade: **0**  
 Clock Start/From: **1**  
 Clock To:  
 1st Value:  
 2nd Value:  
 Value Percent:  
 Continuous Index:  
 Within 8" of Joint: **YES**  
 Remarks:

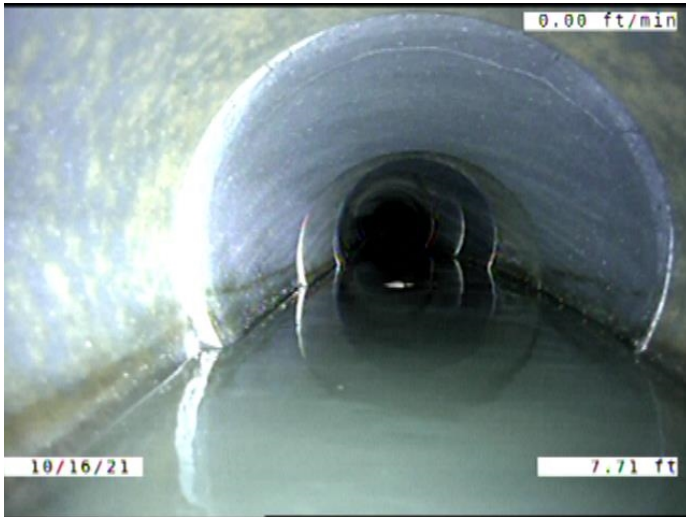
Code: **MWLS**  
 Description: **Miscellaneous Water Level Sag**

Distance (ft): **7.7**  
 Structural Grade: **2**  
 O&M Grade: **0**  
 Clock Start/From:  
 Clock To:  
 1st Value:  
 2nd Value:  
 Value Percent: **15.000**  
 Continuous Index: **S01**  
 Within 8" of Joint: **NO**  
 Remarks:

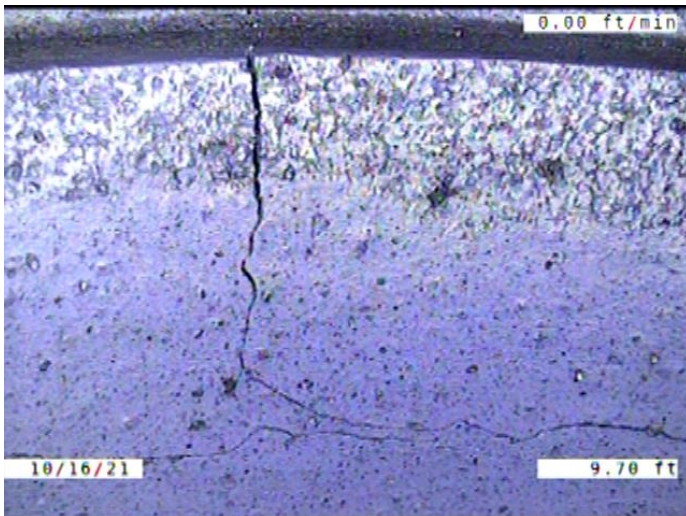
Code: **FM**  
 Description: **Fracture Multiple**

Distance (ft): **9.7**  
 Structural Grade: **4**  
 O&M Grade: **0**  
 Clock Start/From: **8**  
 Clock To: **4**  
 1st Value:  
 2nd Value:  
 Value Percent:  
 Continuous Index:  
 Within 8" of Joint: **YES**  
 Remarks:

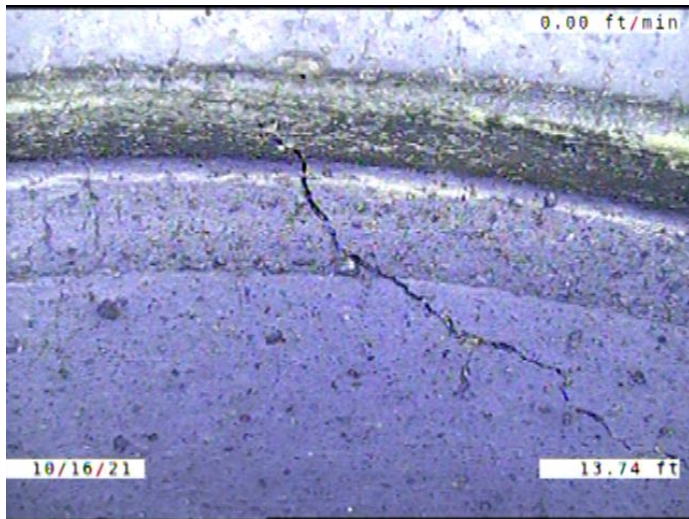
Code: **FM**  
 Description: **Fracture Multiple**

Distance (ft): **13.7**  
 Structural Grade: **4**  
 O&M Grade: **0**  
 Clock Start/From: **12**  
 Clock To: **3**  
 1st Value:  
 2nd Value:  
 Value Percent:  
 Continuous Index:  
 Within 8" of Joint: **YES**  
 Remarks:

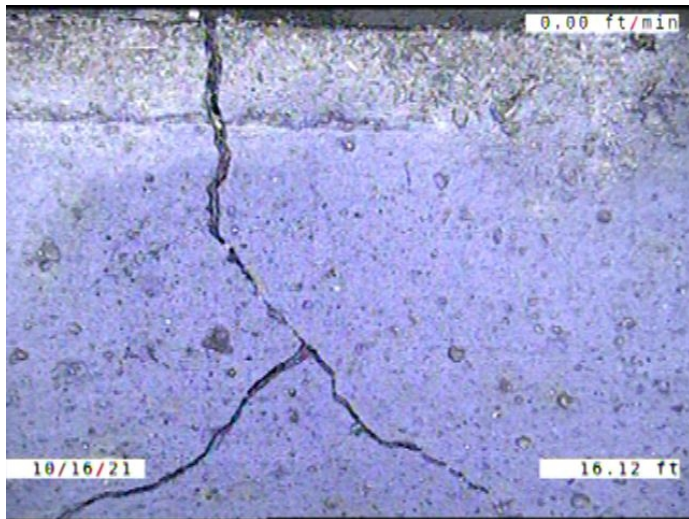
Code: **FM**  
 Description: **Fracture Multiple**

Distance (ft): **16.1**  
 Structural Grade: **4**  
 O&M Grade: **0**  
 Clock Start/From: **10**  
 Clock To: **2**  
 1st Value:  
 2nd Value:  
 Value Percent:  
 Continuous Index:  
 Within 8" of Joint: **YES**  
 Remarks:

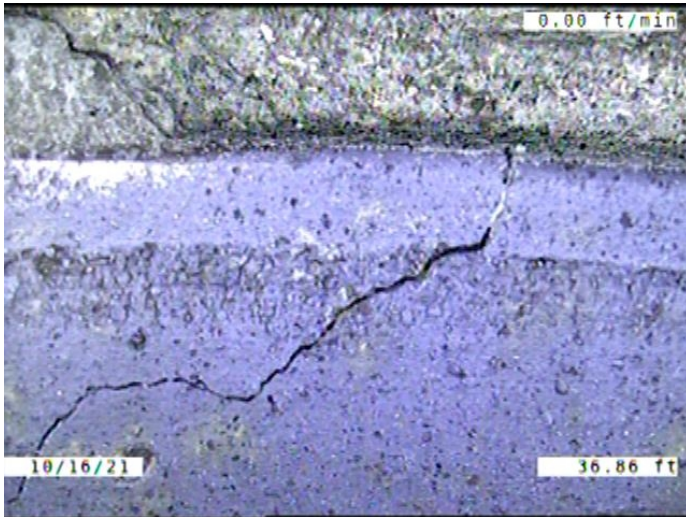
Code: **FM**  
 Description: **Fracture Multiple**

Distance (ft): **36.9**  
 Structural Grade: **4**  
 O&M Grade: **0**  
 Clock Start/From: **9**  
 Clock To: **12**  
 1st Value:  
 2nd Value:  
 Value Percent:  
 Continuous Index:  
 Within 8" of Joint: **YES**  
 Remarks:

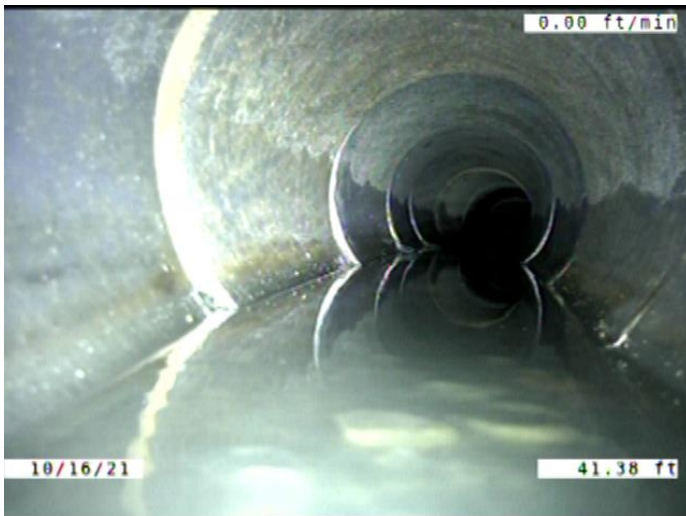
Code: **DSF**  
 Description: **Deposits Settled Fine**

Distance (ft): **41.4**  
 Structural Grade: **0**  
 O&M Grade: **2**  
 Clock Start/From: **5**  
 Clock To: **7**  
 1st Value:  
 2nd Value:  
 Value Percent: **5.000**  
 Continuous Index: **S02**  
 Within 8" of Joint: **YES**  
 Remarks:

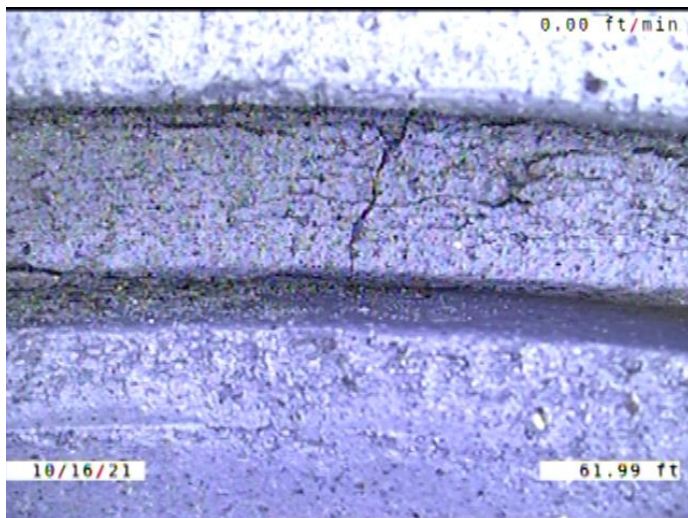
Code: **JSM**  
 Description: **Joint Separated Medium**

Distance (ft): **62.0**  
 Structural Grade: **3**  
 O&M Grade: **0**  
 Clock Start/From:  
 Clock To:  
 1st Value:  
 2nd Value:  
 Value Percent:  
 Continuous Index:  
 Within 8" of Joint: **NO**  
 Remarks:

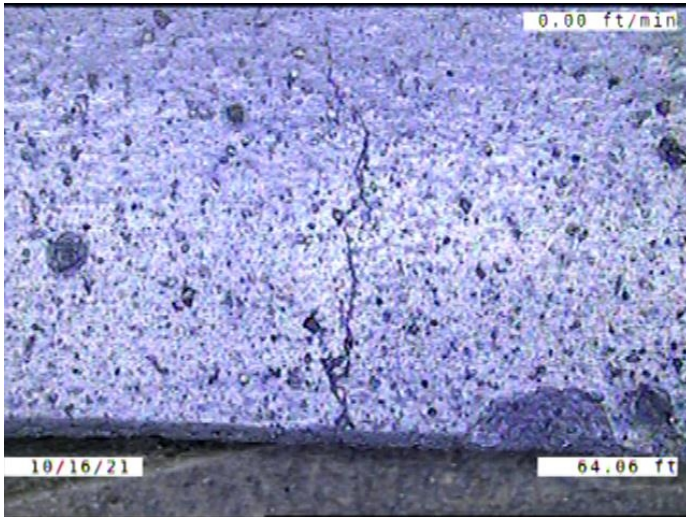
Code: **CL**  
 Description: **Crack Longitudinal**

Distance (ft): **64.1**  
 Structural Grade: **2**  
 O&M Grade: **0**  
 Clock Start/From: **12**  
 Clock To:  
 1st Value:  
 2nd Value:  
 Value Percent:  
 Continuous Index:  
 Within 8" of Joint: **YES**  
 Remarks:

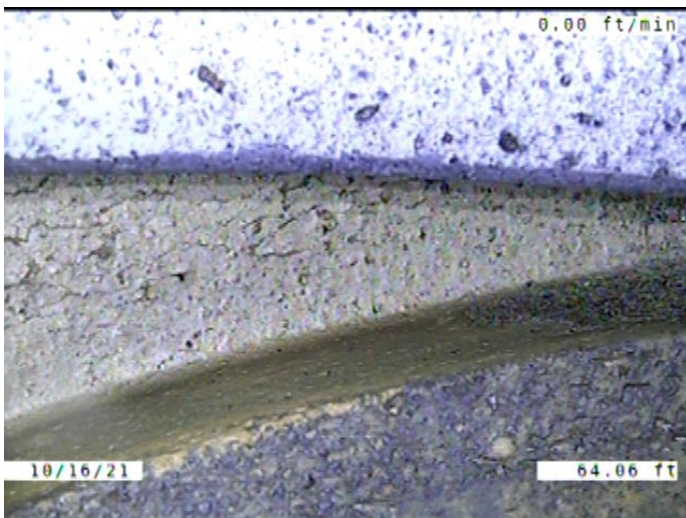
Code: **JAL**  
 Description: **Joint Angular Large**

Distance (ft): **64.1**  
 Structural Grade: **4**  
 O&M Grade: **0**  
 Clock Start/From:  
 Clock To:  
 1st Value:  
 2nd Value:  
 Value Percent:  
 Continuous Index:  
 Within 8" of Joint: **NO**  
 Remarks:

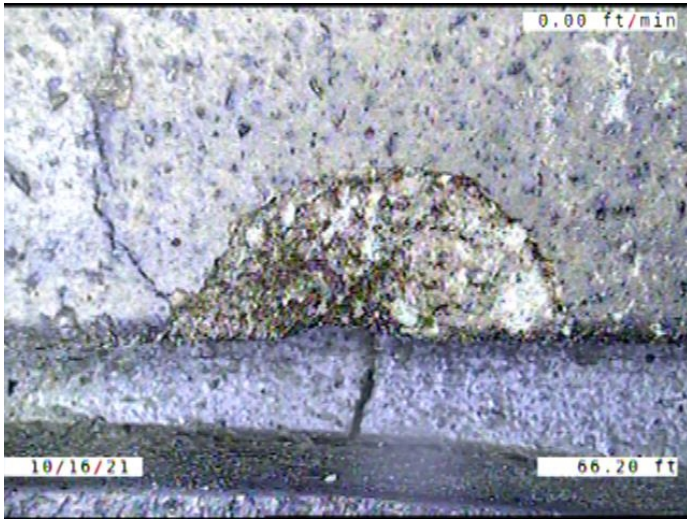
Code: **SSS**  
 Description: **Surface Damage Surface Spalling**

Distance (ft): **66.2**  
 Structural Grade: **2**  
 O&M Grade: **0**  
 Clock Start/From: **10**  
 Clock To:  
 1st Value:  
 2nd Value:  
 Value Percent:  
 Continuous Index:  
 Within 8" of Joint: **YES**  
 Remarks:

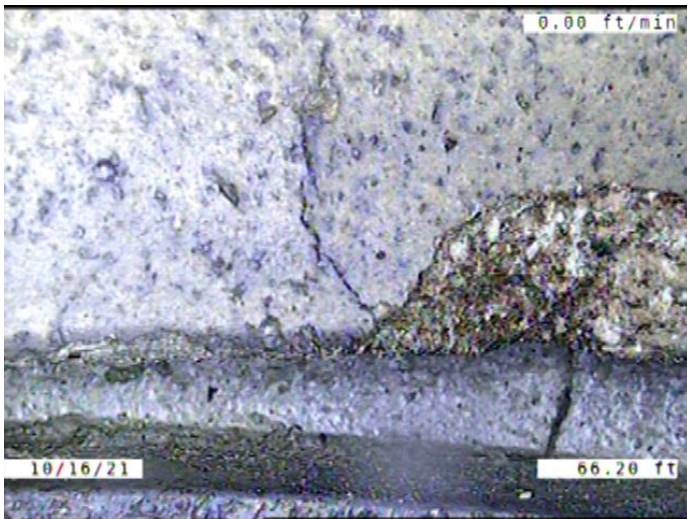
Code: **CL**  
 Description: **Crack Longitudinal**

Distance (ft): **66.2**  
 Structural Grade: **2**  
 O&M Grade: **0**  
 Clock Start/From: **10**  
 Clock To:  
 1st Value:  
 2nd Value:  
 Value Percent:  
 Continuous Index:  
 Within 8" of Joint: **YES**  
 Remarks:

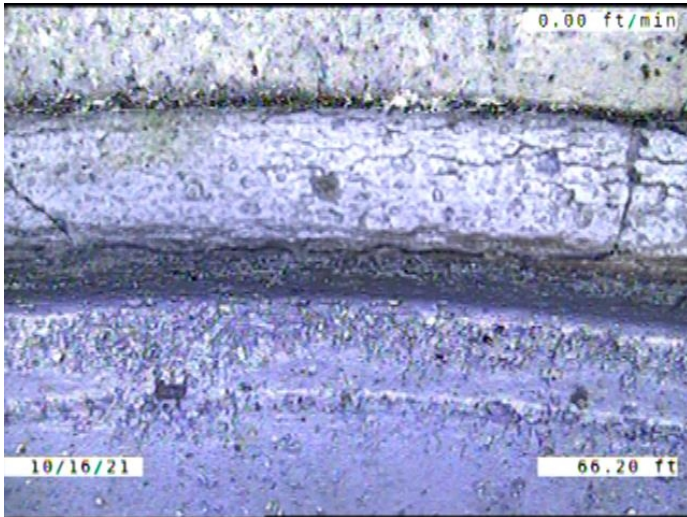
Code: **CM**  
 Description: **Crack Multiple**

Distance (ft): **66.2**  
 Structural Grade: **3**  
 O&M Grade: **0**  
 Clock Start/From: **9**  
 Clock To: **1**  
 1st Value:  
 2nd Value:  
 Value Percent:  
 Continuous Index:  
 Within 8" of Joint: **YES**  
 Remarks:

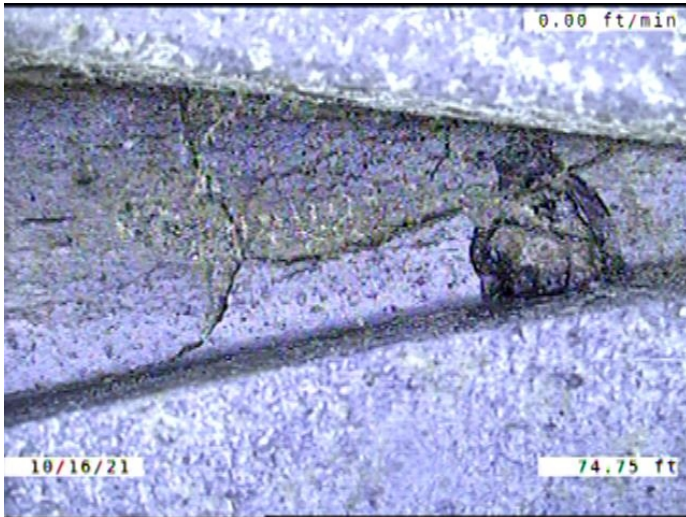
Code: **CM**  
 Description: **Crack Multiple**

Distance (ft): **74.7**  
 Structural Grade: **3**  
 O&M Grade: **0**  
 Clock Start/From: **8**  
 Clock To: **11**  
 1st Value:  
 2nd Value:  
 Value Percent:  
 Continuous Index:  
 Within 8" of Joint: **YES**  
 Remarks:

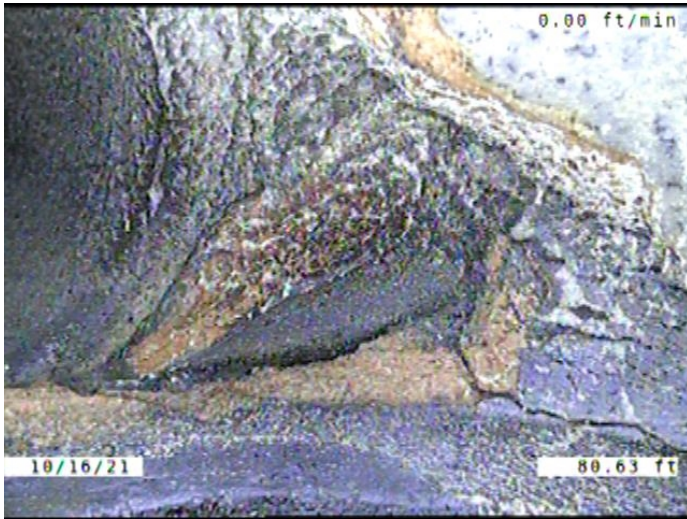
Code: **B**  
 Description: **Broken**

Distance (ft): **80.6**  
 Structural Grade: **4**  
 O&M Grade: **0**  
 Clock Start/From: **8**  
 Clock To: **2**  
 1st Value:  
 2nd Value:  
 Value Percent:  
 Continuous Index:  
 Within 8" of Joint: **YES**  
 Remarks:

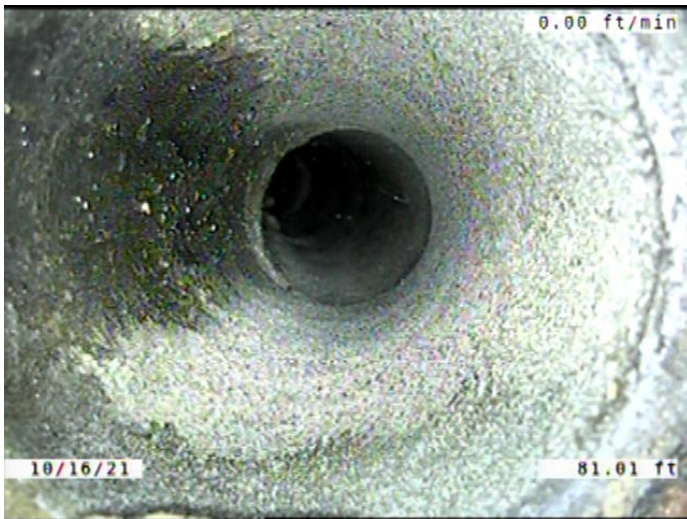
Code: **TBD**  
 Description: **Tap Break-in/Hammer Defective**

Distance (ft): **81.0**  
 Structural Grade: **0**  
 O&M Grade: **3**  
 Clock Start/From: **10**  
 Clock To:  
 1st Value: **4.000**  
 2nd Value:  
 Value Percent:  
 Continuous Index:  
 Within 8" of Joint: **YES**  
 Remarks: **Defective**

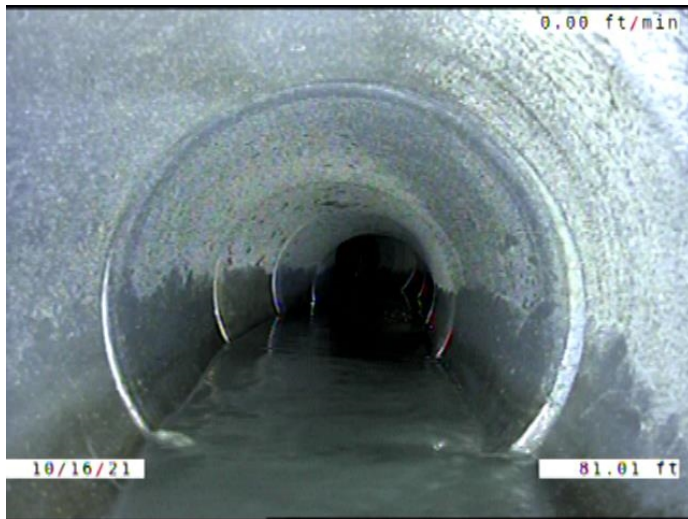
Code: **JAL**  
 Description: **Joint Angular Large**

Distance (ft): **81.0**  
 Structural Grade: **4**  
 O&M Grade: **0**  
 Clock Start/From:  
 Clock To:  
 1st Value:  
 2nd Value:  
 Value Percent:  
 Continuous Index: **F04**  
 Within 8" of Joint: **NO**  
 Remarks:

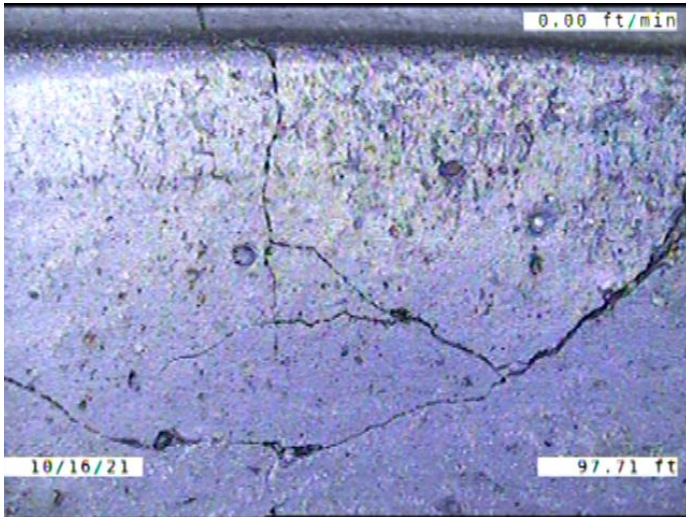
Code: **FM**  
 Description: **Fracture Multiple**

Distance (ft): **97.7**  
 Structural Grade: **4**  
 O&M Grade: **0**  
 Clock Start/From: **9**  
 Clock To: **1**  
 1st Value:  
 2nd Value:  
 Value Percent:  
 Continuous Index:  
 Within 8" of Joint: **YES**  
 Remarks:

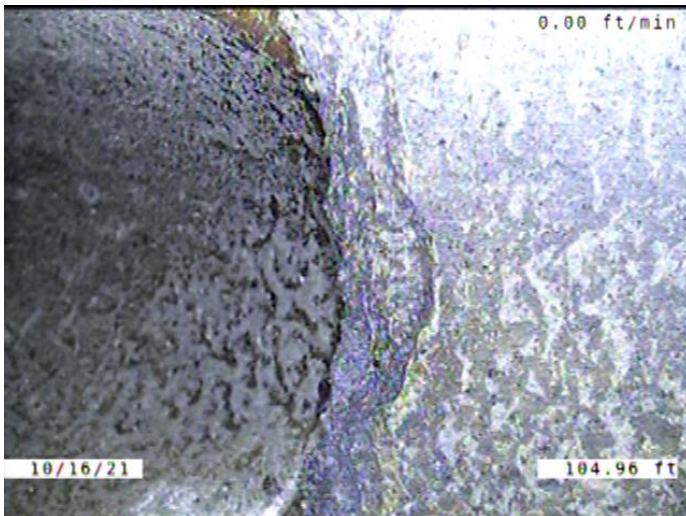
Code: **SSS**  
 Description: **Surface Damage Surface Spalling**

Distance (ft): **105.0**  
 Structural Grade: **2**  
 O&M Grade: **0**  
 Clock Start/From: **10**  
 Clock To: **12**  
 1st Value:  
 2nd Value:  
 Value Percent:  
 Continuous Index:  
 Within 8" of Joint: **YES**  
 Remarks:

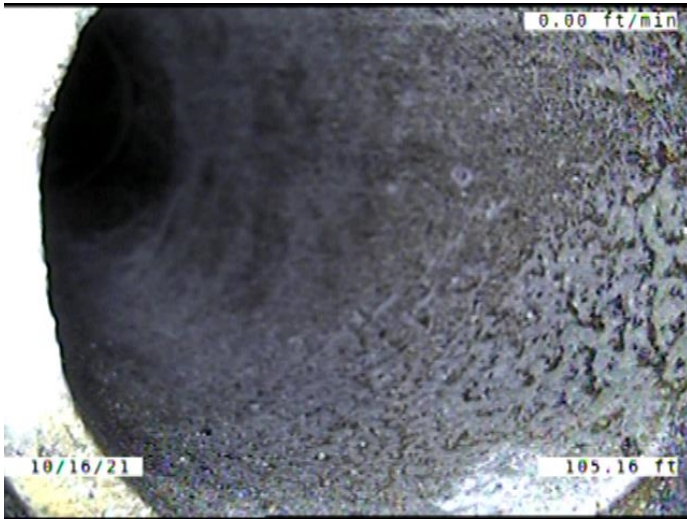
Code: **TBI**  
Description: **Tap Break-in Intruding**

Distance (ft): **105.2**  
Structural Grade: **0**  
O&M Grade: **2**  
Clock Start/From: **11**  
Clock To:  
1st Value: **4.000**  
2nd Value: **1.000**  
Value Percent:  
Continuous Index:  
Within 8" of Joint: **YES**  
Remarks: **CONSTANTLY RUNNING WATER**

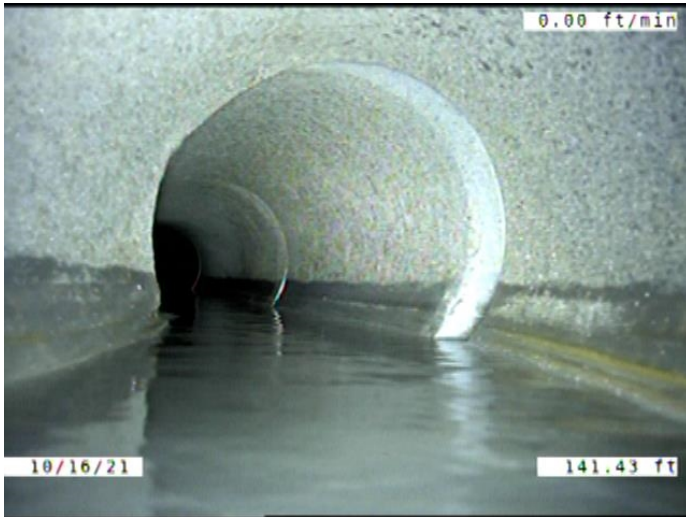
Code: **SZ**  
 Description: **Surface Damage Other**

Distance (ft): **141.4**  
 Structural Grade: **0**  
 O&M Grade: **0**  
 Clock Start/From: **4**  
 Clock To:  
 1st Value:  
 2nd Value:  
 Value Percent:  
 Continuous Index: **S06**  
 Within 8" of Joint: **YES**  
 Remarks: **GROOVE IN THE WALL OF THE PIPE.**

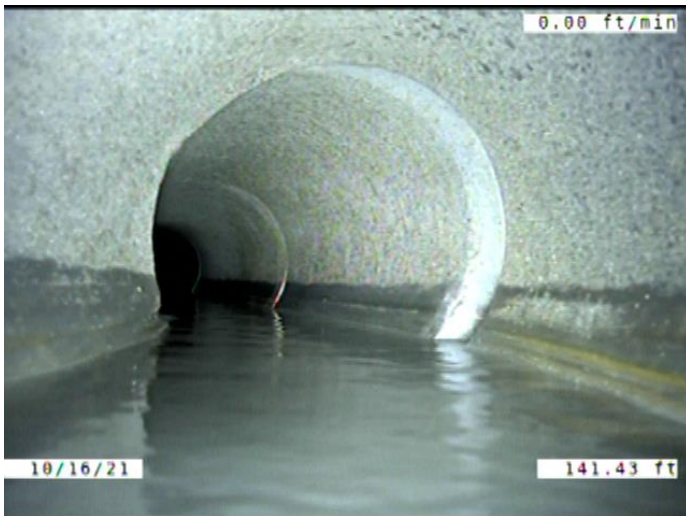
Code: **SZ**  
 Description: **Surface Damage Other**

Distance (ft): **141.4**  
 Structural Grade: **0**  
 O&M Grade: **0**  
 Clock Start/From: **8**  
 Clock To:  
 1st Value:  
 2nd Value:  
 Value Percent:  
 Continuous Index: **S07**  
 Within 8" of Joint: **YES**  
 Remarks: **GROOVE IN THE WALL OF THE PIPE.**

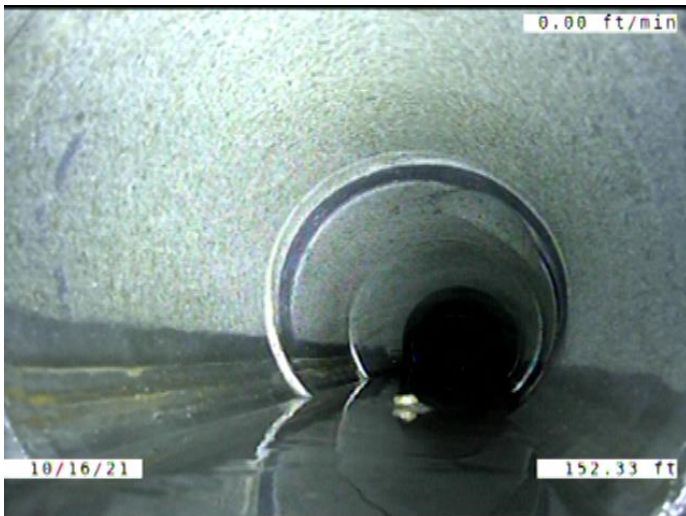
Code: **SZ**  
Description: **Surface Damage Other**

Distance (ft): **152.3**  
Structural Grade: **0**  
O&M Grade: **0**  
Clock Start/From: **4**  
Clock To:  
1st Value:  
2nd Value:  
Value Percent:  
Continuous Index: **F06**  
Within 8" of Joint: **YES**  
Remarks: **GROOVE IN THE WALL OF THE PIPE.**

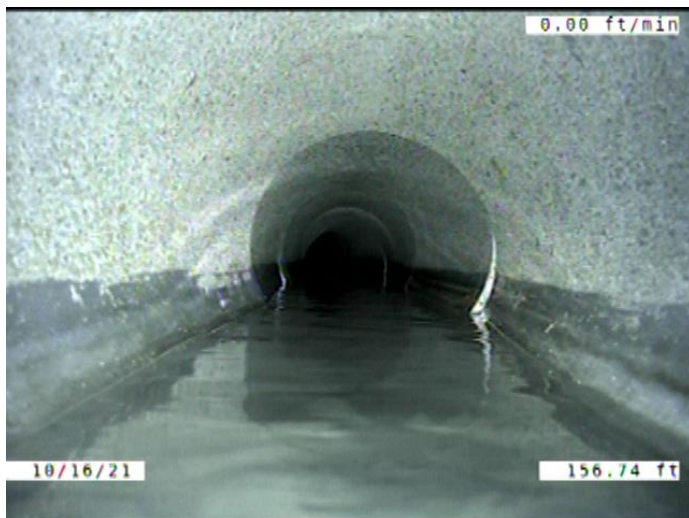
Code: **SZ**  
 Description: **Surface Damage Other**

Distance (ft): **156.7**  
 Structural Grade: **0**  
 O&M Grade: **0**  
 Clock Start/From: **8**  
 Clock To:  
 1st Value:  
 2nd Value:  
 Value Percent:  
 Continuous Index: **F07**  
 Within 8" of Joint: **YES**  
 Remarks: **GROOVE IN THE WALL OF THE PIPE.**

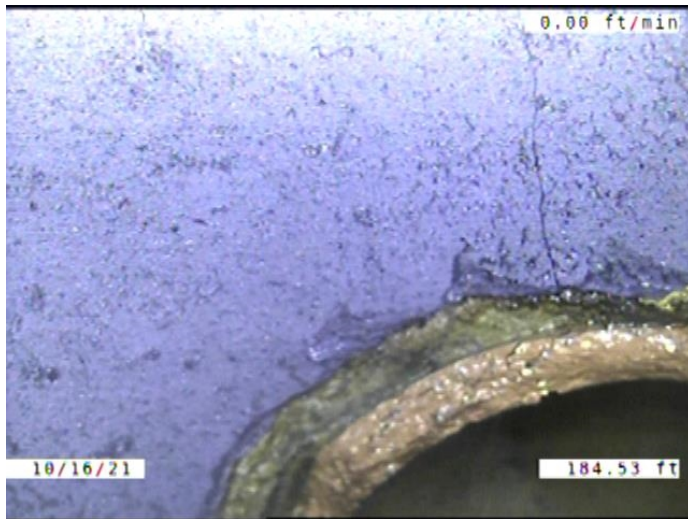
Code: **CM**  
 Description: **Crack Multiple**

Distance (ft): **184.5**  
 Structural Grade: **3**  
 O&M Grade: **0**  
 Clock Start/From: **9**  
 Clock To: **3**  
 1st Value:  
 2nd Value:  
 Value Percent:  
 Continuous Index:  
 Within 8" of Joint: **YES**  
 Remarks:

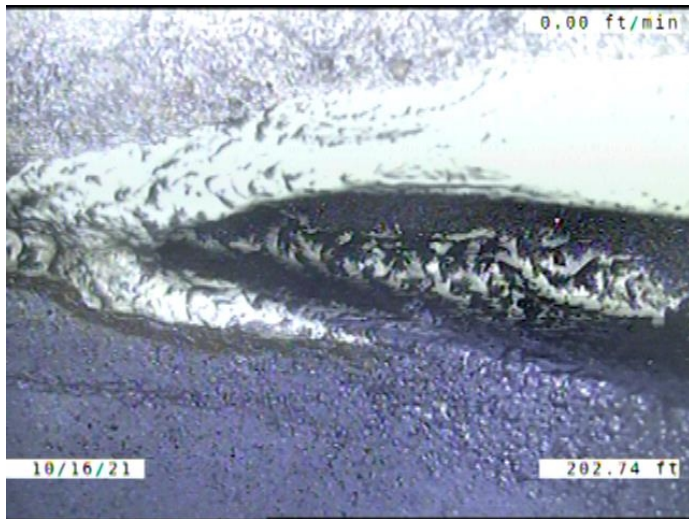
Code: **TFD**  
 Description: **Tap Factory Defective**

Distance (ft): **204.1**  
 Structural Grade: **0**  
 O&M Grade: **3**  
 Clock Start/From: **11**  
 Clock To:  
 1st Value: **4.000**  
 2nd Value:  
 Value Percent:  
 Continuous Index:  
 Within 8" of Joint: **YES**  
 Remarks: **CAP BROKEN**

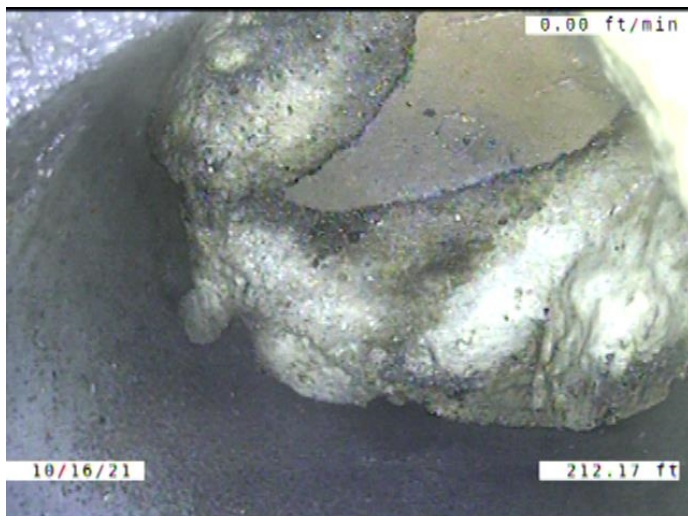
Code: **TFD**  
 Description: **Tap Factory Defective**

Distance (ft): **212.2**  
 Structural Grade: **0**  
 O&M Grade: **3**  
 Clock Start/From: **2**  
 Clock To:  
 1st Value: **4.000**  
 2nd Value:  
 Value Percent:  
 Continuous Index:  
 Within 8" of Joint: **YES**  
 Remarks: **LEAKING AROUND THE CAP.  
 ENCRUSTATION AROUND THE CAP**

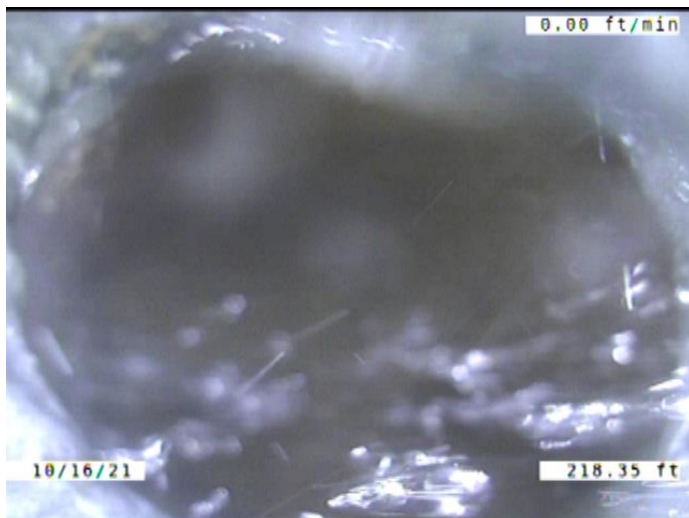
Code: **TBD**  
 Description: **Tap Break-in/Hammer Defective**

Distance (ft): **218.3**  
 Structural Grade: **0**  
 O&M Grade: **3**  
 Clock Start/From: **12**  
 Clock To:  
 1st Value: **4.000**  
 2nd Value:  
 Value Percent:  
 Continuous Index:  
 Within 8" of Joint: **YES**  
 Remarks: **Defective**

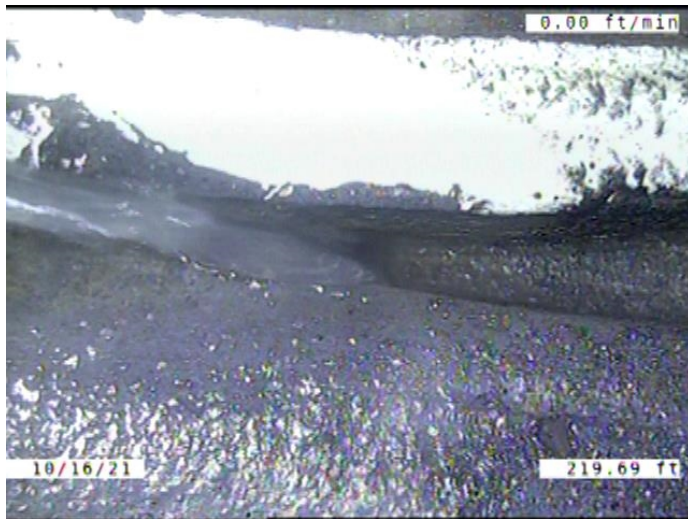
Code: **IGJ**  
 Description: **Infiltration Gusher Joint**

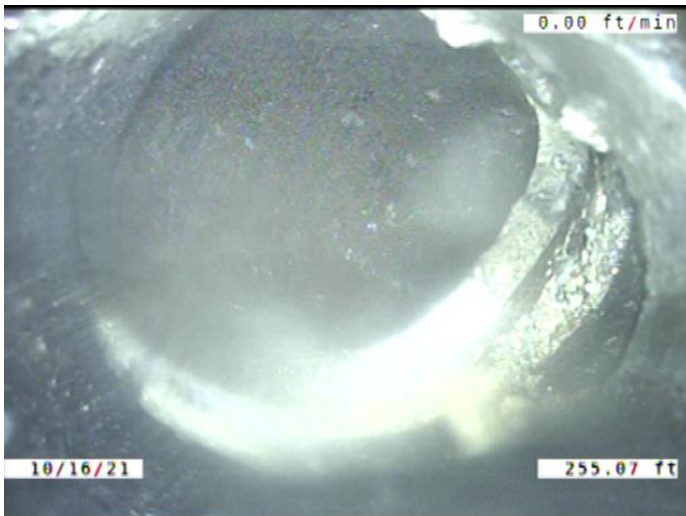
Code: **TFD**  
 Description: **Tap Factory Defective**

Distance (ft): **255.1**  
 Structural Grade: **0**  
 O&M Grade: **3**  
 Clock Start/From: **1**  
 Clock To:  
 1st Value: **4.000**  
 2nd Value:  
 Value Percent:  
 Continuous Index:  
 Within 8" of Joint: **YES**  
 Remarks: **Defective**
