Profile/Photo Observation Report

Date:	10/17/2021	Weather:		Coding:	PACP 7.0
Pipe Length (ft):	307.0	Owner:	City of Hobart	Pre Clean:	Heavy Cleaning
P.O.#:	YES502259	Surveyor:	S. Bucklin	PSR:	P-704-014-013
Customer:	City of Hobart	Clean Date:	10/13/2021	Shape:	C

Street:	North Michigan Avenue	Flow Control:	Not Controlled
City:	Hobart, IN	Year Renewed:	
Location:	Local rural streets with light traffic, t	Tape/Media #:	
Purpose:	Routine Assessment	Dia/Height:	12"
Use:	Sanitary Sewage Pipe	Material:	VCP
Drain Area:		Lining:	
Category:	NA		
Comment:			
Location Details:		Direction of Survey:	Upstream
US MH:	M-704-014	DS MH:	M-704-013
		Total Length Surveyed (ft):	45.1

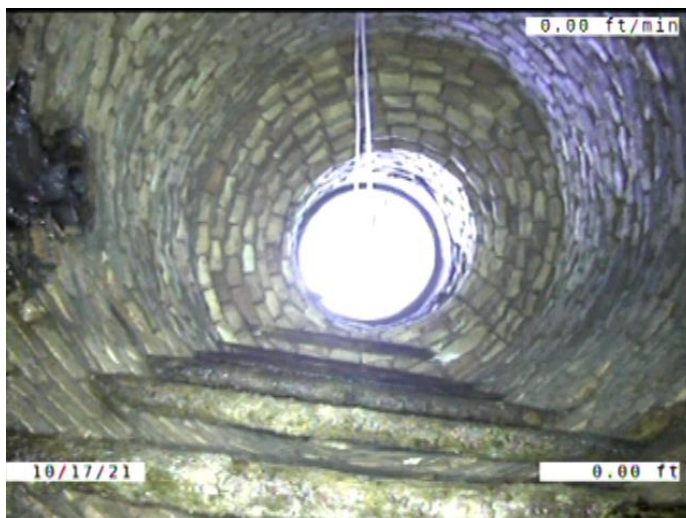
Code: **AMH**
 Description: **Manhole**

Distance (ft): **.0**
 Structural Grade: **0**
 O&M Grade: **0**
 Clock Start/From:
 Clock To:
 1st Value:
 2nd Value:
 Value Percent:
 Continuous Index:
 Within 8" of Joint: **NO**
 Remarks: **M-704-013**

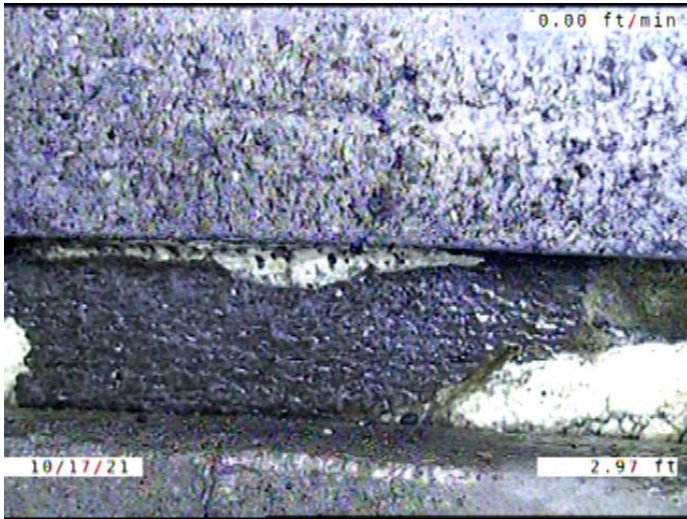
Code: **DAE**
 Description: **Deposits Attached Encrustation**

Distance (ft): **3.0**
 Structural Grade: **0**
 O&M Grade: **2**
 Clock Start/From: **2**
 Clock To: **4**
 1st Value:
 2nd Value:
 Value Percent: **5.000**
 Continuous Index:
 Within 8" of Joint: **YES**
 Remarks:

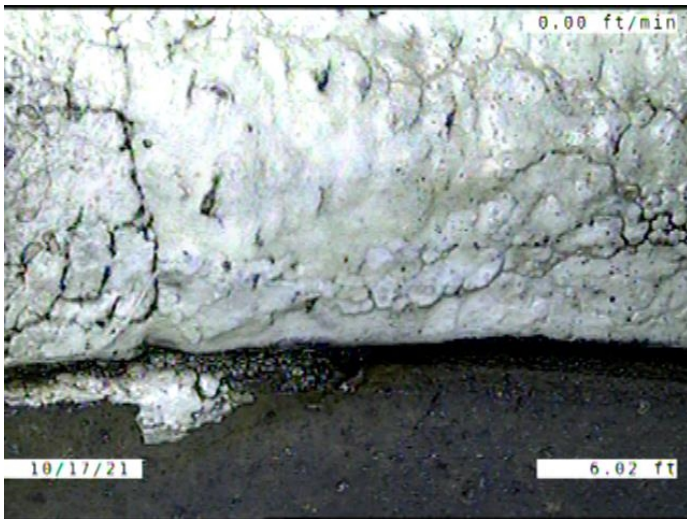
Code: **DAE**
 Description: **Deposits Attached Encrustation**

Distance (ft): **6.0**
 Structural Grade: **0**
 O&M Grade: **2**
 Clock Start/From: **8**
 Clock To: **4**
 1st Value:
 2nd Value:
 Value Percent: **5.000**
 Continuous Index:
 Within 8" of Joint: **YES**
 Remarks:

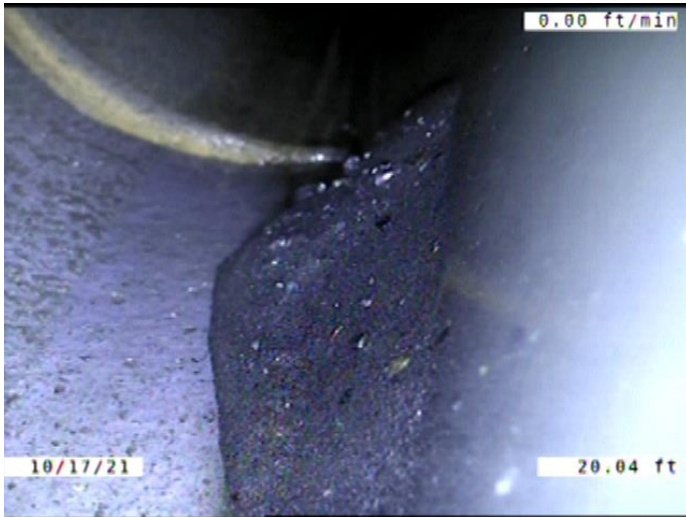
Code: **DSF**
 Description: **Deposits Settled Fine**

Distance (ft): **20.0**
 Structural Grade: **0**
 O&M Grade: **2**
 Clock Start/From: **7**
 Clock To: **8**
 1st Value:
 2nd Value:
 Value Percent: **5.000**
 Continuous Index:
 Within 8" of Joint: **YES**
 Remarks:

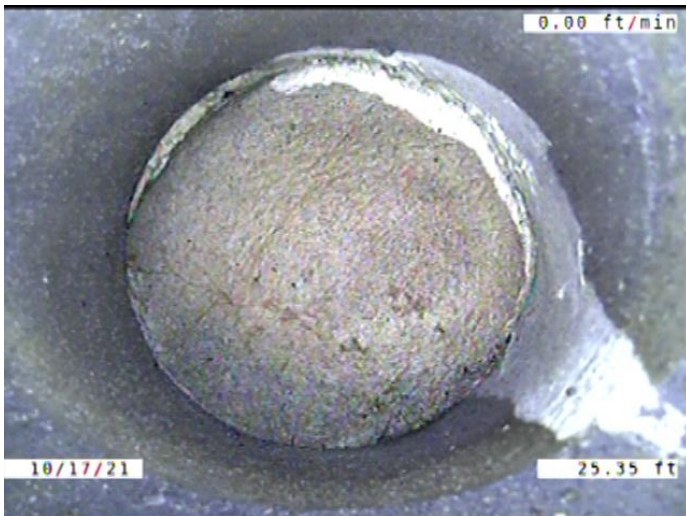
Code: **TFC**
 Description: **Tap Factory Capped**

Distance (ft): **25.4**
 Structural Grade: **0**
 O&M Grade: **0**
 Clock Start/From: **1**
 Clock To:
 1st Value: **4.000**
 2nd Value:
 Value Percent:
 Continuous Index:
 Within 8" of Joint: **YES**
 Remarks: **ENCRUSTATION AROUND THE CAP**

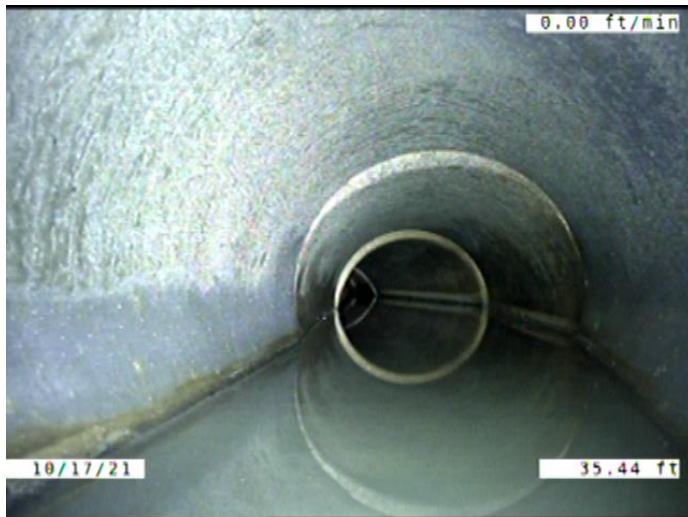
Code: **MWLS**
 Description: **Miscellaneous Water Level Sag**

Distance (ft): **35.4**
 Structural Grade: **3**
 O&M Grade: **0**
 Clock Start/From:
 Clock To:
 1st Value:
 2nd Value:
 Value Percent: **35.000**
 Continuous Index: **S02**
 Within 8" of Joint: **NO**
 Remarks:

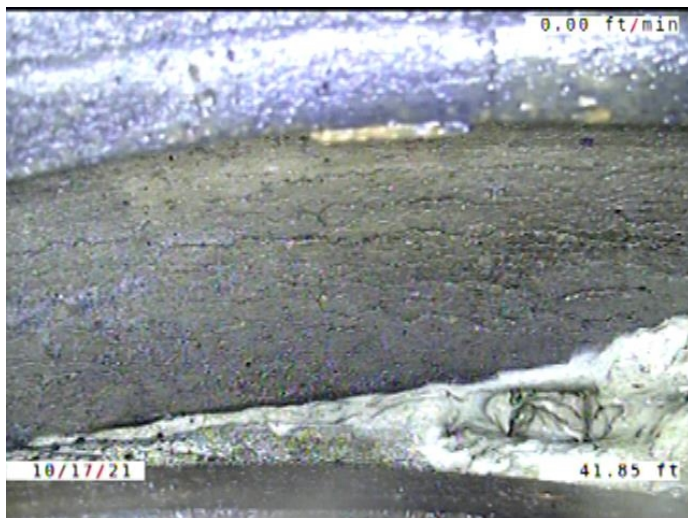
Code: **JAL**
 Description: **Joint Angular Large**

Distance (ft): **41.9**
 Structural Grade: **4**
 O&M Grade: **0**
 Clock Start/From:
 Clock To:
 1st Value:
 2nd Value:
 Value Percent:
 Continuous Index:
 Within 8" of Joint: **NO**
 Remarks:

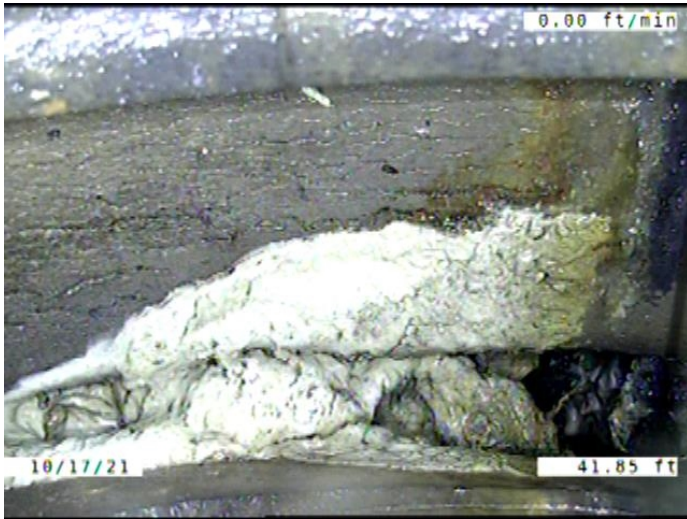
Code: **DAE**
 Description: **Deposits Attached Encrustation**

Distance (ft): **41.9**
 Structural Grade: **0**
 O&M Grade: **2**
 Clock Start/From: **12**
 Clock To: **3**
 1st Value:
 2nd Value:
 Value Percent: **5.000**
 Continuous Index:
 Within 8" of Joint: **NO**
 Remarks:

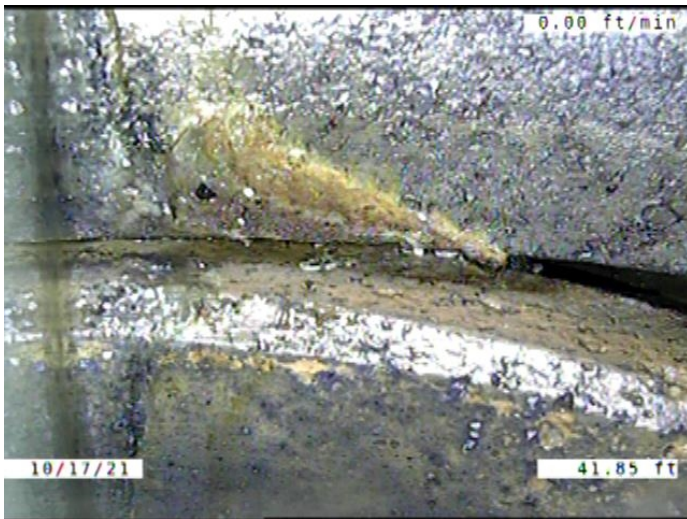
Code: **ISJ**
 Description: **Infiltration Stain Joint**

Distance (ft): **41.9**
 Structural Grade: **0**
 O&M Grade: **1**
 Clock Start/From: **9**
 Clock To: **10**
 1st Value:
 2nd Value:
 Value Percent:
 Continuous Index:
 Within 8" of Joint: **YES**
 Remarks:
