Profile/Photo Observation Report

Date:	10/17/2021	Weather:		Coding:	PACP 7.0
Pipe Length (ft):	307.0	Owner:	City of Hobart	Pre Clean:	Heavy Cleaning
P.O.#:	YES502259	Surveyor:	S. Bucklin	PSR:	P-704-014-013
Customer:	City of Hobart	Clean Date:	10/13/2021	Shape:	C

Street:	North Michigan Avenue	Flow Control:	Not Controlled
City:	Hobart, IN	Year Renewed:	
Location:	Local rural streets with light traffic, t	Tape/Media #:	
Purpose:	Routine Assessment	Dia/Height:	12"
Use:	Sanitary Sewage Pipe	Material:	VCP
Drain Area:		Lining:	
Category:	NA		
Comment:			
Location Details:		Direction of Survey:	Upstream
US MH:	M-704-014	DS MH:	M-704-013
		Total Length Surveyed (ft):	45.1

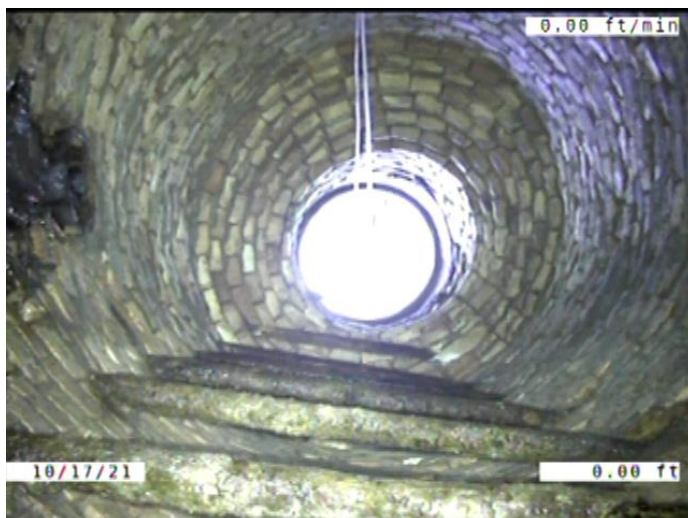
Code: **AMH**
 Description: **Manhole**

Distance (ft): **.0**
 Structural Grade: **0**
 O&M Grade: **0**
 Clock Start/From:
 Clock To:
 1st Value:
 2nd Value:
 Value Percent:
 Continuous Index:
 Within 8" of Joint: **NO**
 Remarks: **M-704-013**

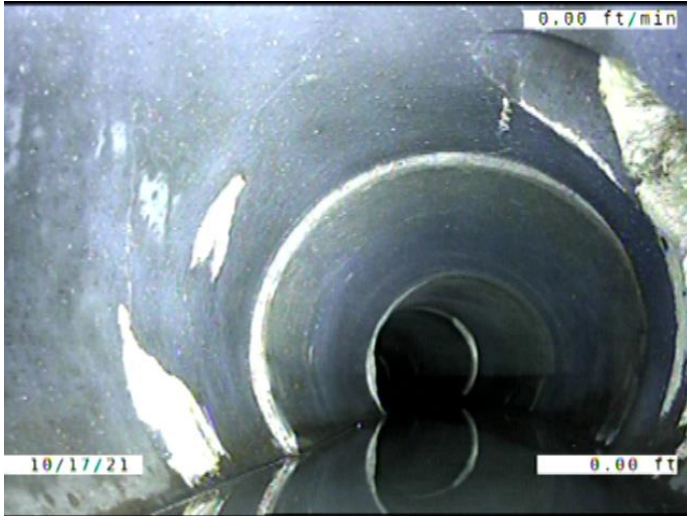
Code: **MWL**
 Description: **Miscellaneous Water Level**

Distance (ft): **.0**
 Structural Grade: **0**
 O&M Grade: **0**
 Clock Start/From:
 Clock To:
 1st Value:
 2nd Value:
 Value Percent: **10.000**
 Continuous Index:
 Within 8" of Joint: **NO**
 Remarks:

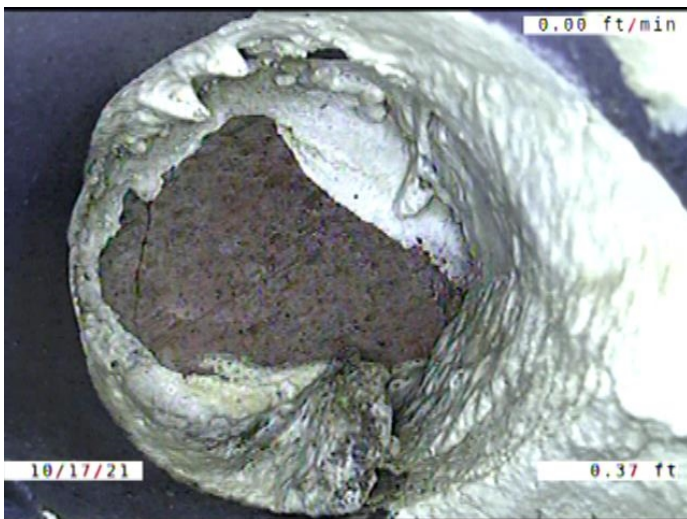
Code: **TFD**
 Description: **Tap Factory Defective**

Distance (ft): **.4**
 Structural Grade: **0**
 O&M Grade: **3**
 Clock Start/From: **2**
 Clock To:
 1st Value: **4.000**
 2nd Value:
 Value Percent:
 Continuous Index:
 Within 8" of Joint: **YES**
 Remarks: **ENCrustation AROUND THE CAP. CAP CRACKED**

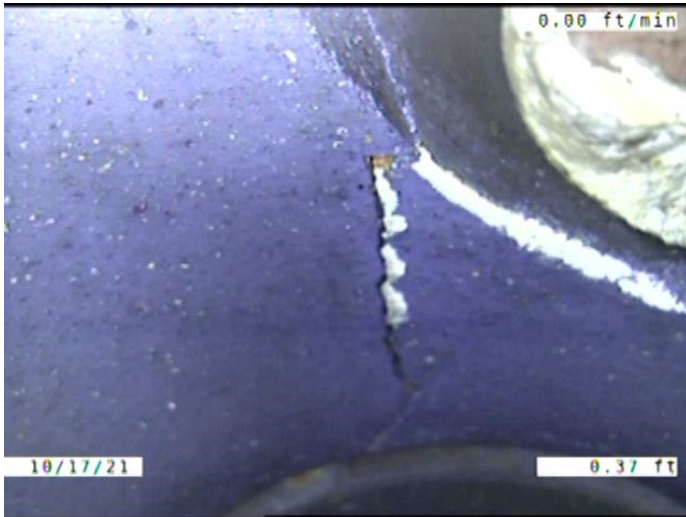
Code: **FM**
 Description: **Fracture Multiple**

Distance (ft): **.4**
 Structural Grade: **4**
 O&M Grade: **0**
 Clock Start/From: **8**
 Clock To: **3**
 1st Value:
 2nd Value:
 Value Percent:
 Continuous Index:
 Within 8" of Joint: **YES**
 Remarks:

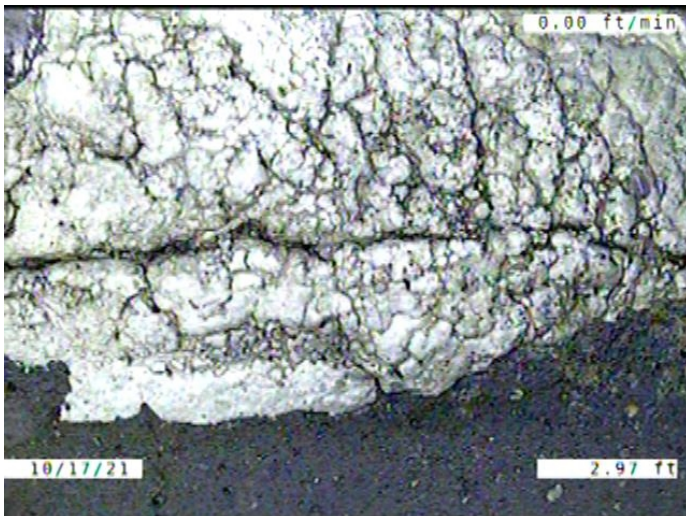
Code: **DAE**
 Description: **Deposits Attached Encrustation**

Distance (ft): **3.0**
 Structural Grade: **0**
 O&M Grade: **2**
 Clock Start/From: **8**
 Clock To: **10**
 1st Value:
 2nd Value:
 Value Percent: **5.000**
 Continuous Index:
 Within 8" of Joint: **YES**
 Remarks:

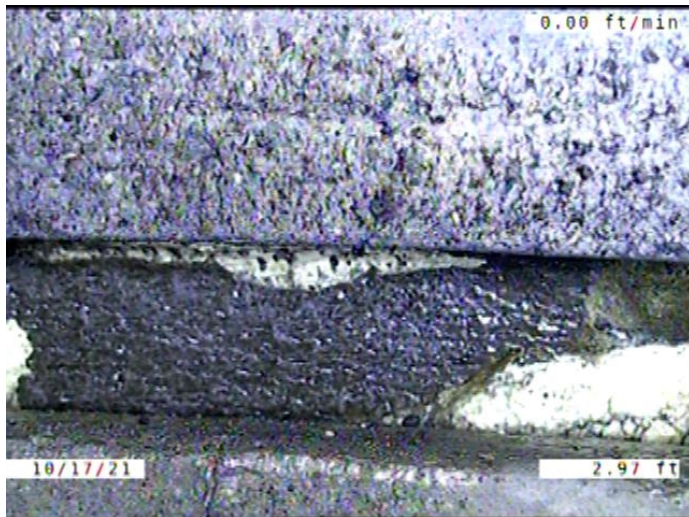
Code: **DAE**
 Description: **Deposits Attached Encrustation**

Distance (ft): **3.0**
 Structural Grade: **0**
 O&M Grade: **2**
 Clock Start/From: **2**
 Clock To: **4**
 1st Value:
 2nd Value:
 Value Percent: **5.000**
 Continuous Index:
 Within 8" of Joint: **YES**
 Remarks:

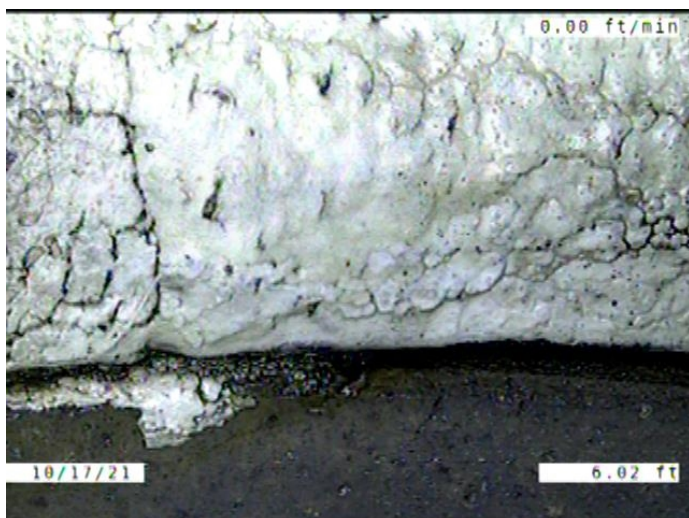
Code: **DAE**
 Description: **Deposits Attached Encrustation**

Distance (ft): **6.0**
 Structural Grade: **0**
 O&M Grade: **2**
 Clock Start/From: **8**
 Clock To: **4**
 1st Value:
 2nd Value:
 Value Percent: **5.000**
 Continuous Index:
 Within 8" of Joint: **YES**
 Remarks:

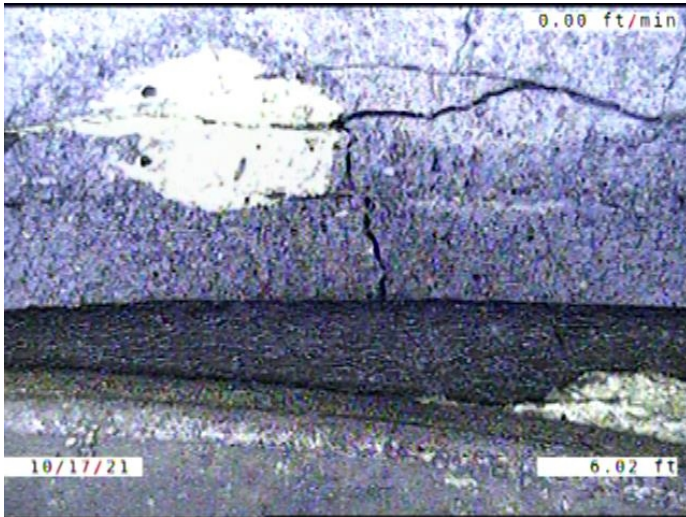
Code: **FM**
 Description: **Fracture Multiple**

Distance (ft): **6.0**
 Structural Grade: **4**
 O&M Grade: **0**
 Clock Start/From: **10**
 Clock To: **1**
 1st Value:
 2nd Value:
 Value Percent:
 Continuous Index:
 Within 8" of Joint: **YES**
 Remarks:

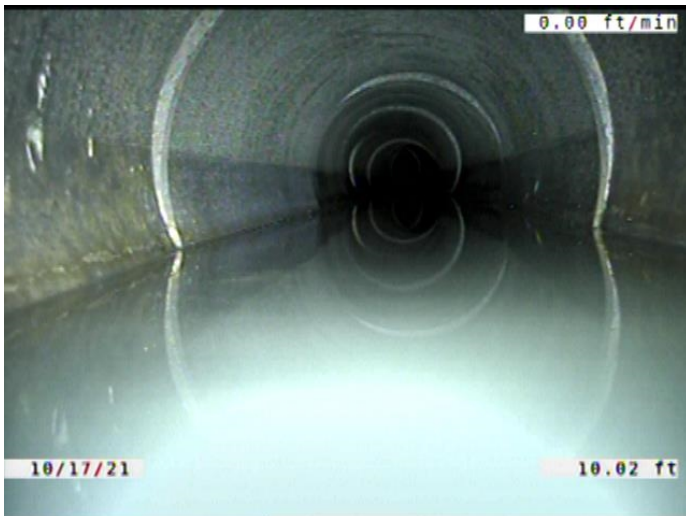
Code: **MWLS**
 Description: **Miscellaneous Water Level Sag**

Distance (ft): **10.0**
 Structural Grade: **2**
 O&M Grade: **0**
 Clock Start/From:
 Clock To:
 1st Value:
 2nd Value:
 Value Percent: **15.000**
 Continuous Index: **S01**
 Within 8" of Joint: **NO**
 Remarks:

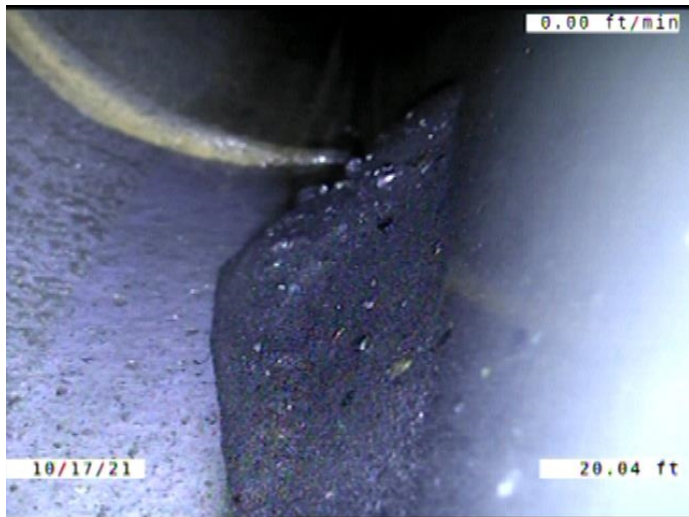
Code: **DSF**
 Description: **Deposits Settled Fine**

Distance (ft): **20.0**
 Structural Grade: **0**
 O&M Grade: **2**
 Clock Start/From: **7**
 Clock To: **8**
 1st Value:
 2nd Value:
 Value Percent: **5.000**
 Continuous Index:
 Within 8" of Joint: **YES**
 Remarks:

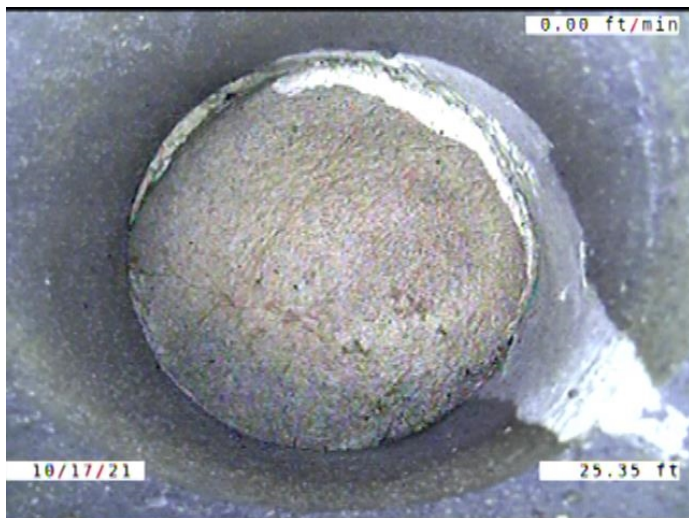
Code: **TFC**
 Description: **Tap Factory Capped**

Distance (ft): **25.4**
 Structural Grade: **0**
 O&M Grade: **0**
 Clock Start/From: **1**
 Clock To:
 1st Value: **4.000**
 2nd Value:
 Value Percent:
 Continuous Index:
 Within 8" of Joint: **YES**
 Remarks: **ENCRUSTATION AROUND THE CAP**

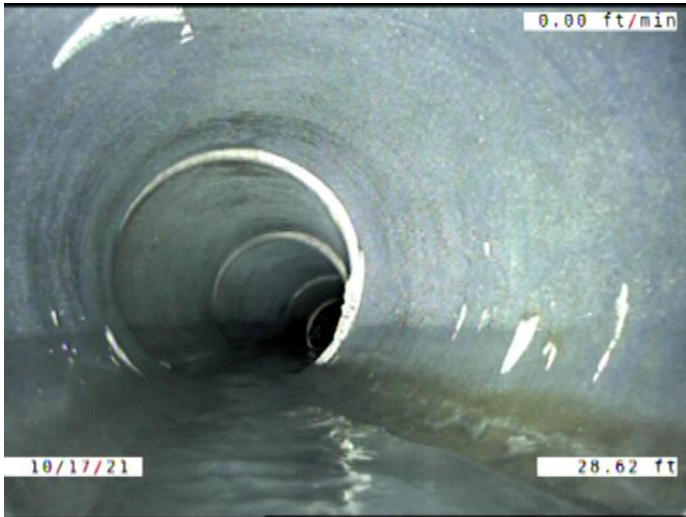
Code: **MWLS**
 Description: **Miscellaneous Water Level Sag**

Distance (ft): **28.6**
 Structural Grade: **2**
 O&M Grade: **0**
 Clock Start/From:
 Clock To:
 1st Value:
 2nd Value:
 Value Percent: **15.000**
 Continuous Index: **F01**
 Within 8" of Joint: **NO**
 Remarks:

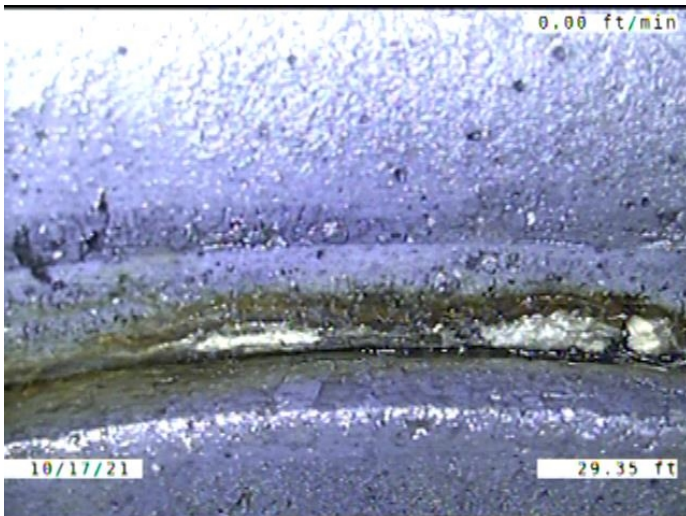
Code: **ISJ**
 Description: **Infiltration Stain Joint**

Distance (ft): **29.3**
 Structural Grade: **0**
 O&M Grade: **1**
 Clock Start/From: **8**
 Clock To: **10**
 1st Value:
 2nd Value:
 Value Percent:
 Continuous Index:
 Within 8" of Joint: **YES**
 Remarks:

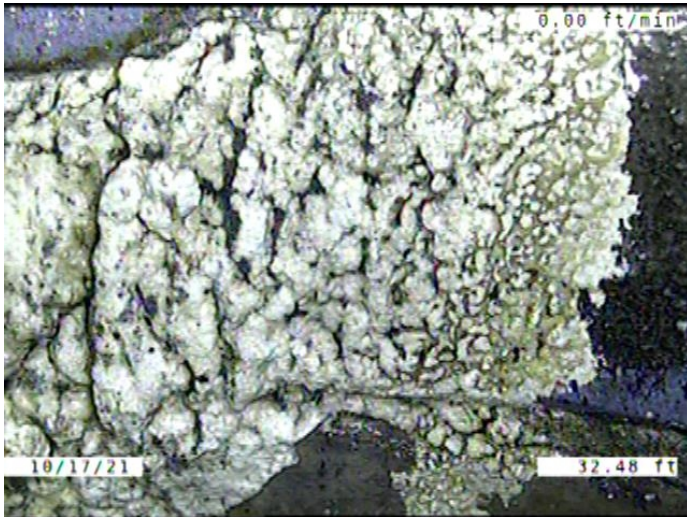
Code: **DAE**
 Description: **Deposits Attached Encrustation**

Distance (ft): **32.5**
 Structural Grade: **0**
 O&M Grade: **2**
 Clock Start/From: **2**
 Clock To: **4**
 1st Value:
 2nd Value:
 Value Percent: **5.000**
 Continuous Index:
 Within 8" of Joint: **YES**
 Remarks:

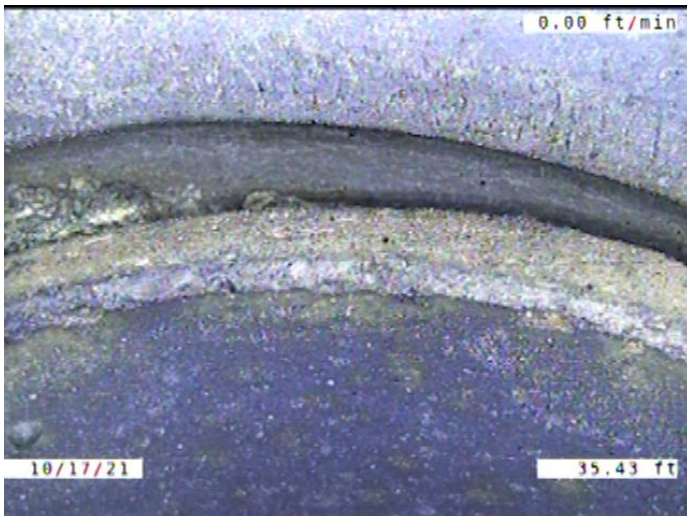
Code: **JAM**
 Description: **Joint Angular Medium**

Distance (ft): **35.4**
 Structural Grade: **3**
 O&M Grade: **0**
 Clock Start/From:
 Clock To:
 1st Value:
 2nd Value:
 Value Percent:
 Continuous Index:
 Within 8" of Joint: **NO**
 Remarks:

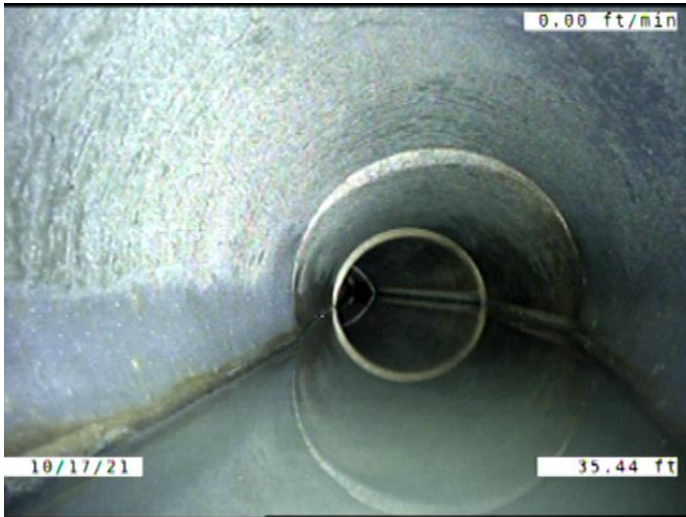
Code: **MWLS**
 Description: **Miscellaneous Water Level Sag**

Distance (ft): **35.4**
 Structural Grade: **3**
 O&M Grade: **0**
 Clock Start/From:
 Clock To:
 1st Value:
 2nd Value:
 Value Percent: **35.000**
 Continuous Index: **S02**
 Within 8" of Joint: **NO**
 Remarks:

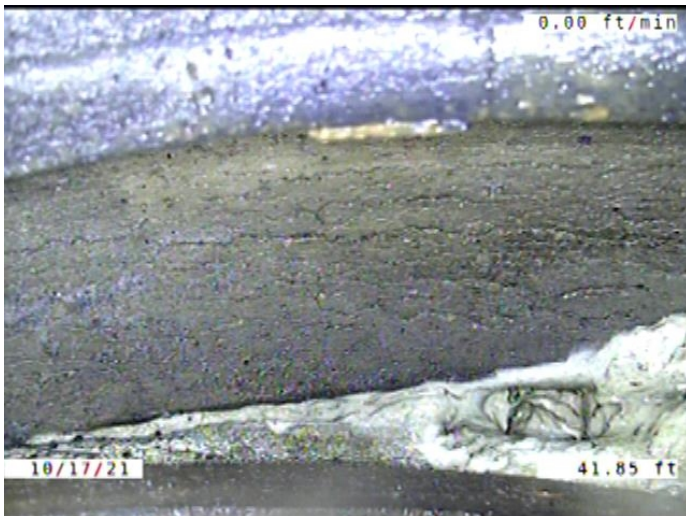
Code: **JAL**
 Description: **Joint Angular Large**

Distance (ft): **41.9**
 Structural Grade: **4**
 O&M Grade: **0**
 Clock Start/From:
 Clock To:
 1st Value:
 2nd Value:
 Value Percent:
 Continuous Index:
 Within 8" of Joint: **NO**
 Remarks:

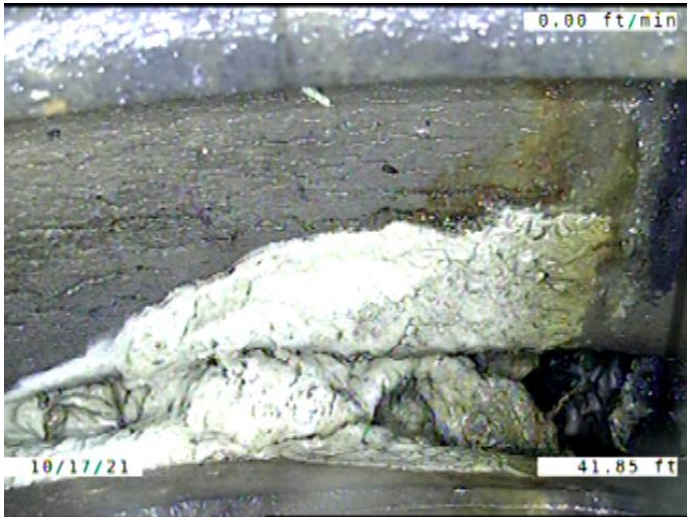
Code: **DAE**
 Description: **Deposits Attached Encrustation**

Distance (ft): **41.9**
 Structural Grade: **0**
 O&M Grade: **2**
 Clock Start/From: **12**
 Clock To: **3**
 1st Value:
 2nd Value:
 Value Percent: **5.000**
 Continuous Index:
 Within 8" of Joint: **NO**
 Remarks:

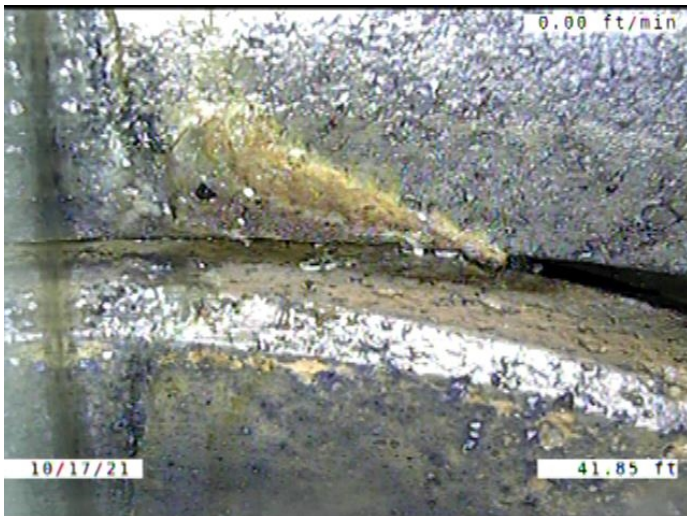
Code: **ISJ**
 Description: **Infiltration Stain Joint**

Distance (ft): **41.9**
 Structural Grade: **0**
 O&M Grade: **1**
 Clock Start/From: **9**
 Clock To: **10**
 1st Value:
 2nd Value:
 Value Percent:
 Continuous Index:
 Within 8" of Joint: **YES**
 Remarks:

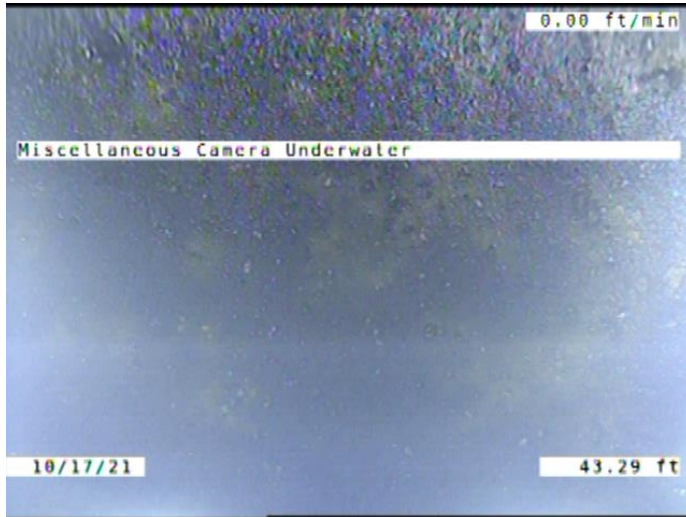
Code: **MCU**
Description: **Miscellaneous Camera Underwater**

Distance (ft): **43.3**
Structural Grade: **0**
O&M Grade: **4**
Clock Start/From:
Clock To:
1st Value:
2nd Value:
Value Percent:
Continuous Index:
Within 8" of Joint: **NO**
Remarks:
