## Profile/Photo Observation Report

| Street: | <b>N MICHIGAN AVE &amp; E HOME AVE</b> | Flow Control: | <b>Not Controlled</b> |
| City: | <b>Hobart, IN</b> | Year Renewed: | |

| US MH: | <b>M-704-014</b> | DS MH: | <b>M-704-015</b> |

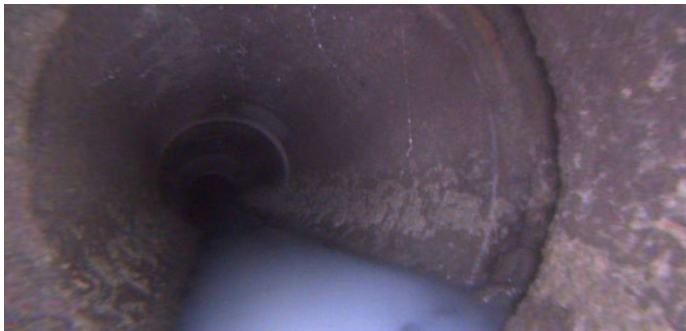
Code: **AMH**  
Description: **Manhole**

Distance (ft): **.0**  
Structural Grade: **0**  
O&M Grade: **0**  
Clock Start/From:  
Clock To:  
1st Value:  
2nd Value:  
Value Percent:  
Continuous Index:  
Within 8" of Joint: **NO**  
Remarks: **M-704-014**

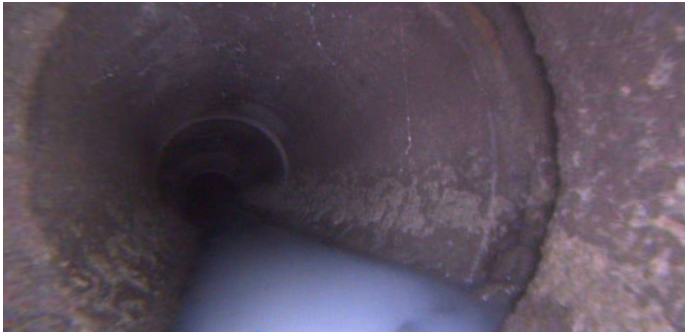
| Code: | <b>MWL</b> |
| Description: | <b>Water Level</b> |

| Value Percent: | <b>10.000</b> |

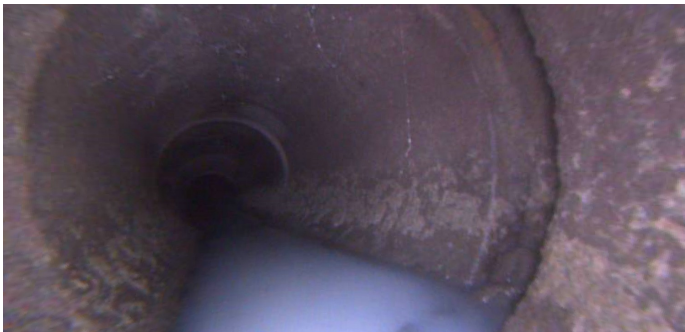
| Code: | <b>LL</b> |
| Description: | <b>Alignment Left</b> |

| O&M Grade: | <b>1</b> |
| Value Percent: | <b>5.000</b> |

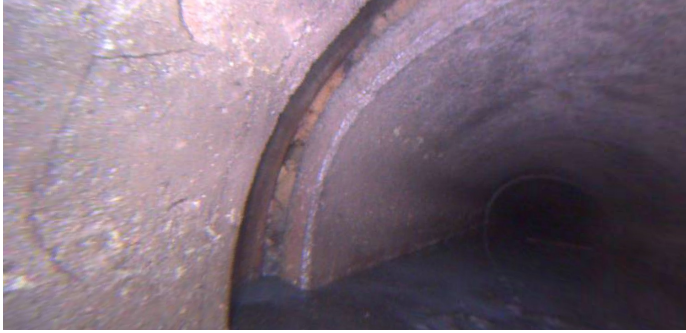
| | Position | Code | Observation | Video (sec) | Grade |
|--|---|---|---|---|---|
| | 16.3 | FM | Fracture Multiple | 77 | S 4 |

Code: **FM**  
Description: **Fracture Multiple**

Distance (ft): **16.3**  
Structural Grade: **4**  
O&M Grade: **0**  
Clock Start/From: **8**  
Clock To: **11**  
1st Value:  
2nd Value:  
Value Percent:  
Continuous Index:  
Within 8" of Joint: **YES**  
Remarks:

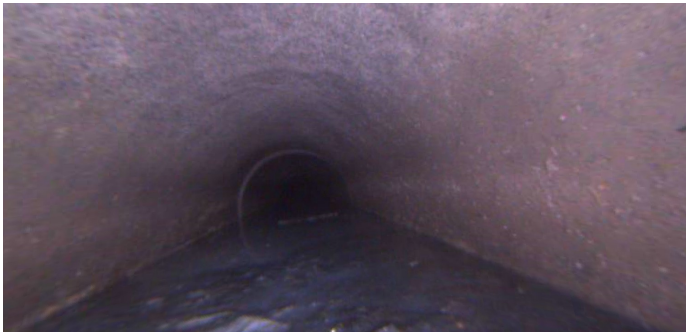
Code: **MSA**  
Description: **Abandoned Survey**

Distance (ft): **17.1**  
Structural Grade: **0**  
O&M Grade: **0**  
Clock Start/From:  
Clock To:  
1st Value:  
2nd Value:  
Value Percent:  
Continuous Index:  
Within 8" of Joint: **NO**  
Remarks: **debris under water**
