Profile/Photo Observation Report

Date:	10/10/2021	Weather:		Coding:	PACP 7.0
Pipe Length (ft):	393.6	Owner:	City of Hobart	Pre Clean:	Heavy Cleaning
P.O.#:	YES502259	Surveyor:	S. Bucklin	PSR:	P-704-015-014
Customer:	City of Hobart	Clean Date:	10/09/2021	Shape:	C

Street:	East Home Avenue	Flow Control:	Not Controlled
City:	Hobart, IN	Year Renewed:	
Location:	Local rural streets with light traffic, t	Tape/Media #:	
Purpose:	Routine Assessment	Dia/Height:	12"
Use:	Sanitary Sewage Pipe	Material:	VCP
Drain Area:		Lining:	
Category:	NA		
Comment:			
Location Details:		Direction of Survey:	Upstream
US MH:	M-704-014	DS MH:	M-704-015
		Total Length Surveyed (ft):	393.6

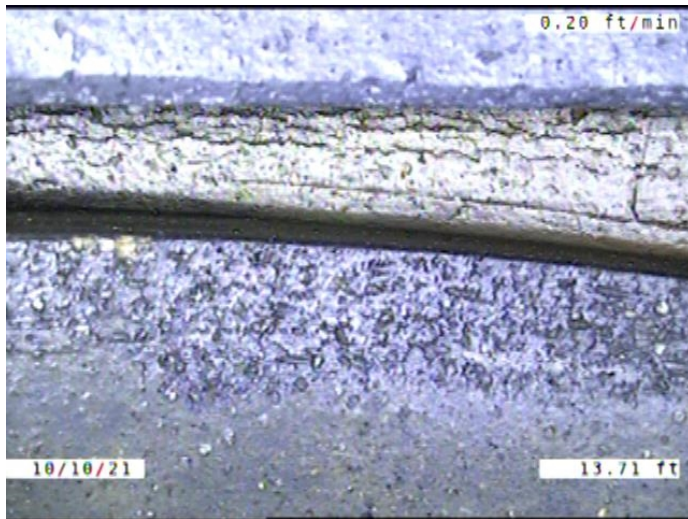
Code: **CM**
 Description: **Crack Multiple**

Distance (ft): **13.7**
 Structural Grade: **3**
 O&M Grade: **0**
 Clock Start/From: **10**
 Clock To: **3**
 1st Value:
 2nd Value:
 Value Percent:
 Continuous Index:
 Within 8" of Joint: **YES**
 Remarks:

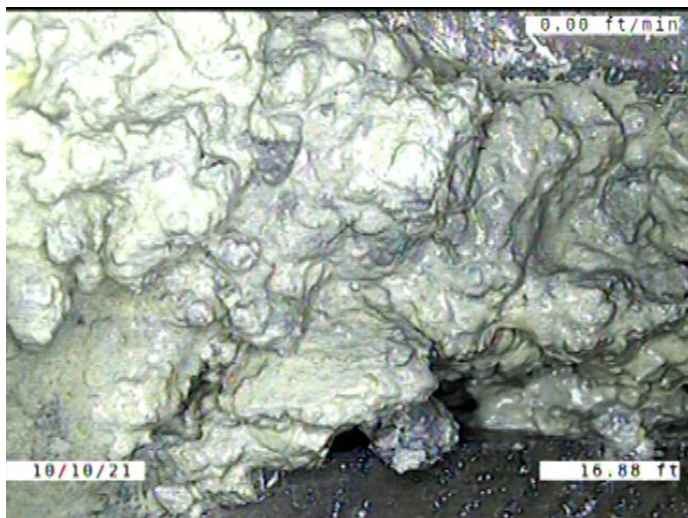
Code: **DAE**
 Description: **Deposits Attached Encrustation**

Distance (ft): **16.9**
 Structural Grade: **0**
 O&M Grade: **2**
 Clock Start/From: **7**
 Clock To: **10**
 1st Value:
 2nd Value:
 Value Percent: **5.000**
 Continuous Index:
 Within 8" of Joint: **YES**
 Remarks:

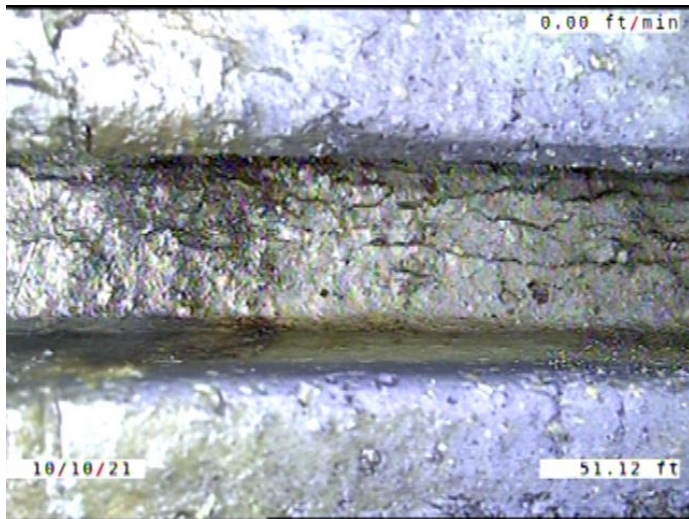
Code: **CM**
 Description: **Crack Multiple**

Distance (ft): **51.1**
 Structural Grade: **3**
 O&M Grade: **0**
 Clock Start/From: **8**
 Clock To: **12**
 1st Value:
 2nd Value:
 Value Percent:
 Continuous Index:
 Within 8" of Joint: **YES**
 Remarks:

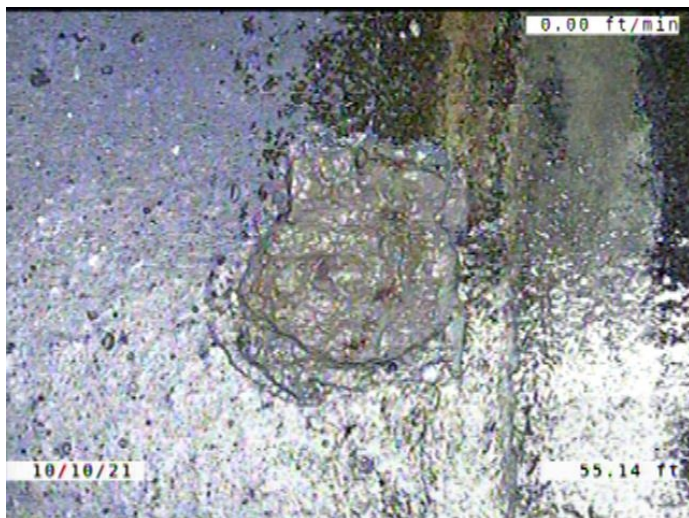
Code: **SSS**
 Description: **Surface Damage Surface Spalling**

Distance (ft): **55.1**
 Structural Grade: **2**
 O&M Grade: **0**
 Clock Start/From: **8**
 Clock To:
 1st Value:
 2nd Value:
 Value Percent:
 Continuous Index:
 Within 8" of Joint: **NO**
 Remarks:

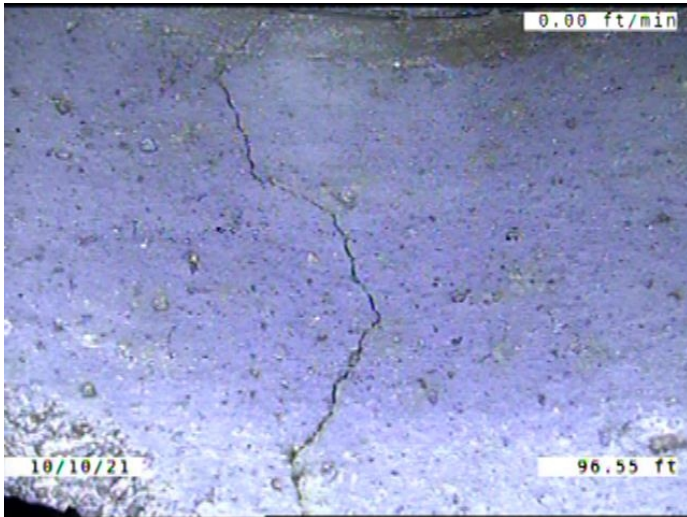
Code: **CL**
Description: **Crack Longitudinal**

Distance (ft): **96.5**
Structural Grade: **2**
O&M Grade: **0**
Clock Start/From: **11**
Clock To:
1st Value:
2nd Value:
Value Percent:
Continuous Index:
Within 8" of Joint: **YES**
Remarks:

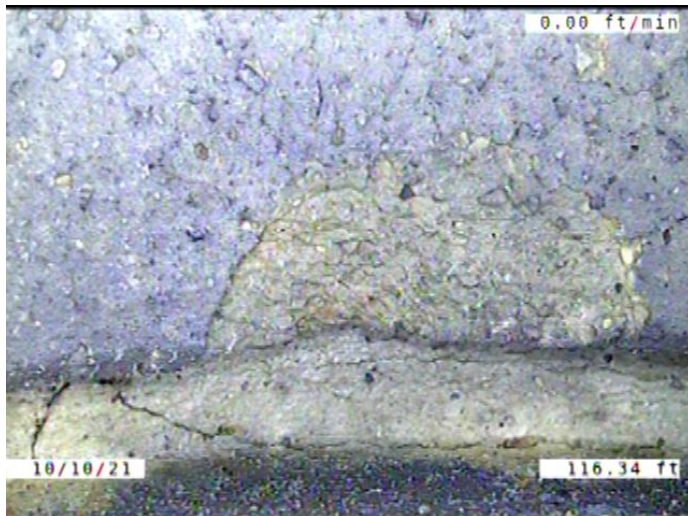
Code: **SZ**
 Description: **Surface Damage Other**

Distance (ft): **116.3**
 Structural Grade: **0**
 O&M Grade: **0**
 Clock Start/From: **11**

YES
A PIECE CHIPPED AWAY FROM THE
JOINT

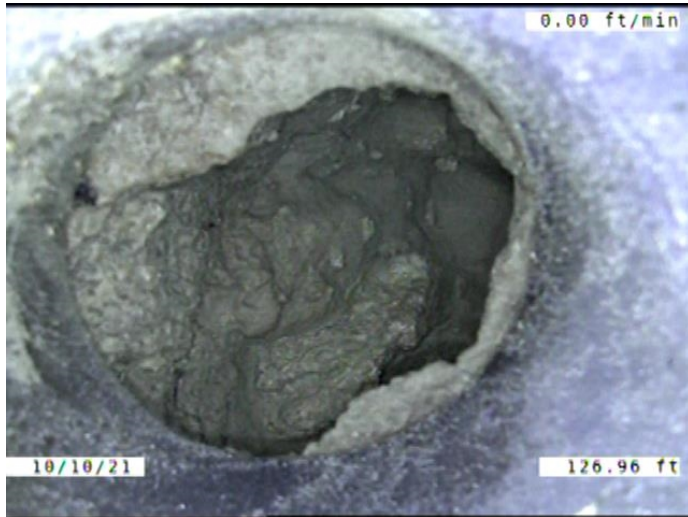
Code: **TFD**
 Description: **Tap Factory Defective**

Distance (ft): **127.0**
 Structural Grade: **0**
 O&M Grade: **3**
 Clock Start/From: **11**
 Clock To:
 1st Value: **4.000**
 2nd Value:
 Value Percent:
 Continuous Index:
 Within 8" of Joint: **YES**
 Remarks: **CAP MISSING VOID AND SOIL VISIBLE**

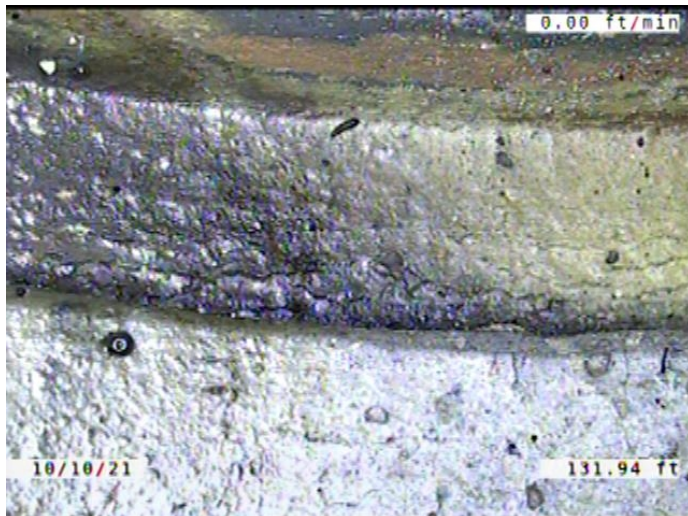
Code: **JAM**
 Description: **Joint Angular Medium**

Distance (ft): **131.9**
 Structural Grade: **3**
 O&M Grade: **0**
 Clock Start/From:
 Clock To:
 1st Value:
 2nd Value:
 Value Percent:
 Continuous Index:
 Within 8" of Joint: **NO**
 Remarks:

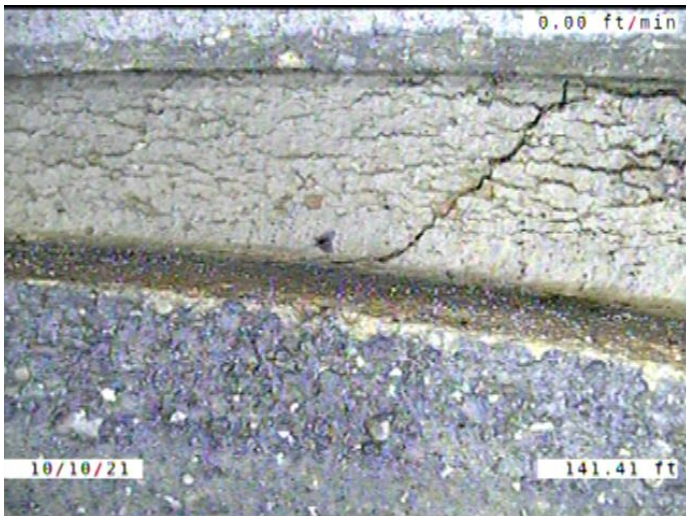
Code: **FM**
 Description: **Fracture Multiple**

Distance (ft): **141.4**
 Structural Grade: **4**
 O&M Grade: **0**
 Clock Start/From: **2**
 Clock To: **3**
 1st Value:
 2nd Value:
 Value Percent:
 Continuous Index:
 Within 8" of Joint: **YES**
 Remarks:

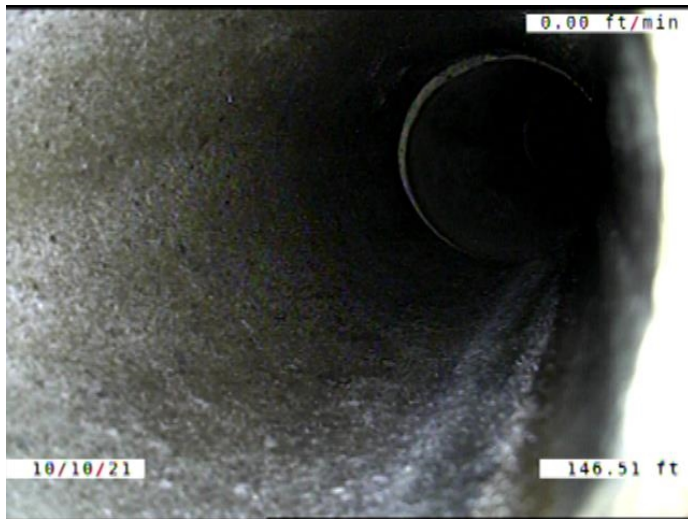
Code: **TBI**
 Description: **Tap Break-in Intruding**

Distance (ft): **146.5**
 Structural Grade: **0**
 O&M Grade: **2**
 Clock Start/From: **1**
 Clock To:
 1st Value: **4.000**
 2nd Value: **3.000**
 Value Percent:
 Continuous Index:
 Within 8" of Joint: **YES**
 Remarks:

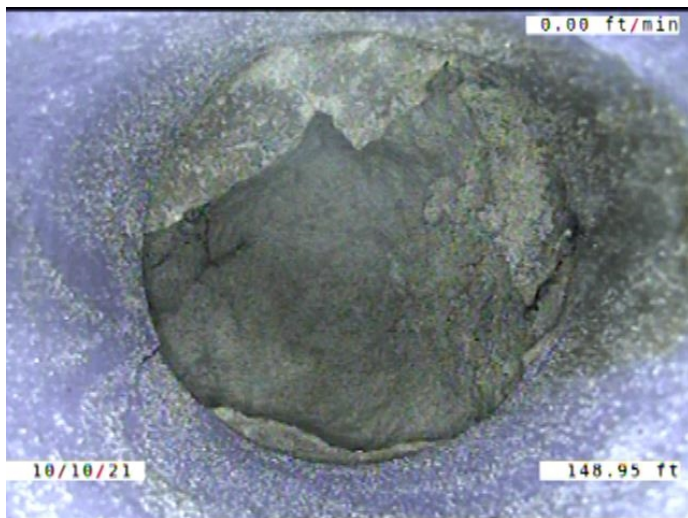
Code: **TFD**
 Description: **Tap Factory Defective**

Distance (ft): **149.0**
 Structural Grade: **0**
 O&M Grade: **3**
 Clock Start/From: **1**
 Clock To:
 1st Value: **4.000**
 2nd Value:
 Value Percent:
 Continuous Index:
 Within 8" of Joint: **YES**
 Remarks: **CAP MISSING. SOIL AND VOID VISIBLE**

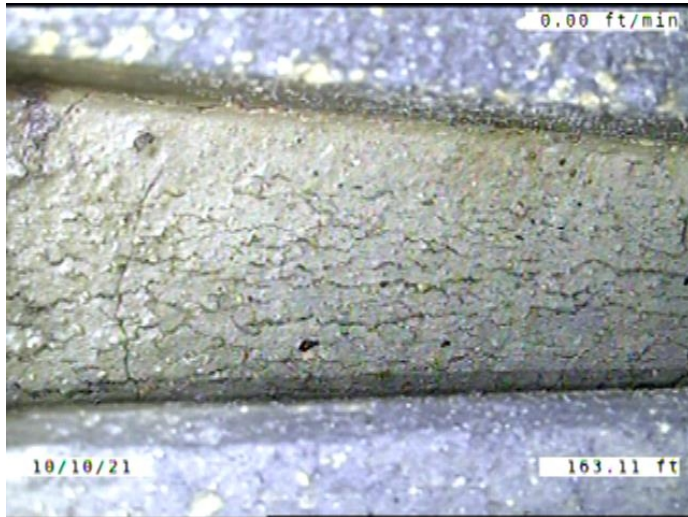
Code: **JAM**
 Description: **Joint Angular Medium**

Distance (ft): **163.1**
 Structural Grade: **3**
 O&M Grade: **0**
 Clock Start/From:
 Clock To:
 1st Value:
 2nd Value:
 Value Percent:
 Continuous Index:
 Within 8" of Joint: **NO**
 Remarks:

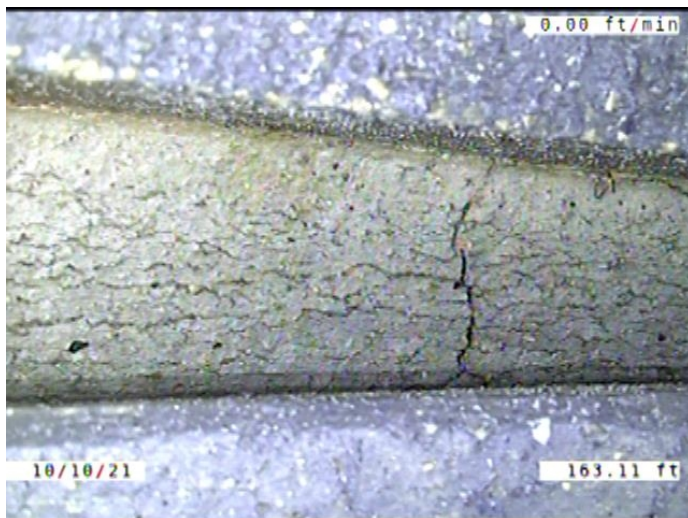
Code: **CM**
 Description: **Crack Multiple**

Distance (ft): **163.1**
 Structural Grade: **3**
 O&M Grade: **0**
 Clock Start/From: **11**
 Clock To: **4**
 1st Value:
 2nd Value:
 Value Percent:
 Continuous Index:
 Within 8" of Joint: **YES**
 Remarks:

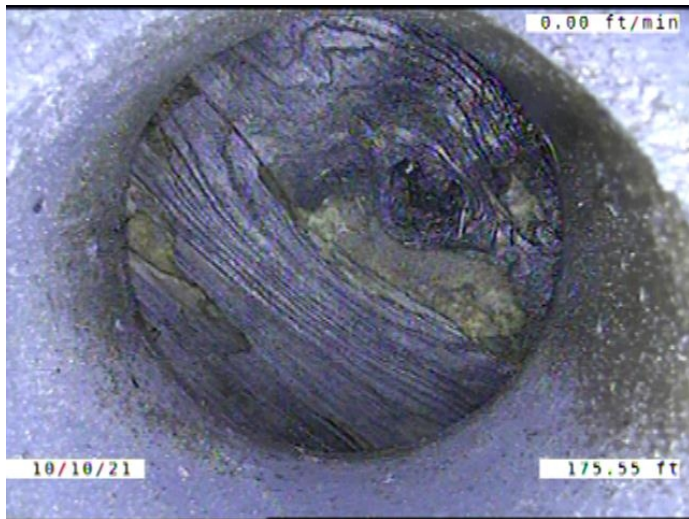
Code: **TFD**
 Description: **Tap Factory Defective**

Distance (ft): **175.6**
 Structural Grade: **0**
 O&M Grade: **3**
 Clock Start/From: **1**
 Clock To:
 1st Value: **4.000**
 2nd Value:
 Value Percent:
 Continuous Index:
 Within 8" of Joint: **YES**
 Remarks: **CAP LOOKS TO BE WOOD AND ROTTING AWAY**

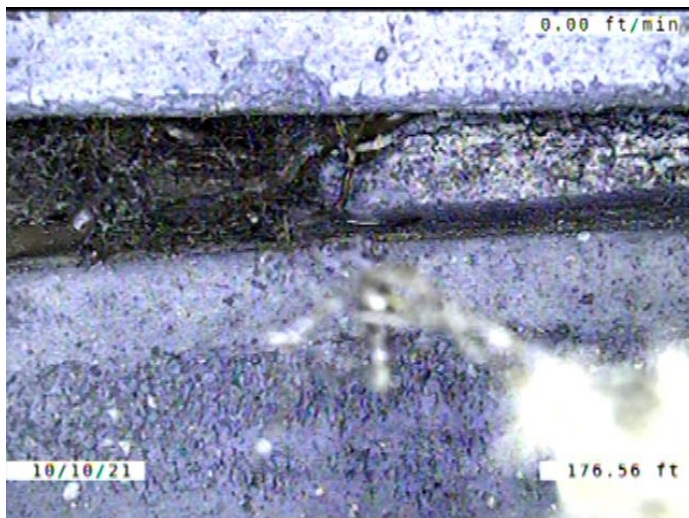
Code: **RFJ**
 Description: **Roots Fine Joint**

Distance (ft): **176.6**
 Structural Grade: **0**
 O&M Grade: **1**
 Clock Start/From: **11**
 Clock To: **12**
 1st Value:
 2nd Value:
 Value Percent:
 Continuous Index:
 Within 8" of Joint: **YES**
 Remarks:

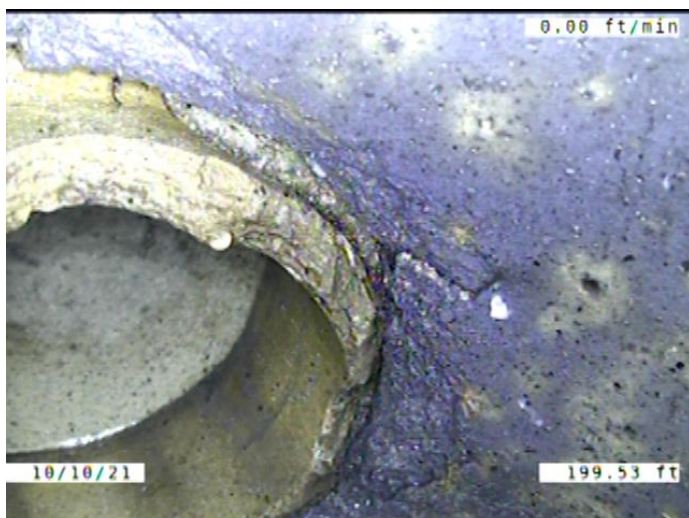
Code: **CM**
 Description: **Crack Multiple**

Distance (ft): **199.5**
 Structural Grade: **3**
 O&M Grade: **0**
 Clock Start/From: **11**
 Clock To: **1**
 1st Value:
 2nd Value:
 Value Percent:
 Continuous Index:
 Within 8" of Joint: **YES**
 Remarks:

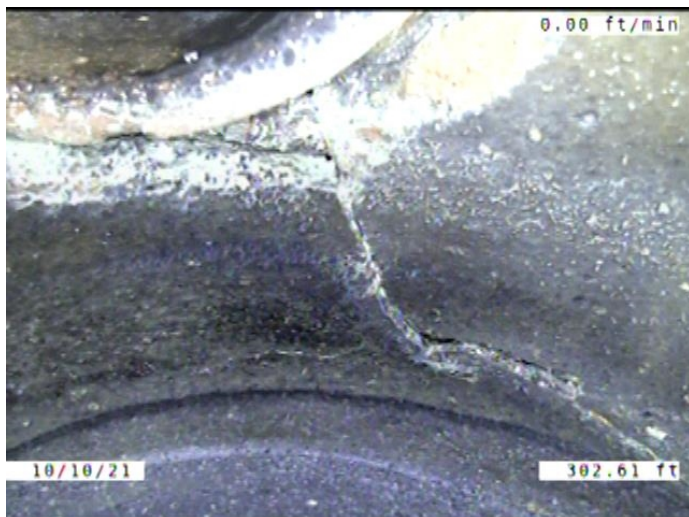
Code: **B**
 Description: **Broken**

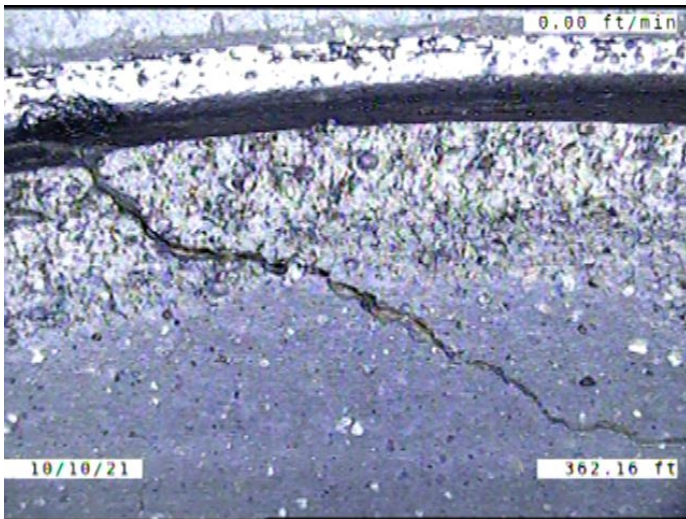
Code: **FM**
 Description: **Fracture Multiple**

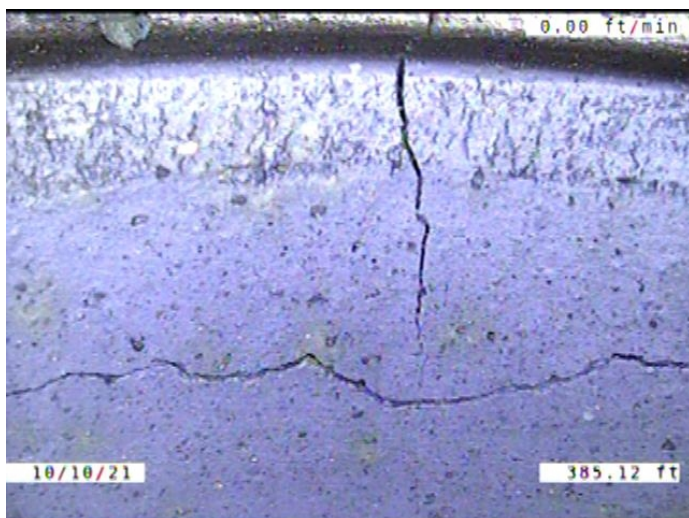
Code: **FM**
 Description: **Fracture Multiple**

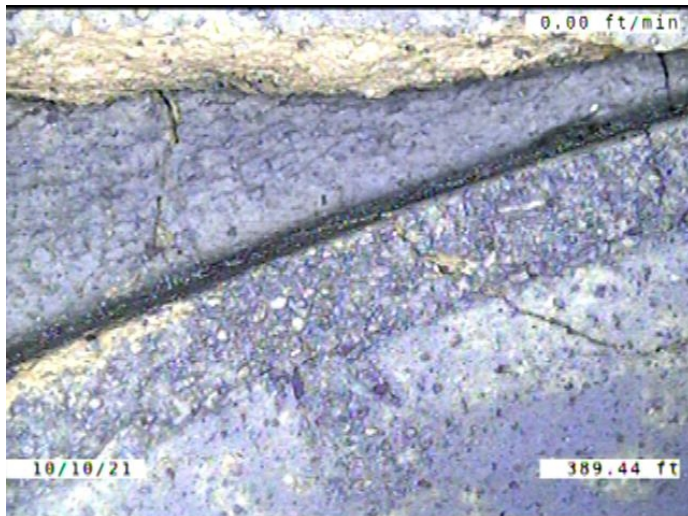
Code: **FM**
 Description: **Fracture Multiple**
