Profile/Photo Observation Report

Date:	10/10/2021	Weather:		Coding:	PACP 7.0
Pipe Length (ft):	393.6	Owner:	City of Hobart	Pre Clean:	Heavy Cleaning
P.O.#:	YES502259	Surveyor:	S. Bucklin	PSR:	P-704-015-014
Customer:	City of Hobart	Clean Date:	10/09/2021	Shape:	C

Street:	East Home Avenue	Flow Control:	Not Controlled
City:	Hobart, IN	Year Renewed:	
Location:	Local rural streets with light traffic, t	Tape/Media #:	
Purpose:	Routine Assessment	Dia/Height:	12"
Use:	Sanitary Sewage Pipe	Material:	VCP
Drain Area:		Lining:	
Category:	NA		
Comment:			
Location Details:		Direction of Survey:	Upstream
US MH:	M-704-014	DS MH:	M-704-015
		Total Length Surveyed (ft):	393.6

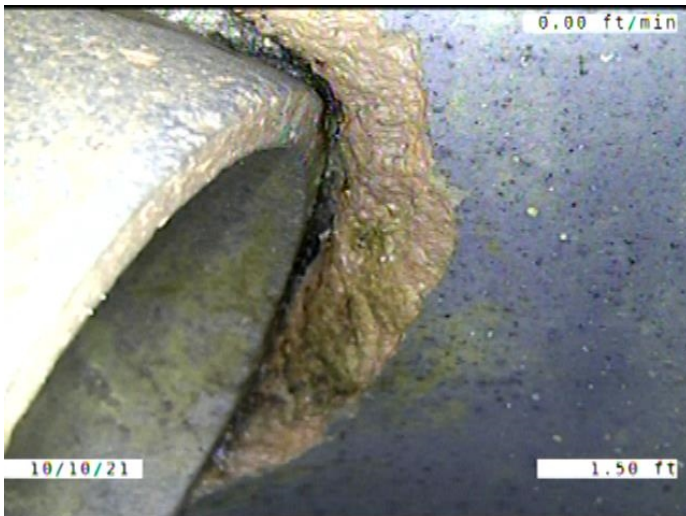
Code: **SSS**
 Description: **Surface Damage Surface Spalling**

Distance (ft): **1.5**
 Structural Grade: **2**
 O&M Grade: **0**
 Clock Start/From: **10**
 Clock To: **12**
 1st Value:
 2nd Value:
 Value Percent:
 Continuous Index:
 Within 8" of Joint: **NO**
 Remarks:

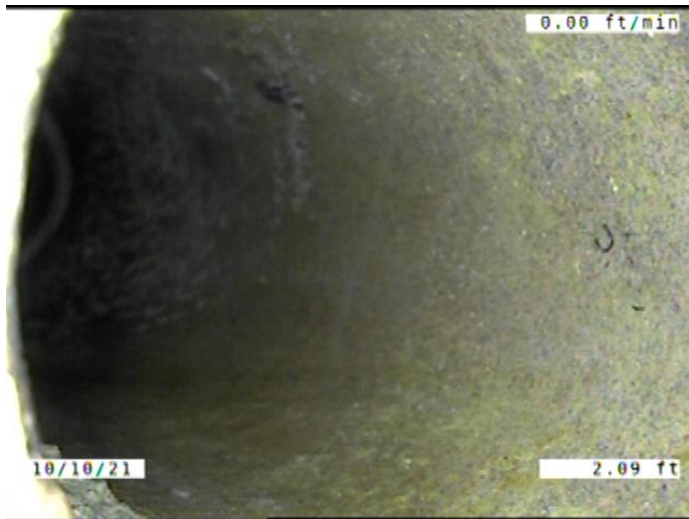
Code: **TBI**
 Description: **Tap Break-in Intruding**

Distance (ft): **2.1**
 Structural Grade: **0**
 O&M Grade: **2**
 Clock Start/From: **11**
 Clock To:
 1st Value: **4.000**
 2nd Value: **3.000**
 Value Percent:
 Continuous Index:
 Within 8" of Joint: **YES**
 Remarks:

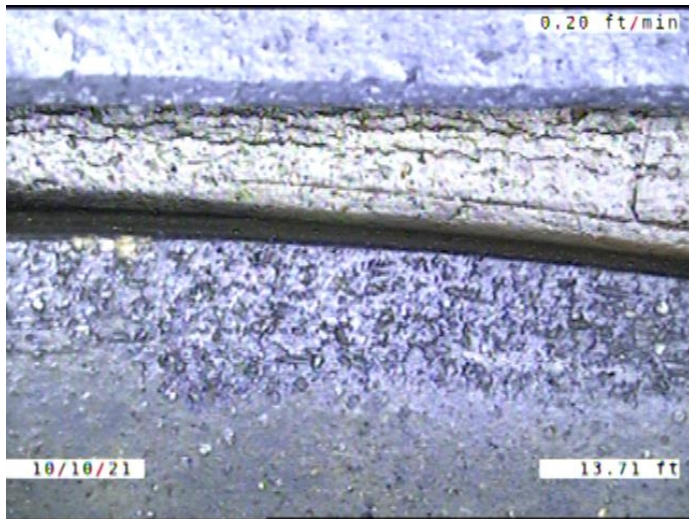
Code: **CM**
 Description: **Crack Multiple**

Distance (ft): **13.7**
 Structural Grade: **3**
 O&M Grade: **0**
 Clock Start/From: **10**
 Clock To: **3**
 1st Value:
 2nd Value:
 Value Percent:
 Continuous Index:
 Within 8" of Joint: **YES**
 Remarks:

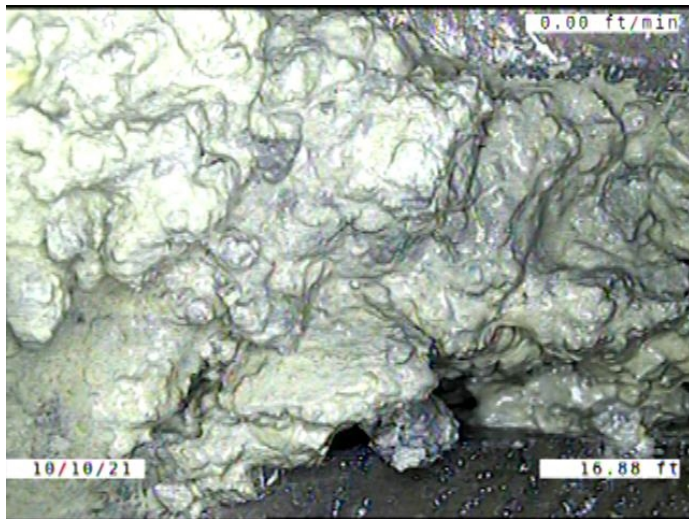
Code: **DAE**
 Description: **Deposits Attached Encrustation**

Distance (ft): **16.9**
 Structural Grade: **0**
 O&M Grade: **2**
 Clock Start/From: **7**
 Clock To: **10**
 1st Value:
 2nd Value:
 Value Percent: **5.000**
 Continuous Index:
 Within 8" of Joint: **YES**
 Remarks:

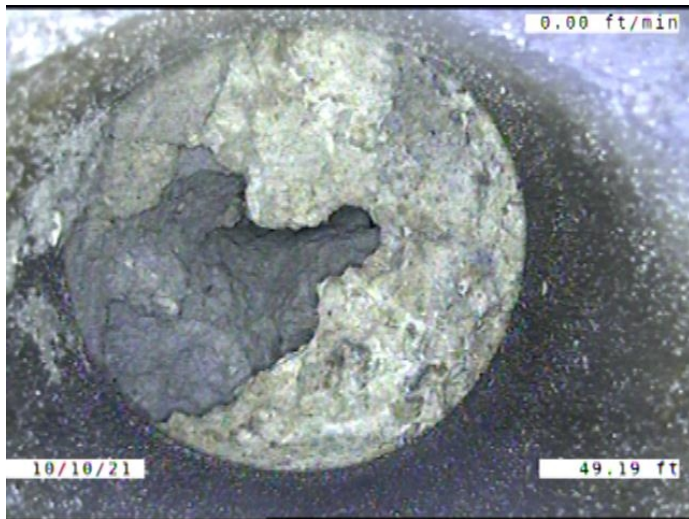
Code: **TFD**
Description: **Tap Factory Defective**

Distance (ft): **49.2**
Structural Grade: **0**
O&M Grade: **3**
Clock Start/From: **11**
Clock To:
1st Value: **4.000**
2nd Value:
Value Percent:
Continuous Index:
Within 8" of Joint: **YES**
Remarks: **CAP MISSING SOIL VISIBLE**

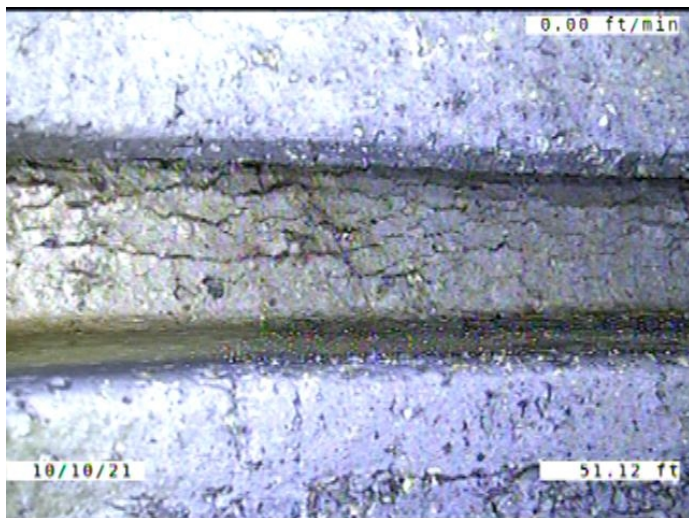
Code: **JAM**
Description: **Joint Angular Medium**

Distance (ft): **51.1**
Structural Grade: **3**
O&M Grade: **0**
Clock Start/From:
Clock To:
1st Value:
2nd Value:
Value Percent:
Continuous Index:
Within 8" of Joint: **NO**
Remarks:

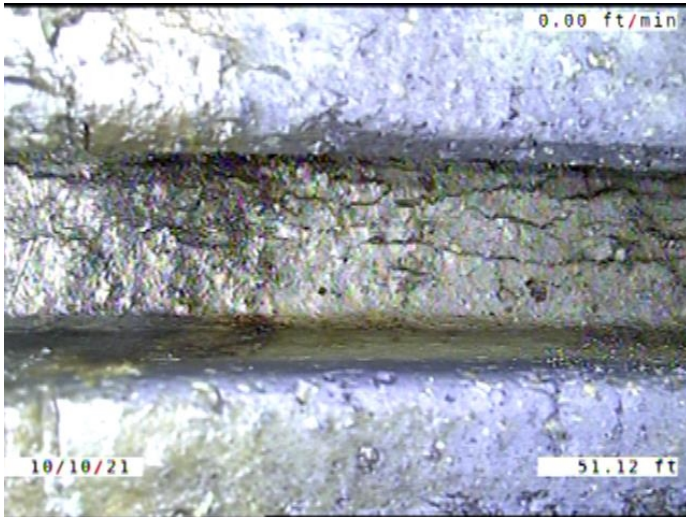
Code: **CM**
 Description: **Crack Multiple**

Distance (ft): **51.1**
 Structural Grade: **3**
 O&M Grade: **0**
 Clock Start/From: **8**
 Clock To: **12**
 1st Value:
 2nd Value:
 Value Percent:
 Continuous Index:
 Within 8" of Joint: **YES**
 Remarks:

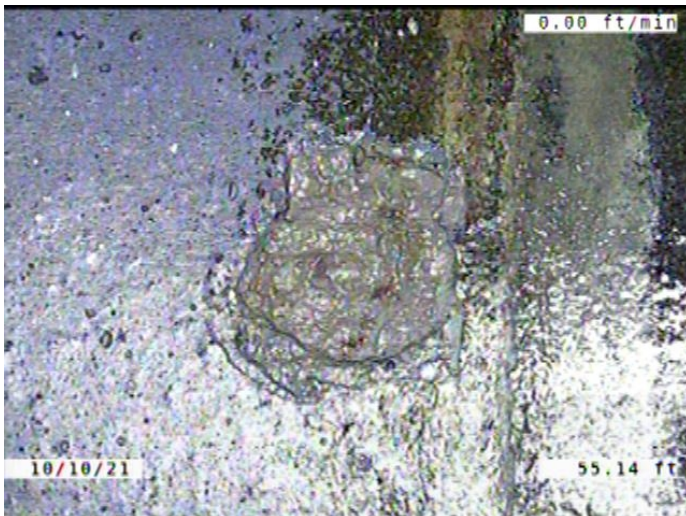
Code: **SSS**
 Description: **Surface Damage Surface Spalling**

Distance (ft): **55.1**
 Structural Grade: **2**
 O&M Grade: **0**
 Clock Start/From: **8**
 Clock To:
 1st Value:
 2nd Value:
 Value Percent:
 Continuous Index:
 Within 8" of Joint: **NO**
 Remarks:

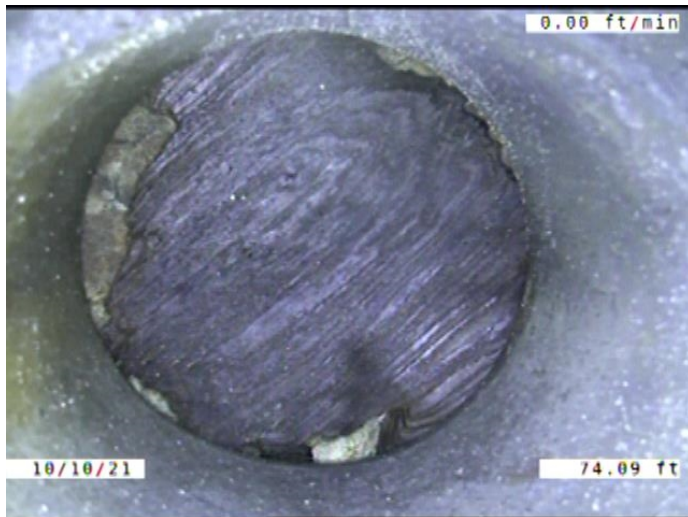
Code: **TFC**
 Description: **Tap Factory Capped**

Distance (ft): **74.1**
 Structural Grade: **0**
 O&M Grade: **0**
 Clock Start/From: **10**
 Clock To:
 1st Value: **4.000**
 2nd Value:
 Value Percent:
 Continuous Index:
 Within 8" of Joint: **YES**
 Remarks: **CAP LOOKS TO BE WOOD AND ROTTING AWAY**

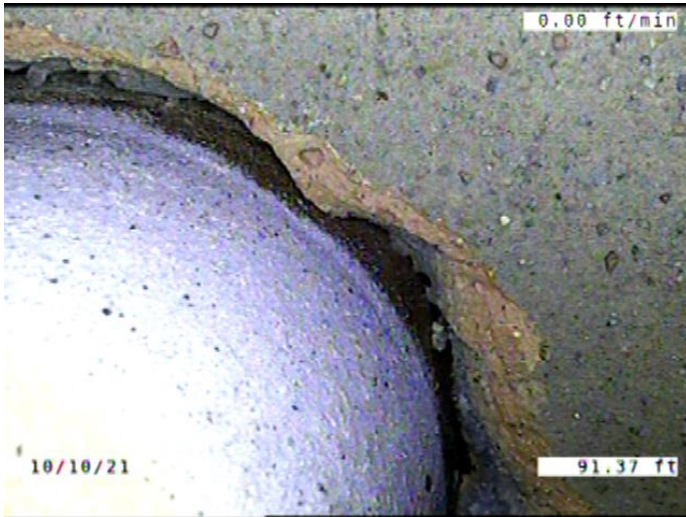
Code: **SSS**
 Description: **Surface Damage Surface Spalling**

Distance (ft): **91.4**
 Structural Grade: **2**
 O&M Grade: **0**
 Clock Start/From: **12**
 Clock To: **2**
 1st Value:
 2nd Value:
 Value Percent:
 Continuous Index:
 Within 8" of Joint: **NO**
 Remarks:

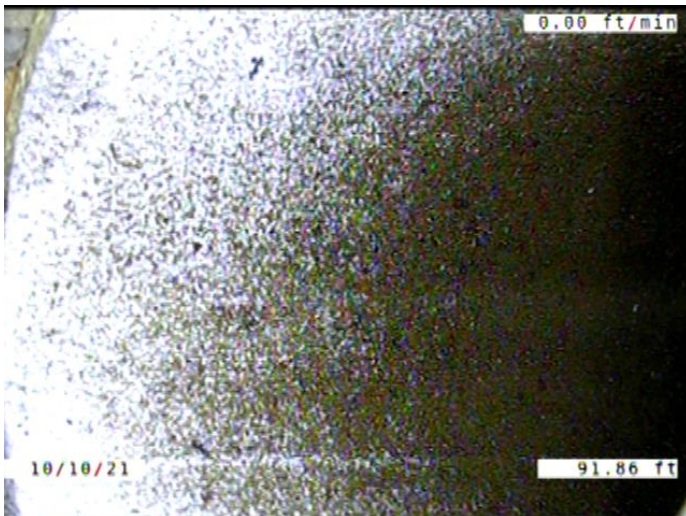
Code: **TBI**
 Description: **Tap Break-in Intruding**

Distance (ft): **91.9**
 Structural Grade: **0**
 O&M Grade: **2**
 Clock Start/From: **1**
 Clock To:
 1st Value: **4.000**
 2nd Value: **3.000**
 Value Percent:
 Continuous Index:
 Within 8" of Joint: **NO**
 Remarks:

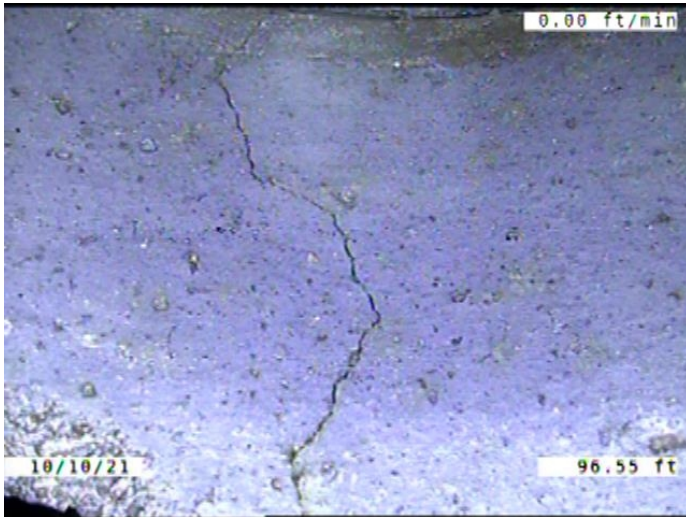
Code: **CL**
Description: **Crack Longitudinal**

Distance (ft): **96.5**
Structural Grade: **2**
O&M Grade: **0**
Clock Start/From: **11**
Clock To:
1st Value:
2nd Value:
Value Percent:
Continuous Index:
Within 8" of Joint: **YES**
Remarks:

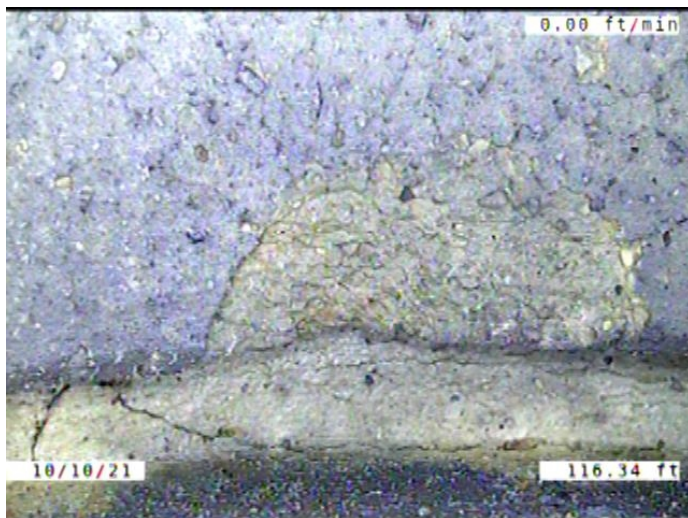
Code: **SZ**
 Description: **Surface Damage Other**

Distance (ft): **116.3**
 Structural Grade: **0**
 O&M Grade: **0**
 Clock Start/From: **11**

Clock To:
 1st Value:
 2nd Value:
 Value Percent:
 Continuous Index:
 Within 8" of Joint: **YES**
 Remarks: **A PIECE CHIPPED AWAY FROM THE JOINT**

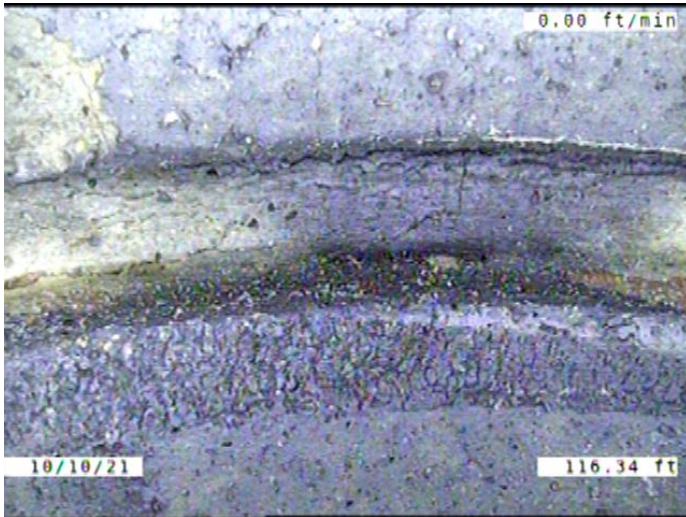
Code: **CM**
Description: **Crack Multiple**

Distance (ft): **116.3**
Structural Grade: **3**
O&M Grade: **0**
Clock Start/From: **8**
Clock To: **1**
1st Value:
2nd Value:
Value Percent:
Continuous Index:
Within 8" of Joint: **YES**
Remarks:

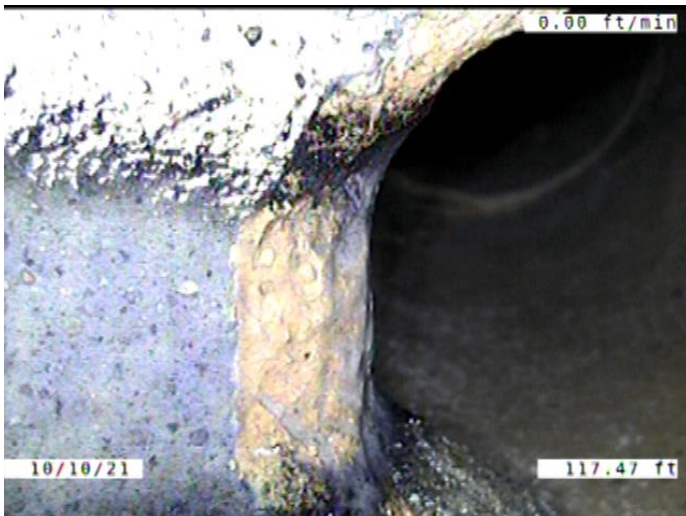
Code: **SSS**
Description: **Surface Damage Surface Spalling**

Distance (ft): **117.5**
Structural Grade: **2**
O&M Grade: **0**
Clock Start/From: **10**
Clock To: **12**
1st Value:
2nd Value:
Value Percent:
Continuous Index:
Within 8" of Joint: **NO**
Remarks:

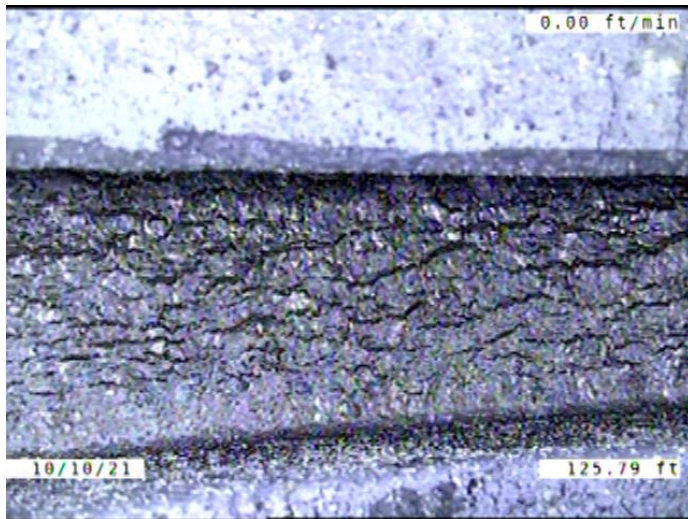
Code: **CM**
 Description: **Crack Multiple**

Distance (ft): **125.8**
 Structural Grade: **3**
 O&M Grade: **0**
 Clock Start/From: **8**
 Clock To: **1**
 1st Value:
 2nd Value:
 Value Percent:
 Continuous Index:
 Within 8" of Joint: **YES**
 Remarks:

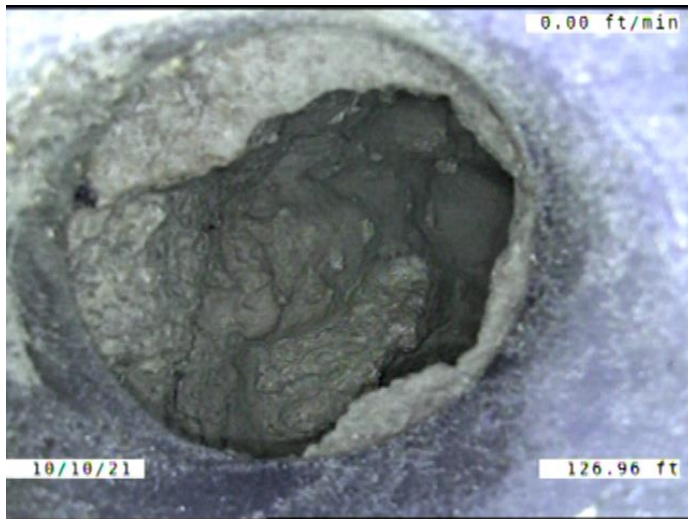
Code: **TFD**
 Description: **Tap Factory Defective**

Distance (ft): **127.0**
 Structural Grade: **0**
 O&M Grade: **3**
 Clock Start/From: **11**
 Clock To:
 1st Value: **4.000**
 2nd Value:
 Value Percent:
 Continuous Index:
 Within 8" of Joint: **YES**
 Remarks: **CAP MISSING VOID AND SOIL VISIBLE**

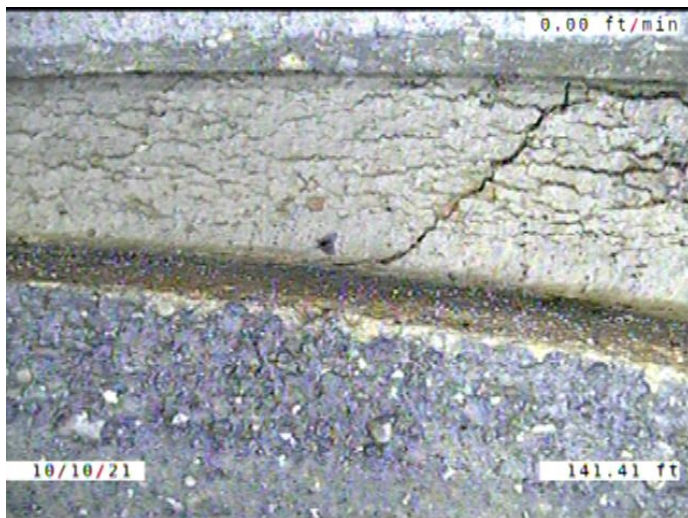
Code: **FM**
 Description: **Fracture Multiple**

Distance (ft): **141.4**
 Structural Grade: **4**
 O&M Grade: **0**
 Clock Start/From: **2**
 Clock To: **3**
 1st Value:
 2nd Value:
 Value Percent:
 Continuous Index:
 Within 8" of Joint: **YES**
 Remarks:

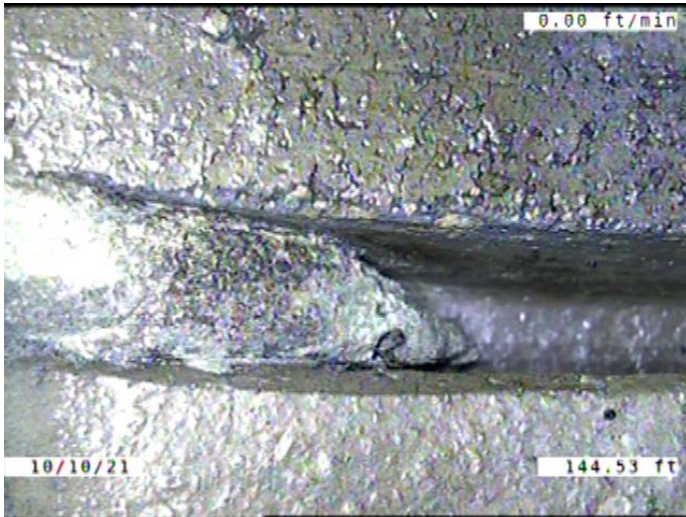
Code: **DAE**
 Description: **Deposits Attached Encrustation**

Distance (ft): **144.5**
 Structural Grade: **0**
 O&M Grade: **2**
 Clock Start/From: **4**
 Clock To: **9**
 1st Value:
 2nd Value:
 Value Percent: **5.000**
 Continuous Index:
 Within 8" of Joint: **YES**
 Remarks:

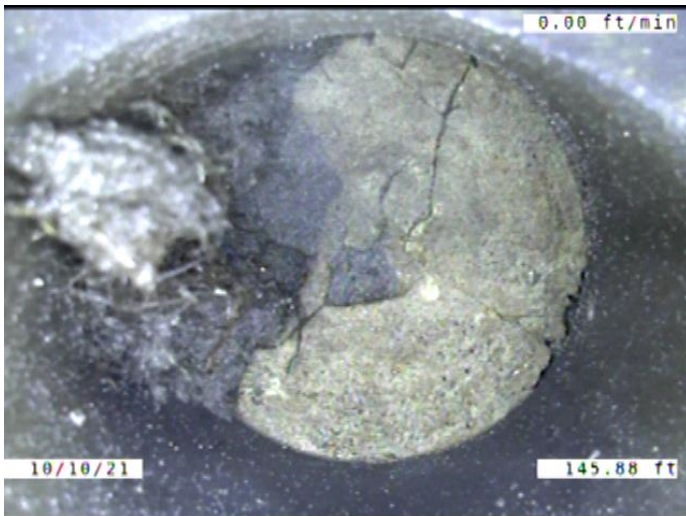
Code: **TFD**
 Description: **Tap Factory Defective**

Distance (ft): **145.9**
 Structural Grade: **0**
 O&M Grade: **3**
 Clock Start/From: **11**
 Clock To:
 1st Value: **4.000**
 2nd Value:
 Value Percent:
 Continuous Index:
 Within 8" of Joint: **YES**
 Remarks: **CAP BROKEN. SOIL VISIBLE AND ROOTS GROWING**

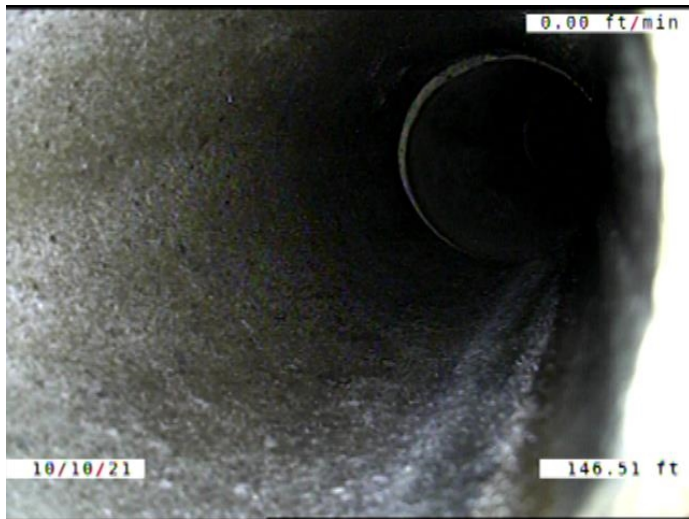
Code: **TBI**
 Description: **Tap Break-in Intruding**

Distance (ft): **146.5**
 Structural Grade: **0**
 O&M Grade: **2**
 Clock Start/From: **1**
 Clock To:
 1st Value: **4.000**
 2nd Value: **3.000**
 Value Percent:
 Continuous Index:
 Within 8" of Joint: **YES**
 Remarks:

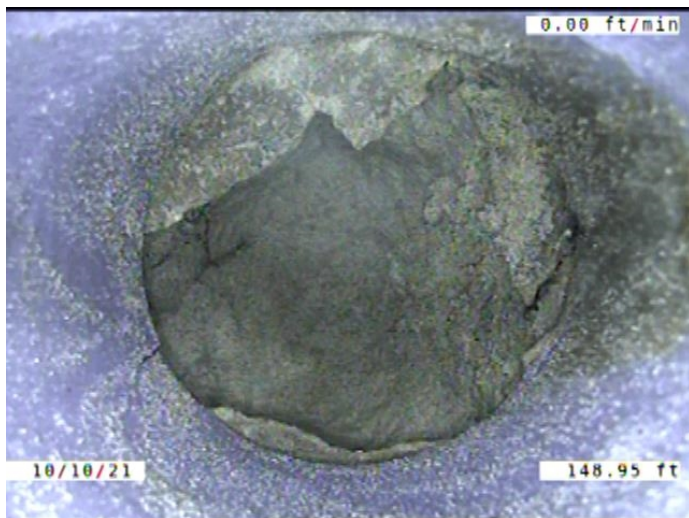
Code: **TFD**
 Description: **Tap Factory Defective**

Distance (ft): **149.0**
 Structural Grade: **0**
 O&M Grade: **3**
 Clock Start/From: **1**
 Clock To:
 1st Value: **4.000**
 2nd Value:
 Value Percent:
 Continuous Index:
 Within 8" of Joint: **YES**
 Remarks: **CAP MISSING. SOIL AND VOID VISIBLE**

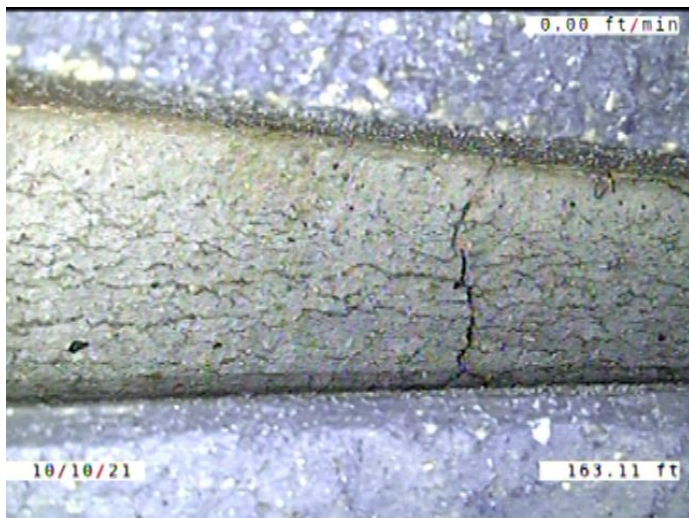
Code: **CM**
 Description: **Crack Multiple**

Distance (ft): **163.1**
 Structural Grade: **3**
 O&M Grade: **0**
 Clock Start/From: **11**
 Clock To: **4**
 1st Value:
 2nd Value:
 Value Percent:
 Continuous Index:
 Within 8" of Joint: **YES**
 Remarks:

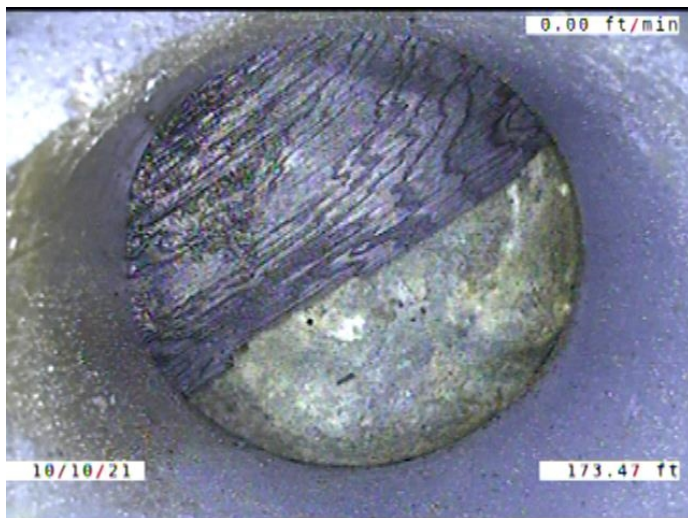
Code: **TFD**
Description: **Tap Factory Defective**

Distance (ft): **173.5**
Structural Grade: **0**
O&M Grade: **3**
Clock Start/From: **10**
Clock To:
1st Value: **4.000**
2nd Value:
Value Percent:
Continuous Index:
Within 8" of Joint: **YES**
Remarks: **CAP LOOKS TO BE WOOD AND
ROTTING AWAY**

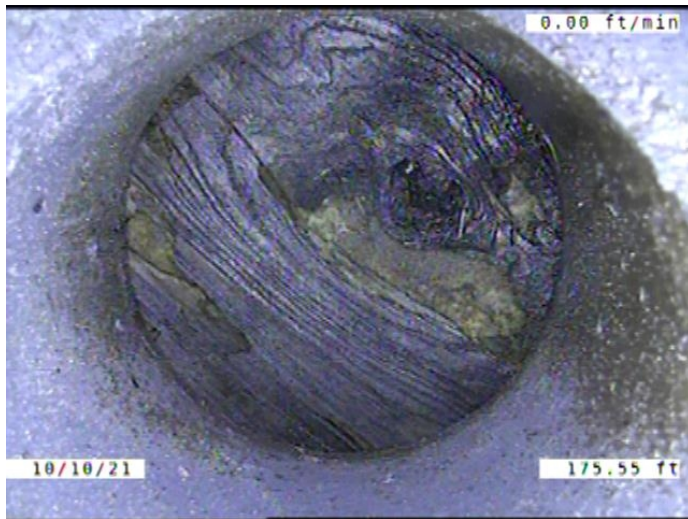
Code: **TFD**
 Description: **Tap Factory Defective**

Distance (ft): **175.6**
 Structural Grade: **0**
 O&M Grade: **3**
 Clock Start/From: **1**
 Clock To:
 1st Value: **4.000**
 2nd Value:
 Value Percent:
 Continuous Index:
 Within 8" of Joint: **YES**
 Remarks: **CAP LOOKS TO BE WOOD AND ROTTING AWAY**

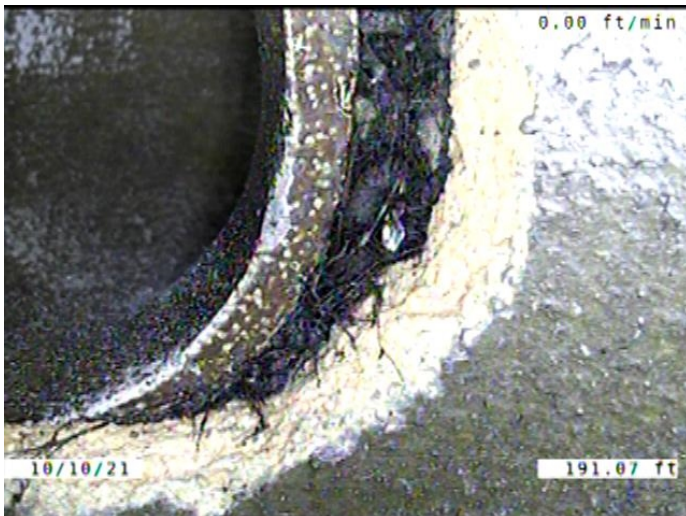
Code: **SSS**
 Description: **Surface Damage Surface Spalling**

Distance (ft): **191.1**
 Structural Grade: **2**
 O&M Grade: **0**
 Clock Start/From: **11**
 Clock To: **1**
 1st Value:
 2nd Value:
 Value Percent:
 Continuous Index:
 Within 8" of Joint: **NO**
 Remarks:

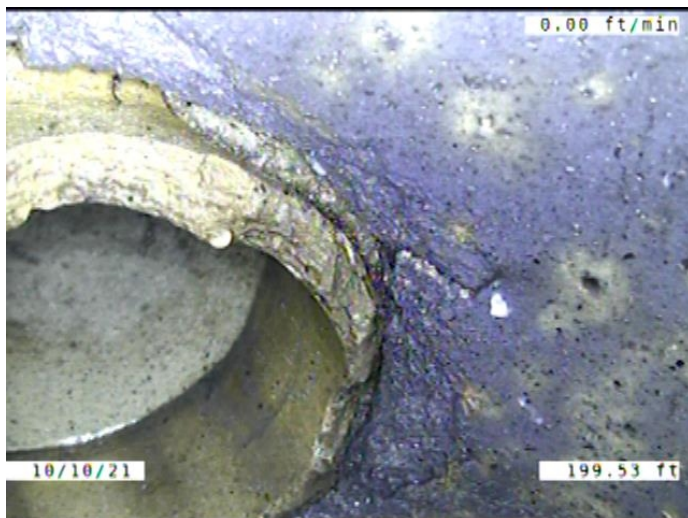
Code: **CM**
 Description: **Crack Multiple**

Distance (ft): **199.5**
 Structural Grade: **3**
 O&M Grade: **0**
 Clock Start/From: **11**
 Clock To: **1**
 1st Value:
 2nd Value:
 Value Percent:
 Continuous Index:
 Within 8" of Joint: **YES**
 Remarks:

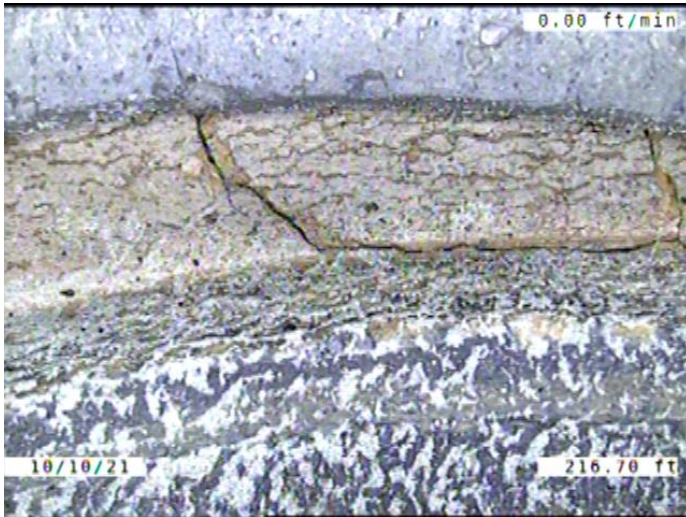
Code: **FM**
 Description: **Fracture Multiple**

Distance (ft): **216.7**
 Structural Grade: **4**
 O&M Grade: **0**
 Clock Start/From: **9**
 Clock To: **2**
 1st Value:
 2nd Value:
 Value Percent:
 Continuous Index:
 Within 8" of Joint: **YES**
 Remarks:

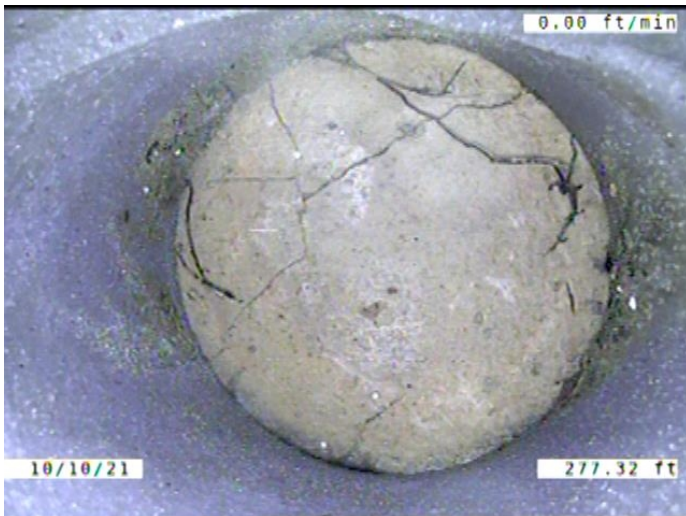
Code: **TFD**
 Description: **Tap Factory Defective**

Distance (ft): **277.3**
 Structural Grade: **0**
 O&M Grade: **3**
 Clock Start/From: **1**
 Clock To:
 1st Value: **4.000**
 2nd Value:
 Value Percent:
 Continuous Index:
 Within 8" of Joint: **YES**
 Remarks: **CAP BROKEN**

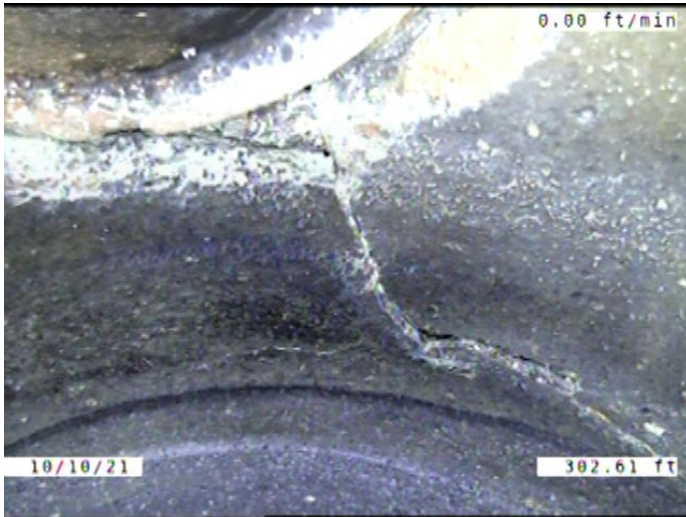
Code: **B**
 Description: **Broken**
