Profile/Photo Observation Report

Street:	E HOME AVE & N LINDA ST	Flow Control:	Not Controlled
City:	Hobart, IN	Year Renewed:	
Location:	Other	Tape/Media #:	
Purpose:	Not Known	Dia/Height:	12"
Use:	Sanitary	Material:	VCP
Drain Area:	NA	Lining:	
Category:	NA		
Comment:

Location Details:		Direction of Survey:	Downstream
US MH:	M-704-015	DS MH:	M-804-018
		Total Length Surveyed (ft):	59.7

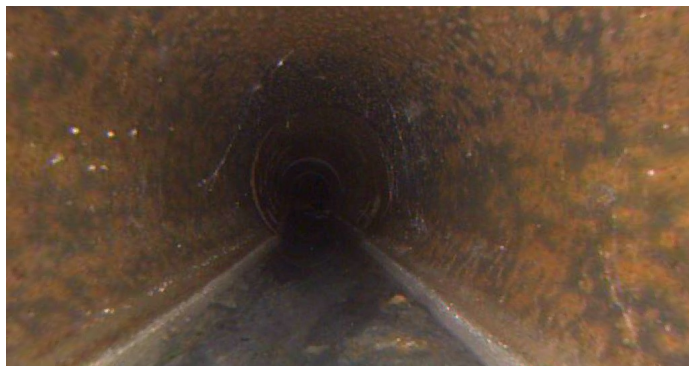
Code: **AMH**
Description: **Manhole**

Distance (ft): **.0**
Structural Grade: **0**
O&M Grade: **0**
Clock Start/From:
Clock To:
1st Value:
2nd Value:
Value Percent:
Continuous Index:
Within 8" of Joint: **NO**
Remarks: **M-704-015**

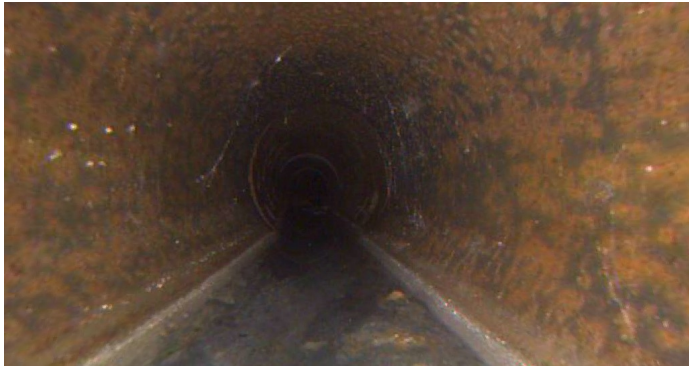
Code: **MWL**
Description: **Water Level**

Distance (ft): **.0**
Structural Grade: **0**
O&M Grade: **0**
Clock Start/From:
Clock To:
1st Value:
2nd Value:
Value Percent: **10.000**
Continuous Index:
Within 8" of Joint: **NO**
Remarks:

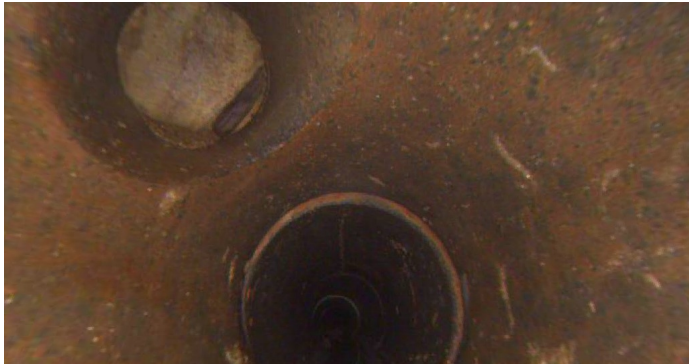
Code: **TFC**
Description: **Tap Factory Capped**

Distance (ft): **19.7**
Structural Grade: **0**
O&M Grade: **0**
Clock Start/From: **10**
Clock To:
1st Value: **4.000**
2nd Value:
Value Percent:
Continuous Index:
Within 8" of Joint:
Remarks:

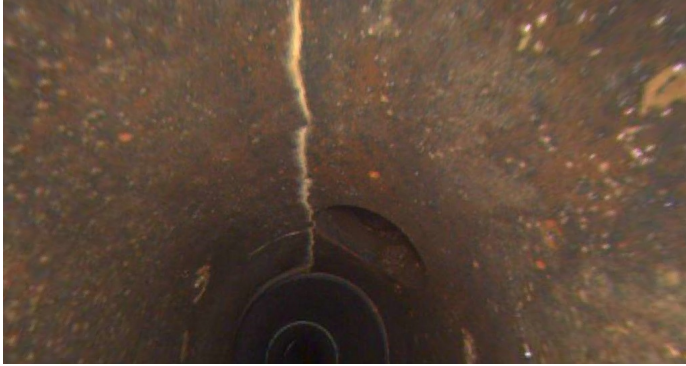
Code: **CL**
Description: **Crack Longitudinal**

Distance (ft): **21.9**
Structural Grade: **2**
O&M Grade: **0**
Clock Start/From: **12**
Clock To:
1st Value:
2nd Value:
Value Percent:
Continuous Index:
Within 8" of Joint:
Remarks:

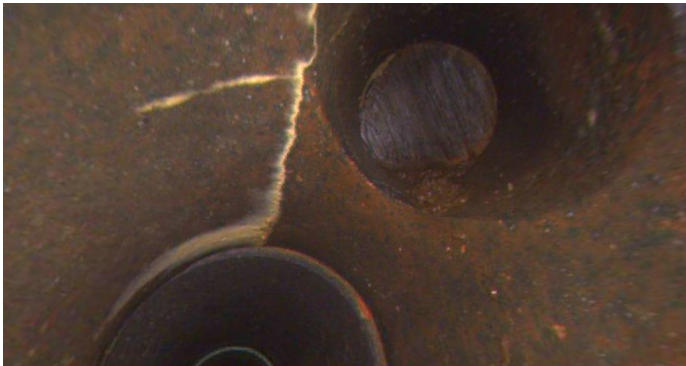
Code: **TFC**
Description: **Tap Factory Capped**

Distance (ft): **22.9**
Structural Grade: **0**
O&M Grade: **0**
Clock Start/From: **2**
Clock To:
1st Value: **4.000**
2nd Value:
Value Percent:
Continuous Index:
Within 8" of Joint:
Remarks:

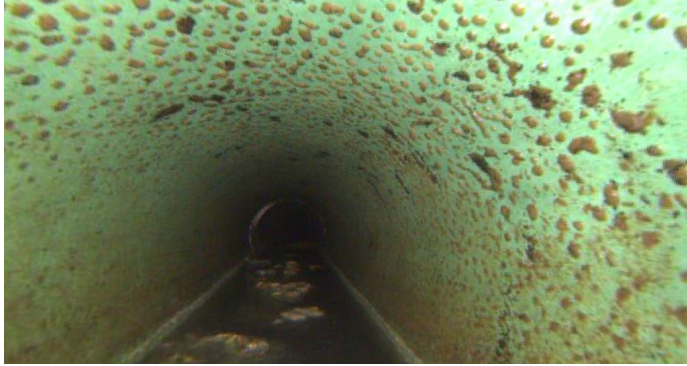
Code:	MMC
Description:	Material Change
Distance (ft):	27.2
Structural Grade:	0
O&M Grade:	0
Clock Start/From:	
Clock To:	
1st Value:	
2nd Value:	
Value Percent:	
Continuous Index:	
Within 8" of Joint:	NO
Remarks:	PVC

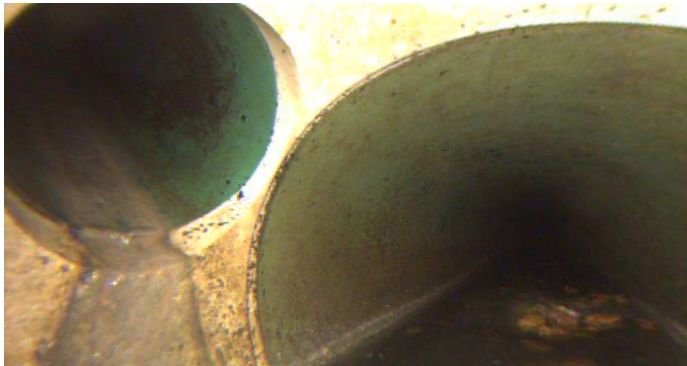
Code:	TF
Description:	Tap Factory
Distance (ft):	31.4
Structural Grade:	0
O&M Grade:	0
Clock Start/From:	10
Clock To:	
1st Value:	4.000
2nd Value:	
Value Percent:	
Continuous Index:	
Within 8" of Joint:	
Remarks:

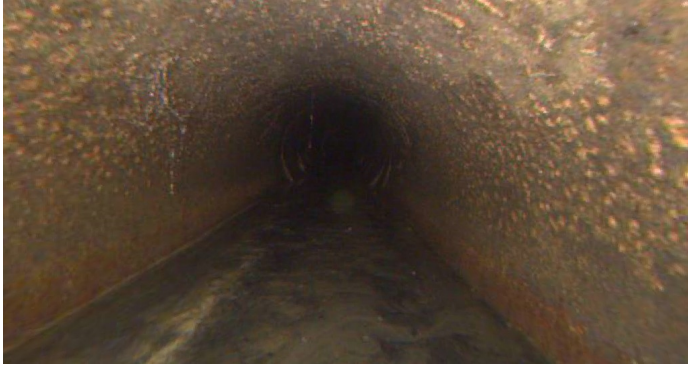
Code:	MMC
Description:	Material Change
Distance (ft):	39.4
Structural Grade:	0
O&M Grade:	0
Clock Start/From:	
Clock To:	
1st Value:	
2nd Value:	
Value Percent:	
Continuous Index:	
Within 8" of Joint:	NO
Remarks:	VCP

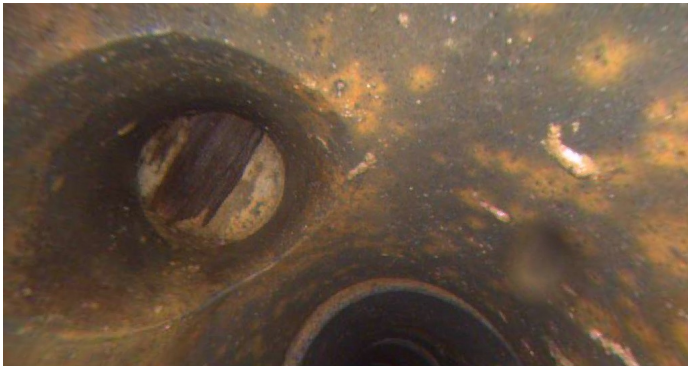
Code:	TFC
Description:	Tap Factory Capped
Distance (ft):	47.2
Structural Grade:	0
O&M Grade:	0
Clock Start/From:	10
Clock To:	
1st Value:	4.000
2nd Value:	
Value Percent:	
Continuous Index:	
Within 8" of Joint:	
Remarks:

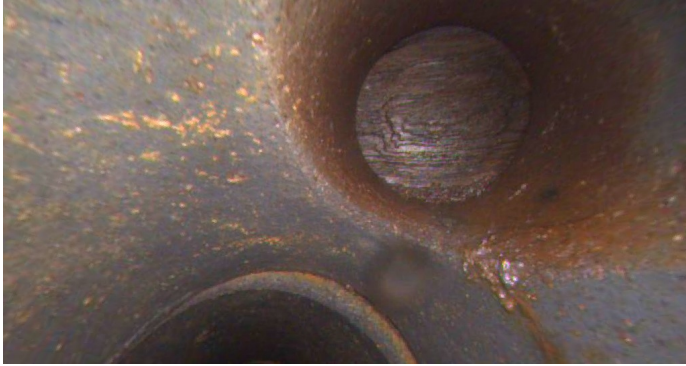
Code: **TFC**
Description: **Tap Factory Capped**

Distance (ft): **49.7**
Structural Grade: **0**
O&M Grade: **0**
Clock Start/From: **2**
Clock To:
1st Value: **4.000**
2nd Value:
Value Percent:
Continuous Index:
Within 8" of Joint:
Remarks:

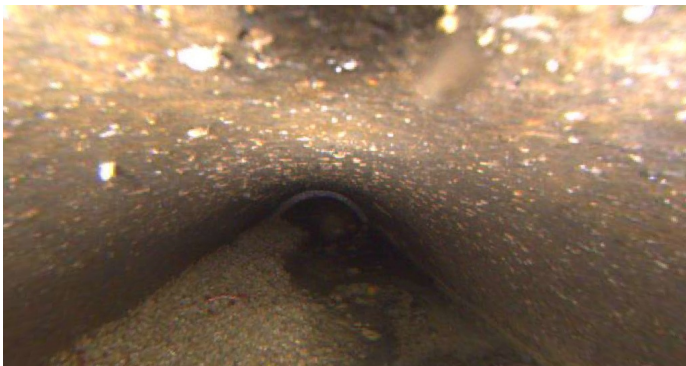
Code: **DAZ**
Description: **Deposits Attached Other**

Distance (ft): **59.7**
Structural Grade: **0**
O&M Grade: **3**
Clock Start/From: **6**
Clock To: **7**
1st Value:
2nd Value:
Value Percent: **15.000**
Continuous Index:
Within 8" of Joint: **NO**
Remarks:

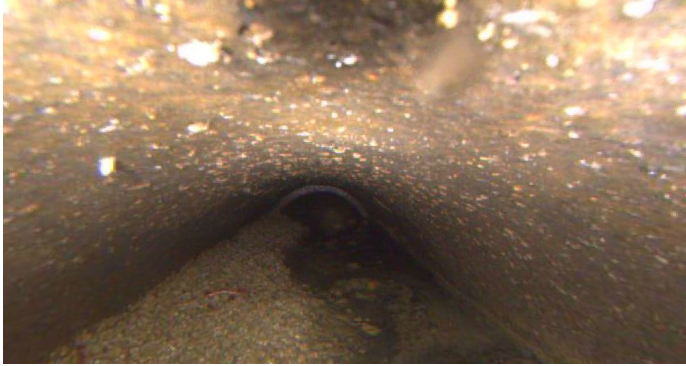
Code:	MSA
Description:	Abandoned Survey
Distance (ft):	59.7
Structural Grade:	0
O&M Grade:	0
Clock Start/From:	
Clock To:	
1st Value:	
2nd Value:	
Value Percent:	
Continuous Index:	
Within 8" of Joint:	NO
Remarks:	DAZ
