Profile/Photo Observation Report

Location Details:		Direction of Survey:	Downstream
US MH:	M-704-015	DS MH:	M-804-018
		Total Length Surveyed (ft):	59.7

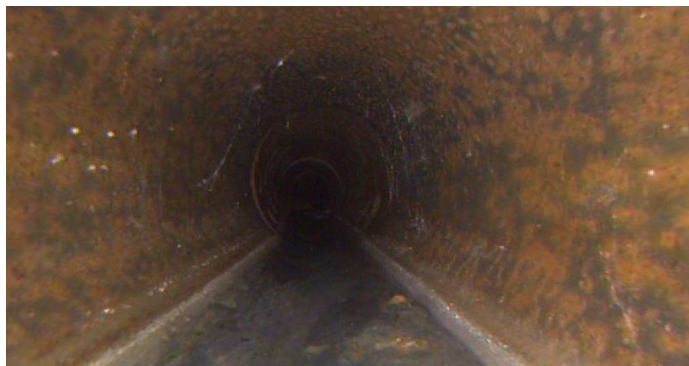
Code: **AMH**
Description: **Manhole**

Distance (ft): **.0**
Structural Grade: **0**
O&M Grade: **0**
Clock Start/From:
Clock To:
1st Value:
2nd Value:
Value Percent:
Continuous Index:
Within 8" of Joint: **NO**
Remarks: **M-704-015**

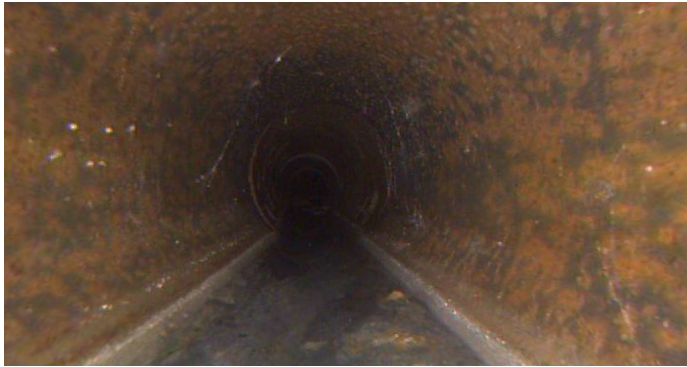
Code: **MWL**
Description: **Water Level**

Distance (ft): **.0**
Structural Grade: **0**
O&M Grade: **0**
Clock Start/From:
Clock To:
1st Value:
2nd Value:
Value Percent: **10.000**
Continuous Index:
Within 8" of Joint: **NO**
Remarks:

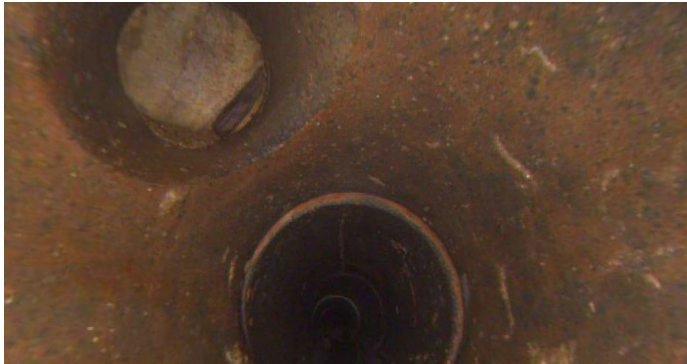
Code: **TFC**
Description: **Tap Factory Capped**

Distance (ft): **19.7**
Structural Grade: **0**
O&M Grade: **0**
Clock Start/From: **10**
Clock To:
1st Value: **4.000**
2nd Value:
Value Percent:
Continuous Index:
Within 8" of Joint:
Remarks:

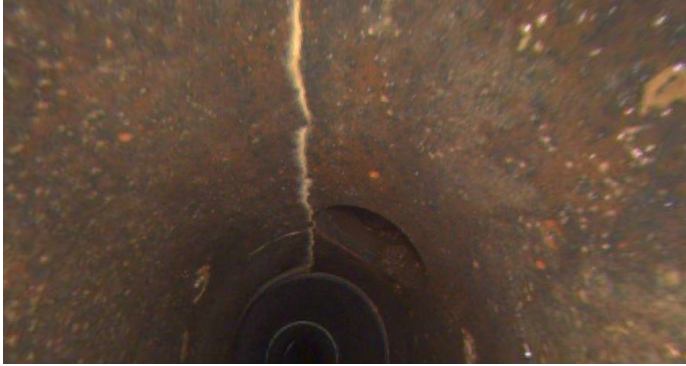
Code: **CL**
Description: **Crack Longitudinal**

Distance (ft): **21.9**
Structural Grade: **2**
O&M Grade: **0**
Clock Start/From: **12**
Clock To:
1st Value:
2nd Value:
Value Percent:
Continuous Index:
Within 8" of Joint:
Remarks:

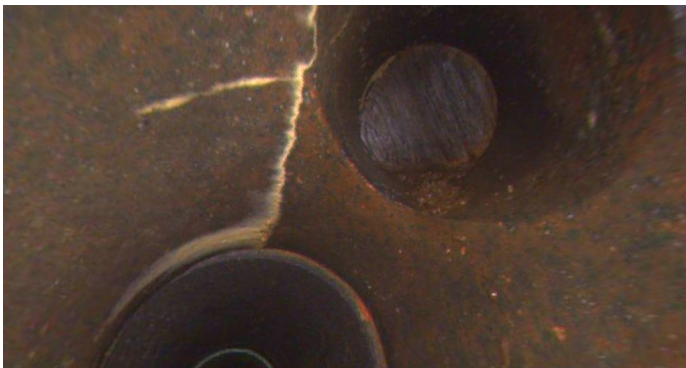
Code: **TFC**
Description: **Tap Factory Capped**

Distance (ft): **22.9**
Structural Grade: **0**
O&M Grade: **0**
Clock Start/From: **2**
Clock To:
1st Value: **4.000**
2nd Value:
Value Percent:
Continuous Index:
Within 8" of Joint:
Remarks:

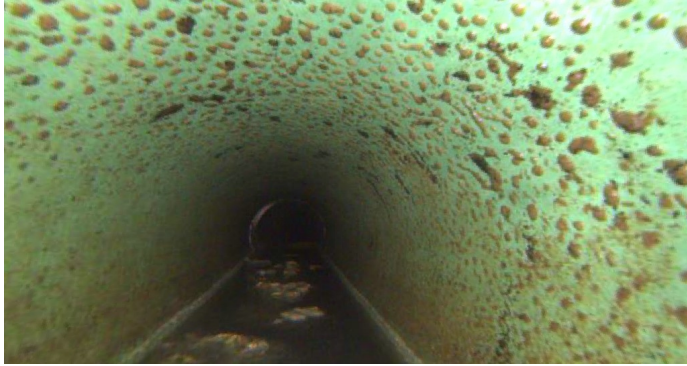
Code: **MMC**
Description: **Material Change**

Distance (ft): **27.2**
Structural Grade: **0**
O&M Grade: **0**
Clock Start/From:
Clock To:
1st Value:
2nd Value:
Value Percent:
Continuous Index:
Within 8" of Joint: **NO**
Remarks: **PVC**

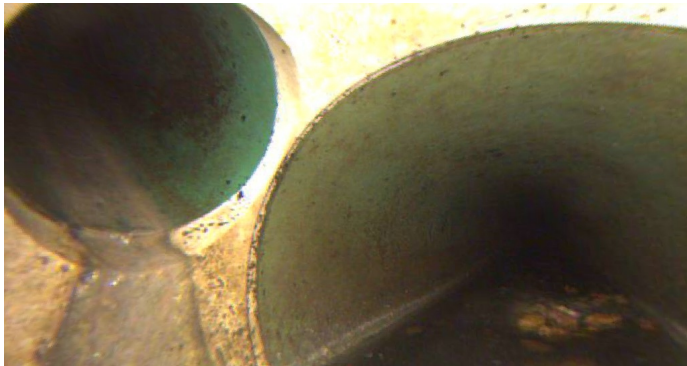
Code: **TF**
Description: **Tap Factory**

Distance (ft): **31.4**
Structural Grade: **0**
O&M Grade: **0**
Clock Start/From: **10**
Clock To:
1st Value: **4.000**
2nd Value:
Value Percent:
Continuous Index:
Within 8" of Joint:
Remarks:

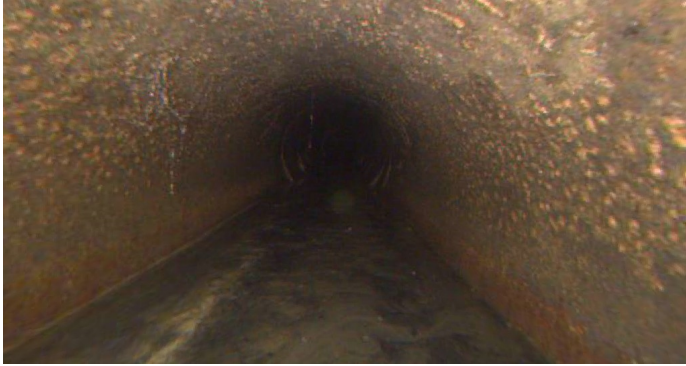
Code: **MMC**
Description: **Material Change**

Distance (ft): **39.4**
Structural Grade: **0**
O&M Grade: **0**
Clock Start/From:
Clock To:
1st Value:
2nd Value:
Value Percent:
Continuous Index:
Within 8" of Joint: **NO**
Remarks: **VCP**

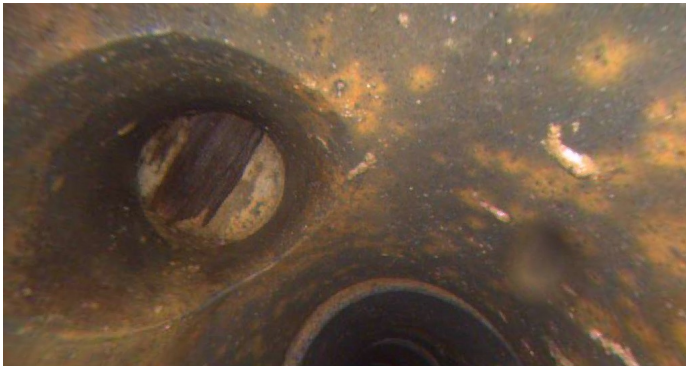
Code: **TFC**
Description: **Tap Factory Capped**

Distance (ft): **47.2**
Structural Grade: **0**
O&M Grade: **0**
Clock Start/From: **10**
Clock To:
1st Value: **4.000**
2nd Value:
Value Percent:
Continuous Index:
Within 8" of Joint:
Remarks:

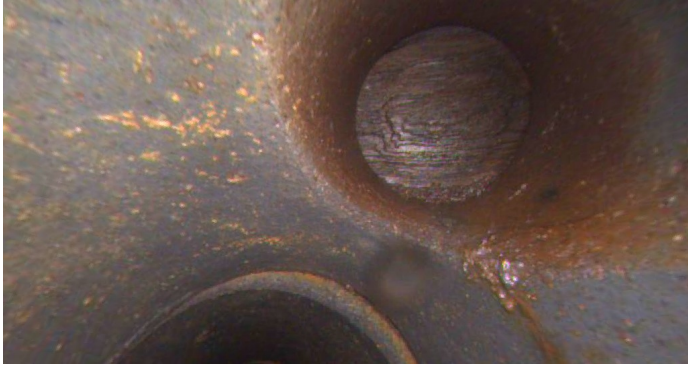
Code: **TFC**
Description: **Tap Factory Capped**

Distance (ft): **49.7**
Structural Grade: **0**
O&M Grade: **0**
Clock Start/From: **2**
Clock To:
1st Value: **4.000**
2nd Value:
Value Percent:
Continuous Index:
Within 8" of Joint:
Remarks:

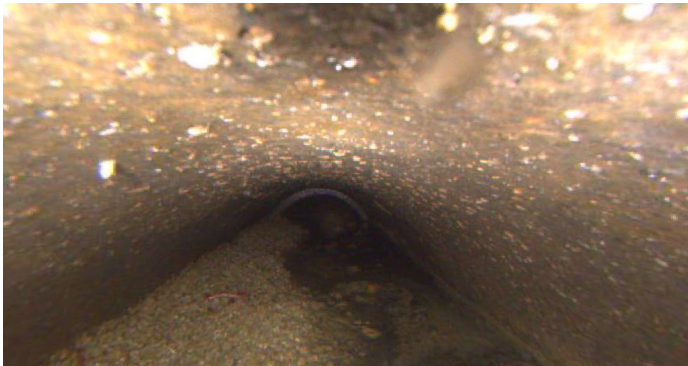
Code: **DAZ**
Description: **Deposits Attached Other**

Distance (ft): **59.7**
Structural Grade: **0**
O&M Grade: **3**
Clock Start/From: **6**
Clock To: **7**
1st Value:
2nd Value:
Value Percent: **15.000**
Continuous Index:
Within 8" of Joint: **NO**
Remarks:

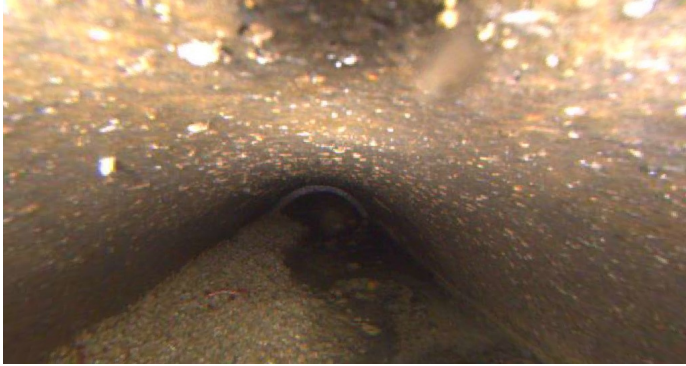
Code:	MSA
Description:	Abandoned Survey
Distance (ft):	59.7
Structural Grade:	0
O&M Grade:	0
Clock Start/From:	
Clock To:	
1st Value:	
2nd Value:	
Value Percent:	
Continuous Index:	
Within 8" of Joint:	NO
Remarks:	DAZ
