# Profile/Photo Observation Report

Date:	<b>10/10/2021</b>	Weather:		Coding:	<b>PACP 7.0</b>
Pipe Length (ft):	<b>112.4</b>	Owner:	<b>City of Hobart</b>	Pre Clean:	<b>Heavy Cleaning</b>
P.O.#:	<b>YES502259</b>	Surveyor:	<b>S. Bucklin</b>	PSR:	<b>P-804-018-015</b>
Customer:	<b>City of Hobart</b>	Clean Date:	<b>10/09/2021</b>	Shape:	<b>C</b>

Street:	<b>East Home Avenue</b>	Flow Control:	<b>Not Controlled</b>
City:	<b>Hobart, IN</b>	Year Renewed:	
Location:	<b>Local rural streets with light traffic, t</b>	Tape/Media #:	
Purpose:	<b>Routine Assessment</b>	Dia/Height:	<b>12"</b>
Use:	<b>Sanitary Sewage Pipe</b>	Material:	<b>VCP</b>
Drain Area:		Lining:	
Category:	<b>NA</b>		
Comment:			
Location Details:		Direction of Survey:	<b>Downstream</b>
US MH:	<b>M-704-015</b>	DS MH:	<b>M-804-018</b>
		Total Length Surveyed (ft):	<b>112.4</b>

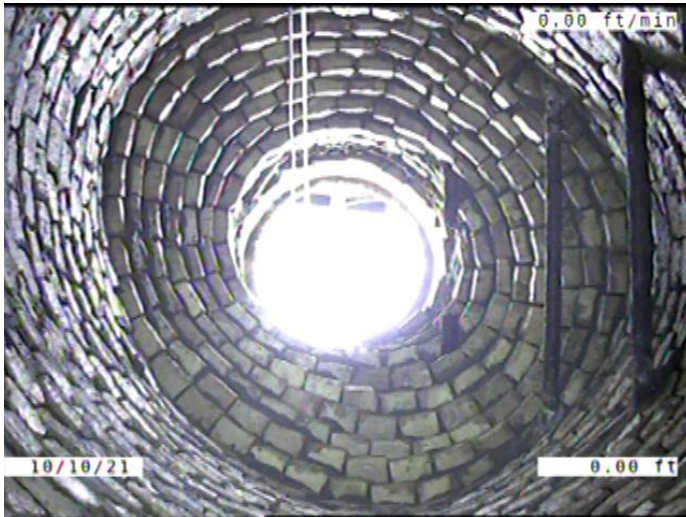
Code: **AMH**  
Description: **Manhole**

Distance (ft): **.0**  
Structural Grade: **0**  
O&M Grade: **0**  
Clock Start/From:  
Clock To:  
1st Value:  
2nd Value:  
Value Percent:  
Continuous Index:  
Within 8" of Joint: **NO**  
Remarks: **M-704-015**

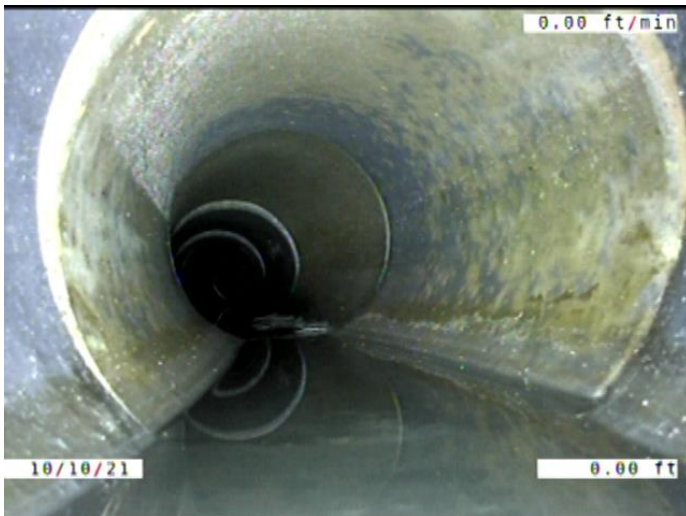
Code: **MWL**  
Description: **Miscellaneous Water Level**

Distance (ft): **.0**  
Structural Grade: **0**  
O&M Grade: **0**  
Clock Start/From:  
Clock To:  
1st Value:  
2nd Value:  
Value Percent: **5.000**  
Continuous Index:  
Within 8" of Joint: **NO**  
Remarks:

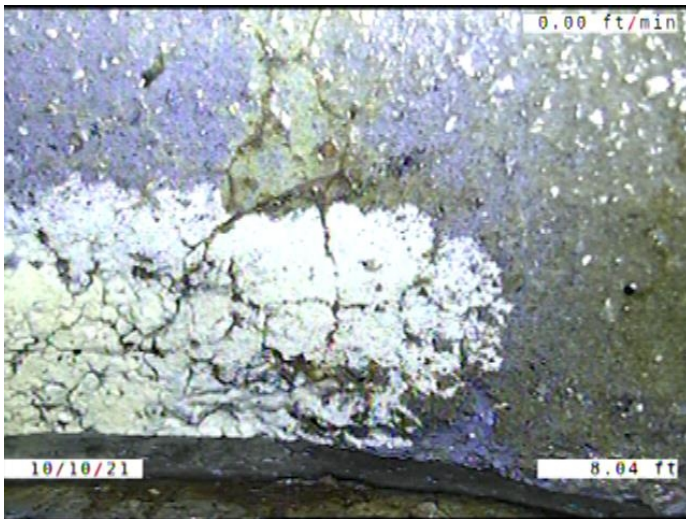
Code: **CM**  
 Description: **Crack Multiple**

Distance (ft): **8.0**  
 Structural Grade: **3**  
 O&M Grade: **0**  
 Clock Start/From: **8**  
 Clock To: **3**  
 1st Value:  
 2nd Value:  
 Value Percent:  
 Continuous Index:  
 Within 8" of Joint: **YES**  
 Remarks:

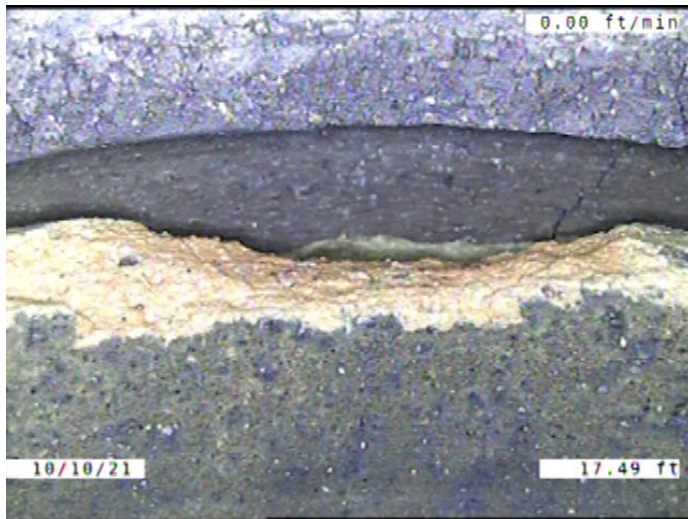
Code:	<b>SZ</b>
Description:	<b>Surface Damage Other</b>
Distance (ft):	<b>17.5</b>
Structural Grade:	<b>0</b>
O&M Grade:	<b>0</b>
Clock Start/From:	<b>11</b>
Clock To:	<b>12</b>
1st Value:	
2nd Value:	
Value Percent:	
Continuous Index:	
Within 8" of Joint:	<b>YES</b>
Remarks:	<b>A PIECE CHIPPED AWAY FROM THE JOINT</b>

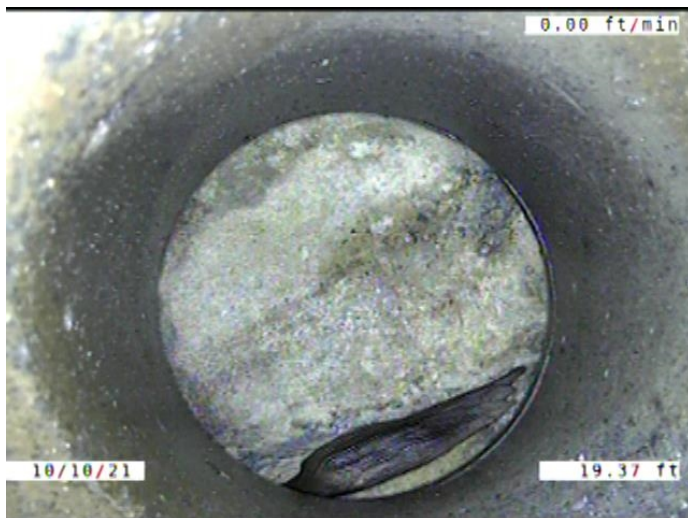
Code:	<b>TFC</b>
Description:	<b>Tap Factory Capped</b>
Distance (ft):	<b>19.4</b>
Structural Grade:	<b>0</b>
O&M Grade:	<b>0</b>
Clock Start/From:	<b>11</b>
Clock To:	
1st Value:	<b>4.000</b>
2nd Value:	
Value Percent:	
Continuous Index:	
Within 8" of Joint:	<b>YES</b>
Remarks:

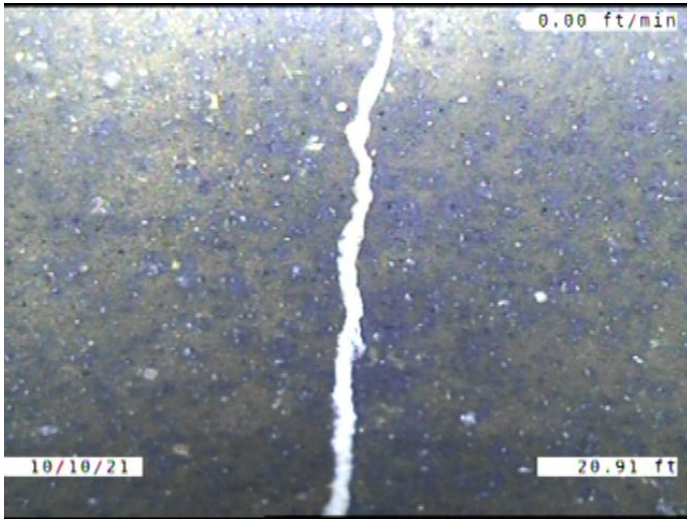
Code: **CL**  
Description: **Crack Longitudinal**

Distance (ft): **20.9**  
Structural Grade: **2**  
O&M Grade: **0**  
Clock Start/From: **12**  
Clock To:  
1st Value:  
2nd Value:  
Value Percent:  
Continuous Index:  
Within 8" of Joint: **YES**  
Remarks:

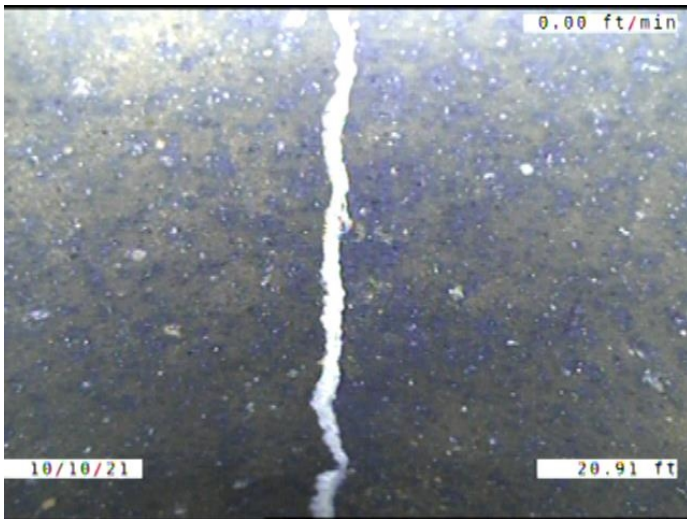
Code: **ISB**  
Description: **Infiltration Stain Barrel**

Distance (ft): **20.9**  
Structural Grade: **0**  
O&M Grade: **1**  
Clock Start/From: **10**  
Clock To: **12**  
1st Value:  
2nd Value:  
Value Percent:  
Continuous Index:  
Within 8" of Joint: **YES**  
Remarks:

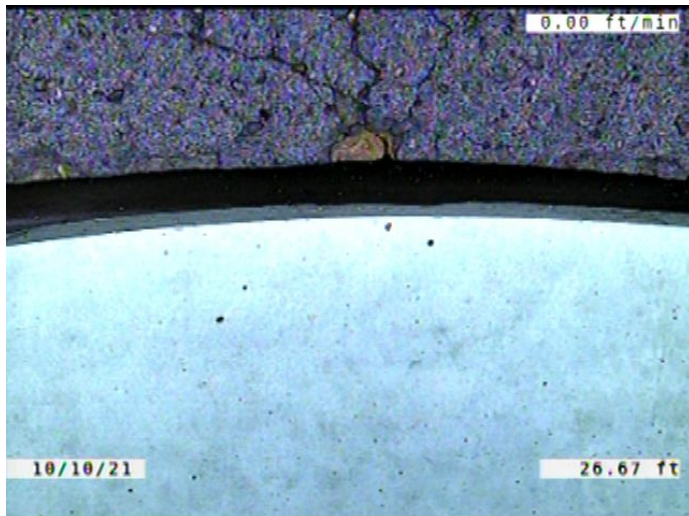
Code: **MMC**  
Description: **Miscellaneous Material Change**

Distance (ft): **26.7**  
Structural Grade: **0**  
O&M Grade: **0**  
Clock Start/From:  
Clock To:  
1st Value:  
2nd Value:  
Value Percent:  
Continuous Index:  
Within 8" of Joint: **NO**  
Remarks: **VCP TO PVC**

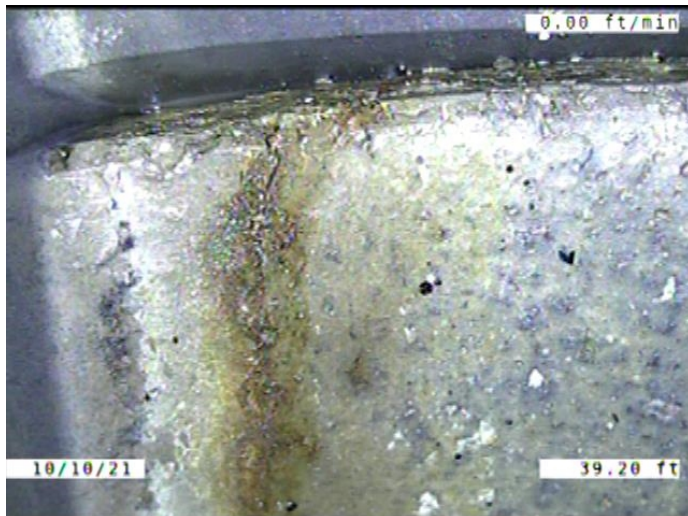
Code: **CL**  
Description: **Crack Longitudinal**

Distance (ft): **39.2**  
Structural Grade: **2**  
O&M Grade: **0**  
Clock Start/From: **8**  
Clock To:  
1st Value:  
2nd Value:  
Value Percent:  
Continuous Index:  
Within 8" of Joint: **YES**  
Remarks:

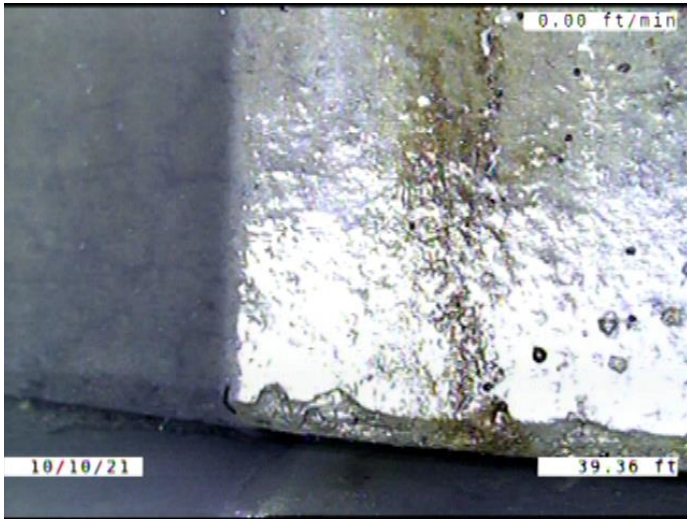
Code: **ISB**  
Description: **Infiltration Stain Barrel**

Distance (ft): **39.4**  
Structural Grade: **0**  
O&M Grade: **1**  
Clock Start/From: **4**  
Clock To:  
1st Value:  
2nd Value:  
Value Percent:  
Continuous Index:  
Within 8" of Joint: **YES**  
Remarks:

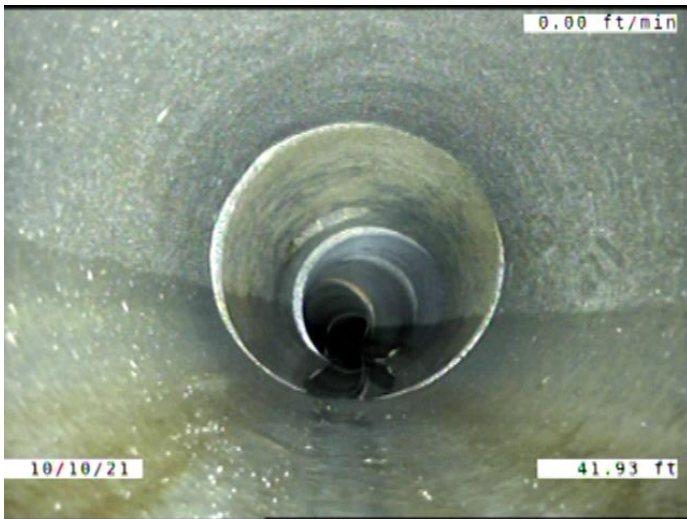
Code: **MWLS**  
Description: **Miscellaneous Water Level Sag**

Distance (ft): **41.9**  
Structural Grade: **2**  
O&M Grade: **0**  
Clock Start/From:  
Clock To:  
1st Value:  
2nd Value:  
Value Percent: **5.000**  
Continuous Index: **F02**  
Within 8" of Joint: **NO**  
Remarks:

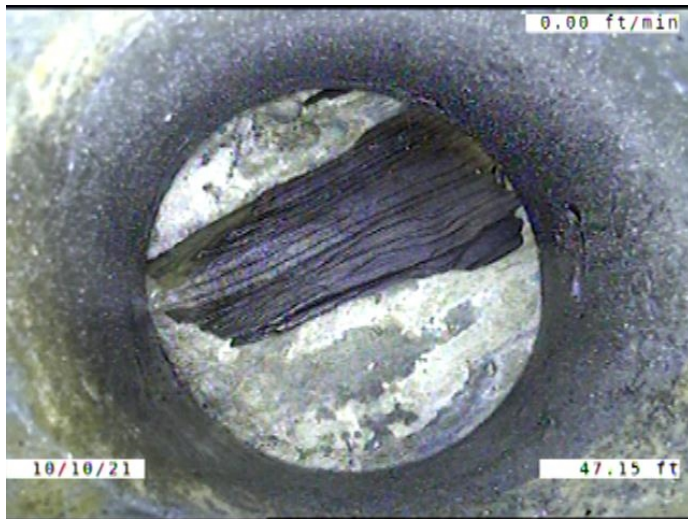
Code: **TFC**  
 Description: **Tap Factory Capped**

Distance (ft): **47.1**  
 Structural Grade: **0**  
 O&M Grade: **0**  
 Clock Start/From: **11**  
 Clock To:  
 1st Value: **4.000**  
 2nd Value:  
 Value Percent:  
 Continuous Index:  
 Within 8" of Joint: **YES**  
 Remarks:

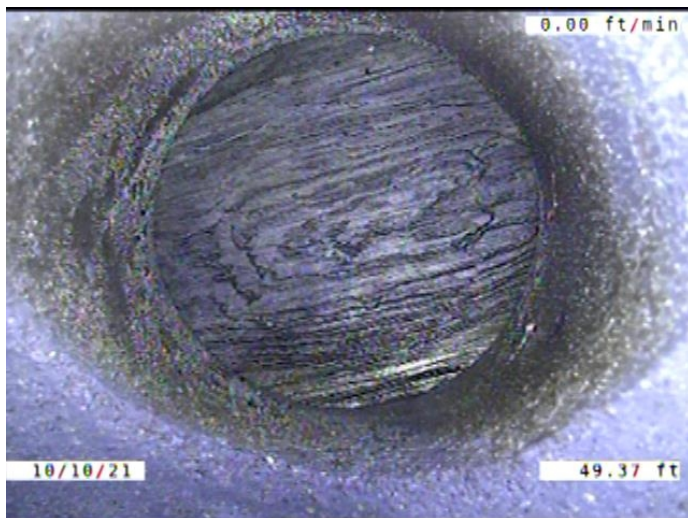
Code: **TFC**  
 Description: **Tap Factory Capped**

Distance (ft): **49.4**  
 Structural Grade: **0**  
 O&M Grade: **0**  
 Clock Start/From: **1**  
 Clock To:  
 1st Value: **4.000**  
 2nd Value:  
 Value Percent:  
 Continuous Index:  
 Within 8" of Joint: **YES**  
 Remarks:

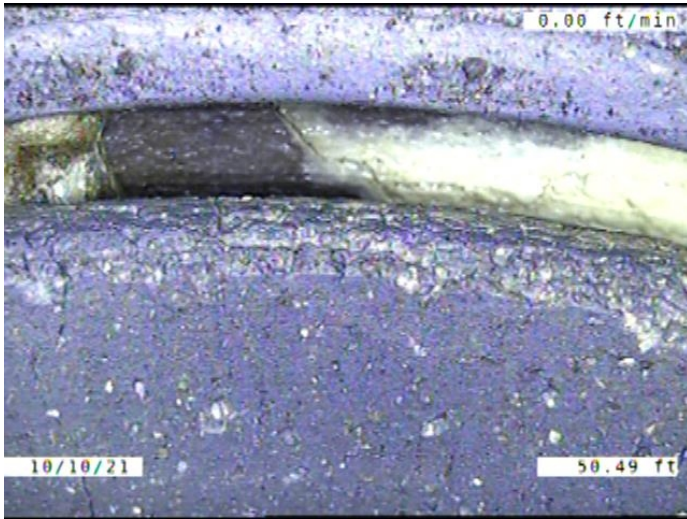
Code: **JAM**  
 Description: **Joint Angular Medium**

Distance (ft): **50.5**  
 Structural Grade: **3**  
 O&M Grade: **0**  
 Clock Start/From:  
 Clock To:  
 1st Value:  
 2nd Value:  
 Value Percent:  
 Continuous Index:  
 Within 8" of Joint: **NO**  
 Remarks:

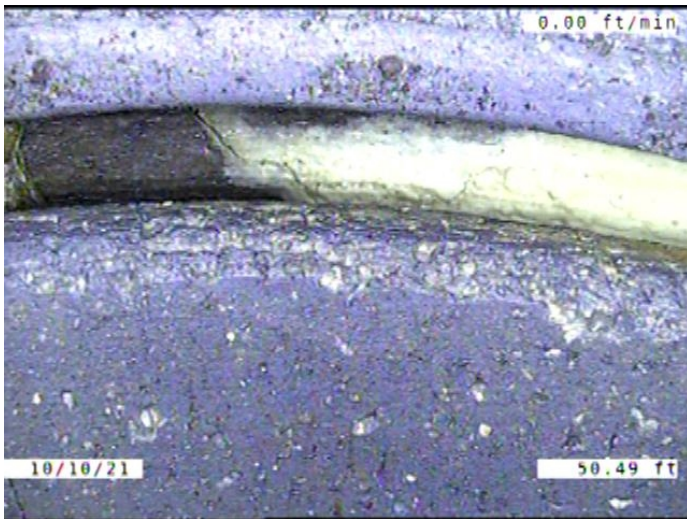
Code: **CM**  
 Description: **Crack Multiple**

Distance (ft): **50.5**  
 Structural Grade: **3**  
 O&M Grade: **0**  
 Clock Start/From: **12**  
 Clock To: **1**  
 1st Value:  
 2nd Value:  
 Value Percent:  
 Continuous Index:  
 Within 8" of Joint: **YES**  
 Remarks:

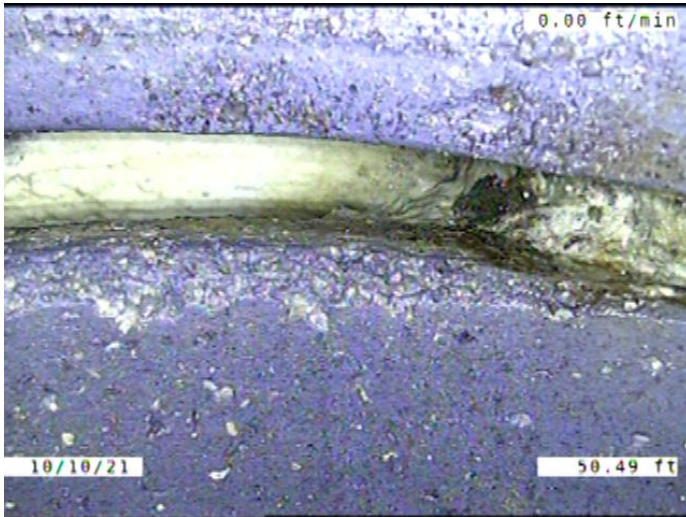
Code: **DAE**  
 Description: **Deposits Attached Encrustation**

Distance (ft): **50.5**  
 Structural Grade: **0**  
 O&M Grade: **2**  
 Clock Start/From: **1**  
 Clock To: **2**  
 1st Value:  
 2nd Value:  
 Value Percent: **5.000**  
 Continuous Index:  
 Within 8" of Joint: **YES**  
 Remarks:

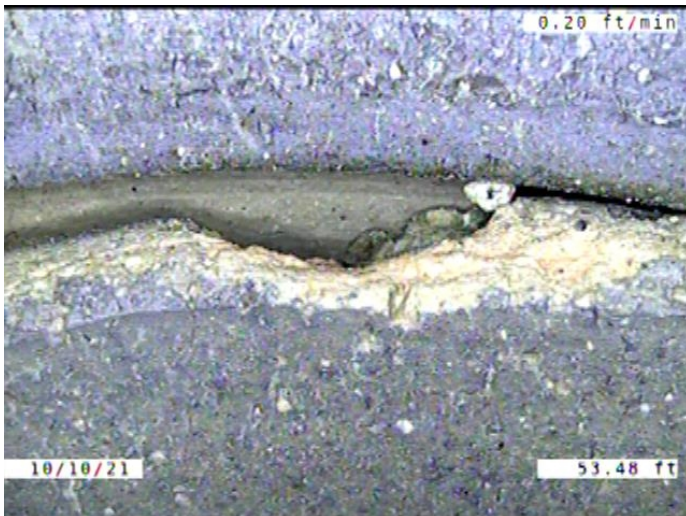
Code: **SZ**  
 Description: **Surface Damage Other**

Distance (ft): **53.5**  
 Structural Grade: **0**  
 O&M Grade: **0**  
 Clock Start/From: **1**  
 Clock To:  
 1st Value:  
 2nd Value:  
 Value Percent:  
 Continuous Index:  
 Within 8" of Joint: **YES**  
 Remarks: **A PIECE OF THE JOINT CHIPPED AWAY**

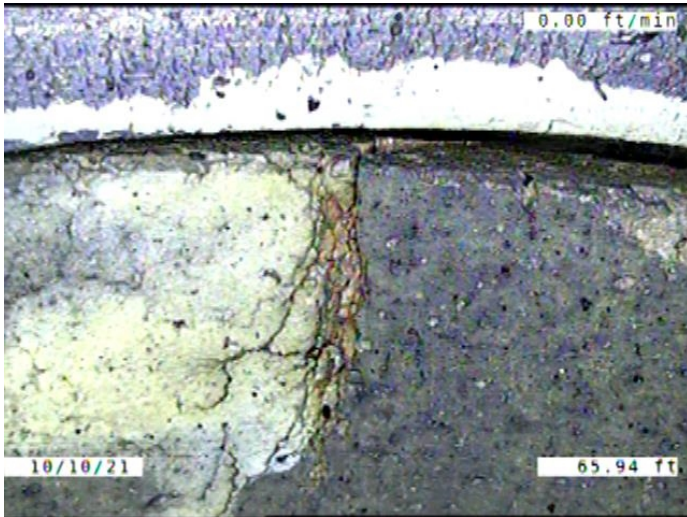
Code: **FM**  
 Description: **Fracture Multiple**

Distance (ft): **65.9**  
 Structural Grade: **4**  
 O&M Grade: **0**  
 Clock Start/From: **9**  
 Clock To: **1**  
 1st Value:  
 2nd Value:  
 Value Percent:  
 Continuous Index:  
 Within 8" of Joint: **YES**  
 Remarks:

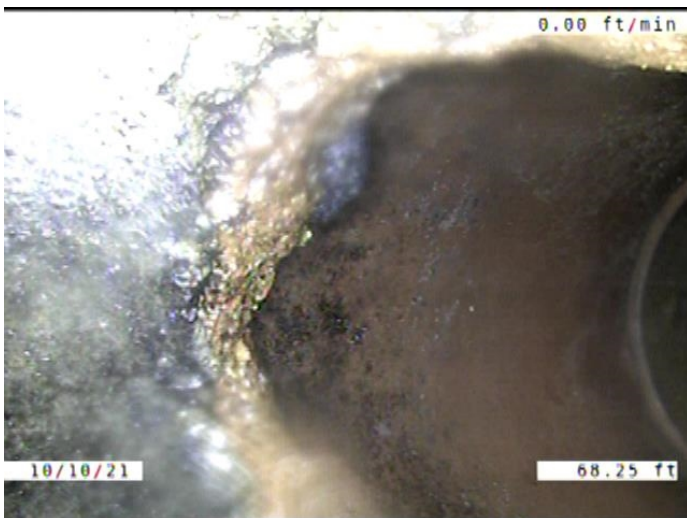
Code: **SSS**  
 Description: **Surface Damage Surface Spalling**

Distance (ft): **68.2**  
 Structural Grade: **2**  
 O&M Grade: **0**  
 Clock Start/From: **1**  
 Clock To: **2**  
 1st Value:  
 2nd Value:  
 Value Percent:  
 Continuous Index:  
 Within 8" of Joint: **YES**  
 Remarks:

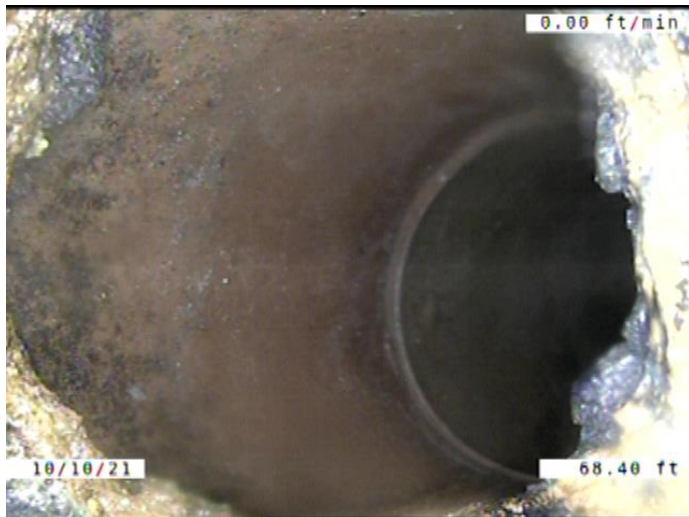
Code: **TB**  
 Description: **Tap Break-in/Hammer**

Distance (ft): **68.4**  
 Structural Grade: **0**  
 O&M Grade: **0**  
 Clock Start/From: **1**  
 Clock To:  
 1st Value: **4.000**  
 2nd Value:  
 Value Percent:  
 Continuous Index:  
 Within 8" of Joint: **YES**  
 Remarks:

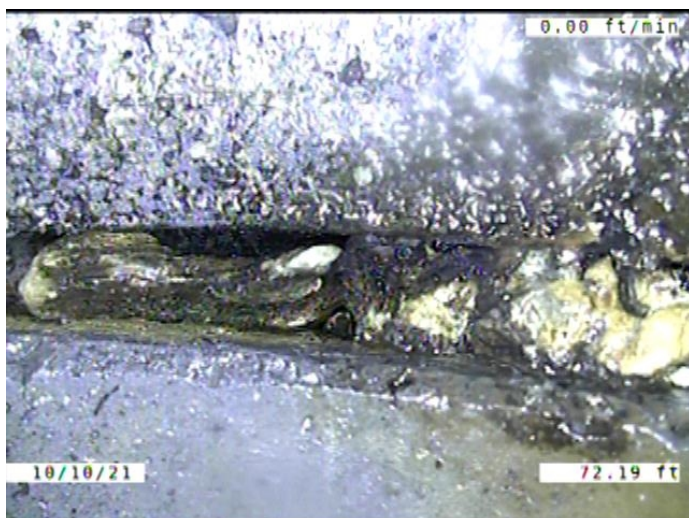
Code: **DAE**  
 Description: **Deposits Attached Encrustation**

Distance (ft): **72.2**  
 Structural Grade: **0**  
 O&M Grade: **2**  
 Clock Start/From: **2**  
 Clock To: **3**  
 1st Value:  
 2nd Value:  
 Value Percent: **5.000**  
 Continuous Index:  
 Within 8" of Joint: **YES**  
 Remarks:

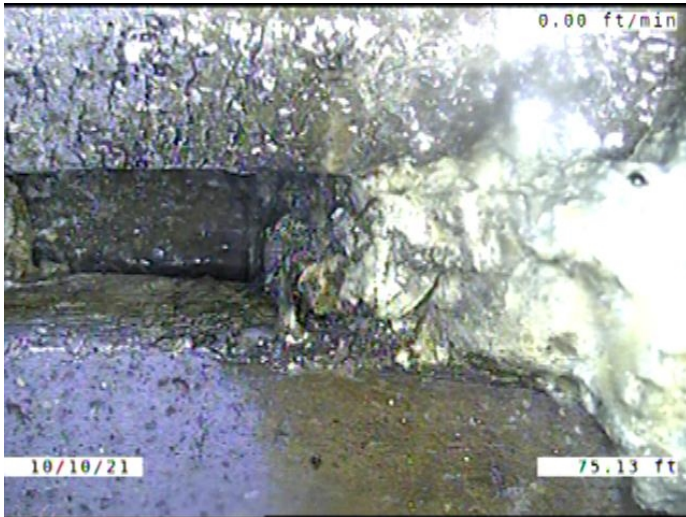
Code: **DAE**  
 Description: **Deposits Attached Encrustation**

Distance (ft): **75.1**  
 Structural Grade: **0**  
 O&M Grade: **2**  
 Clock Start/From: **2**  
 Clock To: **3**  
 1st Value:  
 2nd Value:  
 Value Percent: **5.000**  
 Continuous Index:  
 Within 8" of Joint: **YES**  
 Remarks:

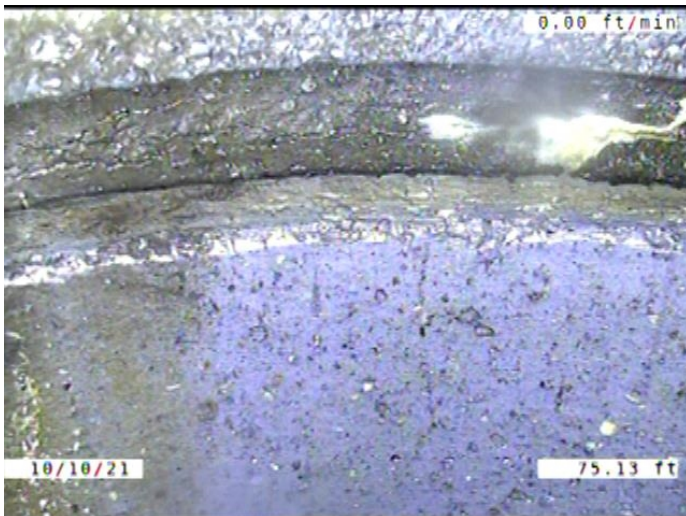
Code: **CM**  
 Description: **Crack Multiple**

Distance (ft): **75.1**  
 Structural Grade: **3**  
 O&M Grade: **0**  
 Clock Start/From: **9**  
 Clock To: **11**  
 1st Value:  
 2nd Value:  
 Value Percent:  
 Continuous Index:  
 Within 8" of Joint: **YES**  
 Remarks:

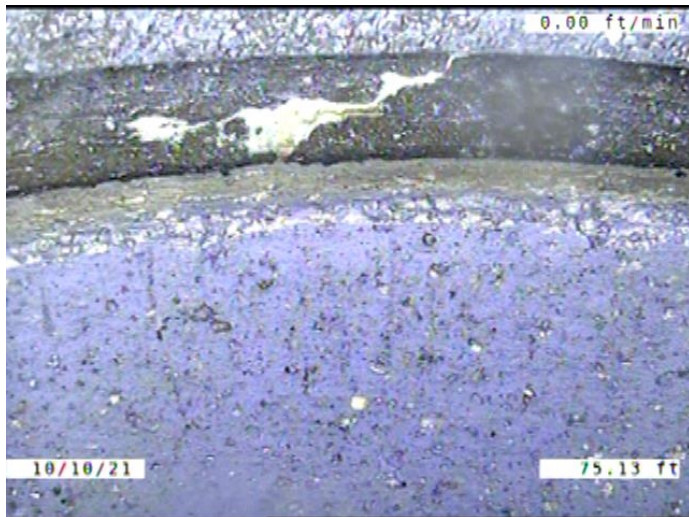
Code: **ISJ**  
 Description: **Infiltration Stain Joint**

Distance (ft): **75.1**  
 Structural Grade: **0**  
 O&M Grade: **1**  
 Clock Start/From: **10**  
 Clock To:  
 1st Value:  
 2nd Value:  
 Value Percent:  
 Continuous Index:  
 Within 8" of Joint: **YES**  
 Remarks:

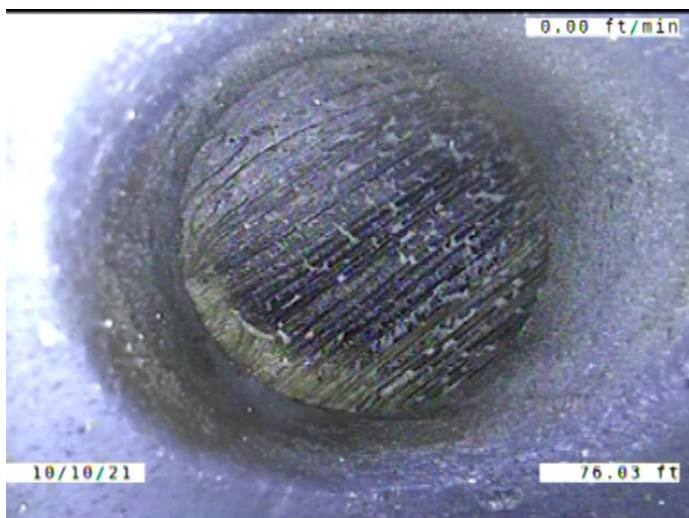
Code: **TFC**  
 Description: **Tap Factory Capped**

Distance (ft): **76.0**  
 Structural Grade: **0**  
 O&M Grade: **0**  
 Clock Start/From: **11**  
 Clock To:  
 1st Value: **4.000**  
 2nd Value:  
 Value Percent:  
 Continuous Index:  
 Within 8" of Joint: **YES**  
 Remarks:

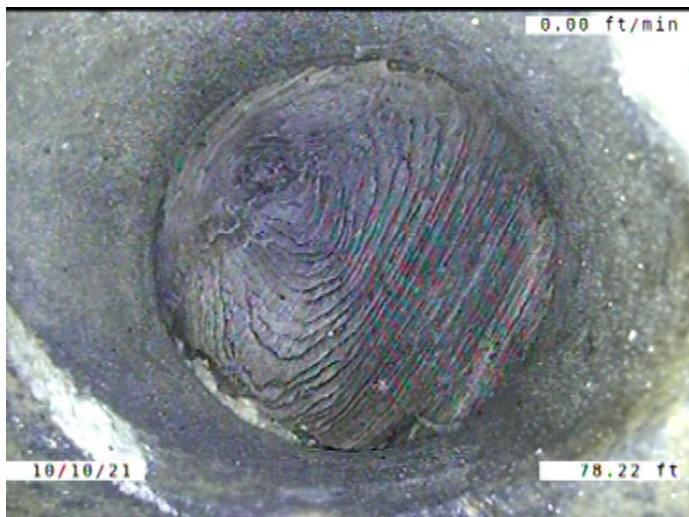
Code: **TFC**  
 Description: **Tap Factory Capped**

Distance (ft): **78.2**  
 Structural Grade: **0**  
 O&M Grade: **0**  
 Clock Start/From: **1**  
 Clock To:  
 1st Value: **4.000**  
 2nd Value:  
 Value Percent:  
 Continuous Index:  
 Within 8" of Joint: **YES**  
 Remarks:

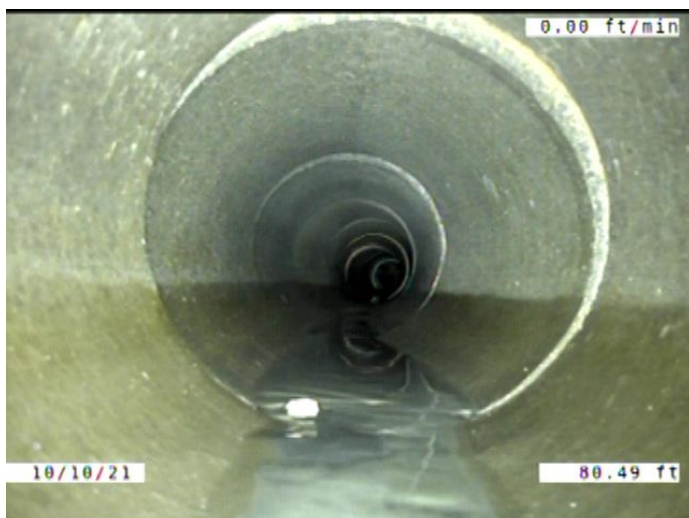
Code: **MWLS**  
 Description: **Miscellaneous Water Level Sag**

Distance (ft): **80.5**  
 Structural Grade: **2**  
 O&M Grade: **0**  
 Clock Start/From:  
 Clock To:  
 1st Value:  
 2nd Value:  
 Value Percent: **10.000**  
 Continuous Index: **F03**  
 Within 8" of Joint: **NO**  
 Remarks:

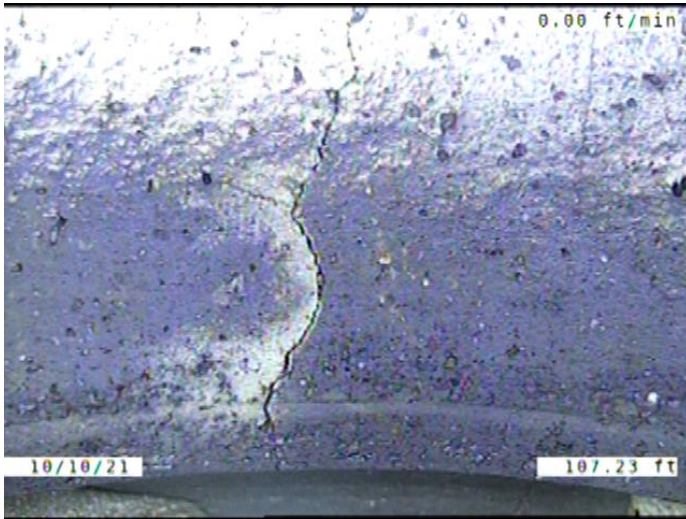
Code: **ISB**  
Description: **Infiltration Stain Barrel**

Distance (ft): **107.2**  
Structural Grade: **0**  
O&M Grade: **1**  
Clock Start/From: **11**  
Clock To:  
1st Value:  
2nd Value:  
Value Percent:  
Continuous Index:  
Within 8" of Joint: **YES**  
Remarks:

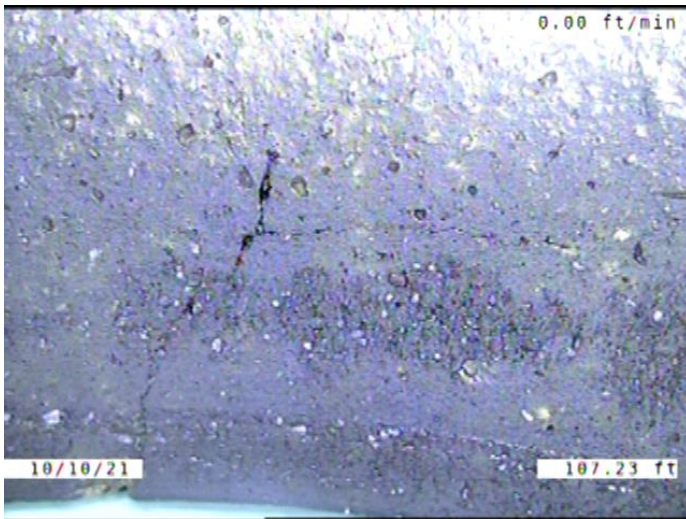
Code: **CM**  
Description: **Crack Multiple**

Distance (ft): **107.2**  
Structural Grade: **3**  
O&M Grade: **0**  
Clock Start/From: **2**  
Clock To: **3**  
1st Value:  
2nd Value:  
Value Percent:  
Continuous Index:  
Within 8" of Joint: **YES**  
Remarks:

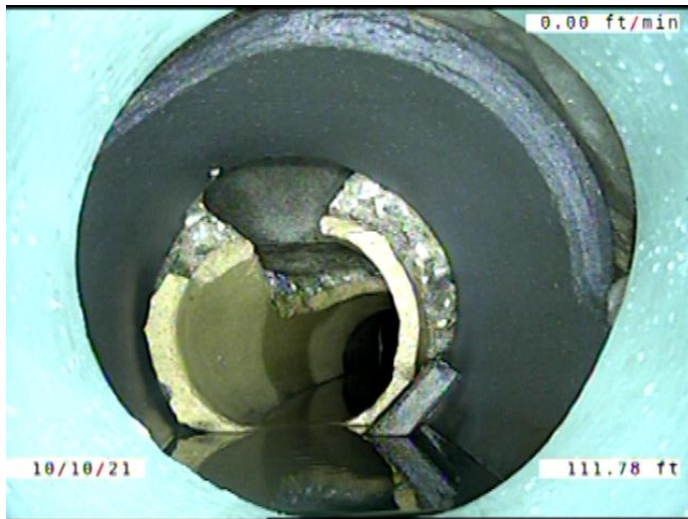
Code: **JOMD**  
Description: **Joint Offset Medium Defective**

Distance (ft): **111.8**  
Structural Grade: **3**  
O&M Grade: **0**  
Clock Start/From:  
Clock To:  
1st Value:  
2nd Value:  
Value Percent:  
Continuous Index:  
Within 8" of Joint: **NO**  
Remarks:

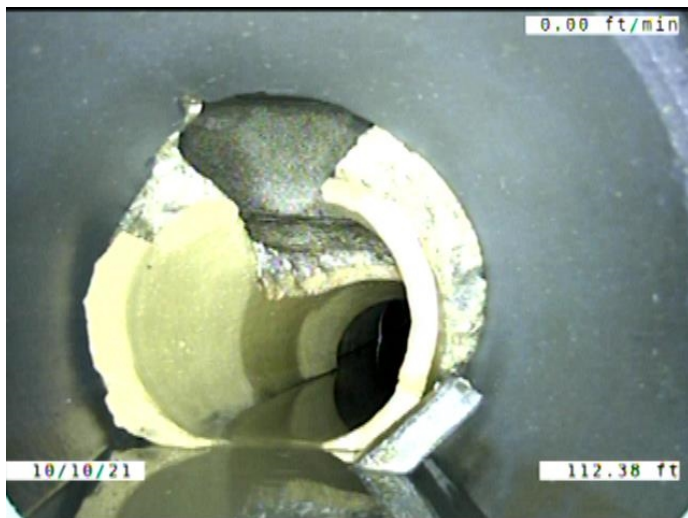
Code: **DSF**  
Description: **Deposits Settled Fine**

Distance (ft): **112.4**  
Structural Grade: **0**  
O&M Grade: **2**  
Clock Start/From: **5**  
Clock To: **7**  
1st Value:  
2nd Value:  
Value Percent: **5.000**  
Continuous Index: **F01**  
Within 8" of Joint: **YES**  
Remarks:

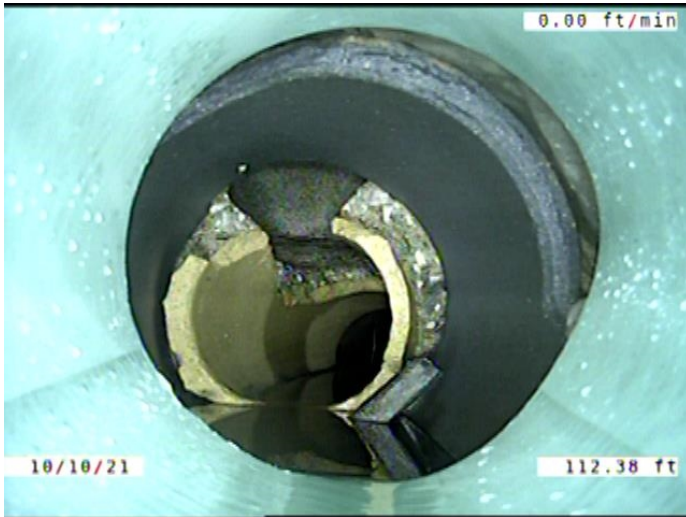
Code: **MGO**  
 Description: **Miscellaneous General Observation**

Distance (ft): **112.4**  
 Structural Grade: **0**  
 O&M Grade: **0**  
 Clock Start/From:  
 Clock To:  
 1st Value:  
 2nd Value:  
 Value Percent:  
 Continuous Index:  
 Within 8" of Joint: **NO**  
 Remarks: **PIPE IS BROKEN AND THE NEXT PIPE SECTION CHANGES SIZES. IT DOES T**

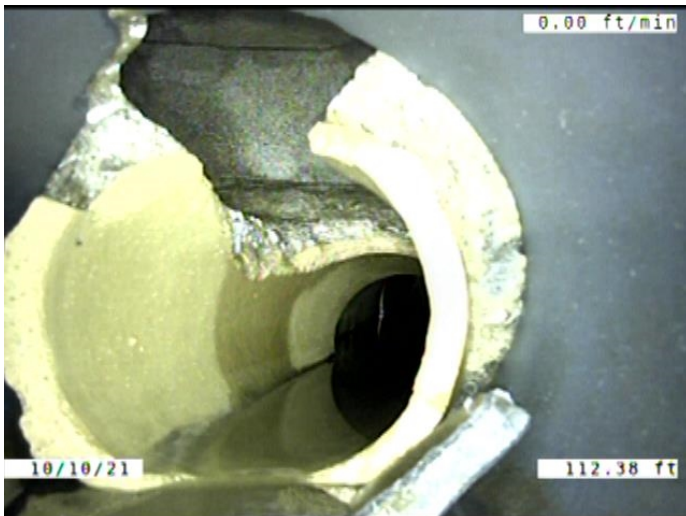
Code: **MSA**  
 Description: **Miscellaneous Survey Abandoned**

Distance (ft): **112.4**  
 Structural Grade: **0**  
 O&M Grade: **0**  
 Clock Start/From:  
 Clock To:  
 1st Value:  
 2nd Value:  
 Value Percent:  
 Continuous Index:  
 Within 8" of Joint: **NO**  
 Remarks: **CAMERA CANT FIT INTO 8" PIPE. PIPE CHANGES AT THE MANHOLE**
