Profile/Photo Observation Report

Date:	10/10/2021	Weather:		Coding:	PACP 7.0
Pipe Length (ft):	112.4	Owner:	City of Hobart	Pre Clean:	Heavy Cleaning
P.O.#:	YES502259	Surveyor:	S. Bucklin	PSR:	P-804-018-015
Customer:	City of Hobart	Clean Date:	10/09/2021	Shape:	C

Street:	East Home Avenue	Flow Control:	Not Controlled
City:	Hobart, IN	Year Renewed:	
Location:	Local rural streets with light traffic, t	Tape/Media #:	
Purpose:	Routine Assessment	Dia/Height:	12"
Use:	Sanitary Sewage Pipe	Material:	VCP
Drain Area:		Lining:	
Category:	NA		
Comment:			
Location Details:		Direction of Survey:	Downstream
US MH:	M-704-015	DS MH:	M-804-018
		Total Length Surveyed (ft):	112.4

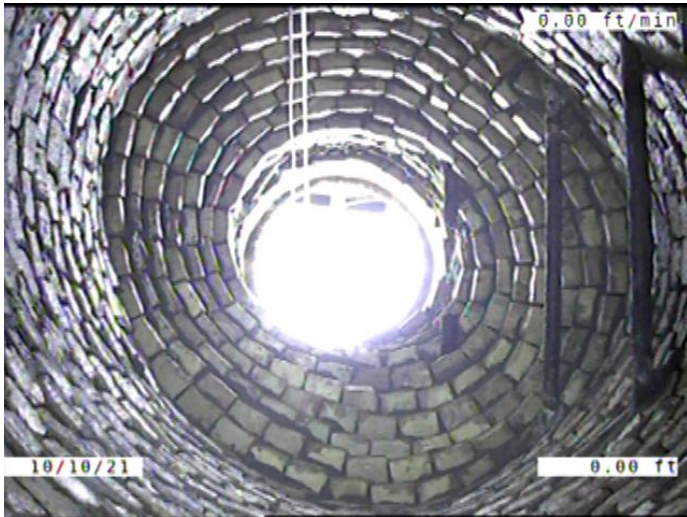
Code: **AMH**
 Description: **Manhole**

Distance (ft): **.0**
 Structural Grade: **0**
 O&M Grade: **0**
 Clock Start/From:
 Clock To:
 1st Value:
 2nd Value:
 Value Percent:
 Continuous Index:
 Within 8" of Joint: **NO**
 Remarks: **M-704-015**

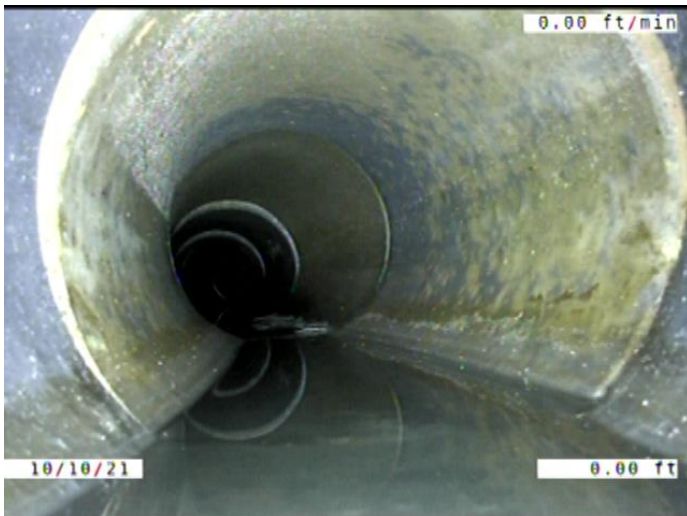
Code: **MWL**
 Description: **Miscellaneous Water Level**

Distance (ft): **.0**
 Structural Grade: **0**
 O&M Grade: **0**
 Clock Start/From:
 Clock To:
 1st Value:
 2nd Value:
 Value Percent: **5.000**
 Continuous Index:
 Within 8" of Joint: **NO**
 Remarks:

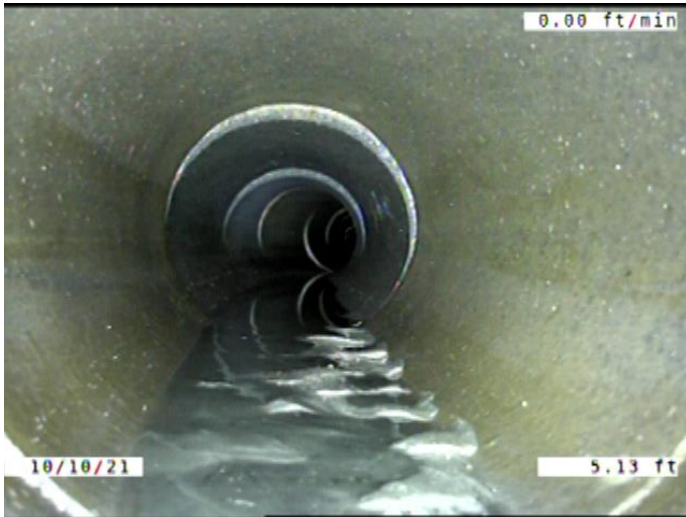
Code: **DSF**
Description: **Deposits Settled Fine**

Distance (ft): **5.1**
Structural Grade: **0**
O&M Grade: **2**
Clock Start/From: **5**
Clock To: **7**
1st Value:
2nd Value:
Value Percent: **5.000**
Continuous Index: **S01**
Within 8" of Joint: **YES**
Remarks:

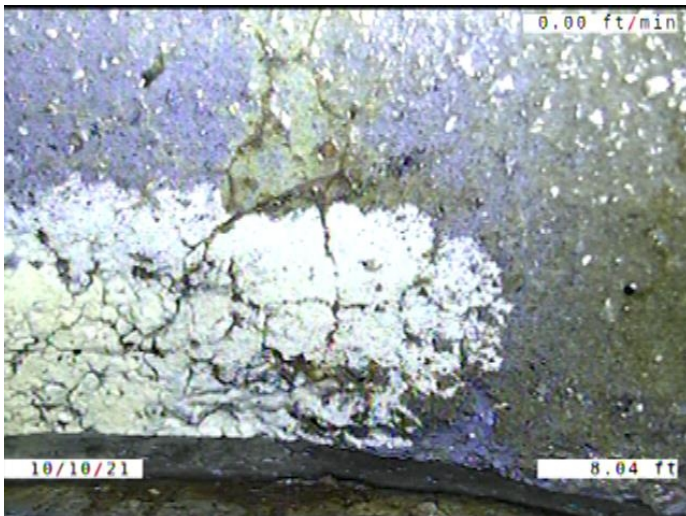
Code: **CM**
Description: **Crack Multiple**

Distance (ft): **8.0**
Structural Grade: **3**
O&M Grade: **0**
Clock Start/From: **8**
Clock To: **3**
1st Value:
2nd Value:
Value Percent:
Continuous Index:
Within 8" of Joint: **YES**
Remarks:

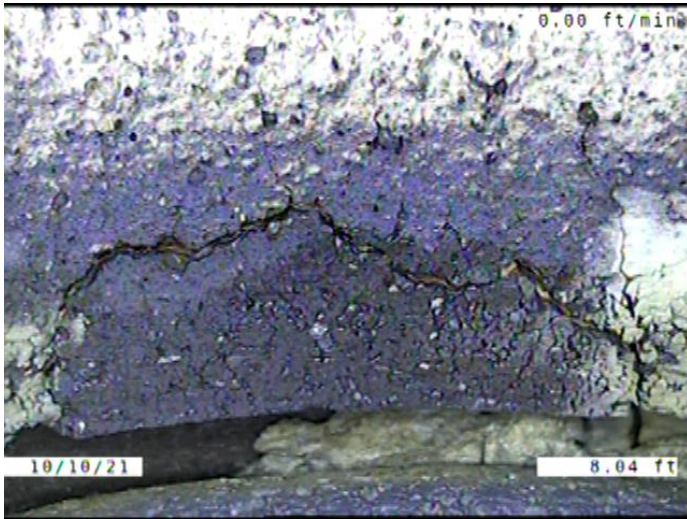
Code: **FM**
 Description: **Fracture Multiple**

Distance (ft): **8.0**
 Structural Grade: **4**
 O&M Grade: **0**
 Clock Start/From: **11**
 Clock To: **12**
 1st Value:
 2nd Value:
 Value Percent:
 Continuous Index:
 Within 8" of Joint: **YES**
 Remarks:

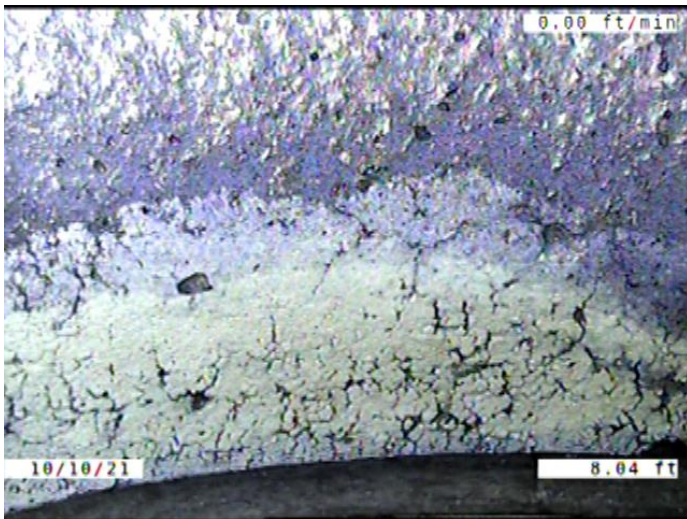
Code: **ISB**
 Description: **Infiltration Stain Barrel**

Distance (ft): **8.0**
 Structural Grade: **0**
 O&M Grade: **1**
 Clock Start/From: **9**
 Clock To: **3**
 1st Value:
 2nd Value:
 Value Percent:
 Continuous Index:
 Within 8" of Joint: **YES**
 Remarks:

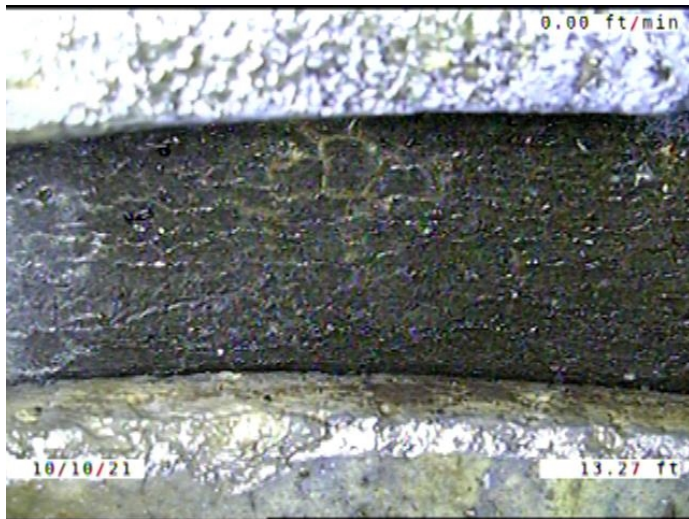
Code: **JAM**
 Description: **Joint Angular Medium**

Distance (ft): **13.3**
 Structural Grade: **3**
 O&M Grade: **0**
 Clock Start/From:
 Clock To:
 1st Value:
 2nd Value:
 Value Percent:
 Continuous Index:
 Within 8" of Joint: **NO**
 Remarks:

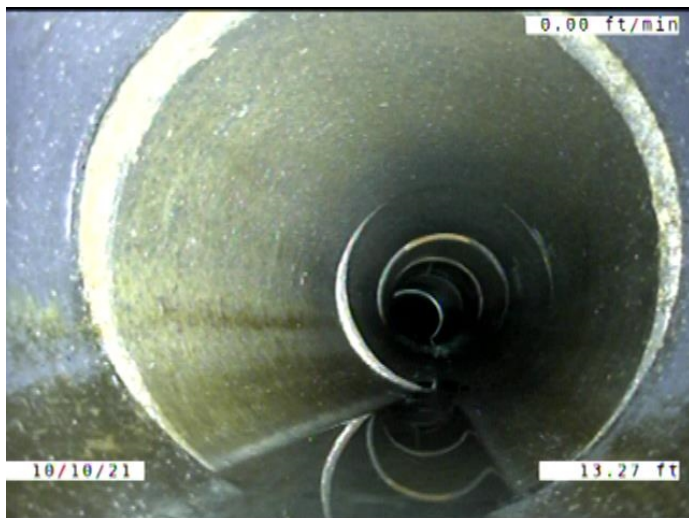
Code: **LR**
 Description: **Line Right**

Distance (ft): **13.3**
 Structural Grade: **0**
 O&M Grade: **1**
 Clock Start/From:
 Clock To:
 1st Value:
 2nd Value:
 Value Percent: **5.000**
 Continuous Index:
 Within 8" of Joint: **NO**
 Remarks:

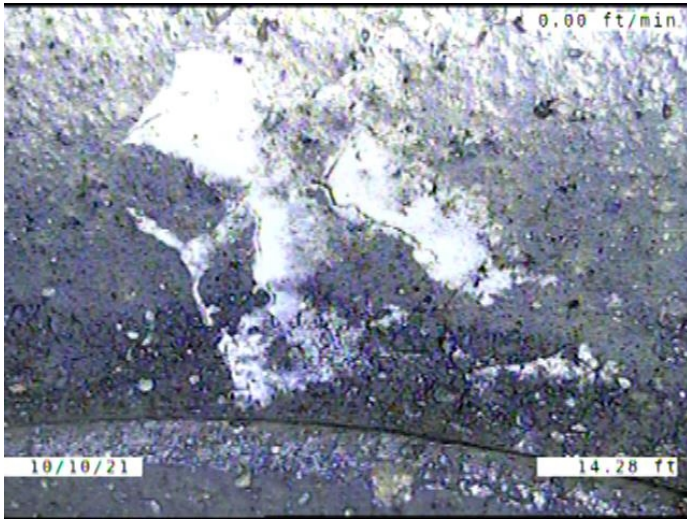
Code: **CM**
 Description: **Crack Multiple**

Distance (ft): **14.3**
 Structural Grade: **3**
 O&M Grade: **0**
 Clock Start/From: **1**
 Clock To: **2**
 1st Value:
 2nd Value:
 Value Percent:
 Continuous Index:
 Within 8" of Joint: **YES**
 Remarks:

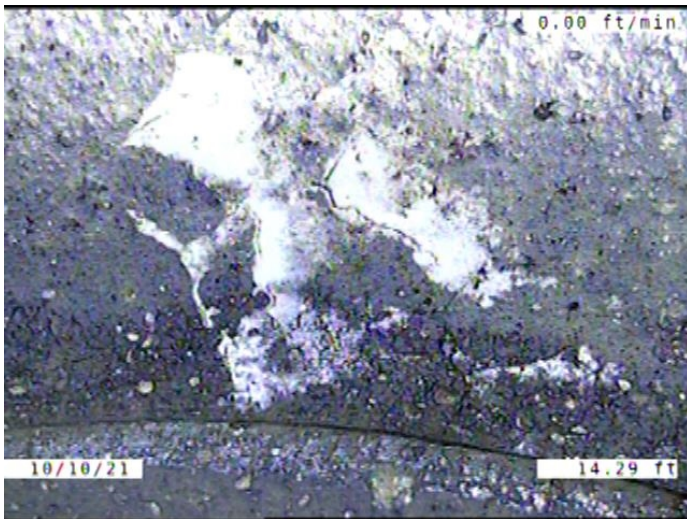
Code: **ISB**
 Description: **Infiltration Stain Barrel**

Distance (ft): **14.3**
 Structural Grade: **0**
 O&M Grade: **1**
 Clock Start/From: **1**
 Clock To: **2**
 1st Value:
 2nd Value:
 Value Percent:
 Continuous Index:
 Within 8" of Joint: **YES**
 Remarks:

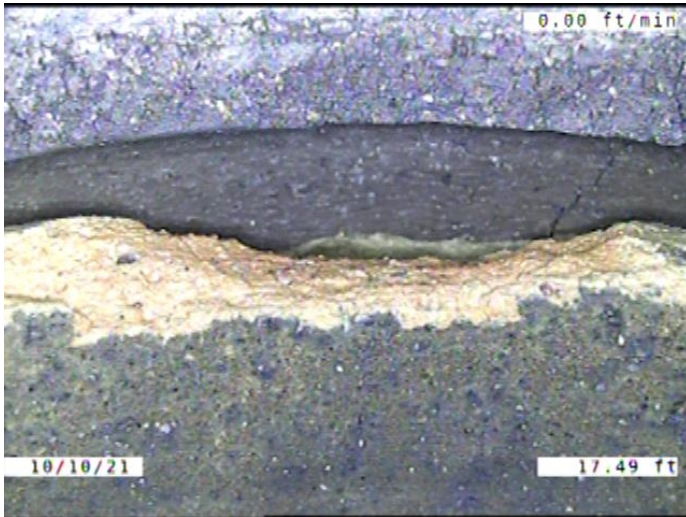
Code:	SZ
Description:	Surface Damage Other
Distance (ft):	17.5
Structural Grade:	0
O&M Grade:	0
Clock Start/From:	11
Clock To:	12
1st Value:	
2nd Value:	
Value Percent:	
Continuous Index:	
Within 8" of Joint:	YES
Remarks:	A PIECE CHIPPED AWAY FROM THE JOINT

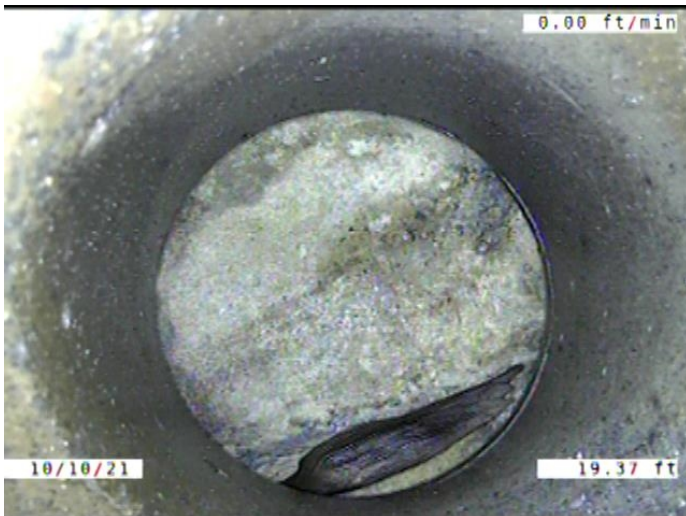
Code:	TFC
Description:	Tap Factory Capped
Distance (ft):	19.4
Structural Grade:	0
O&M Grade:	0
Clock Start/From:	11
Clock To:	
1st Value:	4.000
2nd Value:	
Value Percent:	
Continuous Index:	
Within 8" of Joint:	YES
Remarks:

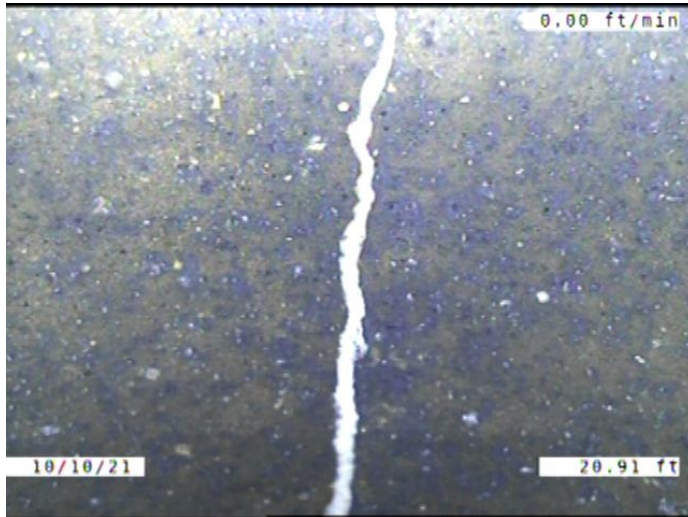
Code: **CL**
 Description: **Crack Longitudinal**

Distance (ft): **20.9**
 Structural Grade: **2**
 O&M Grade: **0**
 Clock Start/From: **12**
 Clock To:
 1st Value:
 2nd Value:
 Value Percent:
 Continuous Index:
 Within 8" of Joint: **YES**
 Remarks:

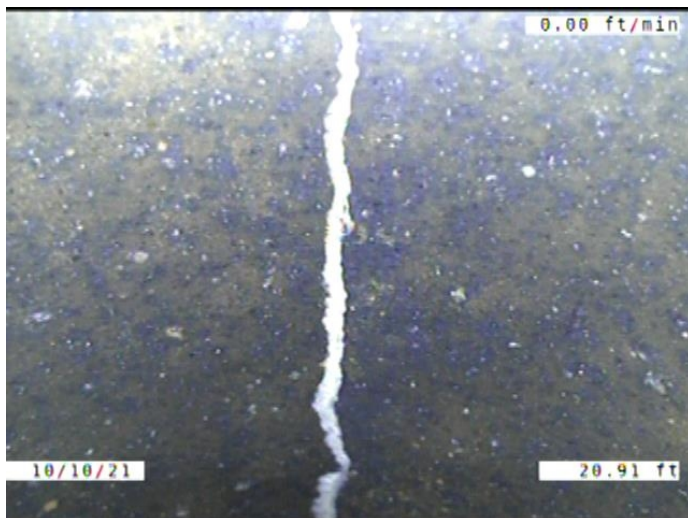
Code: **ISB**
 Description: **Infiltration Stain Barrel**

Distance (ft): **20.9**
 Structural Grade: **0**
 O&M Grade: **1**
 Clock Start/From: **10**
 Clock To: **12**
 1st Value:
 2nd Value:
 Value Percent:
 Continuous Index:
 Within 8" of Joint: **YES**
 Remarks:

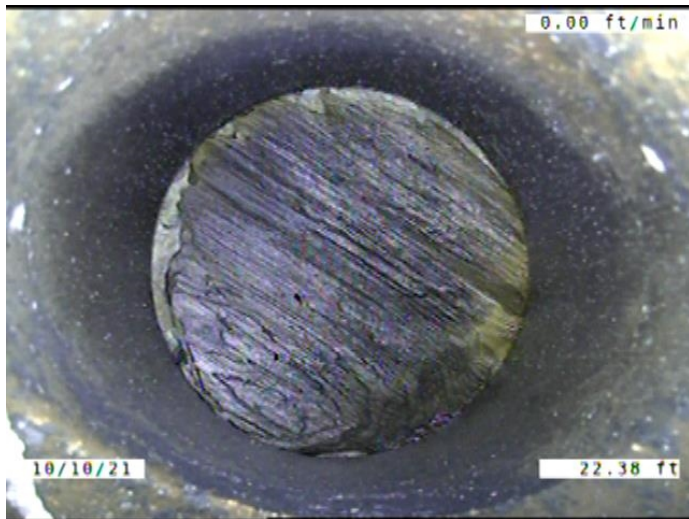
Code: **TFC**
 Description: **Tap Factory Capped**

Distance (ft): **22.4**
 Structural Grade: **0**
 O&M Grade: **0**
 Clock Start/From: **1**
 Clock To:
 1st Value: **4.000**
 2nd Value:
 Value Percent:
 Continuous Index:
 Within 8" of Joint: **YES**
 Remarks:

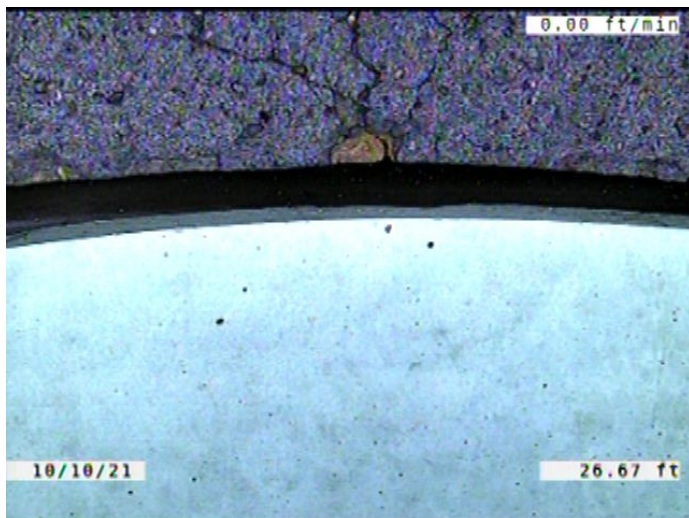
Code: **MMC**
 Description: **Miscellaneous Material Change**

Distance (ft): **26.7**
 Structural Grade: **0**
 O&M Grade: **0**
 Clock Start/From:
 Clock To:
 1st Value:
 2nd Value:
 Value Percent:
 Continuous Index:
 Within 8" of Joint: **NO**
 Remarks: **VCP TO PVC**

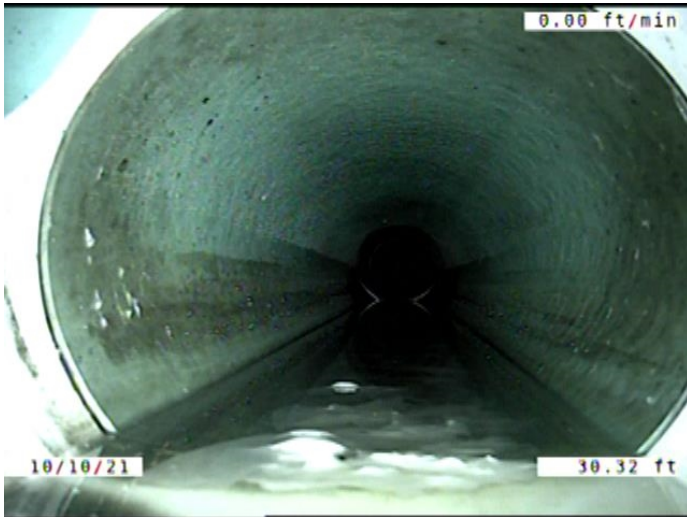
Code: **MWLS**
 Description: **Miscellaneous Water Level Sag**

Distance (ft): **30.3**
 Structural Grade: **2**
 O&M Grade: **0**
 Clock Start/From:
 Clock To:
 1st Value:
 2nd Value:
 Value Percent: **5.000**
 Continuous Index: **S02**
 Within 8" of Joint: **NO**
 Remarks:

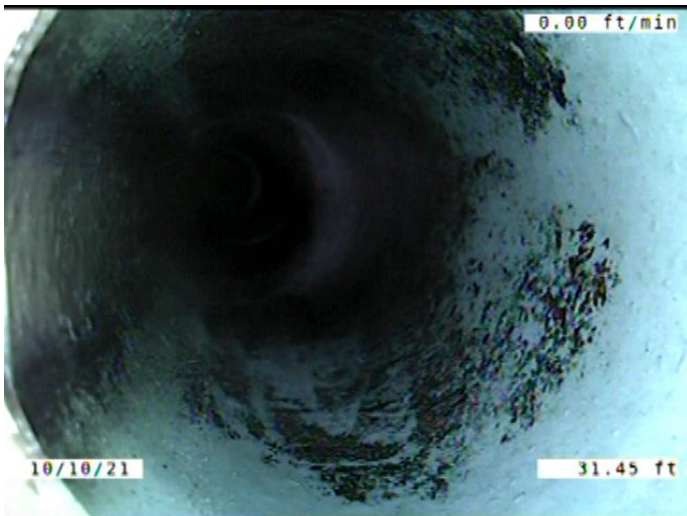
Code: **TF**
 Description: **Tap Factory**

Distance (ft): **31.4**
 Structural Grade: **0**
 O&M Grade: **0**
 Clock Start/From: **10**
 Clock To:
 1st Value: **4.000**
 2nd Value:
 Value Percent:
 Continuous Index:
 Within 8" of Joint: **YES**
 Remarks:

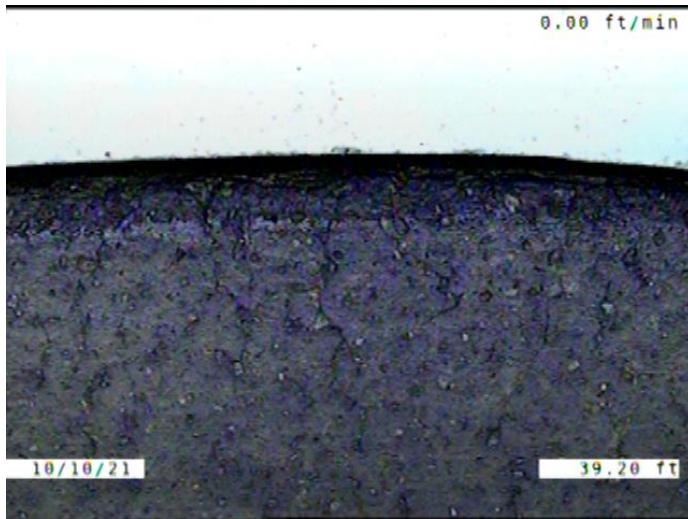
Code: **MMC**
 Description: **Miscellaneous Material Change**

Distance (ft): **39.2**
 Structural Grade: **0**
 O&M Grade: **0**
 Clock Start/From:
 Clock To:
 1st Value:
 2nd Value:
 Value Percent:
 Continuous Index:
 Within 8" of Joint: **NO**
 Remarks: **PVC TO VCP**

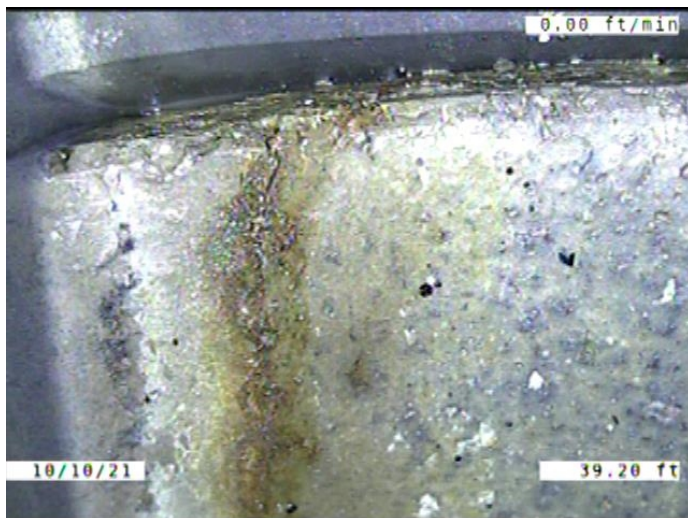
Code: **CL**
 Description: **Crack Longitudinal**

Distance (ft): **39.2**
 Structural Grade: **2**
 O&M Grade: **0**
 Clock Start/From: **8**
 Clock To:
 1st Value:
 2nd Value:
 Value Percent:
 Continuous Index:
 Within 8" of Joint: **YES**
 Remarks:

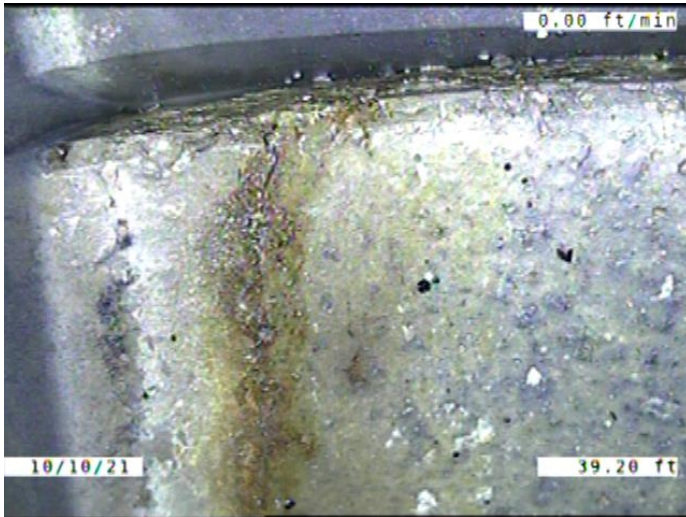
Code: **ISB**
 Description: **Infiltration Stain Barrel**

Distance (ft): **39.2**
 Structural Grade: **0**
 O&M Grade: **1**
 Clock Start/From: **8**
 Clock To:
 1st Value:
 2nd Value:
 Value Percent:
 Continuous Index:
 Within 8" of Joint: **YES**
 Remarks:

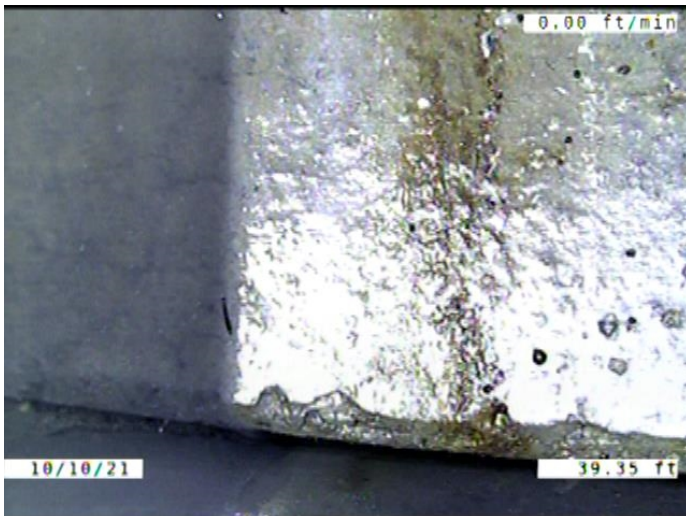
Code: **CL**
 Description: **Crack Longitudinal**

Distance (ft): **39.4**
 Structural Grade: **2**
 O&M Grade: **0**
 Clock Start/From: **4**
 Clock To:
 1st Value:
 2nd Value:
 Value Percent:
 Continuous Index:
 Within 8" of Joint: **YES**
 Remarks:

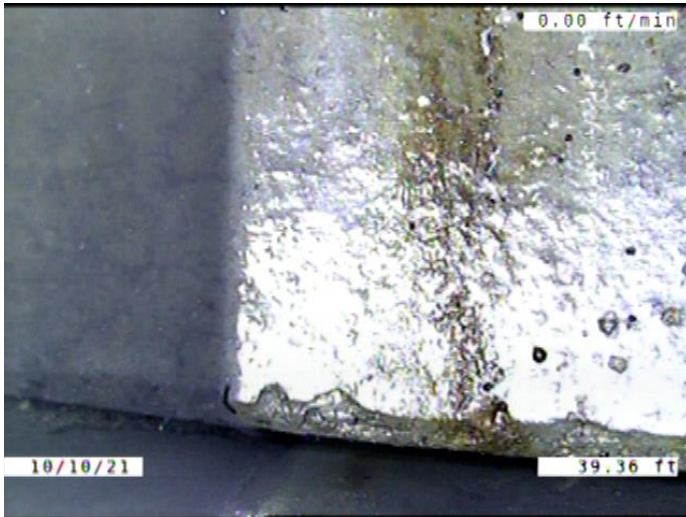
Code: **ISB**
 Description: **Infiltration Stain Barrel**

Distance (ft): **39.4**
 Structural Grade: **0**
 O&M Grade: **1**
 Clock Start/From: **4**
 Clock To:
 1st Value:
 2nd Value:
 Value Percent:
 Continuous Index:
 Within 8" of Joint: **YES**
 Remarks:

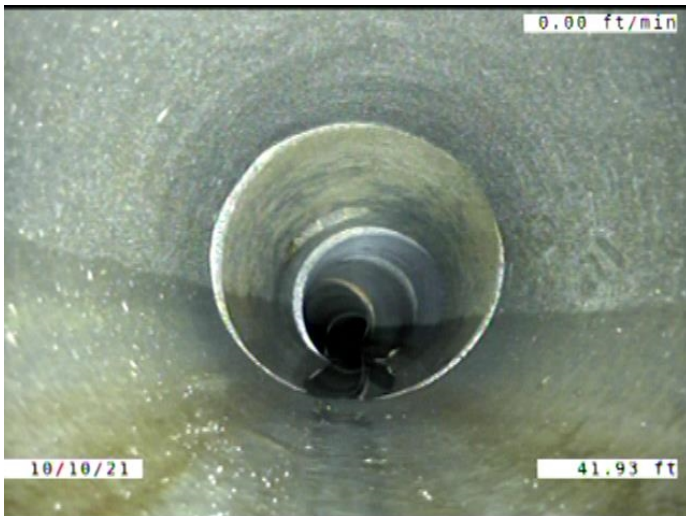
Code: **MWLS**
 Description: **Miscellaneous Water Level Sag**

Distance (ft): **41.9**
 Structural Grade: **2**
 O&M Grade: **0**
 Clock Start/From:
 Clock To:
 1st Value:
 2nd Value:
 Value Percent: **5.000**
 Continuous Index: **F02**
 Within 8" of Joint: **NO**
 Remarks:

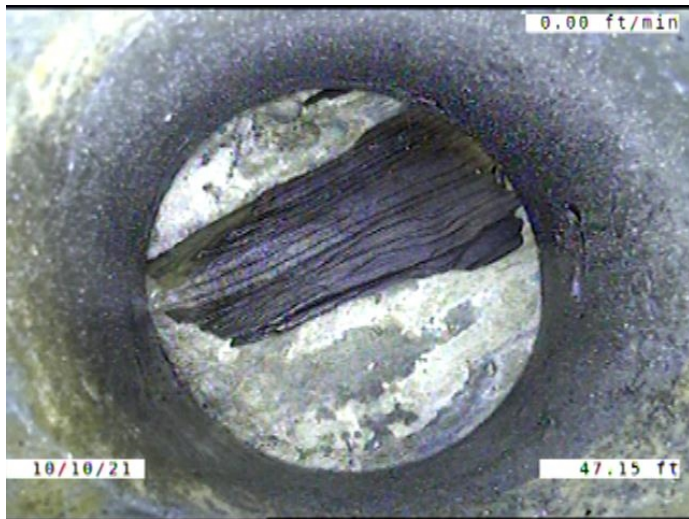
Code: **TFC**
 Description: **Tap Factory Capped**

Distance (ft): **47.1**
 Structural Grade: **0**
 O&M Grade: **0**
 Clock Start/From: **11**
 Clock To:
 1st Value: **4.000**
 2nd Value:
 Value Percent:
 Continuous Index:
 Within 8" of Joint: **YES**
 Remarks:

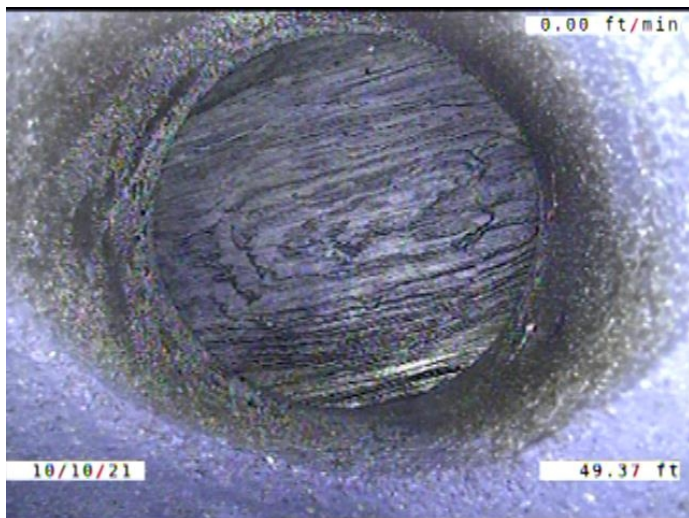
Code: **TFC**
 Description: **Tap Factory Capped**

Distance (ft): **49.4**
 Structural Grade: **0**
 O&M Grade: **0**
 Clock Start/From: **1**
 Clock To:
 1st Value: **4.000**
 2nd Value:
 Value Percent:
 Continuous Index:
 Within 8" of Joint: **YES**
 Remarks:

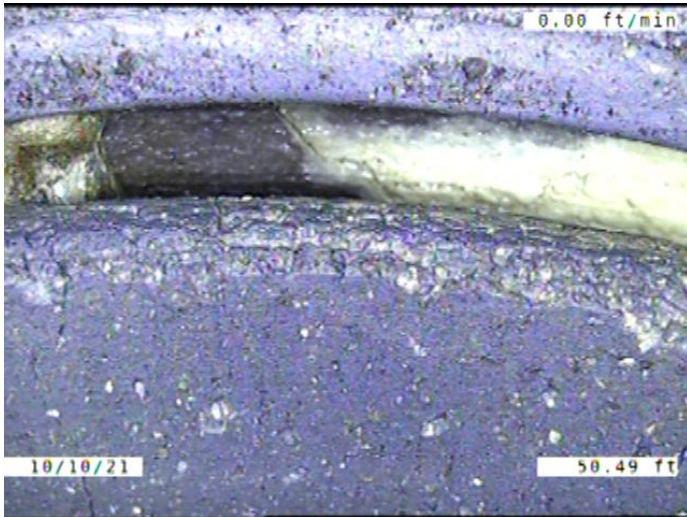
Code: **JAM**
 Description: **Joint Angular Medium**

Distance (ft): **50.5**
 Structural Grade: **3**
 O&M Grade: **0**
 Clock Start/From:
 Clock To:
 1st Value:
 2nd Value:
 Value Percent:
 Continuous Index:
 Within 8" of Joint: **NO**
 Remarks:

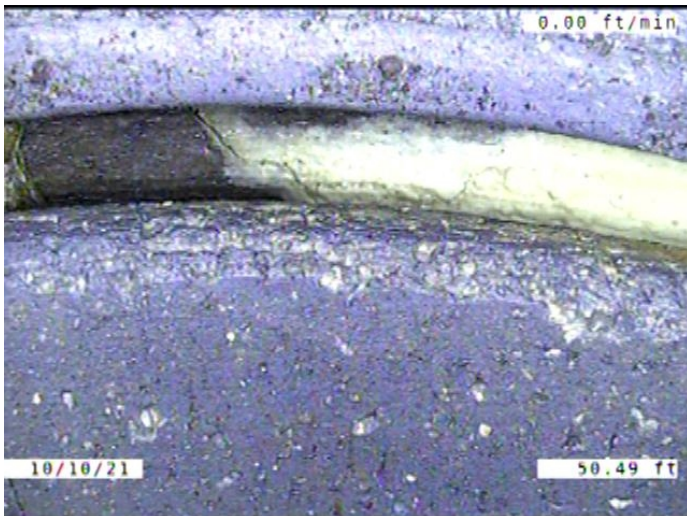
Code: **CM**
 Description: **Crack Multiple**

Distance (ft): **50.5**
 Structural Grade: **3**
 O&M Grade: **0**
 Clock Start/From: **12**
 Clock To: **1**
 1st Value:
 2nd Value:
 Value Percent:
 Continuous Index:
 Within 8" of Joint: **YES**
 Remarks:

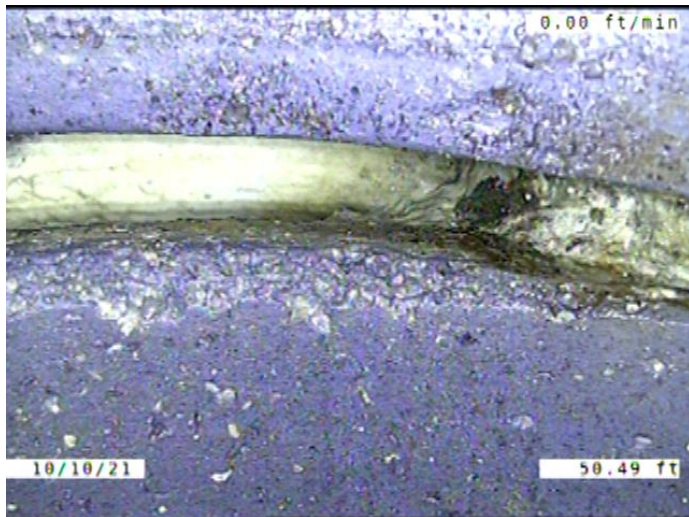
Code: **DAE**
 Description: **Deposits Attached Encrustation**

Distance (ft): **50.5**
 Structural Grade: **0**
 O&M Grade: **2**
 Clock Start/From: **1**
 Clock To: **2**
 1st Value:
 2nd Value:
 Value Percent: **5.000**
 Continuous Index:
 Within 8" of Joint: **YES**
 Remarks:

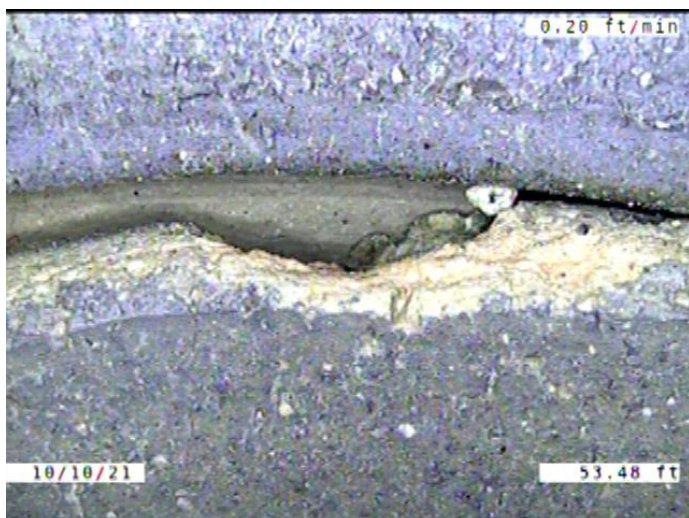
Code: **SZ**
 Description: **Surface Damage Other**

Distance (ft): **53.5**
 Structural Grade: **0**
 O&M Grade: **0**
 Clock Start/From: **1**
 Clock To:
 1st Value:
 2nd Value:
 Value Percent:
 Continuous Index:
 Within 8" of Joint: **YES**
 Remarks: **A PIECE OF THE JOINT CHIPPED AWAY**

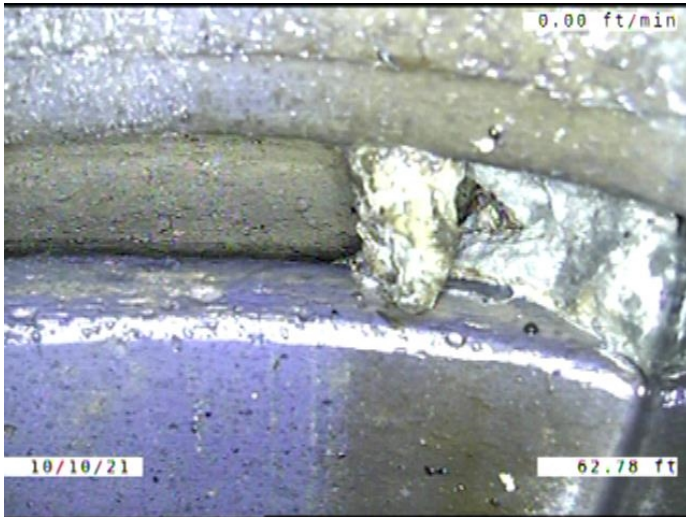
Code: **DAE**
 Description: **Deposits Attached Encrustation**

Distance (ft): **62.8**
 Structural Grade: **0**
 O&M Grade: **2**
 Clock Start/From: **2**
 Clock To: **3**
 1st Value:
 2nd Value:
 Value Percent: **5.000**
 Continuous Index:
 Within 8" of Joint: **YES**
 Remarks:

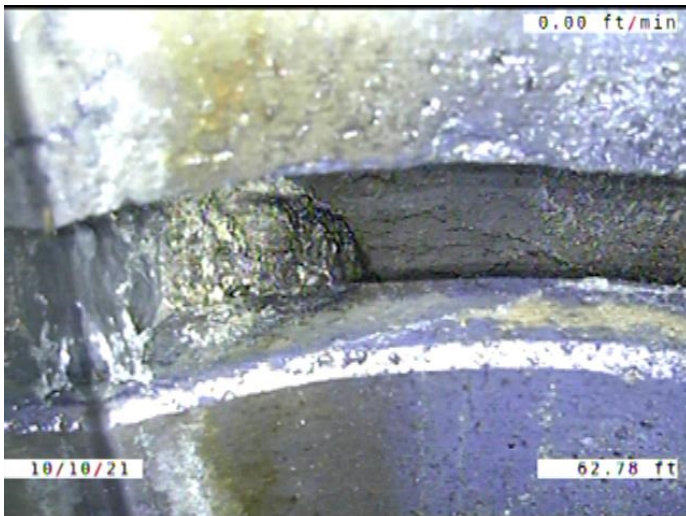
Code: **DAE**
 Description: **Deposits Attached Encrustation**

Distance (ft): **62.8**
 Structural Grade: **0**
 O&M Grade: **2**
 Clock Start/From: **9**
 Clock To: **10**
 1st Value:
 2nd Value:
 Value Percent: **5.000**
 Continuous Index:
 Within 8" of Joint: **YES**
 Remarks:

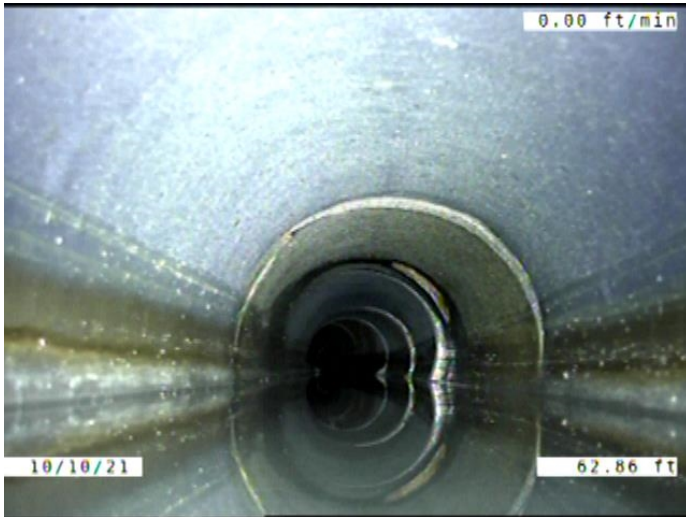
Code: **MWLS**
 Description: **Miscellaneous Water Level Sag**

Distance (ft): **62.9**
 Structural Grade: **2**
 O&M Grade: **0**
 Clock Start/From:
 Clock To:
 1st Value:
 2nd Value:
 Value Percent: **10.000**
 Continuous Index: **S03**
 Within 8" of Joint: **NO**
 Remarks:

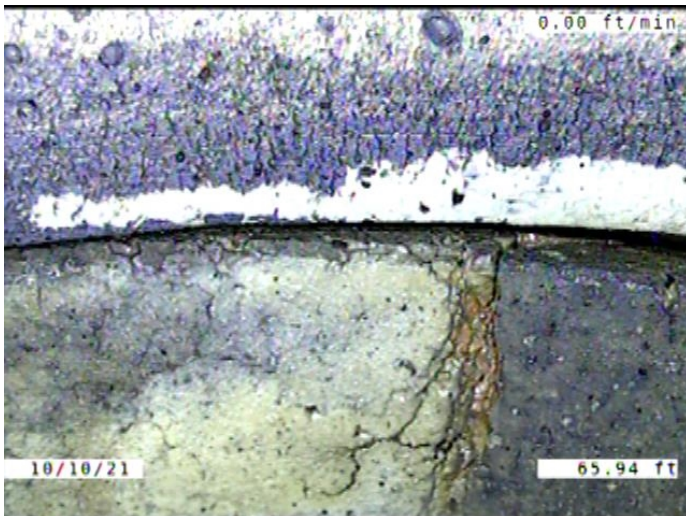
Code: **ISB**
 Description: **Infiltration Stain Barrel**

Distance (ft): **65.9**
 Structural Grade: **0**
 O&M Grade: **1**
 Clock Start/From: **9**
 Clock To: **2**
 1st Value:
 2nd Value:
 Value Percent:
 Continuous Index:
 Within 8" of Joint: **YES**
 Remarks:

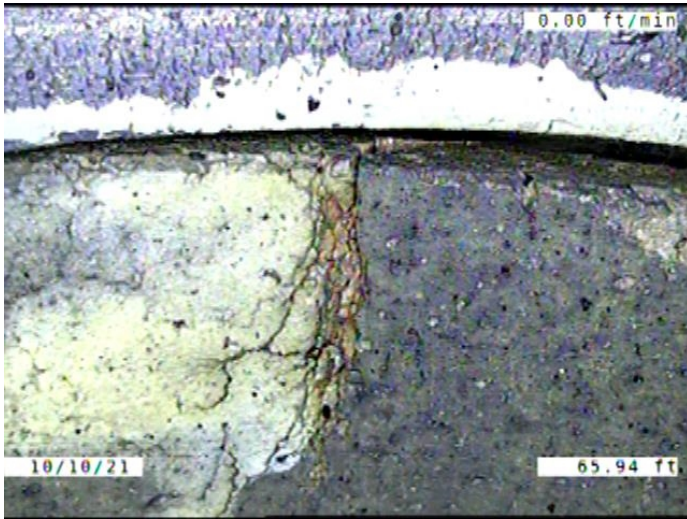
Code: **FM**
 Description: **Fracture Multiple**

Distance (ft): **65.9**
 Structural Grade: **4**
 O&M Grade: **0**
 Clock Start/From: **9**
 Clock To: **1**
 1st Value:
 2nd Value:
 Value Percent:
 Continuous Index:
 Within 8" of Joint: **YES**
 Remarks:

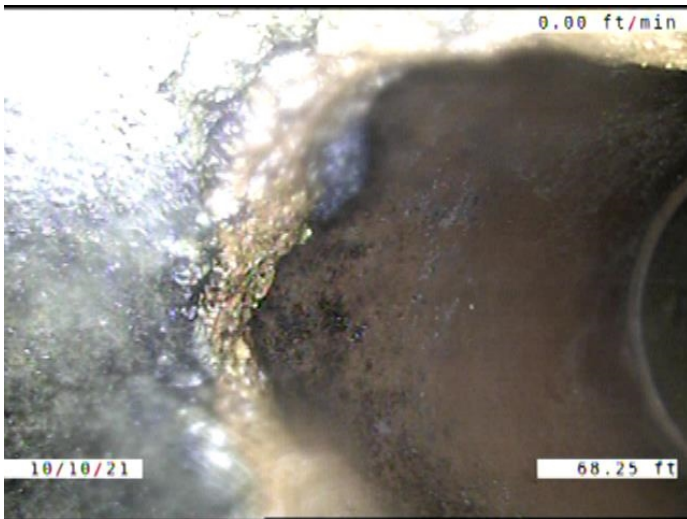
Code: **SSS**
 Description: **Surface Damage Surface Spalling**

Distance (ft): **68.2**
 Structural Grade: **2**
 O&M Grade: **0**
 Clock Start/From: **1**
 Clock To: **2**
 1st Value:
 2nd Value:
 Value Percent:
 Continuous Index:
 Within 8" of Joint: **YES**
 Remarks:

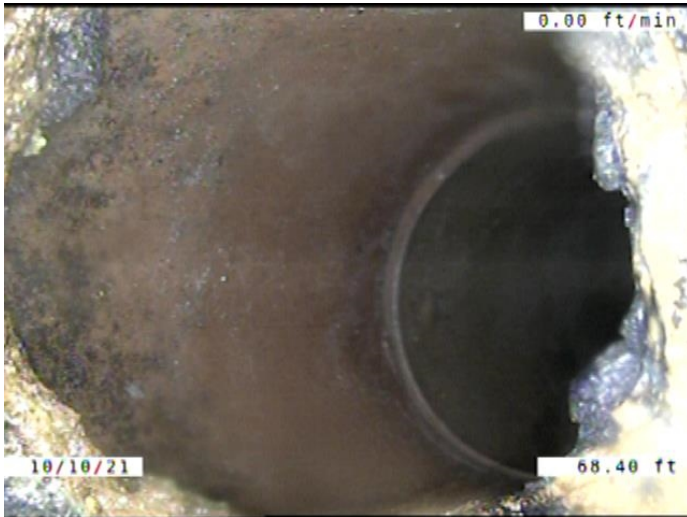
Code: **TB**
 Description: **Tap Break-in/Hammer**

Distance (ft): **68.4**
 Structural Grade: **0**
 O&M Grade: **0**
 Clock Start/From: **1**
 Clock To:
 1st Value: **4.000**
 2nd Value:
 Value Percent:
 Continuous Index:
 Within 8" of Joint: **YES**
 Remarks:

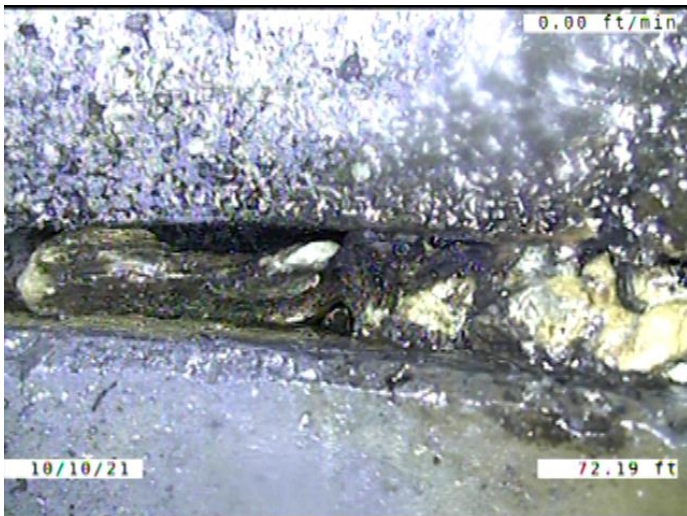
Code: **DAE**
 Description: **Deposits Attached Encrustation**

Distance (ft): **72.2**
 Structural Grade: **0**
 O&M Grade: **2**
 Clock Start/From: **2**
 Clock To: **3**
 1st Value:
 2nd Value:
 Value Percent: **5.000**
 Continuous Index:
 Within 8" of Joint: **YES**
 Remarks:

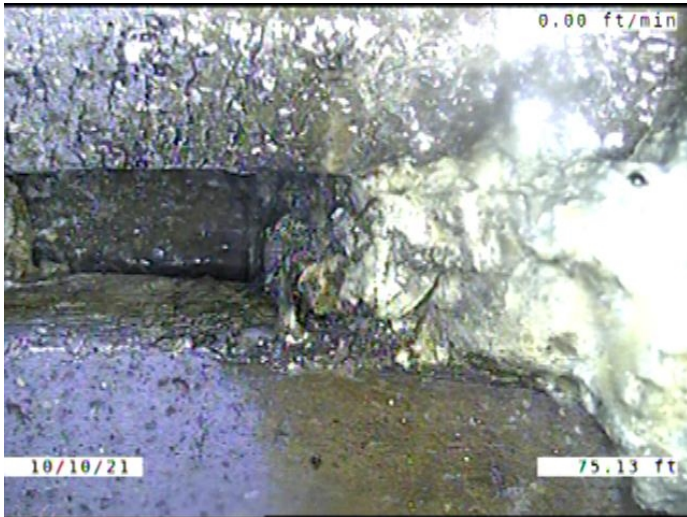
Code: **DAE**
 Description: **Deposits Attached Encrustation**

Distance (ft): **75.1**
 Structural Grade: **0**
 O&M Grade: **2**
 Clock Start/From: **2**
 Clock To: **3**
 1st Value:
 2nd Value:
 Value Percent: **5.000**
 Continuous Index:
 Within 8" of Joint: **YES**
 Remarks:

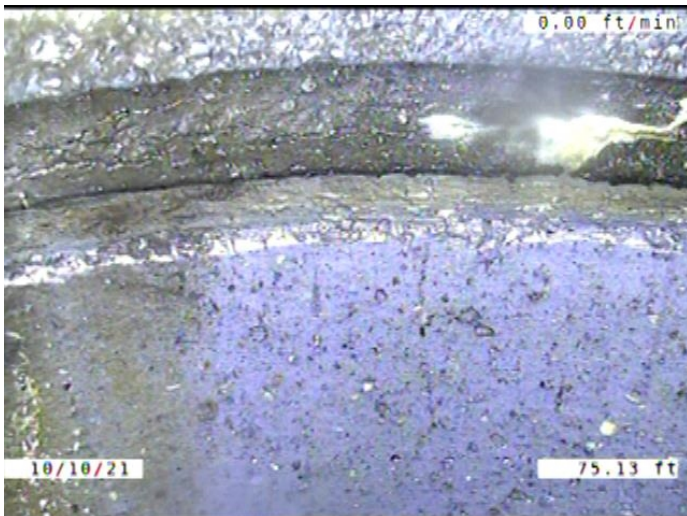
Code: **CM**
 Description: **Crack Multiple**

Distance (ft): **75.1**
 Structural Grade: **3**
 O&M Grade: **0**
 Clock Start/From: **9**
 Clock To: **11**
 1st Value:
 2nd Value:
 Value Percent:
 Continuous Index:
 Within 8" of Joint: **YES**
 Remarks:

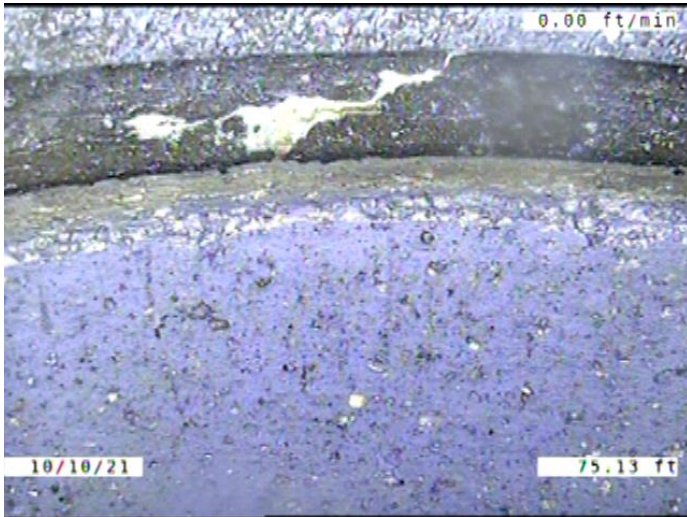
Code: **ISJ**
 Description: **Infiltration Stain Joint**

Distance (ft): **75.1**
 Structural Grade: **0**
 O&M Grade: **1**
 Clock Start/From: **10**
 Clock To:
 1st Value:
 2nd Value:
 Value Percent:
 Continuous Index:
 Within 8" of Joint: **YES**
 Remarks:

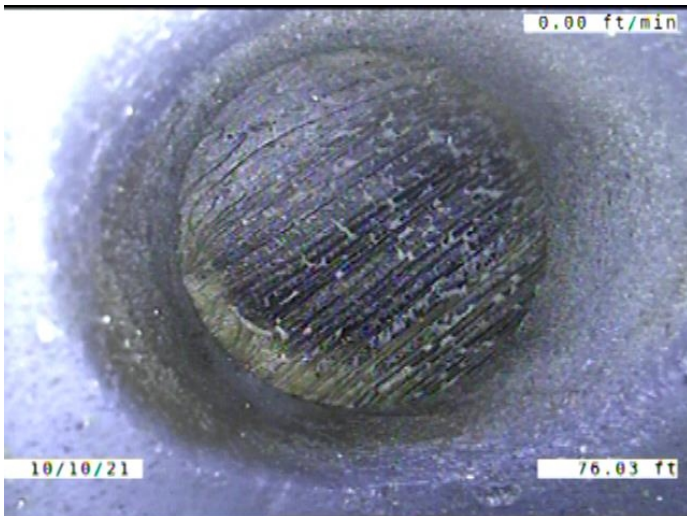
Code: **TFC**
 Description: **Tap Factory Capped**

Distance (ft): **76.0**
 Structural Grade: **0**
 O&M Grade: **0**
 Clock Start/From: **11**
 Clock To:
 1st Value: **4.000**
 2nd Value:
 Value Percent:
 Continuous Index:
 Within 8" of Joint: **YES**
 Remarks:

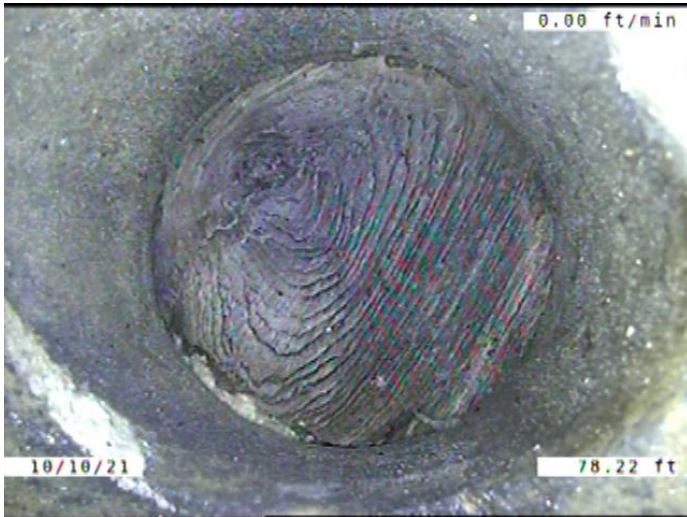
Code: **TFC**
 Description: **Tap Factory Capped**

Distance (ft): **78.2**
 Structural Grade: **0**
 O&M Grade: **0**
 Clock Start/From: **1**
 Clock To:
 1st Value: **4.000**
 2nd Value:
 Value Percent:
 Continuous Index:
 Within 8" of Joint: **YES**
 Remarks:

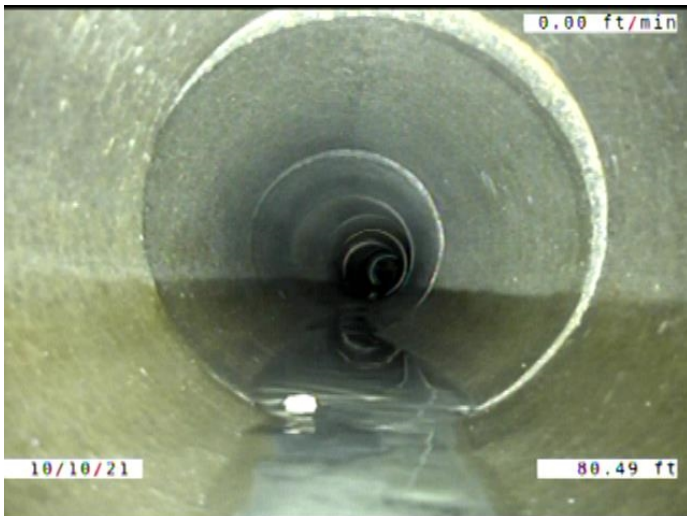
Code: **MWLS**
 Description: **Miscellaneous Water Level Sag**

Distance (ft): **80.5**
 Structural Grade: **2**
 O&M Grade: **0**
 Clock Start/From:
 Clock To:
 1st Value:
 2nd Value:
 Value Percent: **10.000**
 Continuous Index: **F03**
 Within 8" of Joint: **NO**
 Remarks:

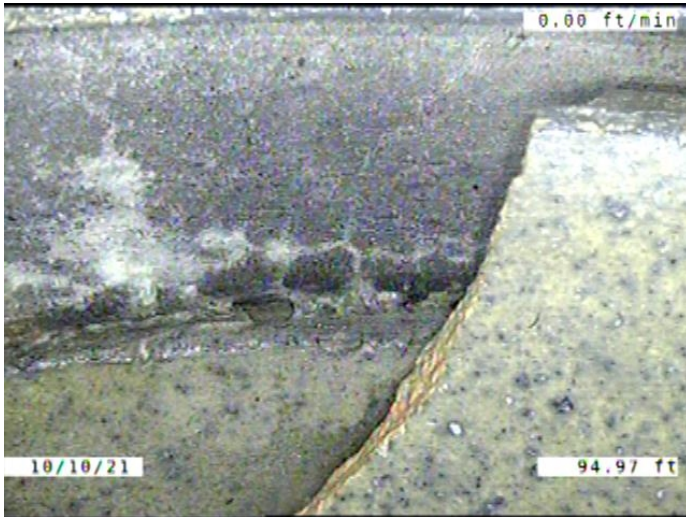
Code: **B**
 Description: **Broken**

Distance (ft): **95.0**
 Structural Grade: **4**
 O&M Grade: **0**
 Clock Start/From: **10**
 Clock To: **11**
 1st Value:
 2nd Value:
 Value Percent:
 Continuous Index:
 Within 8" of Joint: **YES**
 Remarks:

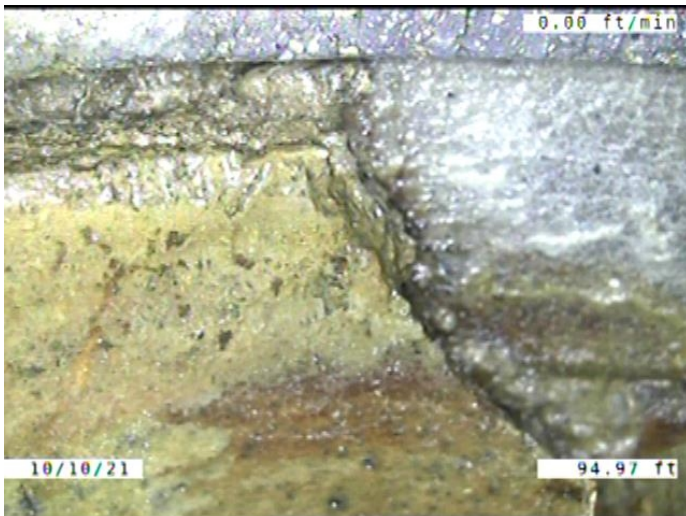
Code: **ISJ**
 Description: **Infiltration Stain Joint**

Distance (ft): **95.0**
 Structural Grade: **0**
 O&M Grade: **1**
 Clock Start/From: **9**
 Clock To: **11**
 1st Value:
 2nd Value:
 Value Percent:
 Continuous Index:
 Within 8" of Joint: **YES**
 Remarks:

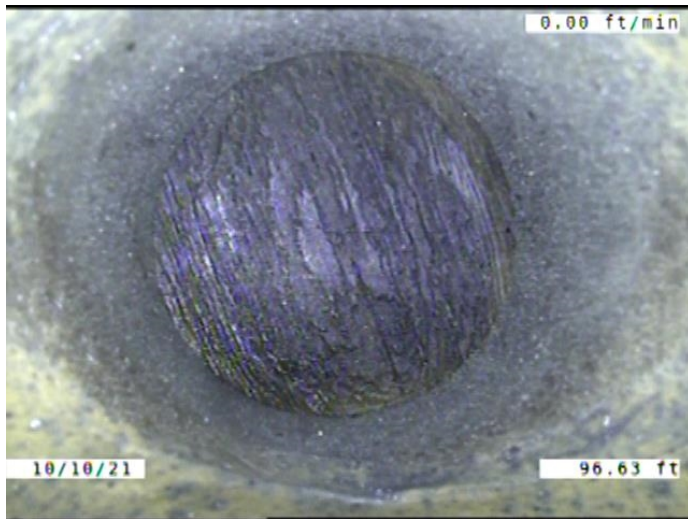
Code: **TFC**
 Description: **Tap Factory Capped**

Distance (ft): **96.6**
 Structural Grade: **0**
 O&M Grade: **0**
 Clock Start/From: **11**
 Clock To:
 1st Value: **4.000**
 2nd Value:
 Value Percent:
 Continuous Index:
 Within 8" of Joint: **YES**
 Remarks:

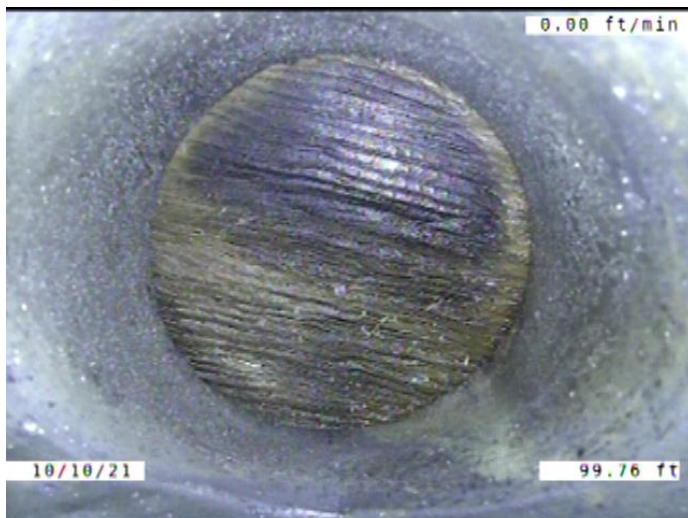
Code: **TFC**
 Description: **Tap Factory Capped**

Distance (ft): **99.8**
 Structural Grade: **0**
 O&M Grade: **0**
 Clock Start/From: **1**
 Clock To:
 1st Value: **4.000**
 2nd Value:
 Value Percent:
 Continuous Index:
 Within 8" of Joint: **YES**
 Remarks:

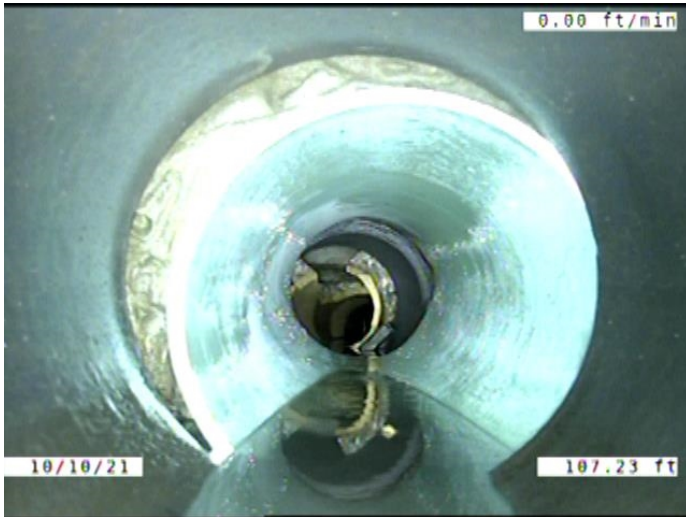
Code: **JOLD**
 Description: **Joint Offset Large Defective**

Distance (ft): **107.2**
 Structural Grade: **4**
 O&M Grade: **0**
 Clock Start/From:
 Clock To:
 1st Value:
 2nd Value:
 Value Percent:
 Continuous Index:
 Within 8" of Joint: **NO**
 Remarks:

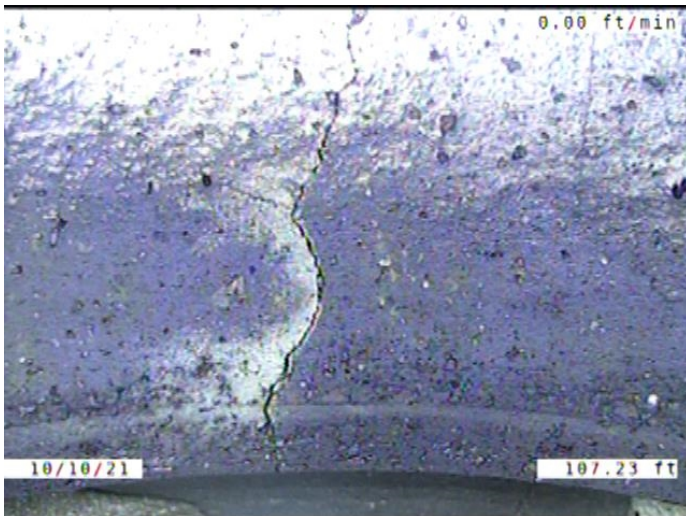
Code: **CL**
 Description: **Crack Longitudinal**

Distance (ft): **107.2**
 Structural Grade: **2**
 O&M Grade: **0**
 Clock Start/From: **11**
 Clock To:
 1st Value:
 2nd Value:
 Value Percent:
 Continuous Index:
 Within 8" of Joint: **YES**
 Remarks:

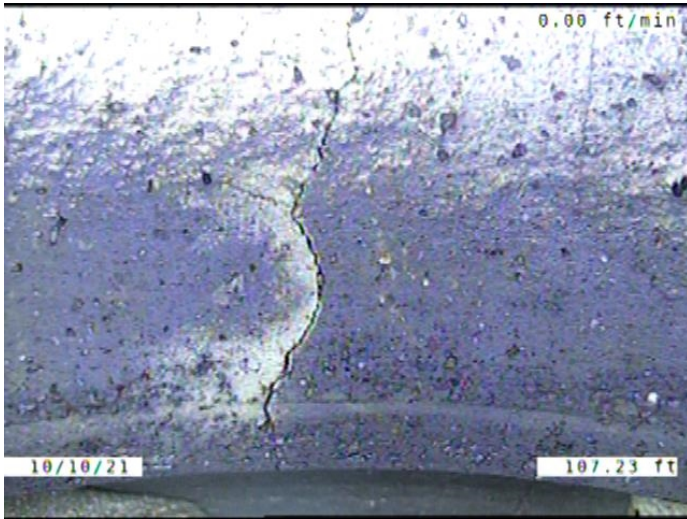
Code: **ISB**
 Description: **Infiltration Stain Barrel**

Distance (ft): **107.2**
 Structural Grade: **0**
 O&M Grade: **1**
 Clock Start/From: **11**
 Clock To:
 1st Value:
 2nd Value:
 Value Percent:
 Continuous Index:
 Within 8" of Joint: **YES**
 Remarks:

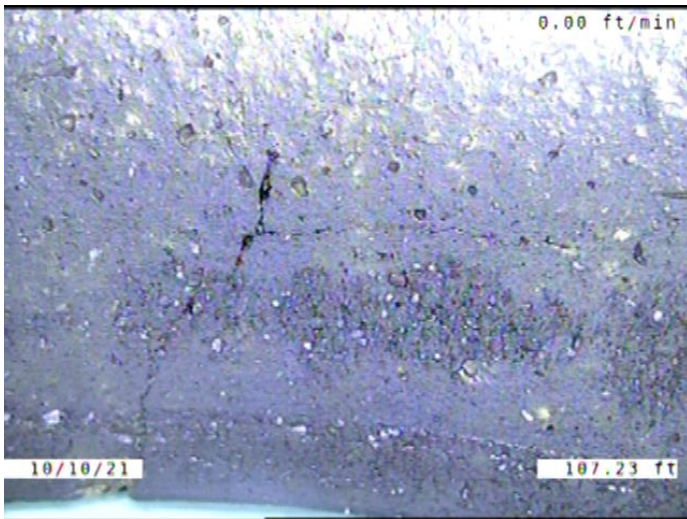
Code: **CM**
 Description: **Crack Multiple**

Distance (ft): **107.2**
 Structural Grade: **3**
 O&M Grade: **0**
 Clock Start/From: **2**
 Clock To: **3**
 1st Value:
 2nd Value:
 Value Percent:
 Continuous Index:
 Within 8" of Joint: **YES**
 Remarks:

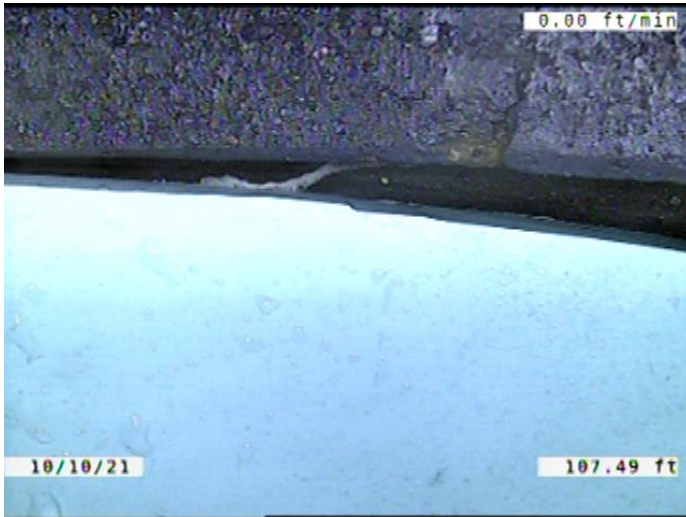
Code: **MMC**
 Description: **Miscellaneous Material Change**

Distance (ft): **107.5**
 Structural Grade: **0**
 O&M Grade: **0**
 Clock Start/From:
 Clock To:
 1st Value:
 2nd Value:
 Value Percent:
 Continuous Index:
 Within 8" of Joint: **NO**
 Remarks: **VCP TO PVC**
