Profile/Photo Observation Report

Date:	10/10/2021	Weather:		Coding:	PACP 7.0
Pipe Length (ft):	112.4	Owner:	City of Hobart	Pre Clean:	Heavy Cleaning
P.O.#:	YES502259	Surveyor:	S. Bucklin	PSR:	P-804-018-015
Customer:	City of Hobart	Clean Date:	10/09/2021	Shape:	C

Street:	East Home Avenue	Flow Control:	Not Controlled
City:	Hobart, IN	Year Renewed:	
Location:	Local rural streets with light traffic, t	Tape/Media #:	
Purpose:	Routine Assessment	Dia/Height:	12"
Use:	Sanitary Sewage Pipe	Material:	VCP
Drain Area:		Lining:	
Category:	NA		
Comment:			
Location Details:		Direction of Survey:	Downstream
US MH:	M-704-015	DS MH:	M-804-018
		Total Length Surveyed (ft):	112.4

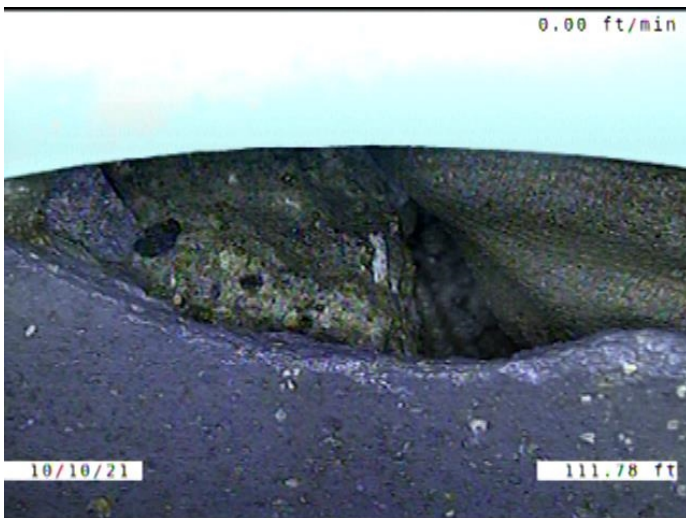
Code: **SMW**
 Description: **Surface Damage Missing Wall**

Distance (ft): **111.8**
 Structural Grade: **5**
 O&M Grade: **0**
 Clock Start/From: **10**
 Clock To: **3**
 1st Value:
 2nd Value:
 Value Percent:
 Continuous Index:
 Within 8" of Joint: **YES**
 Remarks: **SOIL VISIBLE**

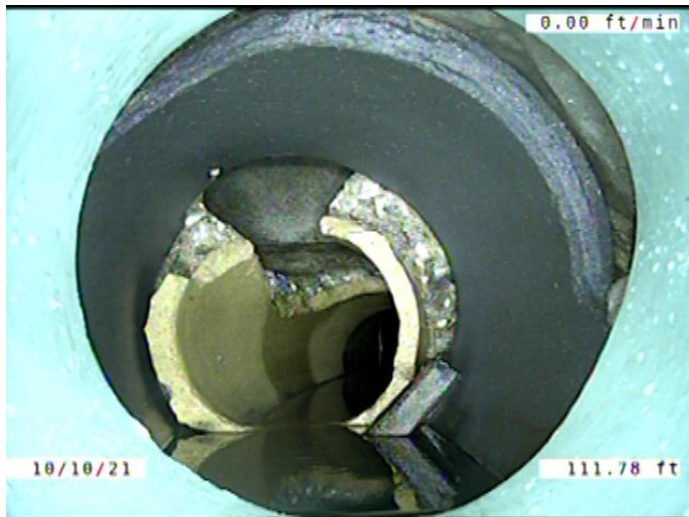
Code: **JOMD**
 Description: **Joint Offset Medium Defective**

Distance (ft): **111.8**
 Structural Grade: **3**
 O&M Grade: **0**
 Clock Start/From:
 Clock To:
 1st Value:
 2nd Value:
 Value Percent:
 Continuous Index:
 Within 8" of Joint: **NO**
 Remarks:

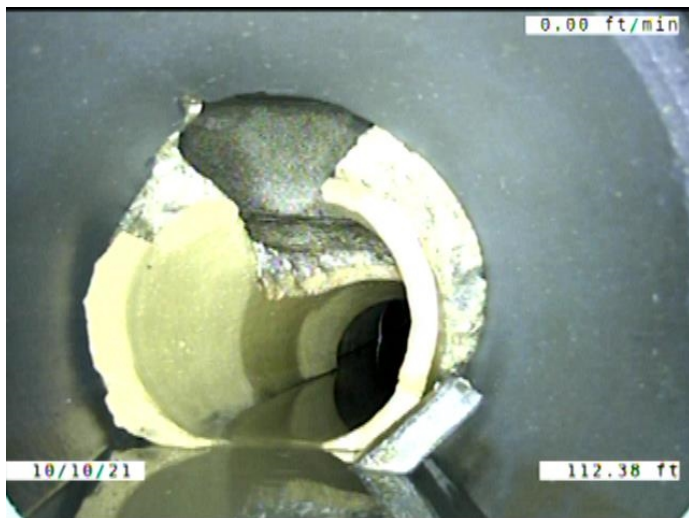
Code: **DSF**
 Description: **Deposits Settled Fine**

Distance (ft): **112.4**
 Structural Grade: **0**
 O&M Grade: **2**
 Clock Start/From: **5**
 Clock To: **7**
 1st Value:
 2nd Value:
 Value Percent: **5.000**
 Continuous Index: **F01**
 Within 8" of Joint: **YES**
 Remarks:

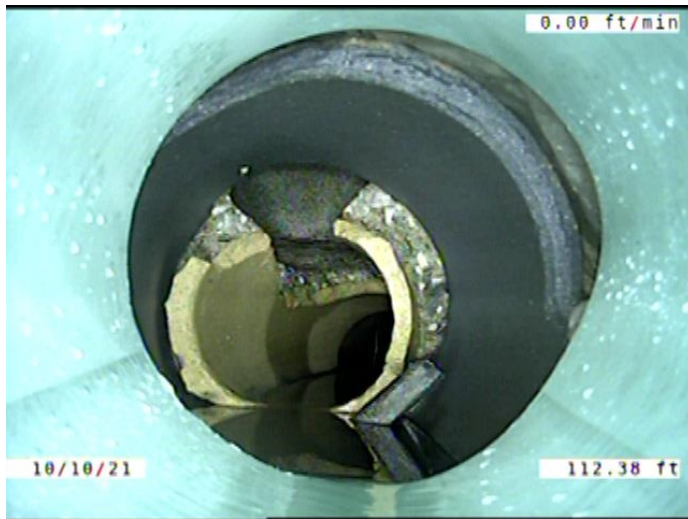
Code:	MGO
Description:	Miscellaneous General Observation
Distance (ft):	112.4
Structural Grade:	0
O&M Grade:	0
Clock Start/From:	
Clock To:	
1st Value:	
2nd Value:	
Value Percent:	
Continuous Index:	
Within 8" of Joint:	NO
Remarks:	PIPE IS BROKEN AND THE NEXT PIPE SECTION CHANGES SIZES. IT DOES T

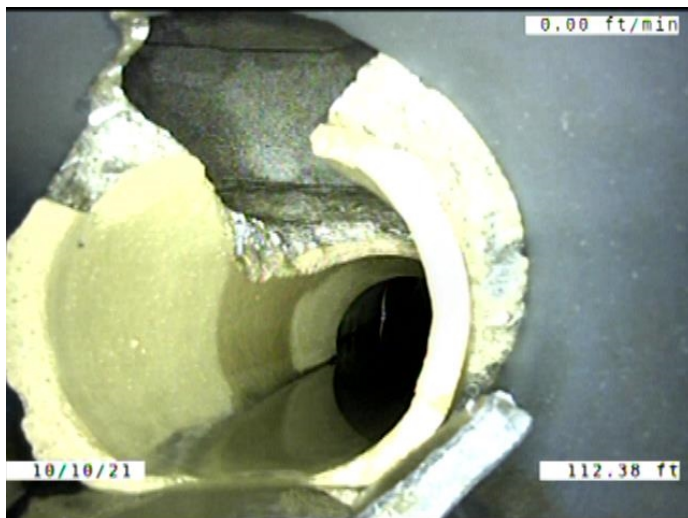
Code:	MSA
Description:	Miscellaneous Survey Abandoned
Distance (ft):	112.4
Structural Grade:	0
O&M Grade:	0
Clock Start/From:	
Clock To:	
1st Value:	
2nd Value:	
Value Percent:	
Continuous Index:	
Within 8" of Joint:	NO
Remarks:	CAMERA CANT FIT INTO 8" PIPE. PIPE CHANGES AT THE MANHOLE
