Profile/Photo Observation Report

Date:	10/15/2021	Weather:		Coding:	PACP 7.0
Pipe Length (ft):	331.2	Owner:	City of Hobart	Pre Clean:	Heavy Cleaning
P.O.#:	YES502259	Surveyor:	S. Bucklin	PSR:	P-704-016-014
Customer:	City of Hobart	Clean Date:	10/12/2021	Shape:	C

Street:	North Michigan Avenue	Flow Control:	Not Controlled
City:	Hobart, IN	Year Renewed:	
Location:	Local rural streets with light traffic, t	Tape/Media #:	
Purpose:	Routine Assessment	Dia/Height:	8"
Use:	Sanitary Sewage Pipe	Material:	VCP
Drain Area:		Lining:	
Category:	NA		
Comment:			
Location Details:		Direction of Survey:	Downstream
US MH:	M-704-016	DS MH:	M-704-014
		Total Length Surveyed (ft):	331.2

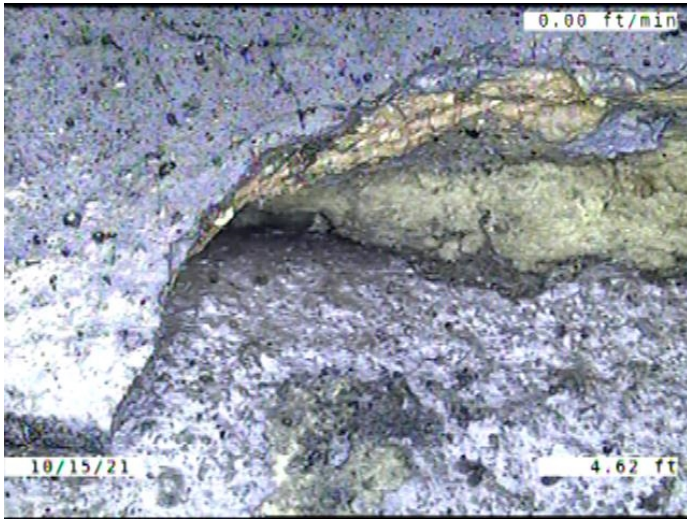
Code: **SMW**
Description: **Surface Damage Missing Wall**

Distance (ft): **4.6**
Structural Grade: **5**
O&M Grade: **0**
Clock Start/From: **11**
Clock To: **1**
1st Value:
2nd Value:
Value Percent:
Continuous Index:
Within 8" of Joint: **YES**
Remarks: **INSIDE OF THE JOINT**

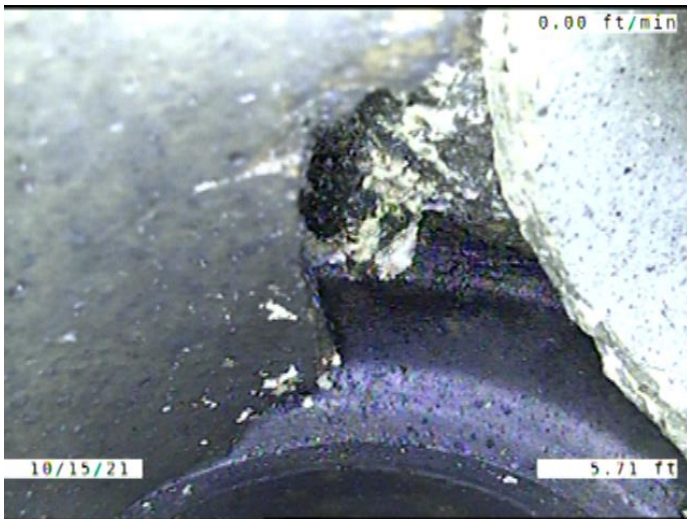
Code: **HSV**
Description: **Hole Soil Visible**

Distance (ft): **5.7**
Structural Grade: **5**
O&M Grade: **0**
Clock Start/From: **11**
Clock To:
1st Value:
2nd Value:
Value Percent:
Continuous Index:
Within 8" of Joint: **YES**
Remarks:

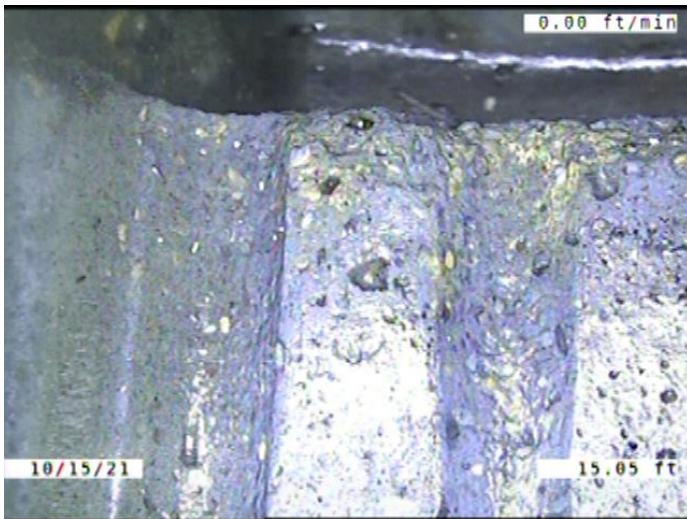
Code: **SZ**
Description: **Surface Damage Other**

Distance (ft): **15.0**
Structural Grade: **0**
O&M Grade: **0**
Clock Start/From: **3**
Clock To: **4**
1st Value:
2nd Value:
Value Percent:
Continuous Index:
Within 8" of Joint: **YES**
Remarks: **GROOVE IN THE PIPE WALL**

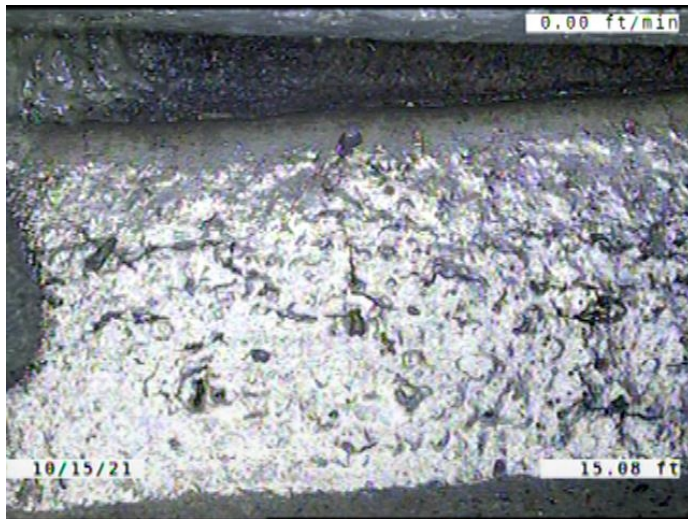
Code: **JAL**
 Description: **Joint Angular Large**

Distance (ft): **15.1**
 Structural Grade: **4**
 O&M Grade: **0**
 Clock Start/From:
 Clock To:
 1st Value:
 2nd Value:
 Value Percent:
 Continuous Index:
 Within 8" of Joint: **NO**
 Remarks:

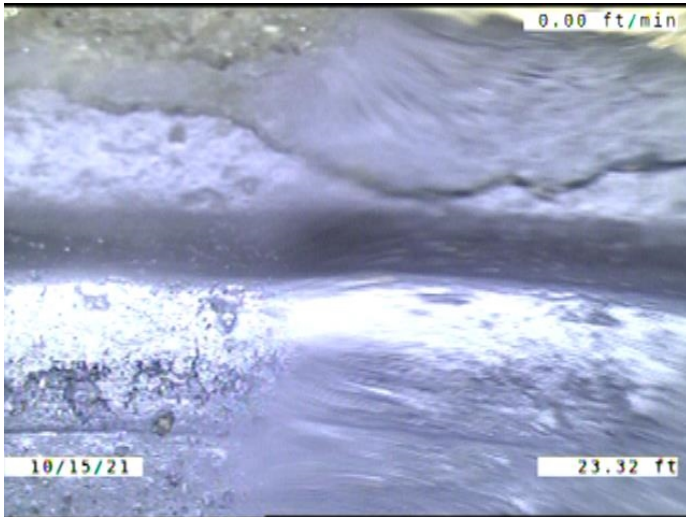
Code: **FM**
 Description: **Fracture Multiple**

Distance (ft): **23.3**
 Structural Grade: **4**
 O&M Grade: **0**
 Clock Start/From: **12**
 Clock To: **1**
 1st Value:
 2nd Value:
 Value Percent:
 Continuous Index:
 Within 8" of Joint: **YES**
 Remarks:

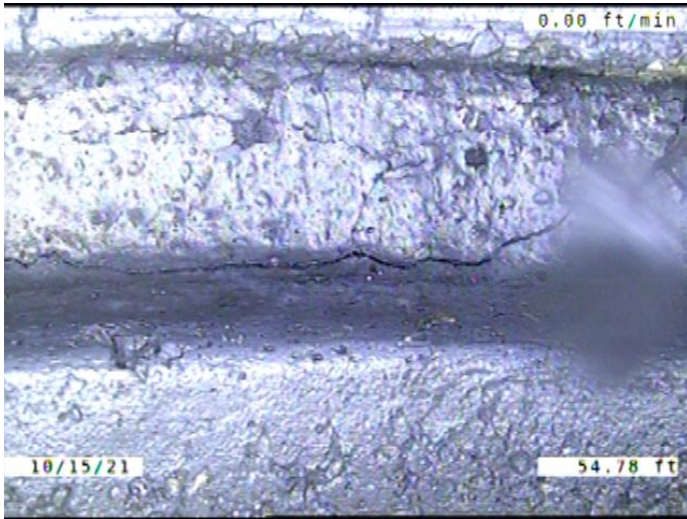
Code: **JAM**
Description: **Joint Angular Medium**

Distance (ft): **54.8**
Structural Grade: **3**
O&M Grade: **0**
Clock Start/From:
Clock To:
1st Value:
2nd Value:
Value Percent:
Continuous Index:
Within 8" of Joint: **NO**
Remarks:

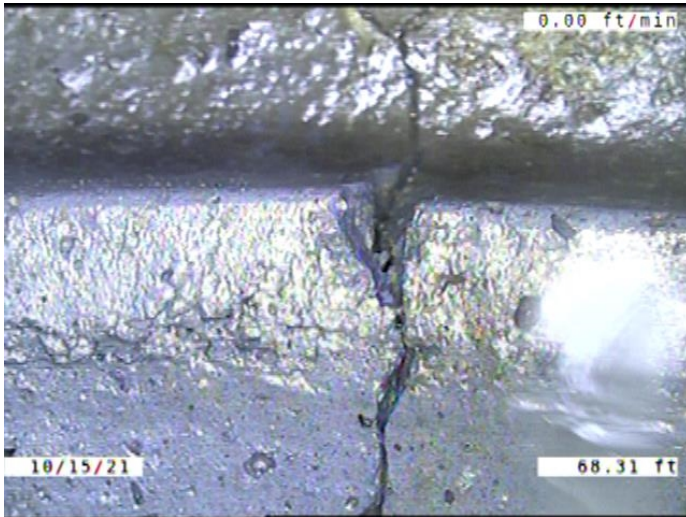
Code: **FM**
 Description: **Fracture Multiple**

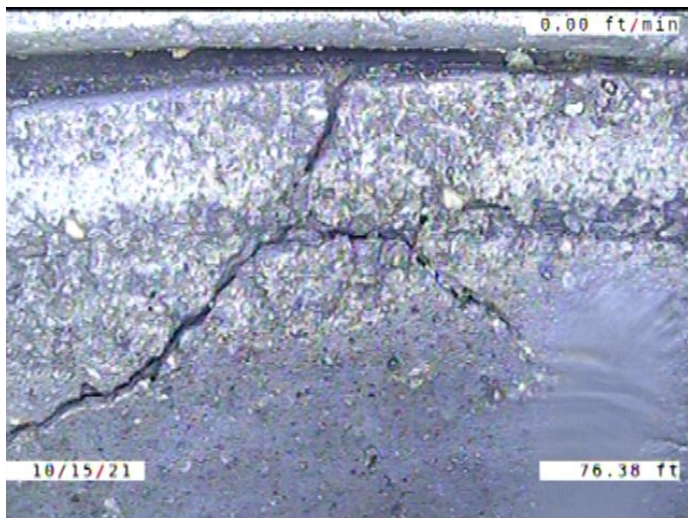
Code:	FM
Description:	Fracture Multiple
Distance (ft):	76.4
Structural Grade:	4
O&M Grade:	0
Clock Start/From:	10
Clock To:	1
1st Value:	
2nd Value:	
Value Percent:	
Continuous Index:	
Within 8" of Joint:	YES
Remarks:

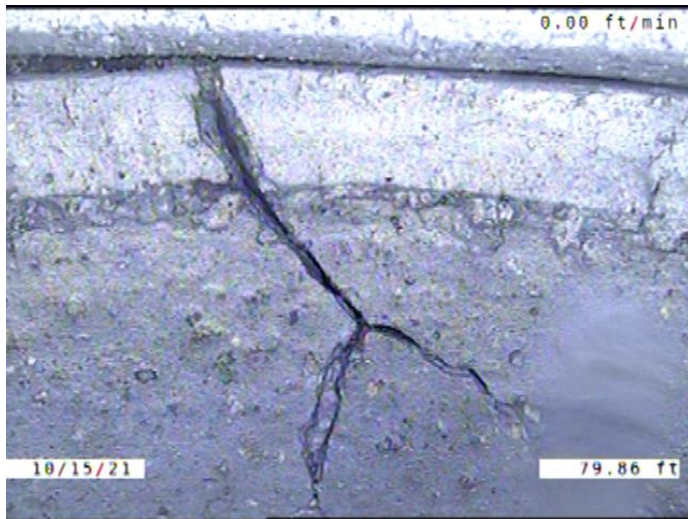
Code: **B**
 Description: **Broken**

Distance (ft): **79.9**
 Structural Grade: **4**
 O&M Grade: **0**
 Clock Start/From: **9**
 Clock To: **4**
 1st Value:
 2nd Value:
 Value Percent:
 Continuous Index:
 Within 8" of Joint: **YES**
 Remarks:

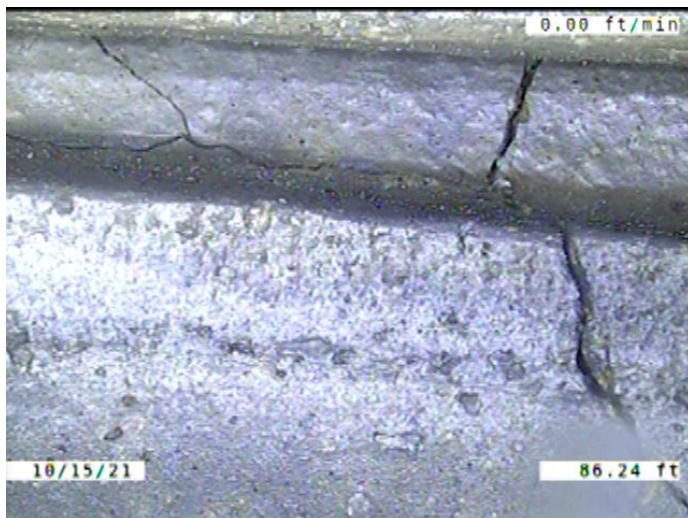
Code: **FM**
 Description: **Fracture Multiple**

Distance (ft): **86.2**
 Structural Grade: **4**
 O&M Grade: **0**
 Clock Start/From: **10**
 Clock To: **3**
 1st Value:
 2nd Value:
 Value Percent:
 Continuous Index:
 Within 8" of Joint: **YES**
 Remarks:

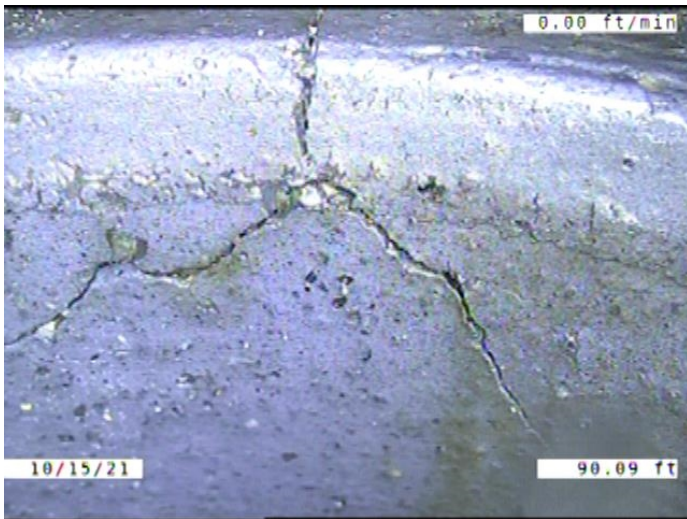
Code: **FM**
Description: **Fracture Multiple**

Distance (ft): **90.1**
Structural Grade: **4**
O&M Grade: **0**
Clock Start/From: **9**
Clock To: **4**
1st Value:
2nd Value:
Value Percent:
Continuous Index:
Within 8" of Joint: **YES**
Remarks:

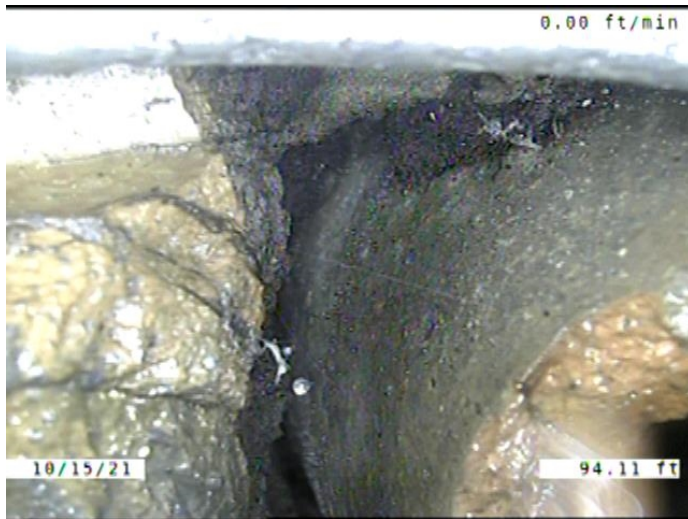
Code: **BSV**
Description: **Broken Soil Visible**

Distance (ft): **94.1**
Structural Grade: **5**
O&M Grade: **0**
Clock Start/From: **8**
Clock To: **4**
1st Value:
2nd Value:
Value Percent:
Continuous Index:
Within 8" of Joint: **YES**
Remarks:

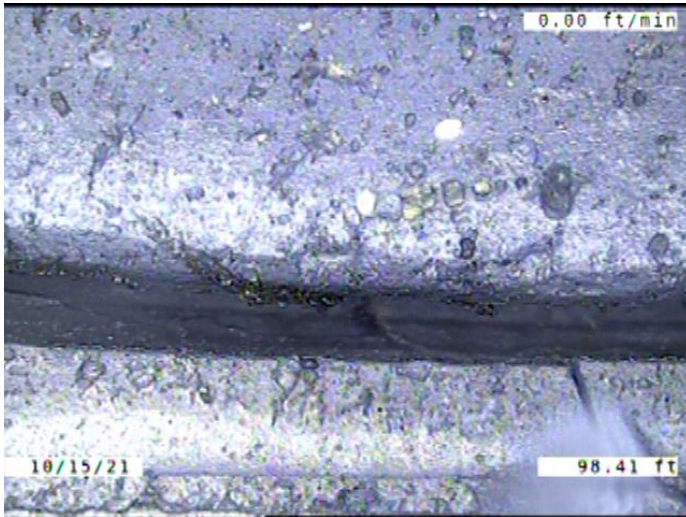
Code: **RFJ**
Description: **Roots Fine Joint**

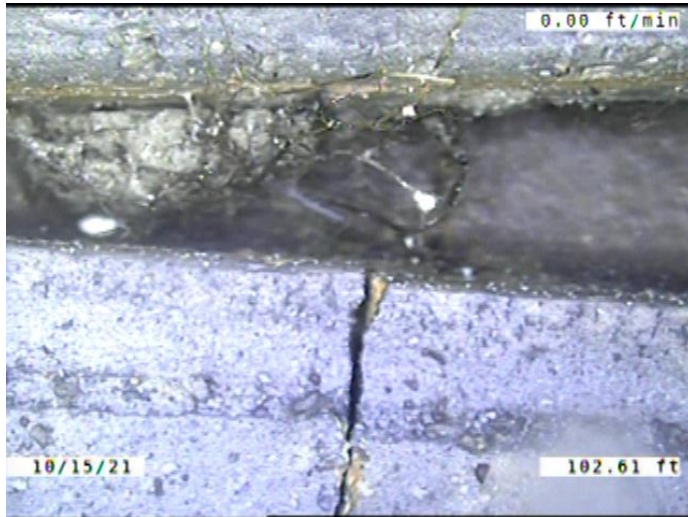
Code: **RFJ**
 Description: **Roots Fine Joint**

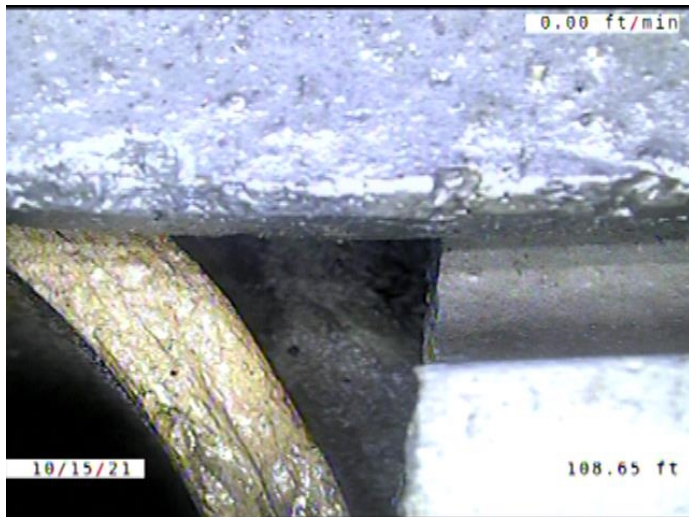
Code: **SMW**
 Description: **Surface Damage Missing Wall**

Distance (ft): **108.6**
 Structural Grade: **5**
 O&M Grade: **0**
 Clock Start/From: **12**
 Clock To: **3**
 1st Value:
 2nd Value:
 Value Percent:
 Continuous Index:
 Within 8" of Joint: **YES**
 Remarks:

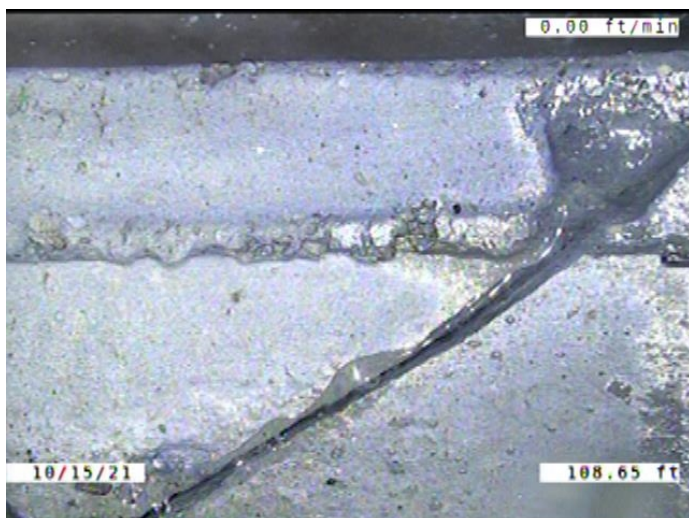
Code: **BSV**
 Description: **Broken Soil Visible**

Distance (ft): **108.6**
 Structural Grade: **5**
 O&M Grade: **0**
 Clock Start/From: **9**
 Clock To: **4**
 1st Value:
 2nd Value:
 Value Percent:
 Continuous Index:
 Within 8" of Joint: **YES**
 Remarks:

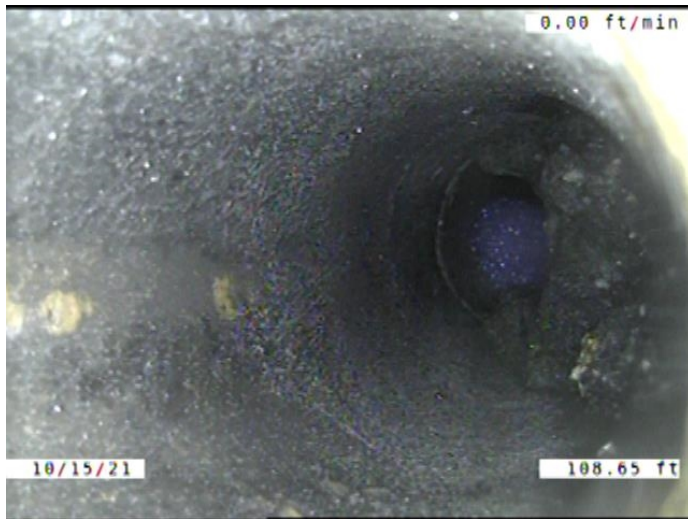
Code: **TBD**
 Description: **Tap Break-in/Hammer Defective**

Distance (ft): **108.6**
 Structural Grade: **0**
 O&M Grade: **3**
 Clock Start/From: **2**
 Clock To:
 1st Value: **4.000**
 2nd Value:
 Value Percent:
 Continuous Index:
 Within 8" of Joint: **YES**
 Remarks: **Defective**

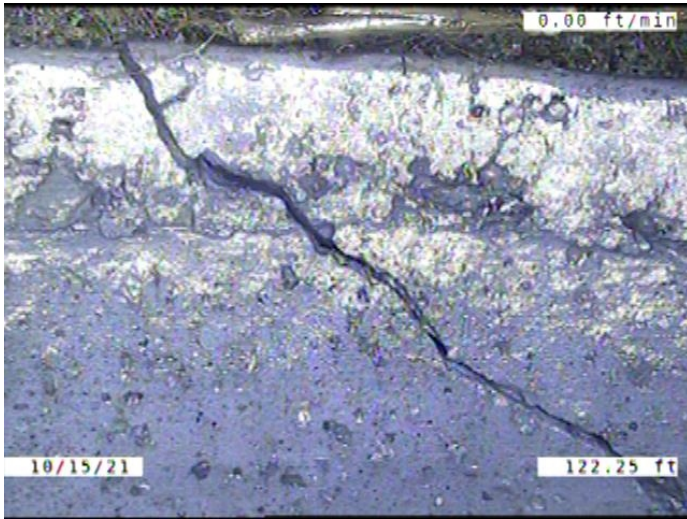
Code: **FM**
 Description: **Fracture Multiple**

Distance (ft): **122.3**
 Structural Grade: **4**
 O&M Grade: **0**
 Clock Start/From: **9**
 Clock To: **2**
 1st Value:
 2nd Value:
 Value Percent:
 Continuous Index:
 Within 8" of Joint: **YES**
 Remarks:

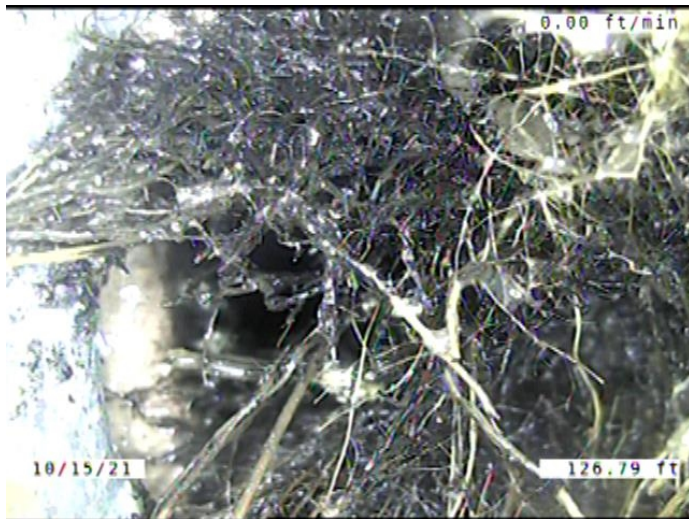
Code:	TBD
Description:	Tap Break-in/Hammer Defective
Distance (ft):	126.8
Structural Grade:	0
O&M Grade:	3
Clock Start/From:	10
Clock To:	
1st Value:	4.000
2nd Value:	
Value Percent:	
Continuous Index:	
Within 8" of Joint:	YES
Remarks:	CONSTANTLY RUNNING WATER. 95% PLUGGED WITH ROOTS

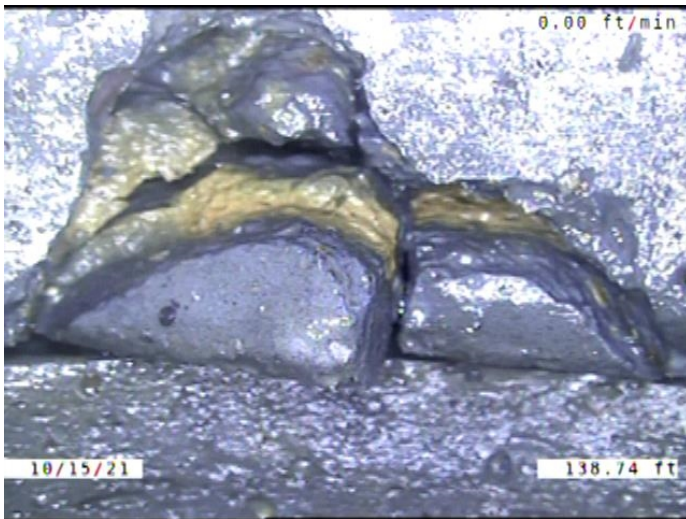
Code: **B**
Description: **Broken**

Distance (ft): **138.7**
Structural Grade: **4**
O&M Grade: **0**
Clock Start/From: **11**
Clock To: **1**
1st Value:
2nd Value:
Value Percent:
Continuous Index:
Within 8" of Joint: **YES**
Remarks:

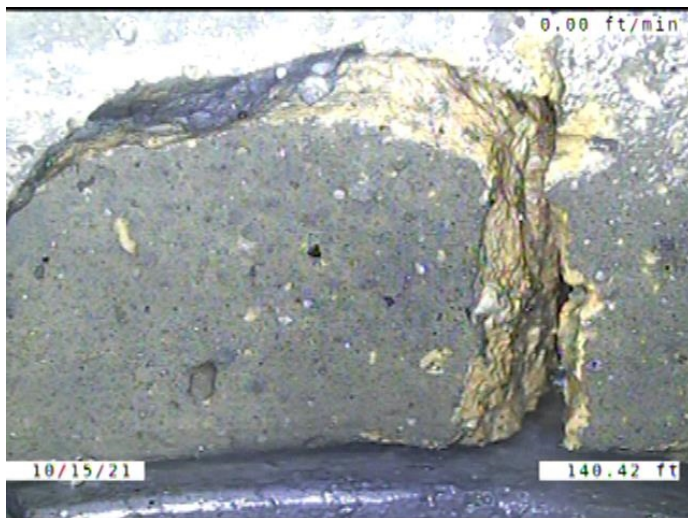
Code: **FM**
Description: **Fracture Multiple**

Distance (ft): **140.4**
Structural Grade: **4**
O&M Grade: **0**
Clock Start/From: **8**
Clock To: **3**
1st Value:
2nd Value:
Value Percent:
Continuous Index:
Within 8" of Joint: **YES**
Remarks:

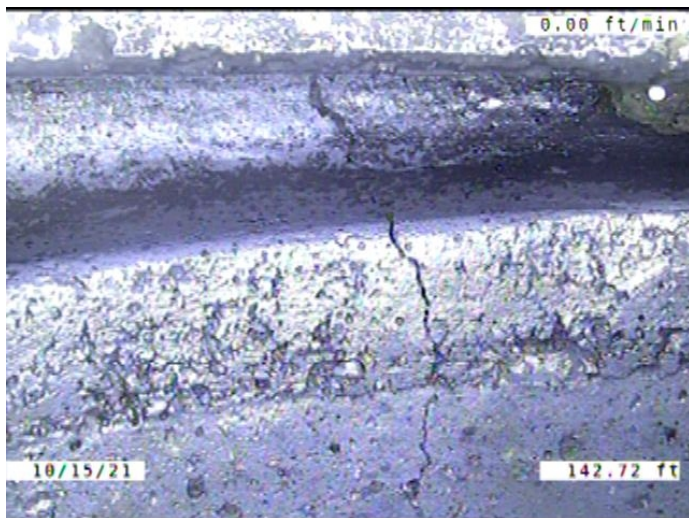
Code: **FM**
 Description: **Fracture Multiple**

Distance (ft): **142.7**
 Structural Grade: **4**
 O&M Grade: **0**
 Clock Start/From: **9**
 Clock To: **11**
 1st Value:
 2nd Value:
 Value Percent:
 Continuous Index:
 Within 8" of Joint: **YES**
 Remarks:

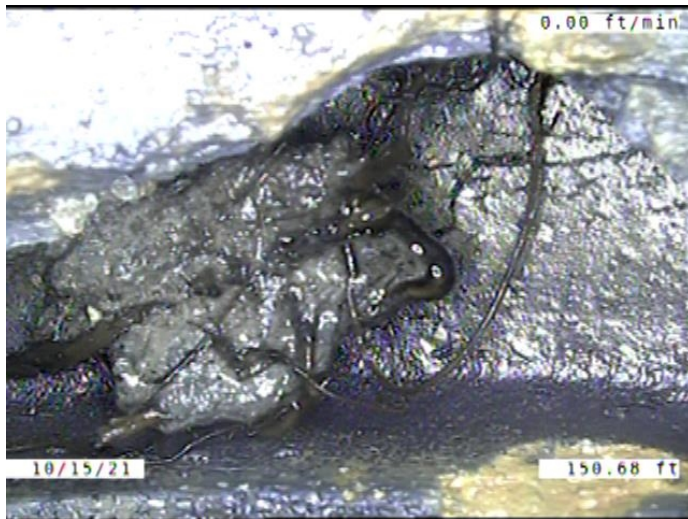
Code: **SMW**
 Description: **Surface Damage Missing Wall**

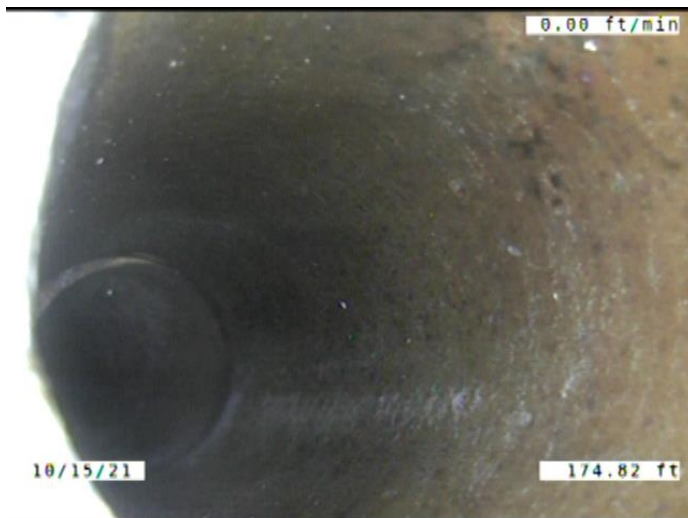
Code: **TBD**
Description: **Tap Break-in/Hammer Defective**

Distance (ft): **174.8**
Structural Grade: **0**
O&M Grade: **3**
Clock Start/From: **11**
Clock To:
1st Value: **4.000**
2nd Value:
Value Percent:
Continuous Index:
Within 8" of Joint: **YES**
Remarks: **Defective**

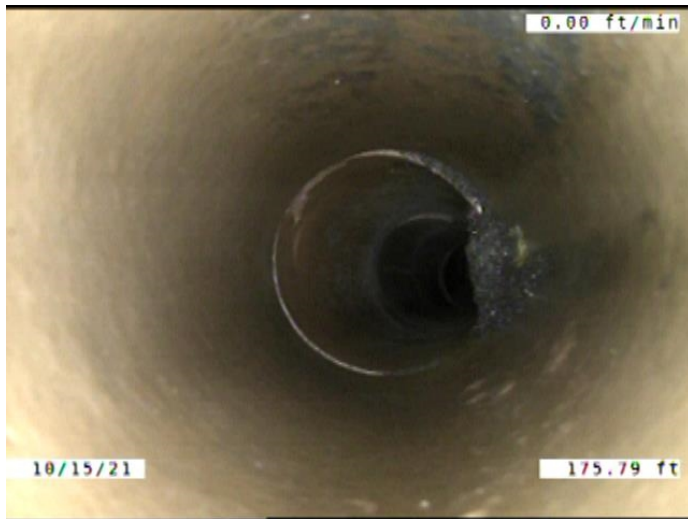
Code: **TBD**
Description: **Tap Break-in/Hammer Defective**

Distance (ft): **175.8**
Structural Grade: **0**
O&M Grade: **3**
Clock Start/From: **2**
Clock To:
1st Value: **4.000**
2nd Value:
Value Percent:
Continuous Index:
Within 8" of Joint: **YES**
Remarks: **Defective**
