Profile/Photo Observation Report

Street:	N MICHIGAN AVE	Flow Control:	Not Controlled
City:	Hobart, IN	Year Renewed:	
Location:	Other	Tape/Media #:	
Purpose:	Not Known	Dia/Height:	8"
Use:	Sanitary	Material:	VCP
Drain Area:	NA	Lining:	
Category:	NA		
Comment:

Location Details:		Direction of Survey:	Downstream
US MH:	M-704-017	DS MH:	M-704-016
		Total Length Surveyed (ft):	16.8

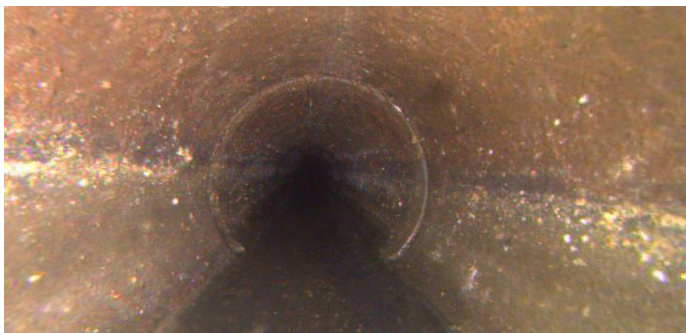
Code: **AMH**
Description: **Manhole**

Distance (ft): **.0**
Structural Grade: **0**
O&M Grade: **0**
Clock Start/From:
Clock To:
1st Value:
2nd Value:
Value Percent:
Continuous Index:
Within 8" of Joint: **NO**
Remarks: **M-704-017**

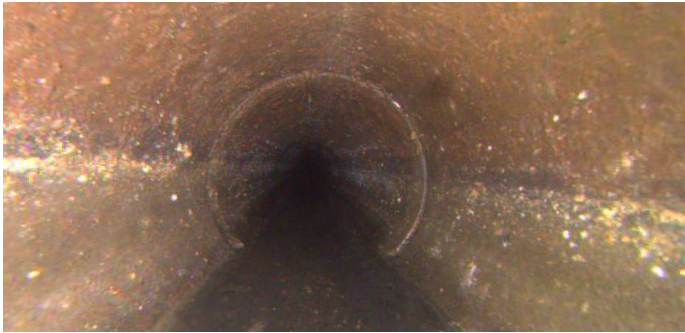
Code:	MWL
Description:	Water Level

Distance (ft):	.0
Structural Grade:	0
O&M Grade:	0
Clock Start/From:	
Clock To:	
1st Value:	
2nd Value:	
Value Percent:	5.000
Continuous Index:	
Within 8" of Joint:	NO
Remarks:

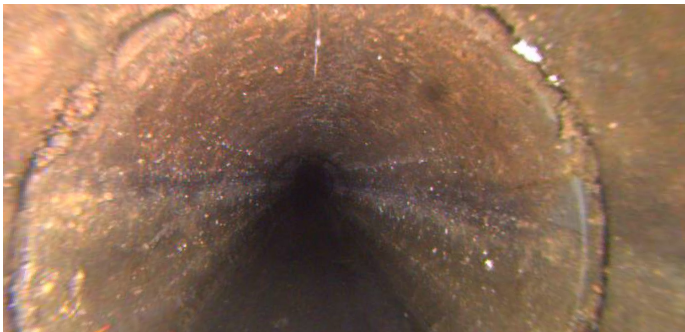
Code:	RFJ
Description:	Roots Fine Joint

Distance (ft):	1.1
Structural Grade:	0
O&M Grade:	1
Clock Start/From:	12
Clock To:	
1st Value:	
2nd Value:	
Value Percent:	
Continuous Index:	
Within 8" of Joint:	YES
Remarks:

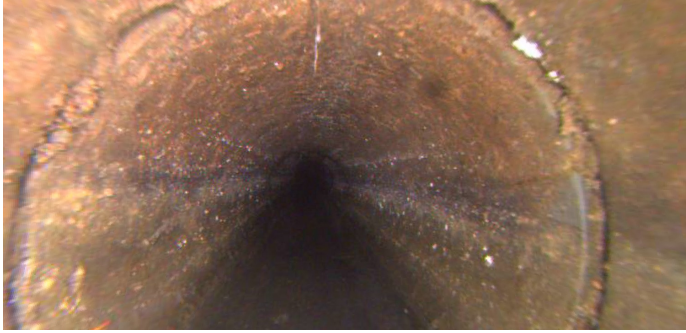
Code: **DAGS**
Description: **Deposits Attached Grease**

Distance (ft): **1.1**
Structural Grade: **0**
O&M Grade: **2**
Clock Start/From: **8**
Clock To: **4**
1st Value:
2nd Value:
Value Percent: **5.000**
Continuous Index: **S01**
Within 8" of Joint: **NO**
Remarks:

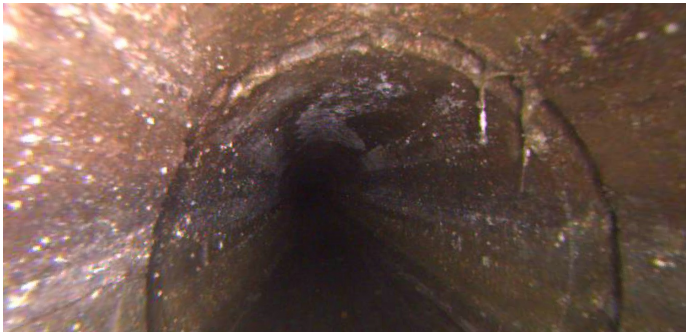
Code: **RFJ**
Description: **Roots Fine Joint**

Distance (ft): **5.6**
Structural Grade: **0**
O&M Grade: **1**
Clock Start/From: **11**
Clock To: **1**
1st Value:
2nd Value:
Value Percent:
Continuous Index:
Within 8" of Joint: **YES**
Remarks:

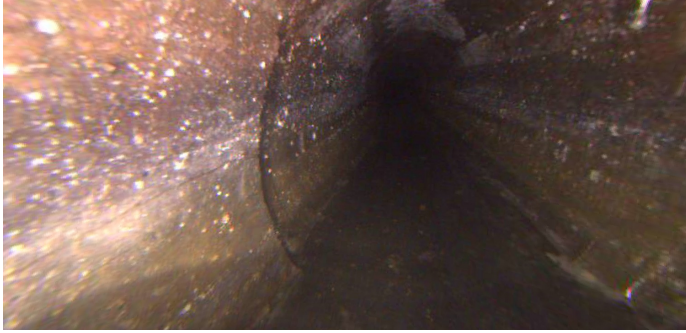
Code: **CL**
Description: **Crack Longitudinal**

Distance (ft): **5.6**
Structural Grade: **2**
O&M Grade: **0**
Clock Start/From: **9**
Clock To:
1st Value:
2nd Value:
Value Percent:
Continuous Index:
Within 8" of Joint: **YES**
Remarks:

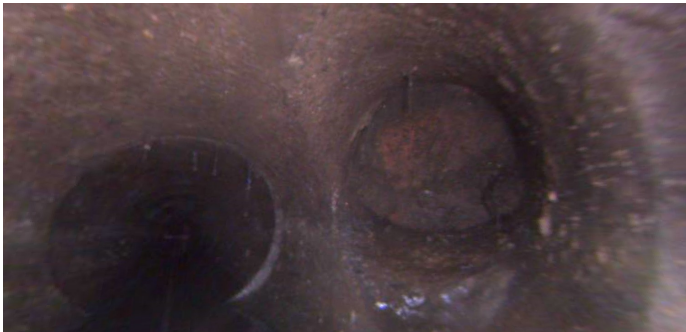
Code: **TFC**
Description: **Tap Factory Capped**

Distance (ft): **11.3**
Structural Grade: **0**
O&M Grade: **0**
Clock Start/From: **9**
Clock To:
1st Value: **4.000**
2nd Value:
Value Percent:
Continuous Index:
Within 8" of Joint:
Remarks:

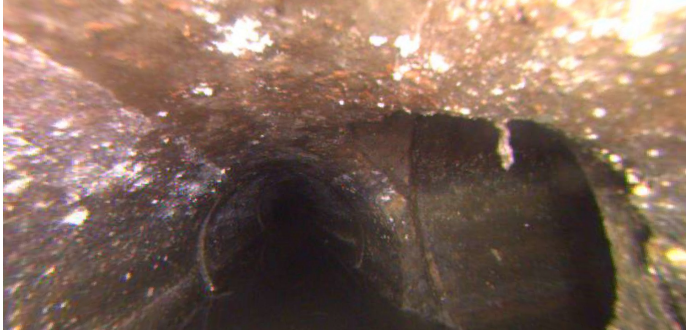
Code: **TB**
Description: **Tap Break-in**

Distance (ft): **14.8**
Structural Grade: **0**
O&M Grade: **0**
Clock Start/From: **3**
Clock To:
1st Value: **4.000**
2nd Value:
Value Percent:
Continuous Index:
Within 8" of Joint:
Remarks:

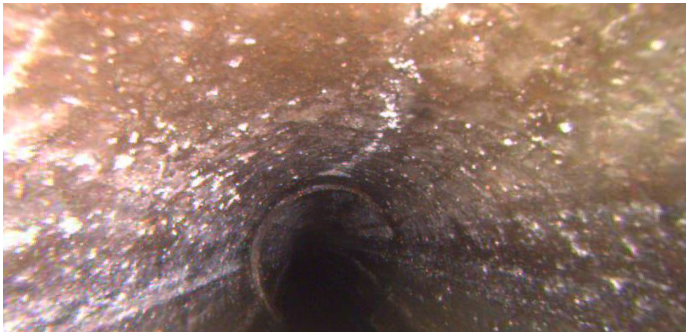
Code: **MSA**
Description: **Abandoned Survey**

Distance (ft): **16.8**
Structural Grade: **0**
O&M Grade: **0**
Clock Start/From:
Clock To:
1st Value:
2nd Value:
Value Percent:
Continuous Index:
Within 8" of Joint: **NO**
Remarks: **debris**

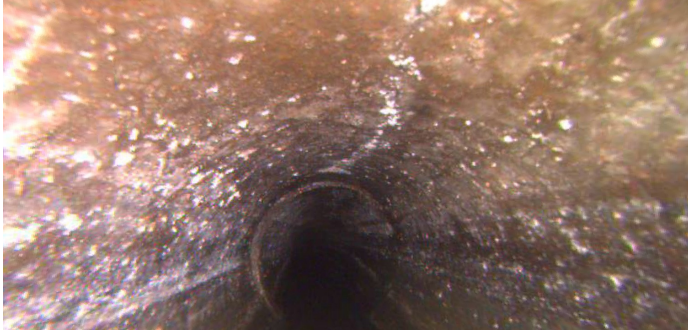
Code:	DAGS
Description:	Deposits Attached Grease
Distance (ft):	16.8
Structural Grade:	0
O&M Grade:	2
Clock Start/From:	8
Clock To:	4
1st Value:	
2nd Value:	
Value Percent:	5.000
Continuous Index:	F01
Within 8" of Joint:	NO
Remarks:
